ARBORIST REPORT

24 Trevor Rd, Newport

August, 2020

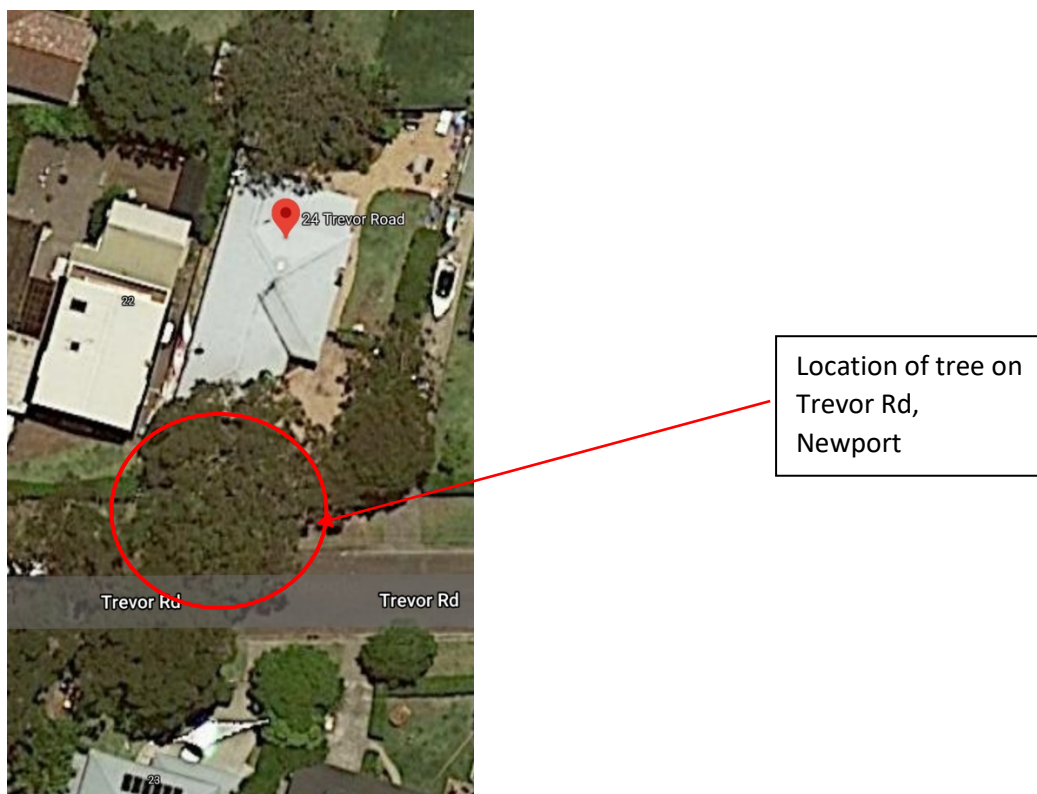
Figure 3- Tree Location

This mature *Eucalyptus punctata* has a single dominant trunk with a branching canopy. The tree is growing under power lines. The trunk has been pruned to avoid overhead wires resulting in a curved trunk at 4m then becoming straight and regular with a well structured canopy. Less than 10% dead wood is present in canopy. There is no evidence of lightning strike or internal decay.

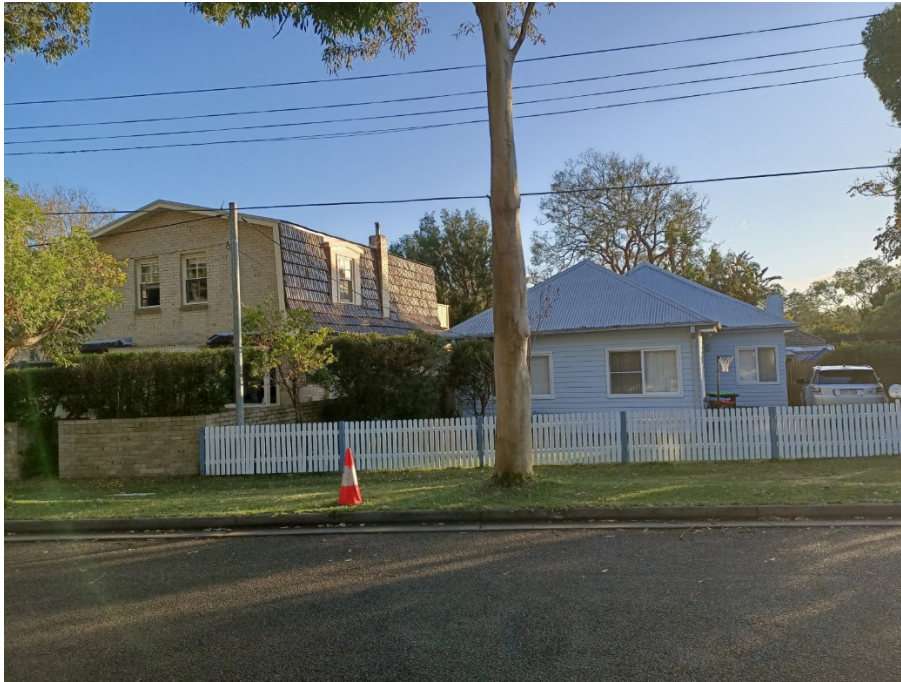
Figure 4- Position of tree (proposed driveway is on the western side of the tree)

Sule Rating: A2

Scenario 1- If approval for the tree's removal is given, WEW recommends the tree be replaced by a 3:1 ratio with locally endemic species that are part of the Pittwater Spotted Gum Forest Vegetation Community. See recommended replacement species below.

Scenario 2- Tree to be retained. The Structural Root Zone (SRZ) extends 3.81m from the centre of the trunk. If the proposed driveway encroaches on the (SRZ) then tree protection measures must be incorporated into the design of the new driveway, see diagram below.
