## PRELIMINARY GEOTECHNICAL ASSESSMENT:

### 43 Parni Place, Frenchs Forest

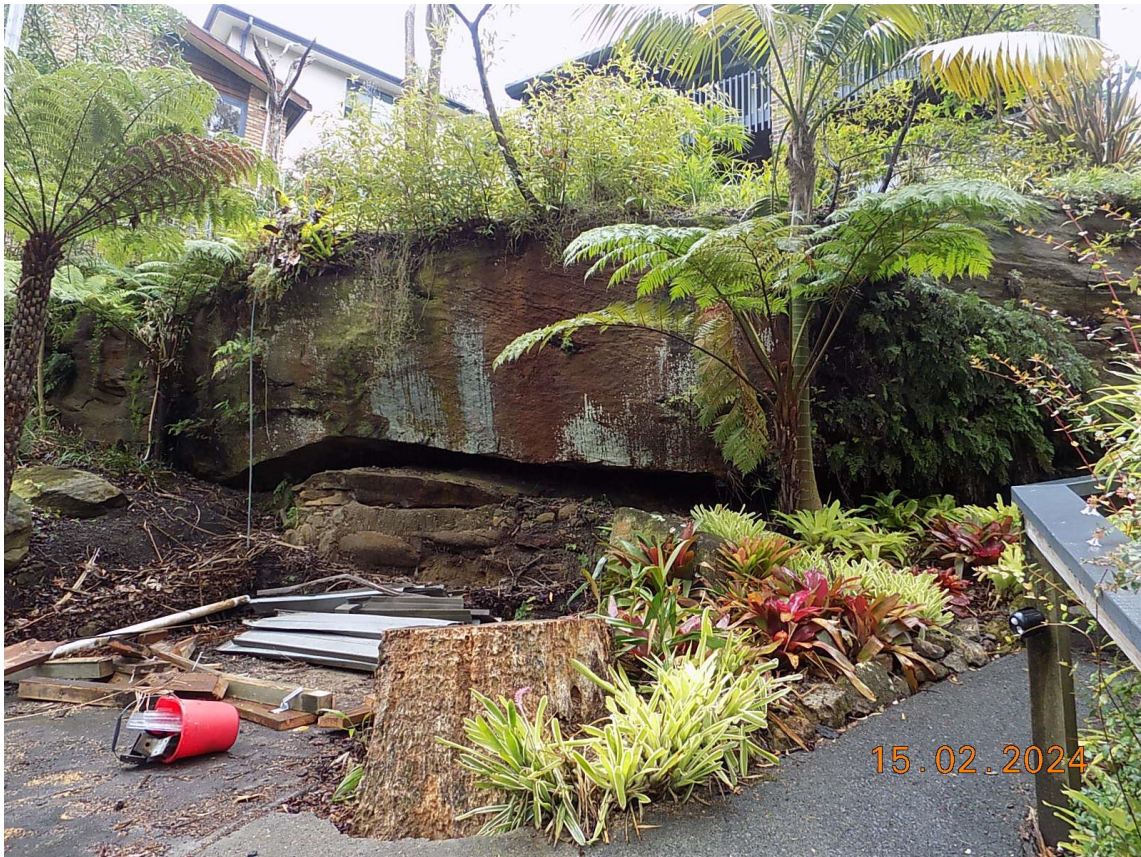
Photo 1

- ~8.0m from the subject house.
- ~0.8m from the undercut outcrop to the N below the house (Photo 1).
- ~3.5m from the undercut outcrop to the W below the neighbouring house. (Photo 2)
- ~4.5m from the W neighbouring house.

Excavation methods are to be used that limit peak particle velocity to 5mm/sec at the undercut outcrops. Vibration monitoring will be required to verify this is achieved. Vibration monitoring must include a light/alarm so the operator knows if vibration limits have been exceeded. The equipment is to log and record vibrations throughout the excavation works.

- Rock sawing the excavation perimeter to at least 1.0m deep prior to any rock breaking with hammers, keeping the saw cuts below the rock to be broken throughout the excavation process.
- Limiting rock hammer size.
- Rock hammering in short bursts so vibrations do not amplify.
- Rock breaking with the hammer angled away from the nearby sensitive structures.
- Creating additional saw breaks in the rock where vibration limits are exceeded, as well as reducing hammer size as necessary.
- Use of rock grinders (milling head).
