## **GEOTECHNICAL INVESTIGATION:**

Proposed Unit Block at **17-19 Anzac Avenue, Collaroy**

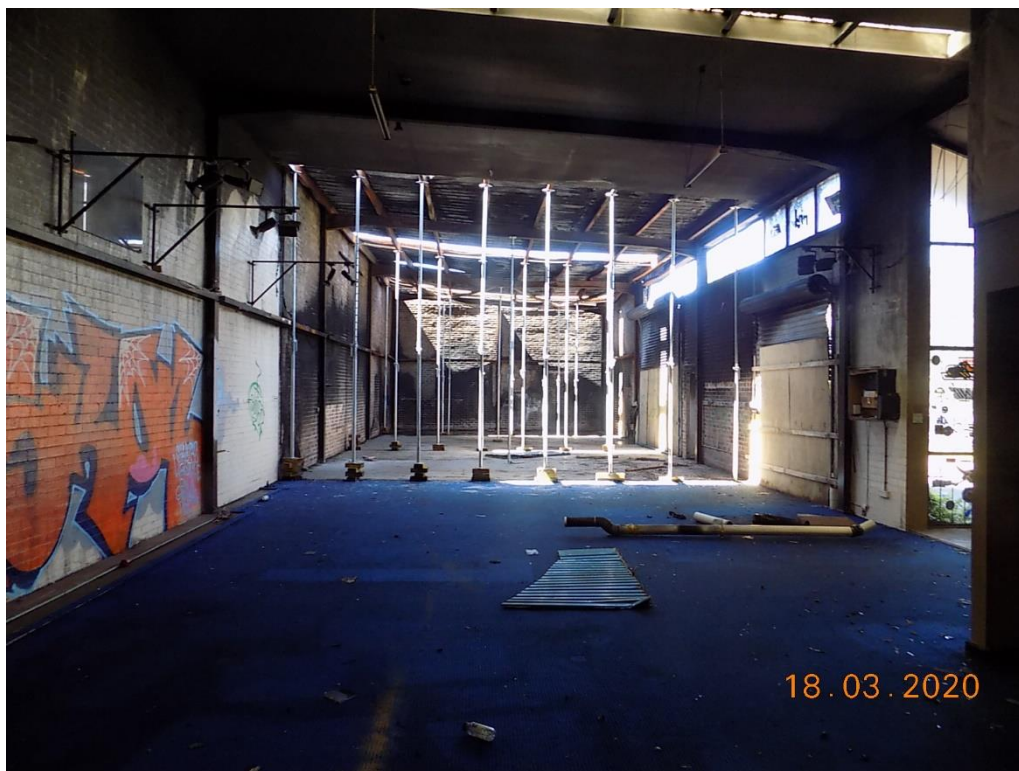
Photo 3

- 2.1** The site was inspected on the 18<sup>th</sup> March, 2020.
- 2.2** This commercial property is level with the road and has an E aspect. It is located on the gently graded lower reaches of a hillslope. The slope rises across the site at an average angle of <5°. The slope above and below the property continues at similar angles.
- 2.3** At the road frontage to Anzac Avenue, a concrete driveway runs to a parking area on the S side of the property (Photo 1). The single-storey brick warehouse encompasses the remainder of the property (Photo 2). The warehouse has been structurally compromised in a fire and will be demolished as part of the proposed works (Photo 3).

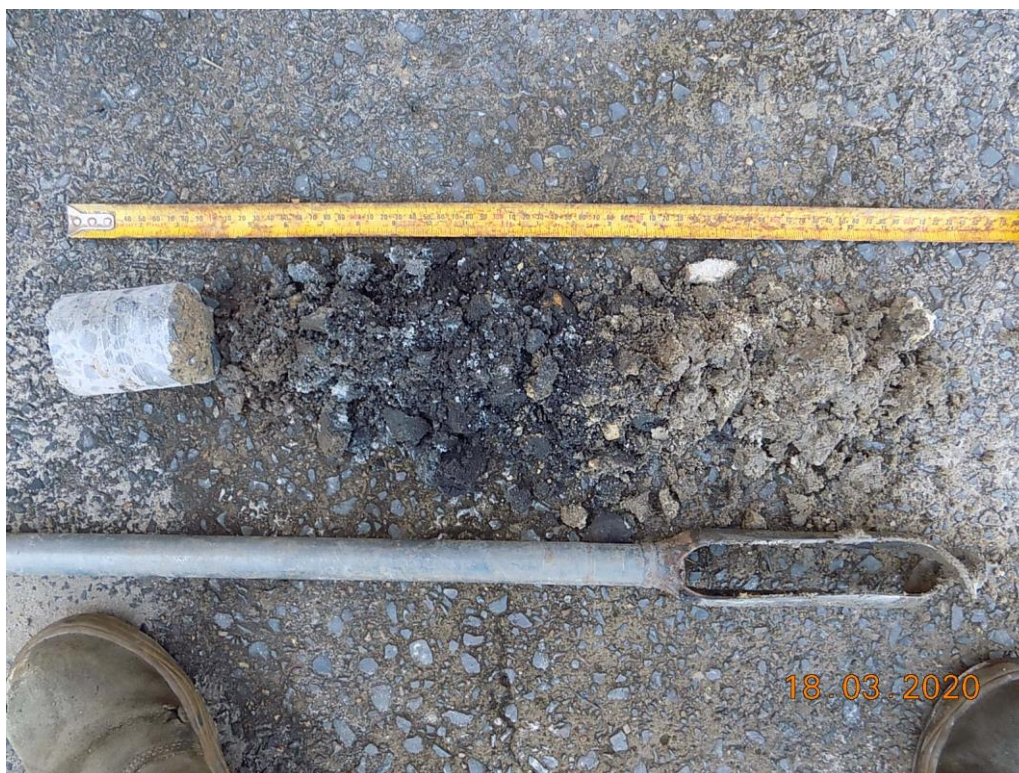
### AUGER HOLE 1 (~RL13.3) – AH1 (Photo 4)

Depth (m)	Material Encountered
0.0 to 0.1	<b>CONCRETE SLAB.</b>
0.1 to 0.6	<b>FILL</b> , disturbed sandy soil, dark brown, brown, and white, medium dense to very dense, medium to coarse grained with fine trace organic matter.

Refusal @ 0.6m on unknown obstruction. No watertable encountered.

Photo 4: AH1 – Downhole is from left to right

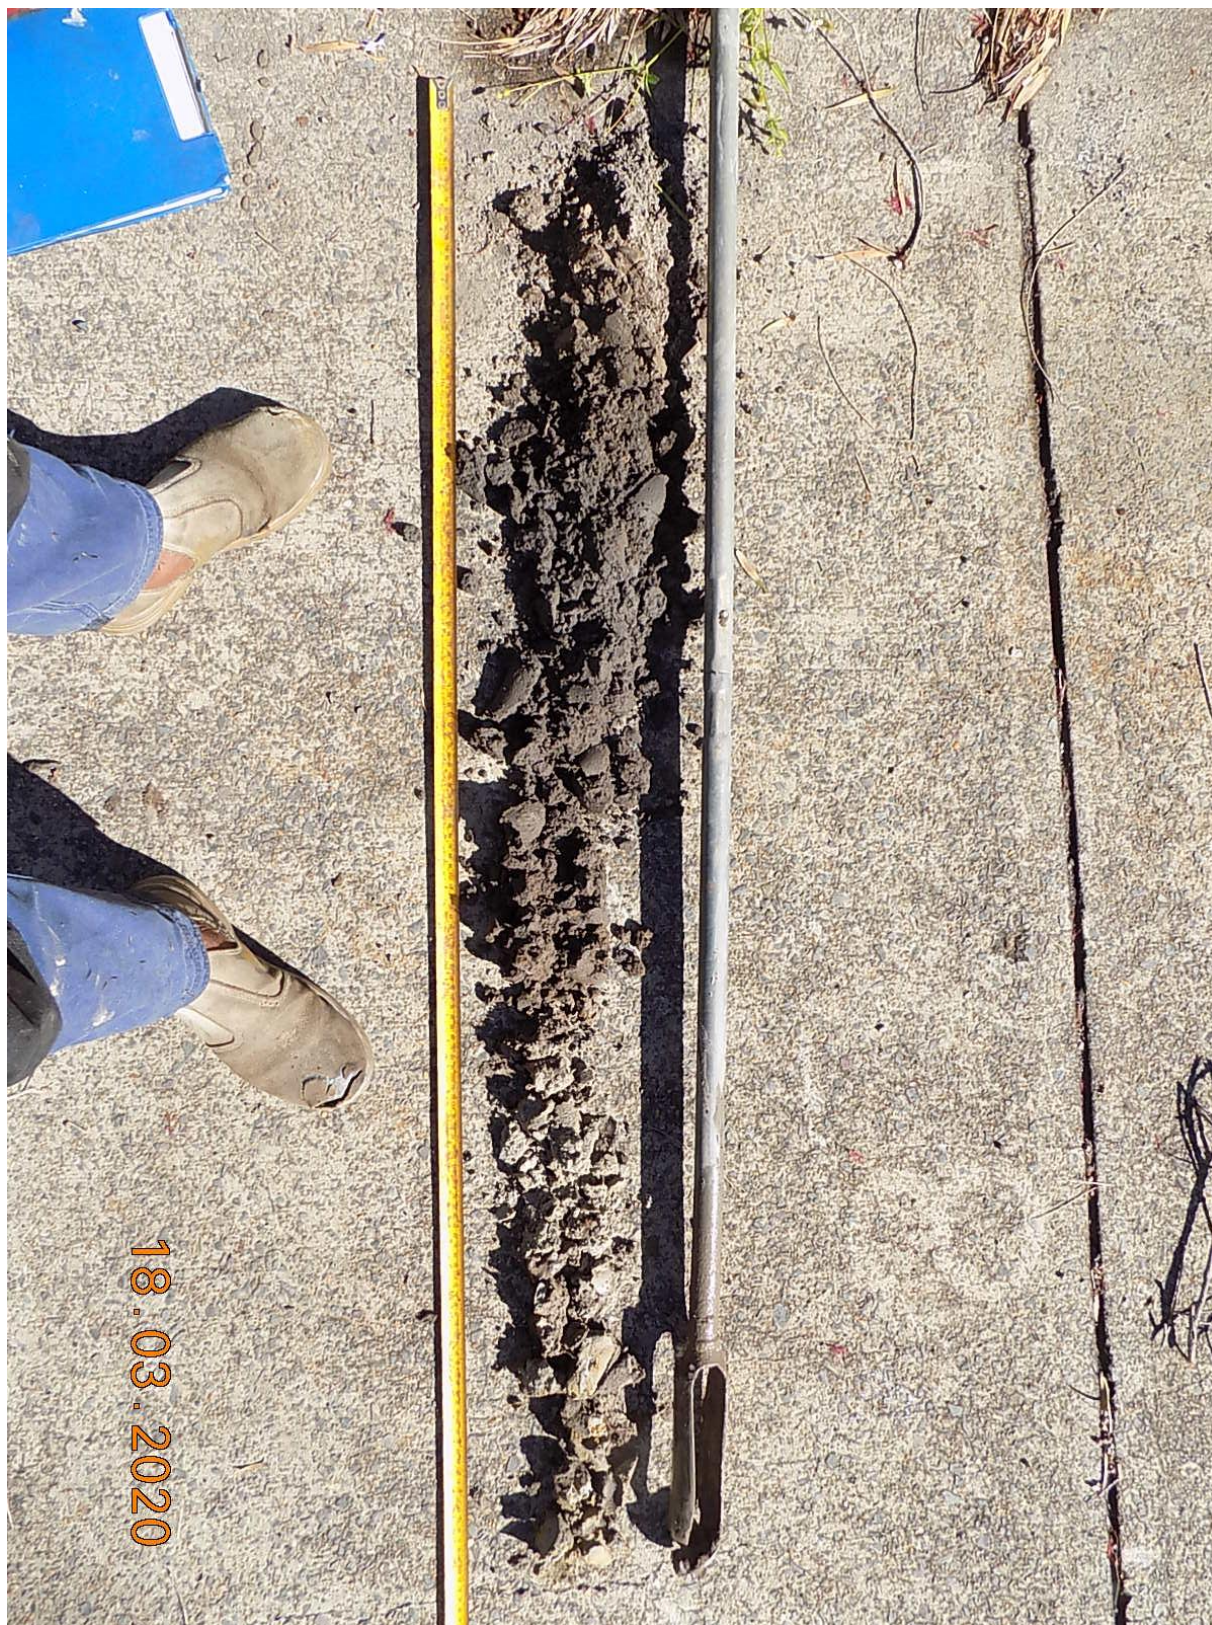
### AUGER HOLE 2 (~RL12.9) – AH2 (Photo 5)

Depth (m)	Material Encountered
0.0 to 0.2	<b>FILL</b> , gravel, grey, loose to medium dense, dry, coarse grained.
0.2 to 1.0	<b>SAND</b> , dark brown, medium dense, damp, coarse grained with fine trace organic matter.
1.0 to 1.3	<b>CLAYEY SAND</b> , grey, medium dense, wet, coarse grained with sugary texture.
1.3 to 1.5	<b>CLAY</b> , Very Low Strength Sandstone, grey and mottled orange, very stiff, damp, fine grained with sugary texture.

End of hole @ 1.5m in Very Low Strength Sandstone. Groundwater seepage observed.

Photo 5: AH2 – Downhole is from top to bottom

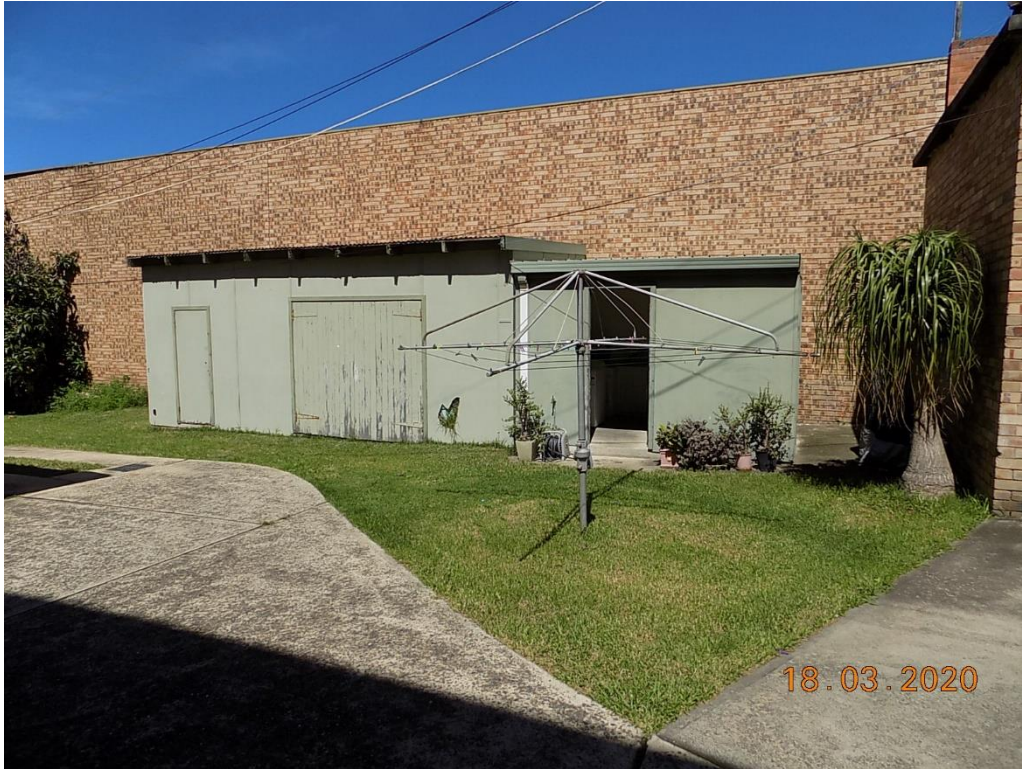
Photo 6

The excavation for the proposed car stackers will reach a maximum depth of ~3.4m and will be taken close to flush with the N and E common boundaries. The excavation will be taken close to flush with a fibro shed on the N neighbouring property (Photo 6) and will be set back ~1.0m from the E neighbouring house (Photo 7). Thus, the N and E property boundaries, N neighbouring fibro shed, and E neighbouring house will be within the zone of influence of the proposed excavations. In this instance, the zone of influence is the area above a theoretical 30° line from the base of the excavation towards the surrounding structures or boundaries. Heavy ground support is recommended due to the presence of manmade fill and sand, groundwater, and the proximity to the N and E neighbouring structures/properties.

The proposed excavation requires support installed along all sides before excavations commence. In this instance, due to the manmade fill, sand, and groundwater encountered secant or contiguous piers are suitable support. Secant piers are the preferred option but if contiguous piers are used, the gaps between the piers are to be grouted closed as the excavation is lowered so no sand moves through the wall. The piers can be temporarily supported by embedment below the base of the excavation and/or propping but are to be tied into the floor and ceiling slabs of the garage structure during construction.

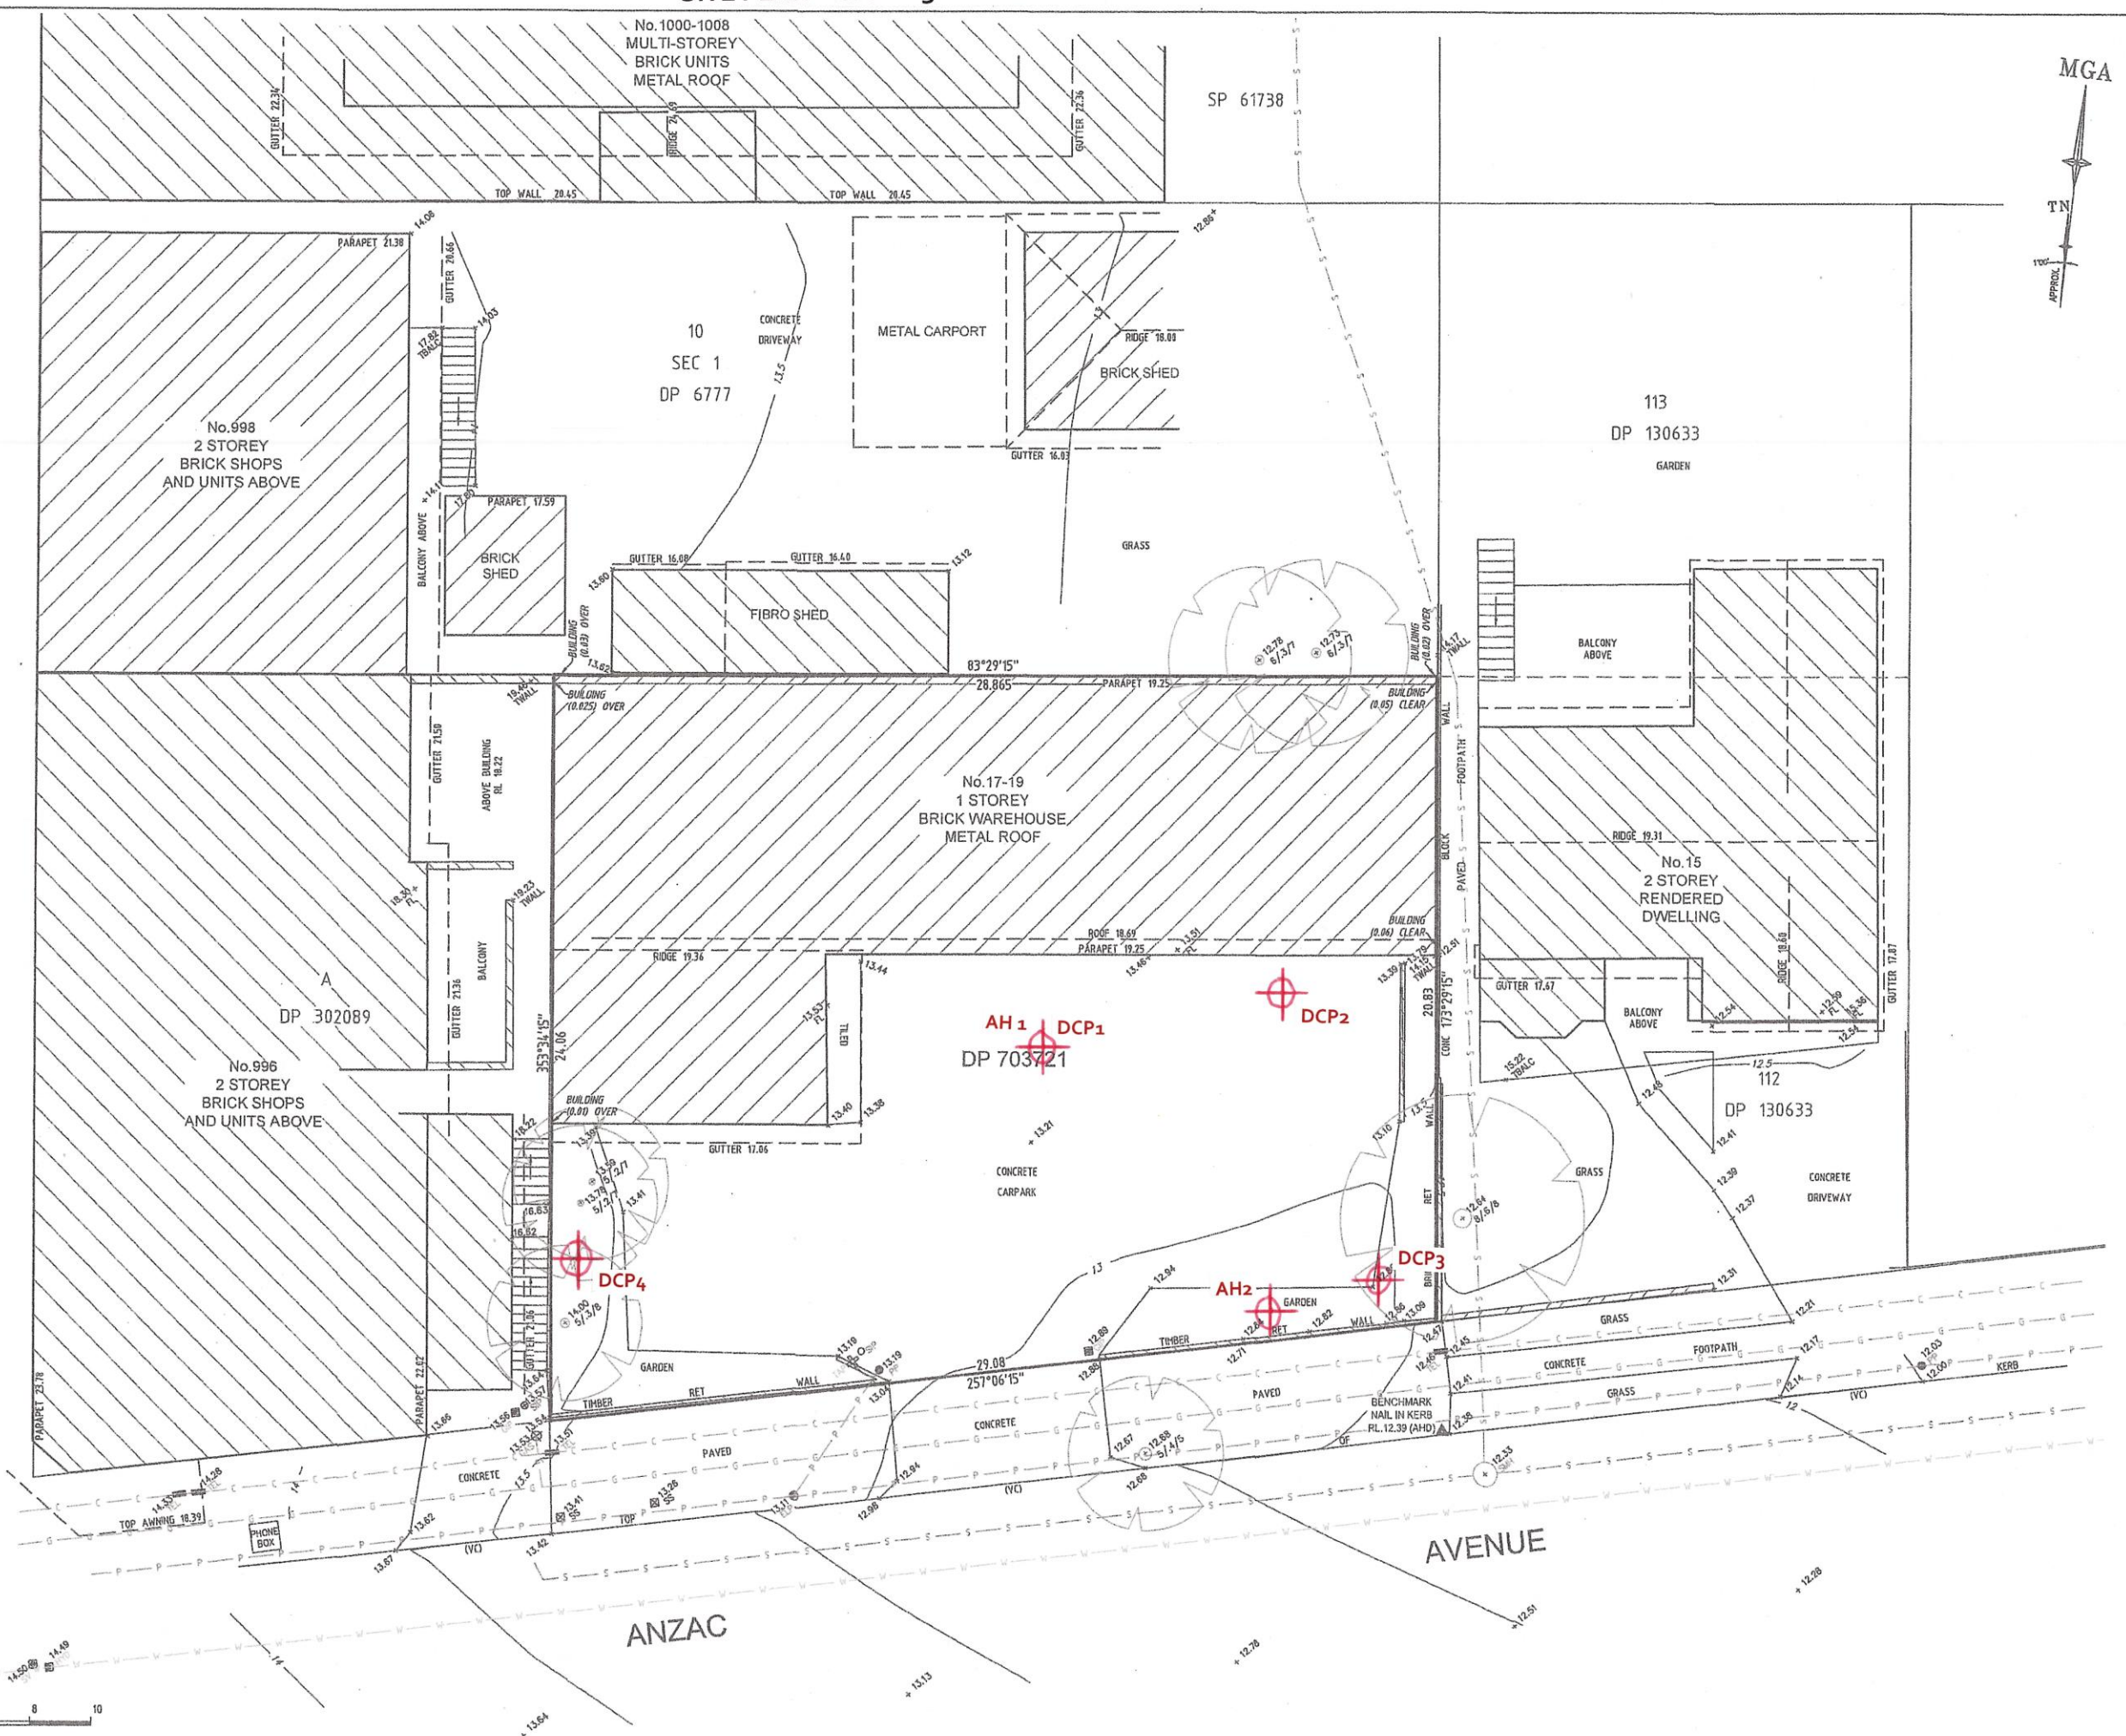
**SITE PLAN – showing test locations**

Minimum extent of required shoring shown in blue

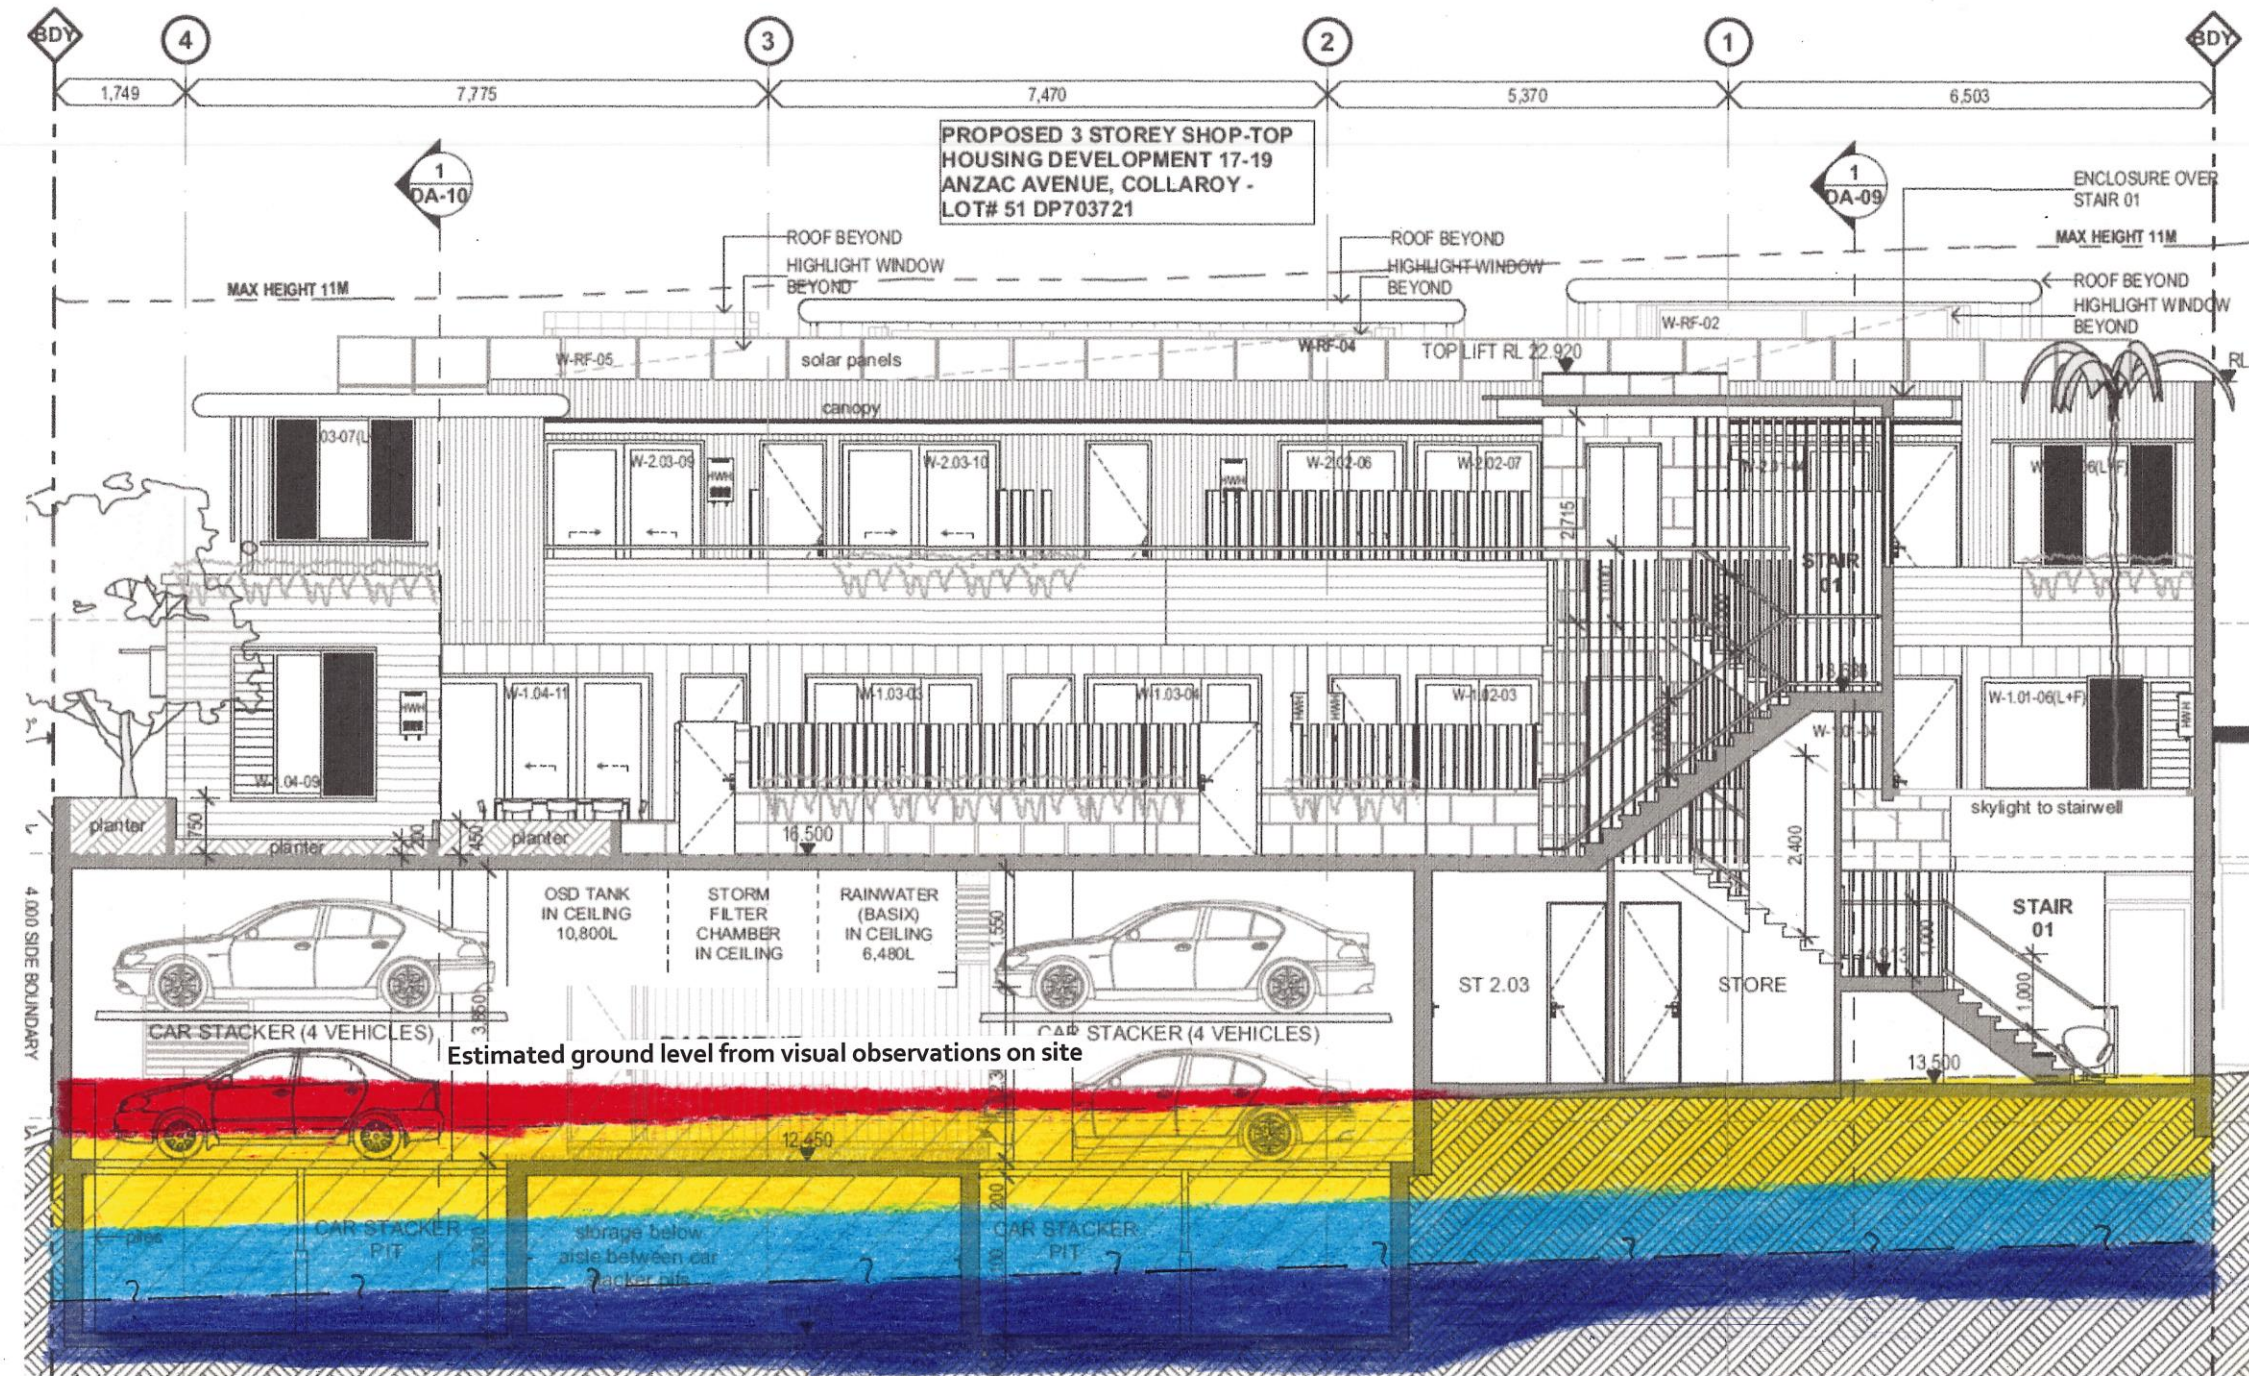
# TYPE SECTION – Diagrammatic Interpretation of expected Ground Materials

- Fill
- Sands and Clayey Sands
- Very Low Strength Sandstone
- Possible Low to Medium Strength Sandstone Band through Narrabeen Group Rocks – Depth to rock not known.
