Report Title: Geotechnical Report 46A Irrubel Road, Newport
Report Date: 11/2/19
Author: BEN WHITE
Author's Company/Organisation: WHITE GEOTECHNICAL GROUP PTY LTD

GEOTECHNICAL INVESTIGATION:

Proposed Pool at **46A Irrubel Road, Newport**

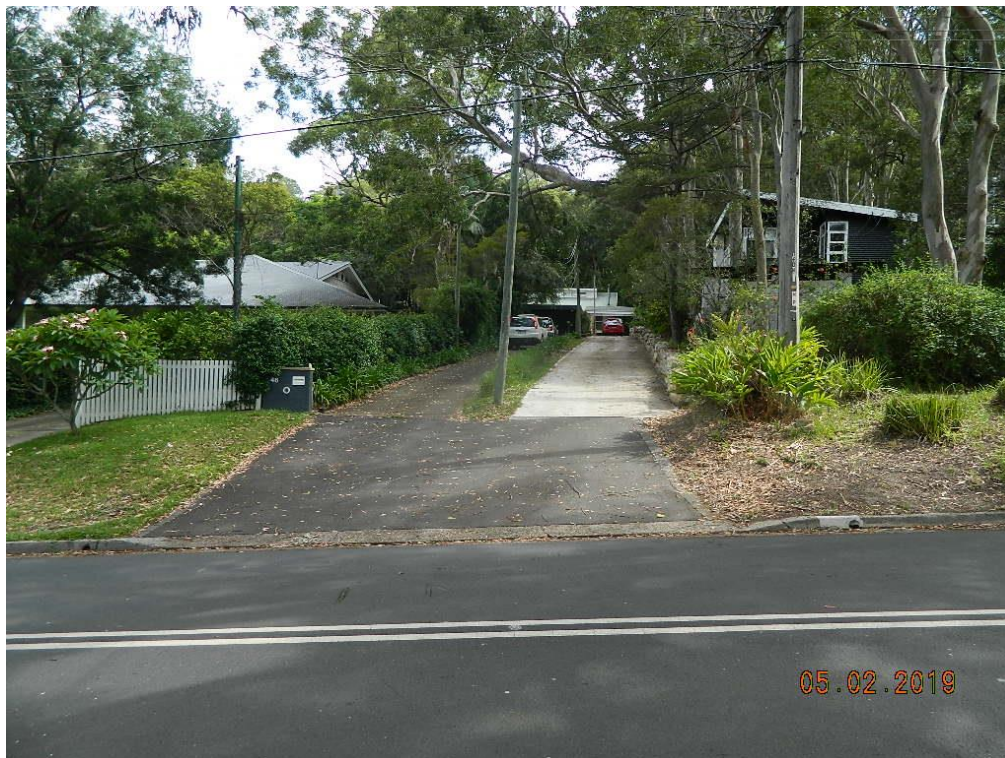
- 2.3** At the road frontage, a concrete driveway runs to a carport attached to the S side of the house (Photos 1 & 2). An excavation has been made along the uphill boundary to level an area for the driveway and house (Photo 3). The cut is supported by a stable sandstone block retaining wall reaching a maximum height of ~1.0m a

Photo 1: Subject driveway is on the right

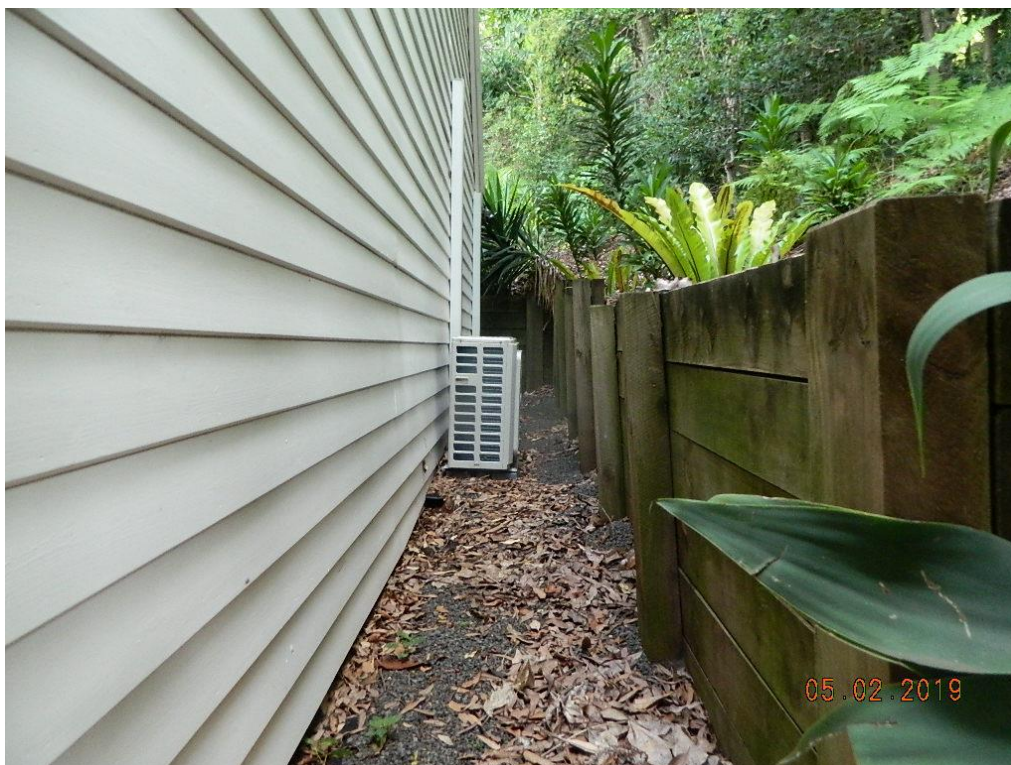
Photo 4

which becomes a treated timber retaining wall reaching a maximum height of ~1.1m along the uphill side of the house (Photo 4). Both walls will be replaced as part of the proposed works. The part two-storey brick and timber clad house is supported on brick walls and brick piers (Photo 5). Settlement cracking was observed in the supporting walls of the downhill side of the house and one of the supporting brick piers was observed to be tilting (Photos 6, 7 & 8). Steel bracing has been placed for additional support to the cross beams. The brick walls will be remediated and the brick pier replaced as part of the proposed works. Ground tests indicate a fill up to a maximum depth of ~1.5m has been placed on the downhill side of the house for a level lawn area (Photo 9). The fill has been battered at safe angles. An old treated timber retaining wall on the downhill side of the property will be replaced as part of the proposed works (Photo 10). The slope below the wall falls at steep angles to intermittent watercourse along the lower boundary that flows from NE to SW. The watercourse was dry at the time of the inspection and the banks of the creek appear stable (Photo 11). No significant signs of movement were observed on the property. No geotechnical hazards that could impact on the subject property were observed on the neighbouring properties as seen from the subject property and the road.

Any retaining walls that are to be demolished as part of the proposed works are to be dismantled from the top down. Any fill and soil behind the wall is to be lowered simultaneously and battered at 1.0 Horizontal to 1.7 Vertical (30°) until the new retaining walls are installed. Excavations through undisturbed clay and Extremely Low Strength Shale or better will stand at vertical angles unsupported for the short period of time until retaining walls are installed provided the cut batters are prevented from becoming saturated. See "Excavation Advice Applying to All Excavations" to follow.

If cut batters will be left for more than a few days before the retaining wall construction begins temporary support is to be installed for the ~16.5m where the excavation is close to flush with the E common boundary. The support is to be approved/designed by the structural engineer. All temporary support is to remain in place until the retaining wall is built.

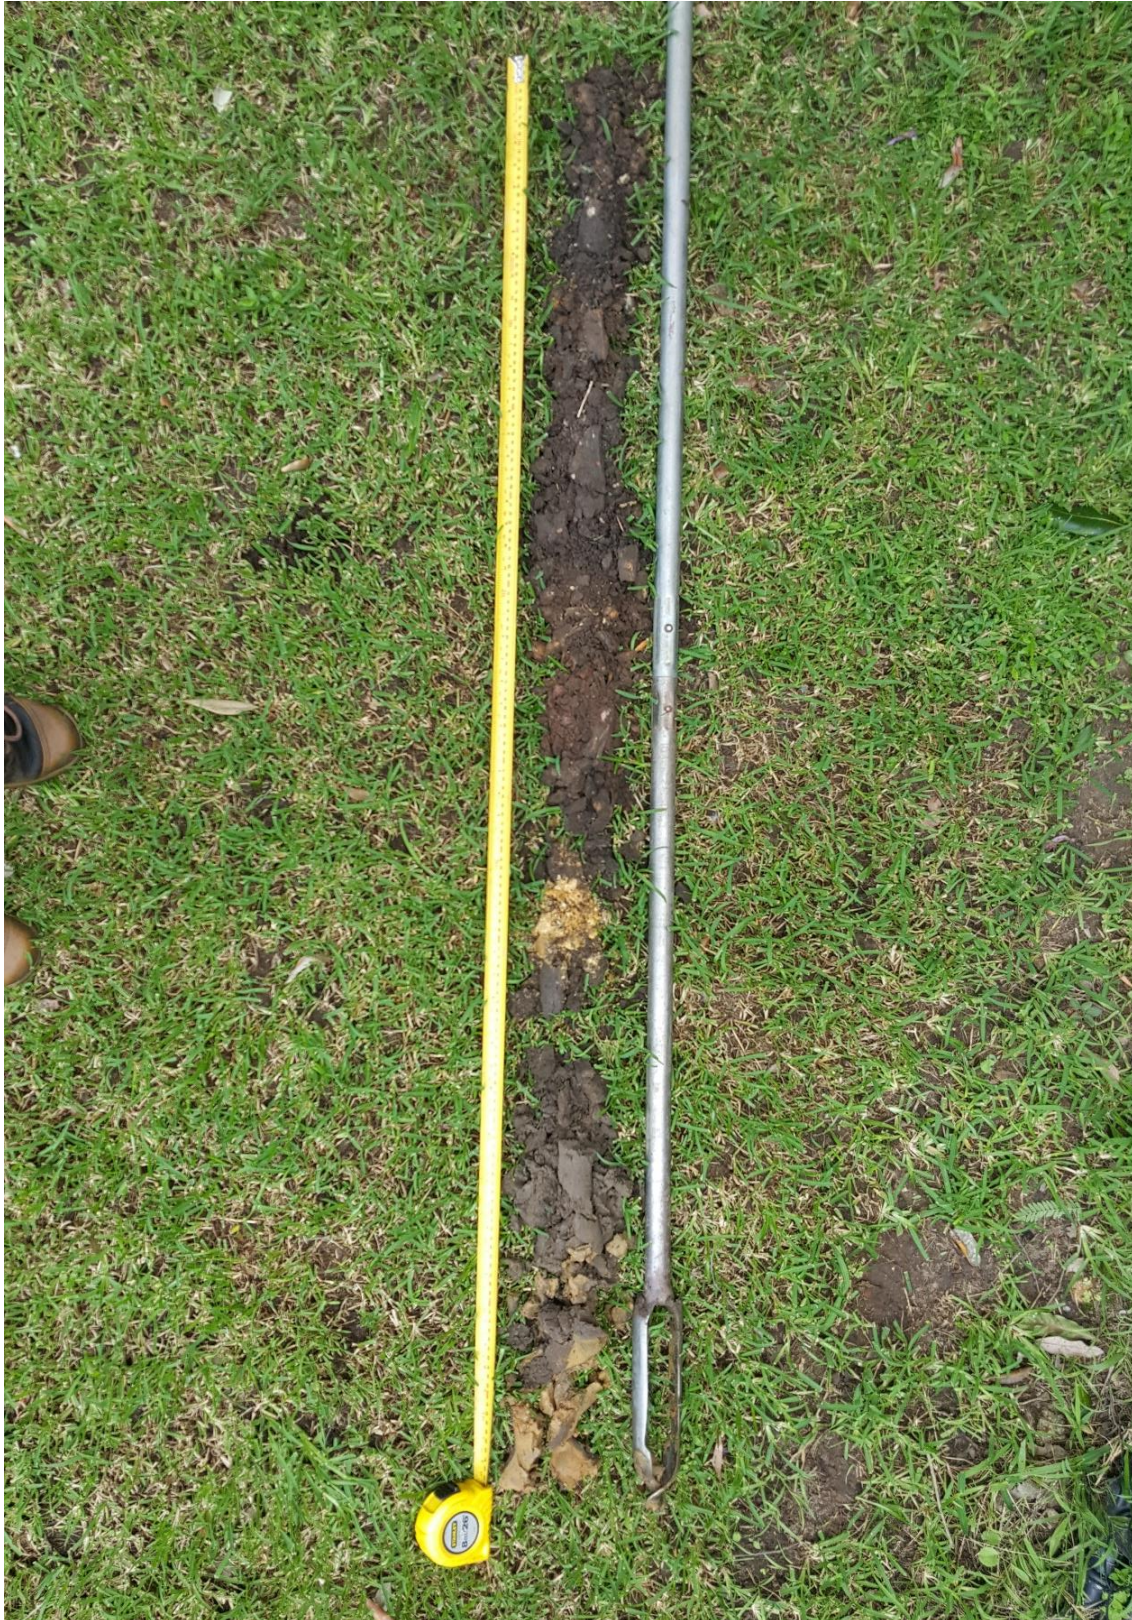
AUGER HOLE 1 (~RL32.0) – AH1 (Photo 12)

Depth (m)	Material Encountered
0.0 to 0.3	FILL , disturbed sandy soil, brown, loose, rock fragments, fine to medium grained, organic matter, dry.
0.3 to 0.6	FILL , disturbed sandy soil, brown, loose, rock fragments, fine to medium grained, dry.
0.6 to 1.0	SILTY CLAY , brown to reddish brown, firm, fine to medium grained, rock fragments, dry.
1.0 to 1.3	SANDY CLAY , brown, firm, fine to medium grained, dry.
1.3 to 1.6	CLAY , yellowish brown, very stiff, mottled red, fine grained, dry.

End of hole @ 1.6m in stiff clay. No watertable encountered.

Photo 12 - End of the auger is at the bottom of the picture

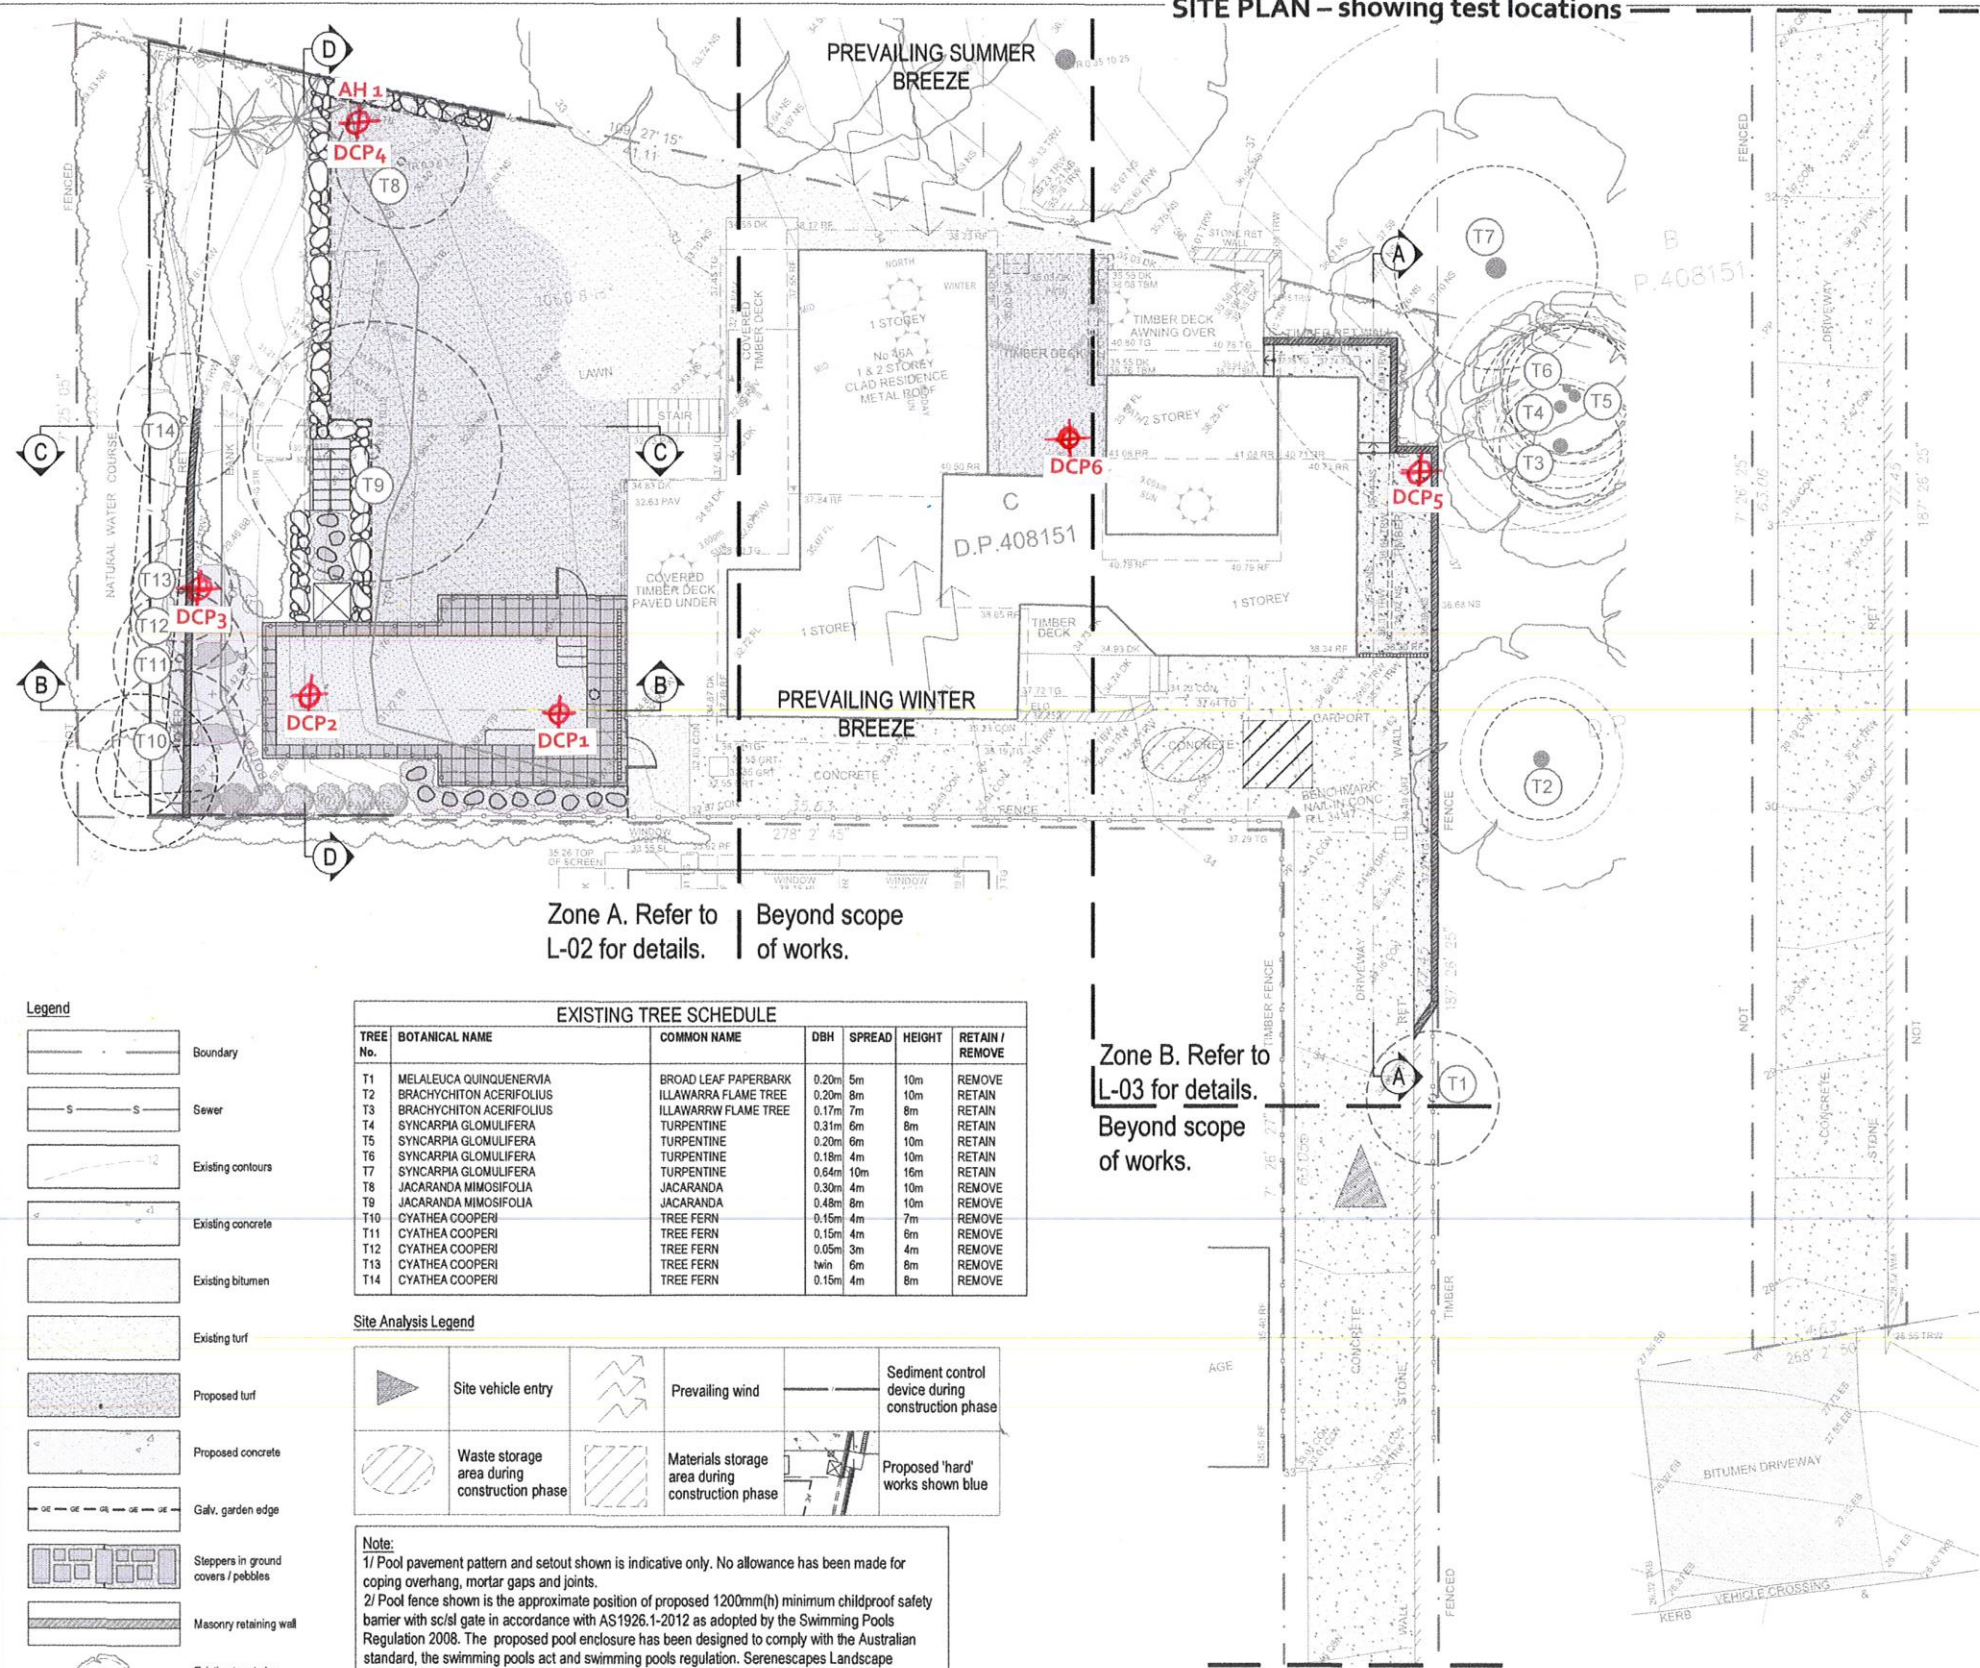
SITE PLAN – showing test locations

One Hand Auger Hole (AH) was put down to identify the soil materials. Six Dynamic Cone Penetrometer (DCP) tests were put down to determine the relative density of the overlying soil and the depth to weathered rock. The locations of the tests are shown on the site plan. It should be noted that a level of caution should be applied when interpreting DCP test results. The test will not pass through hard buried objects so in some instances it can be difficult to

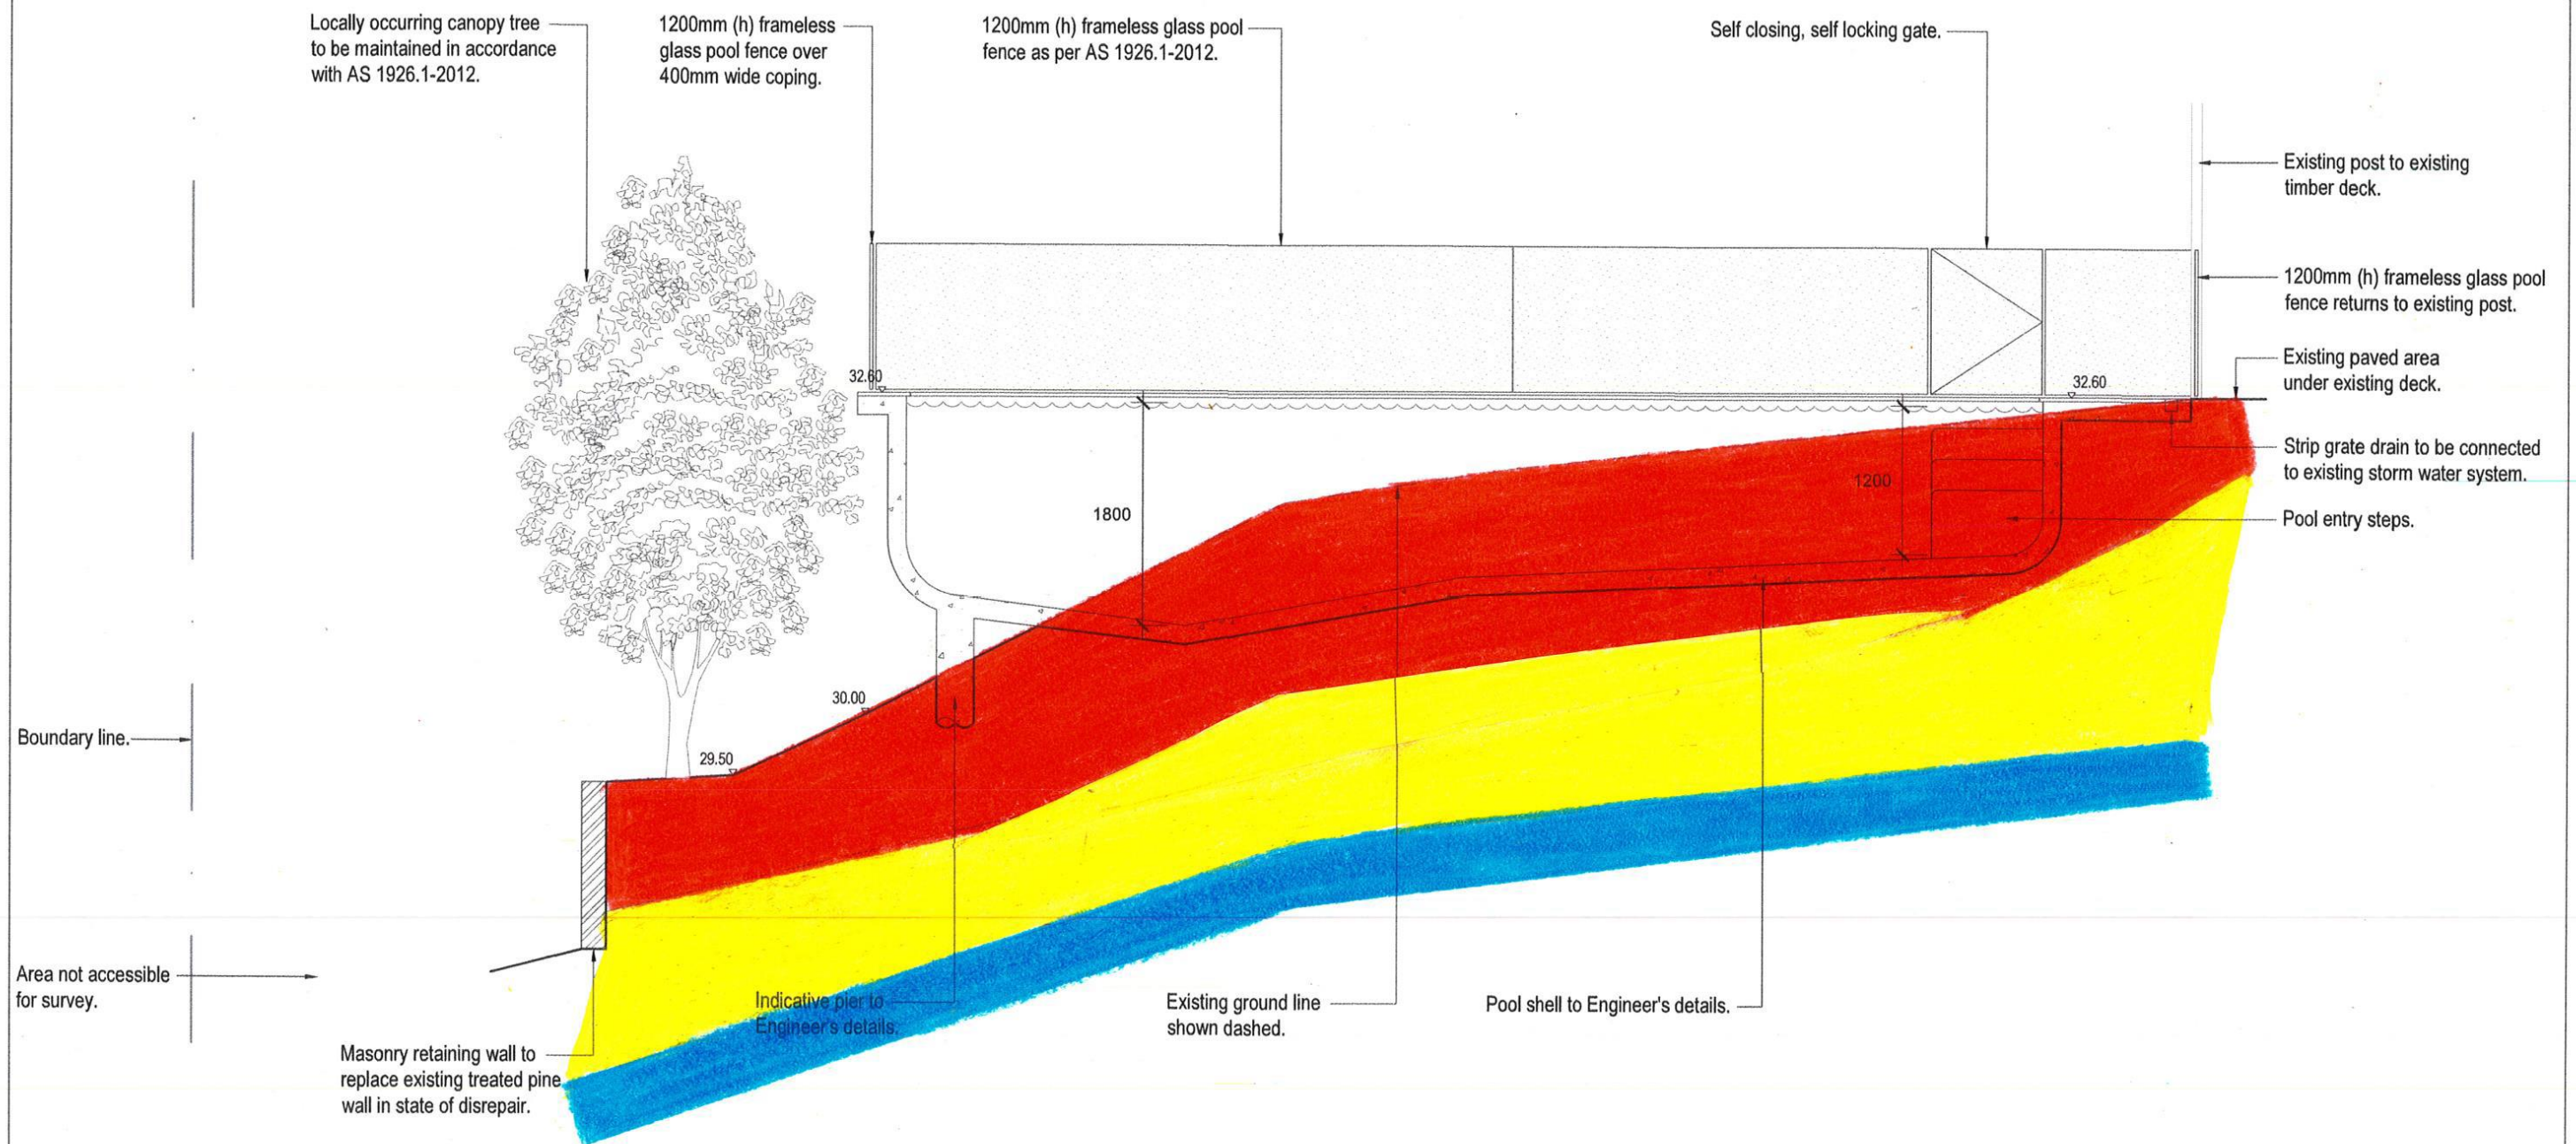
TYPE SECTION – Diagrammatical Interpretation of expected Ground Materials

The slope materials are colluvial at the near surface and residual at depth. They consist of a fill and thin sandy topsoil over silty and sandy clays and clays with rock fragments throughout the profile. In the test locations the silty and sandy clays and clays merge into the weathered zone of the underlying shale at depths between ~0.6 to ~1.2m below the current surface,

being deeper over DCP1, 2 and 4 due to the fill placed to level lawn area on the downhill side of the house. It is interpreted from ground tests that the fill reaches a maximum depth of ~1.5m. The weathered zone is interpreted as Extremely Low Strength Shale. It is to be noted that this material can appear as a mottled stiff clay when it is cut up by excavation equipment. See Type Section attached for a diagrammatical representation of the expected ground materials.
