50 Condoever Street, North Balgowlah

Comments on Updates to Plans

GEOTECHNICAL INVESTIGATION:

Subdivision and Two New Houses at 50 Condoover Street, North Balgowlah

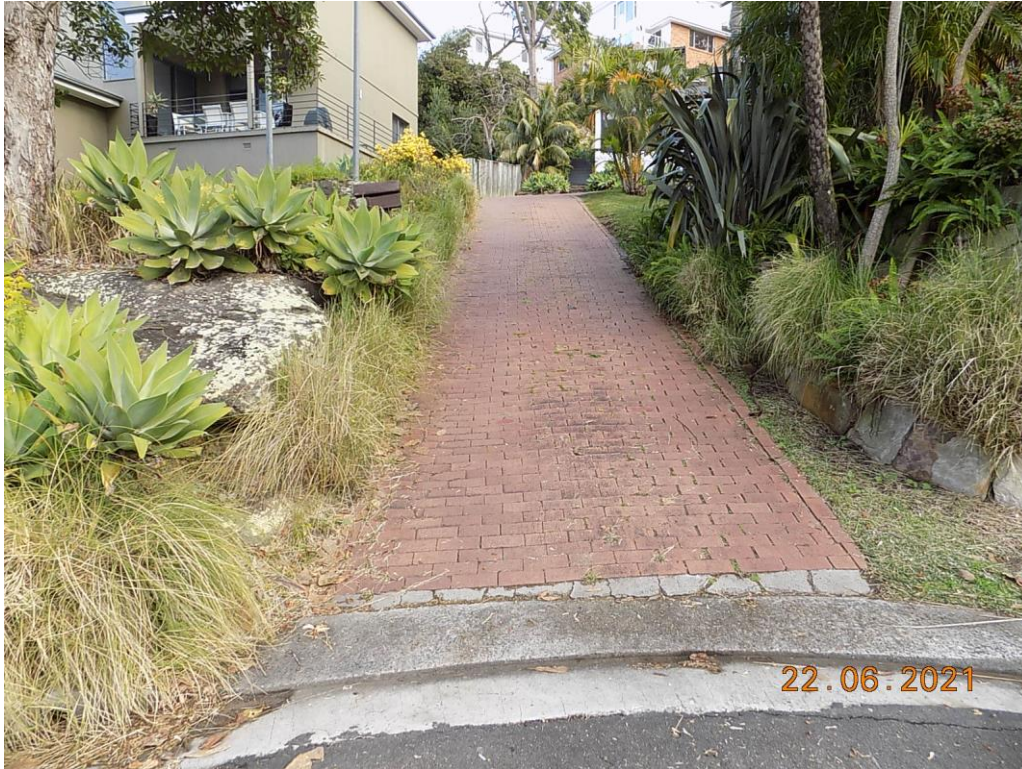
Photo 1

- 2.3** At the road frontage, a brick-paved driveway runs up the slope to a carport on the downhill side of the property (Photo 1). The driveway and carport will both be demolished as part of the proposed works. Competent Medium Strength Sandstone outcrops at the road frontage and on the downhill side of the carport (Photo 2). The single-storey brick house was observed to be supported directly off outcropping sandstone and will also be demolished as part of the proposed works (Photo 3). The cut for the uphill side of the house is supported by a stable stack rock retaining wall ~1.0m high (Photo 4). Medium Strength Sandstone bedrock outcrops and steps up the

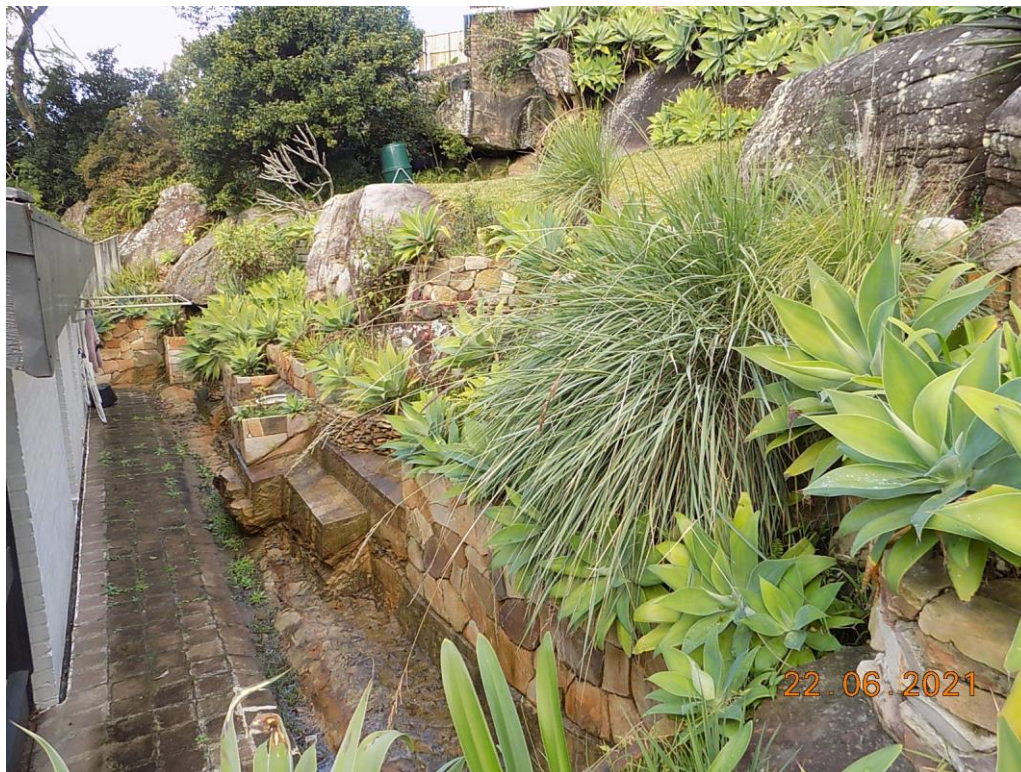
Photo 5

slope above the cut (Photo 5). The outcropping rock is slightly undercut but has been underpinned in the past by the owner using concrete block and brick blade walls and piers mortared with non-shrink grout (Photo 6). A gentle to moderately sloping lawn rises above the outcrop to the road frontage with Kimo Street (Photo 7). Medium Strength Sandstone outcrops and steps up the slope through this lawn (Photo 8). No significant geological defects were observed in the outcrop and it is considered stable.

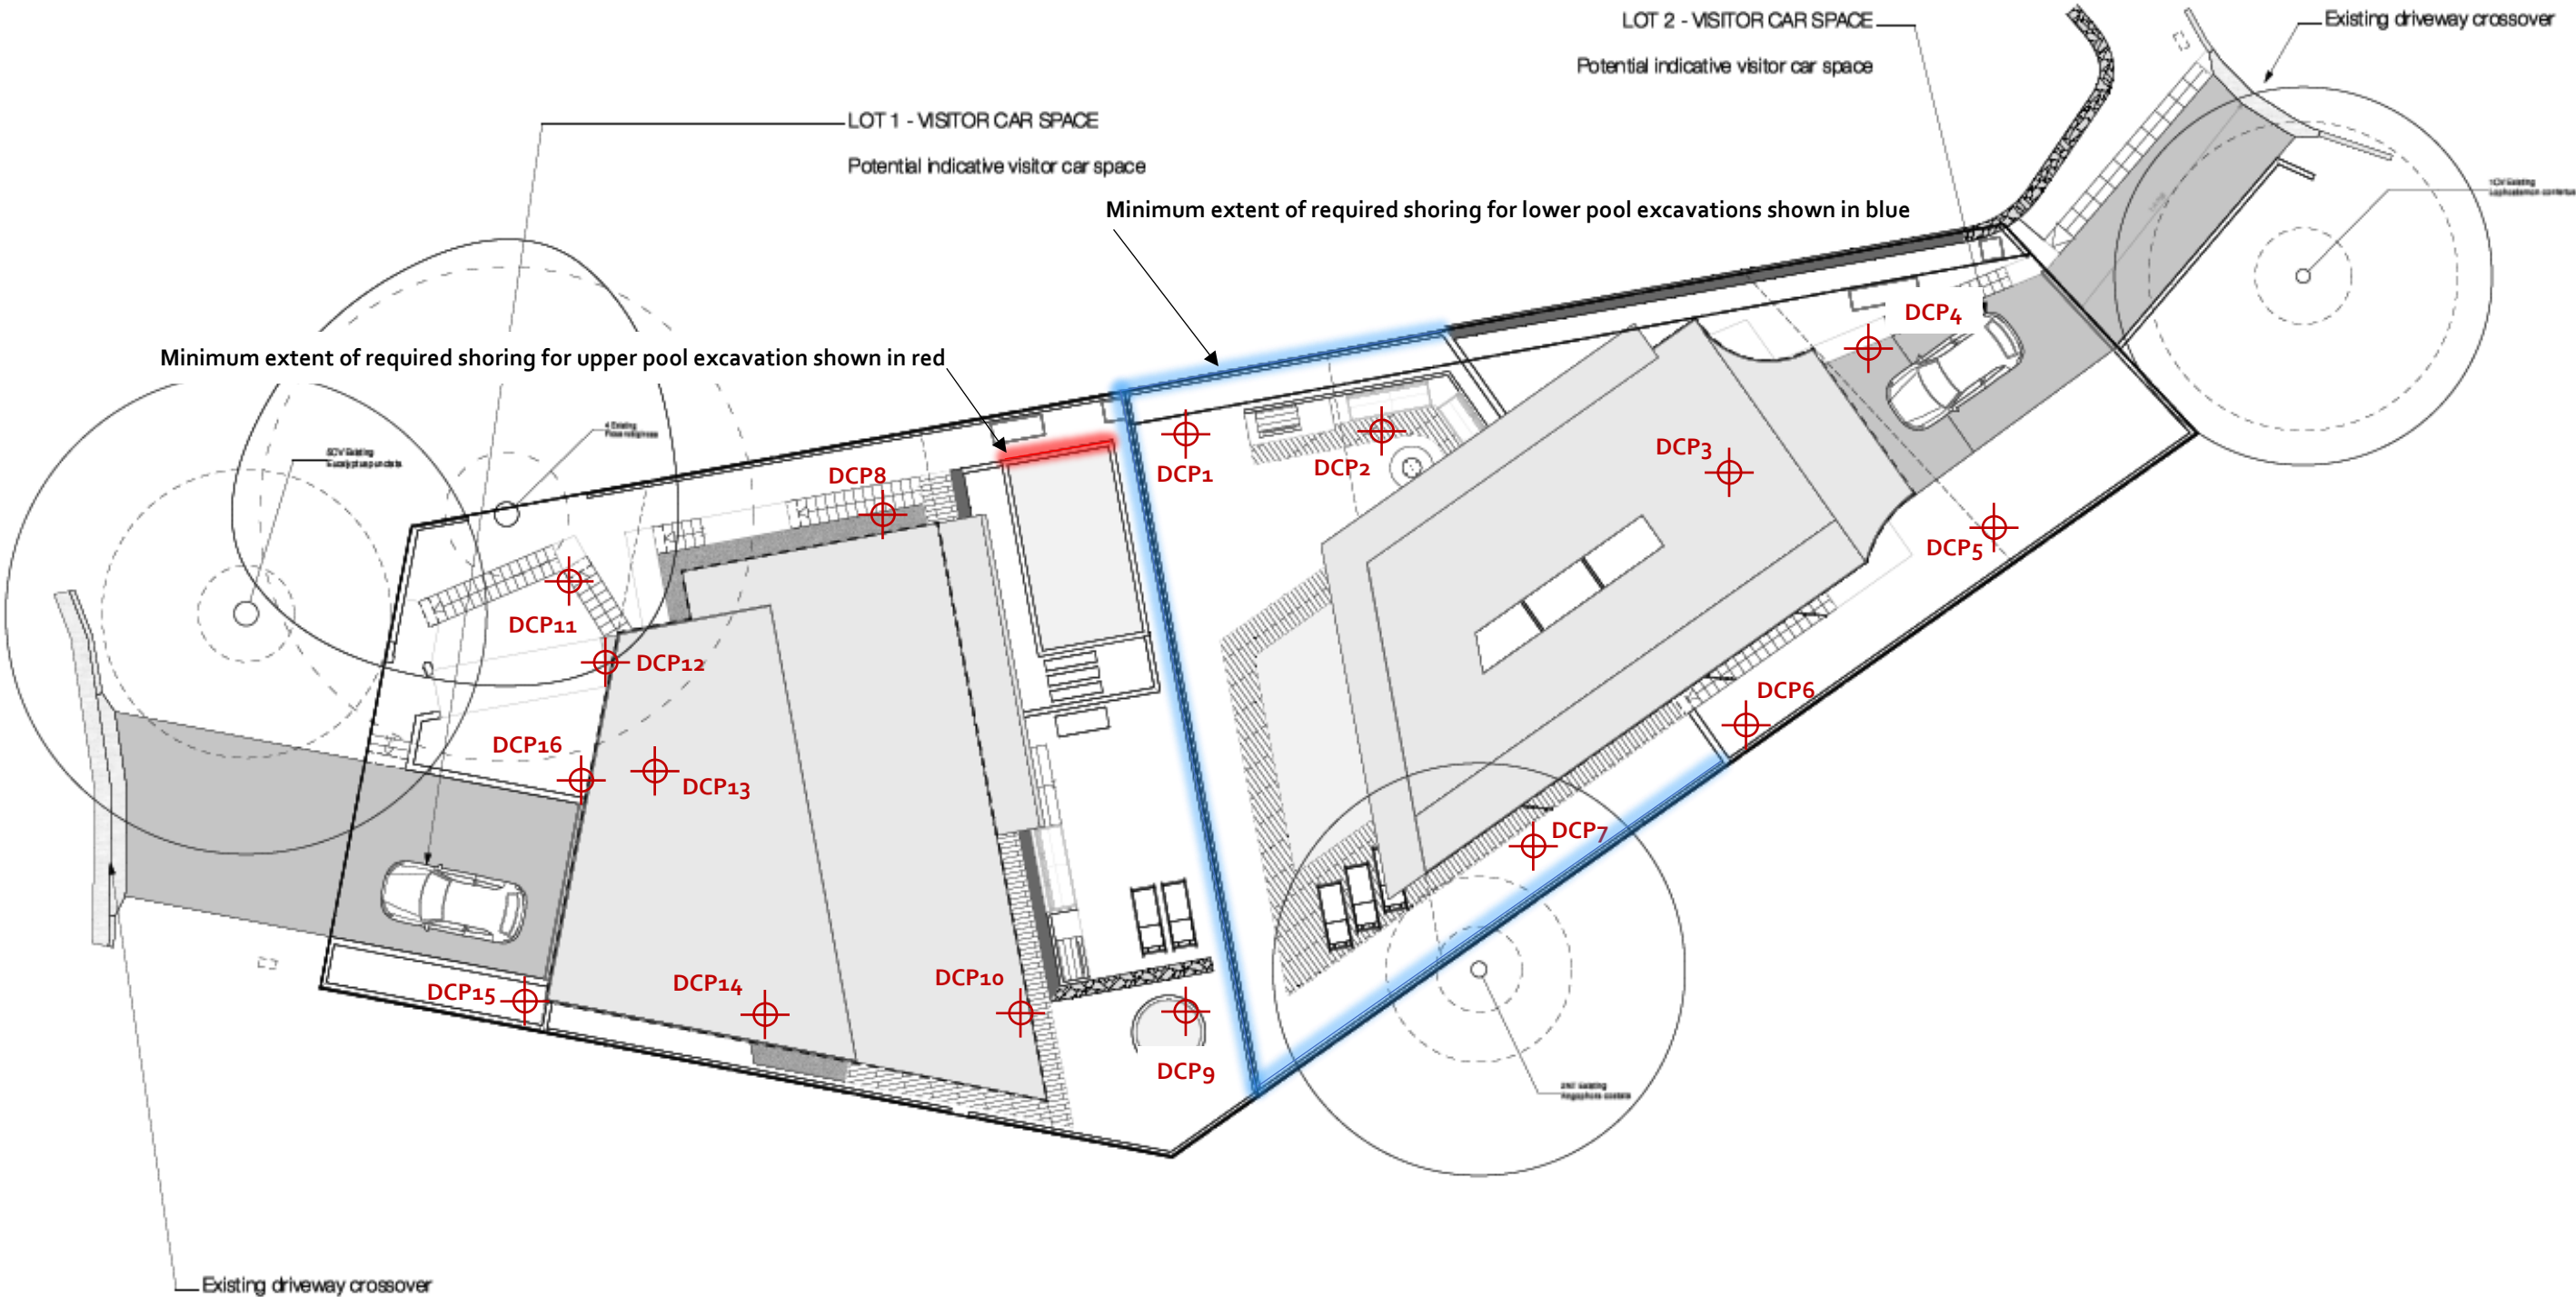
SITE PLAN – showing test locations

Sixteen Dynamic Cone Penetrometer (DCP) tests were put down to determine the relative density of the overlying soil and the depth to bedrock. The locations of the tests are shown on the site plan attached. It should be noted that a level of caution should be applied when interpreting DCP test results. The test will not pass through hard buried objects so in some instances it can be difficult to determine whether refusal has occurred on an obstruction in the profile or on the natural rock surface. This is not expected to be an issue for the testing on this site. However, excavation and foundation budgets should always allow for the possibility that the interpreted ground conditions in this report vary from those encountered during excavations. See the appended "Important information about your report" for a more comprehensive explanation. The results are as follows:

The cut is to be permanently or temporarily supported along the N, SE, and uphill sides before the excavation through rock commences. The support is to be installed systematically as the excavation progresses to ensure the integrity of the neighbouring property into the future. If the support is temporary, it is to remain in place until the retaining wall is built as a sacrificial-type system. See the site plan attached for the minimum required extent of the shoring.

until the pool structure is in place. See the site plan attached showing the minimum extent of the required shoring.

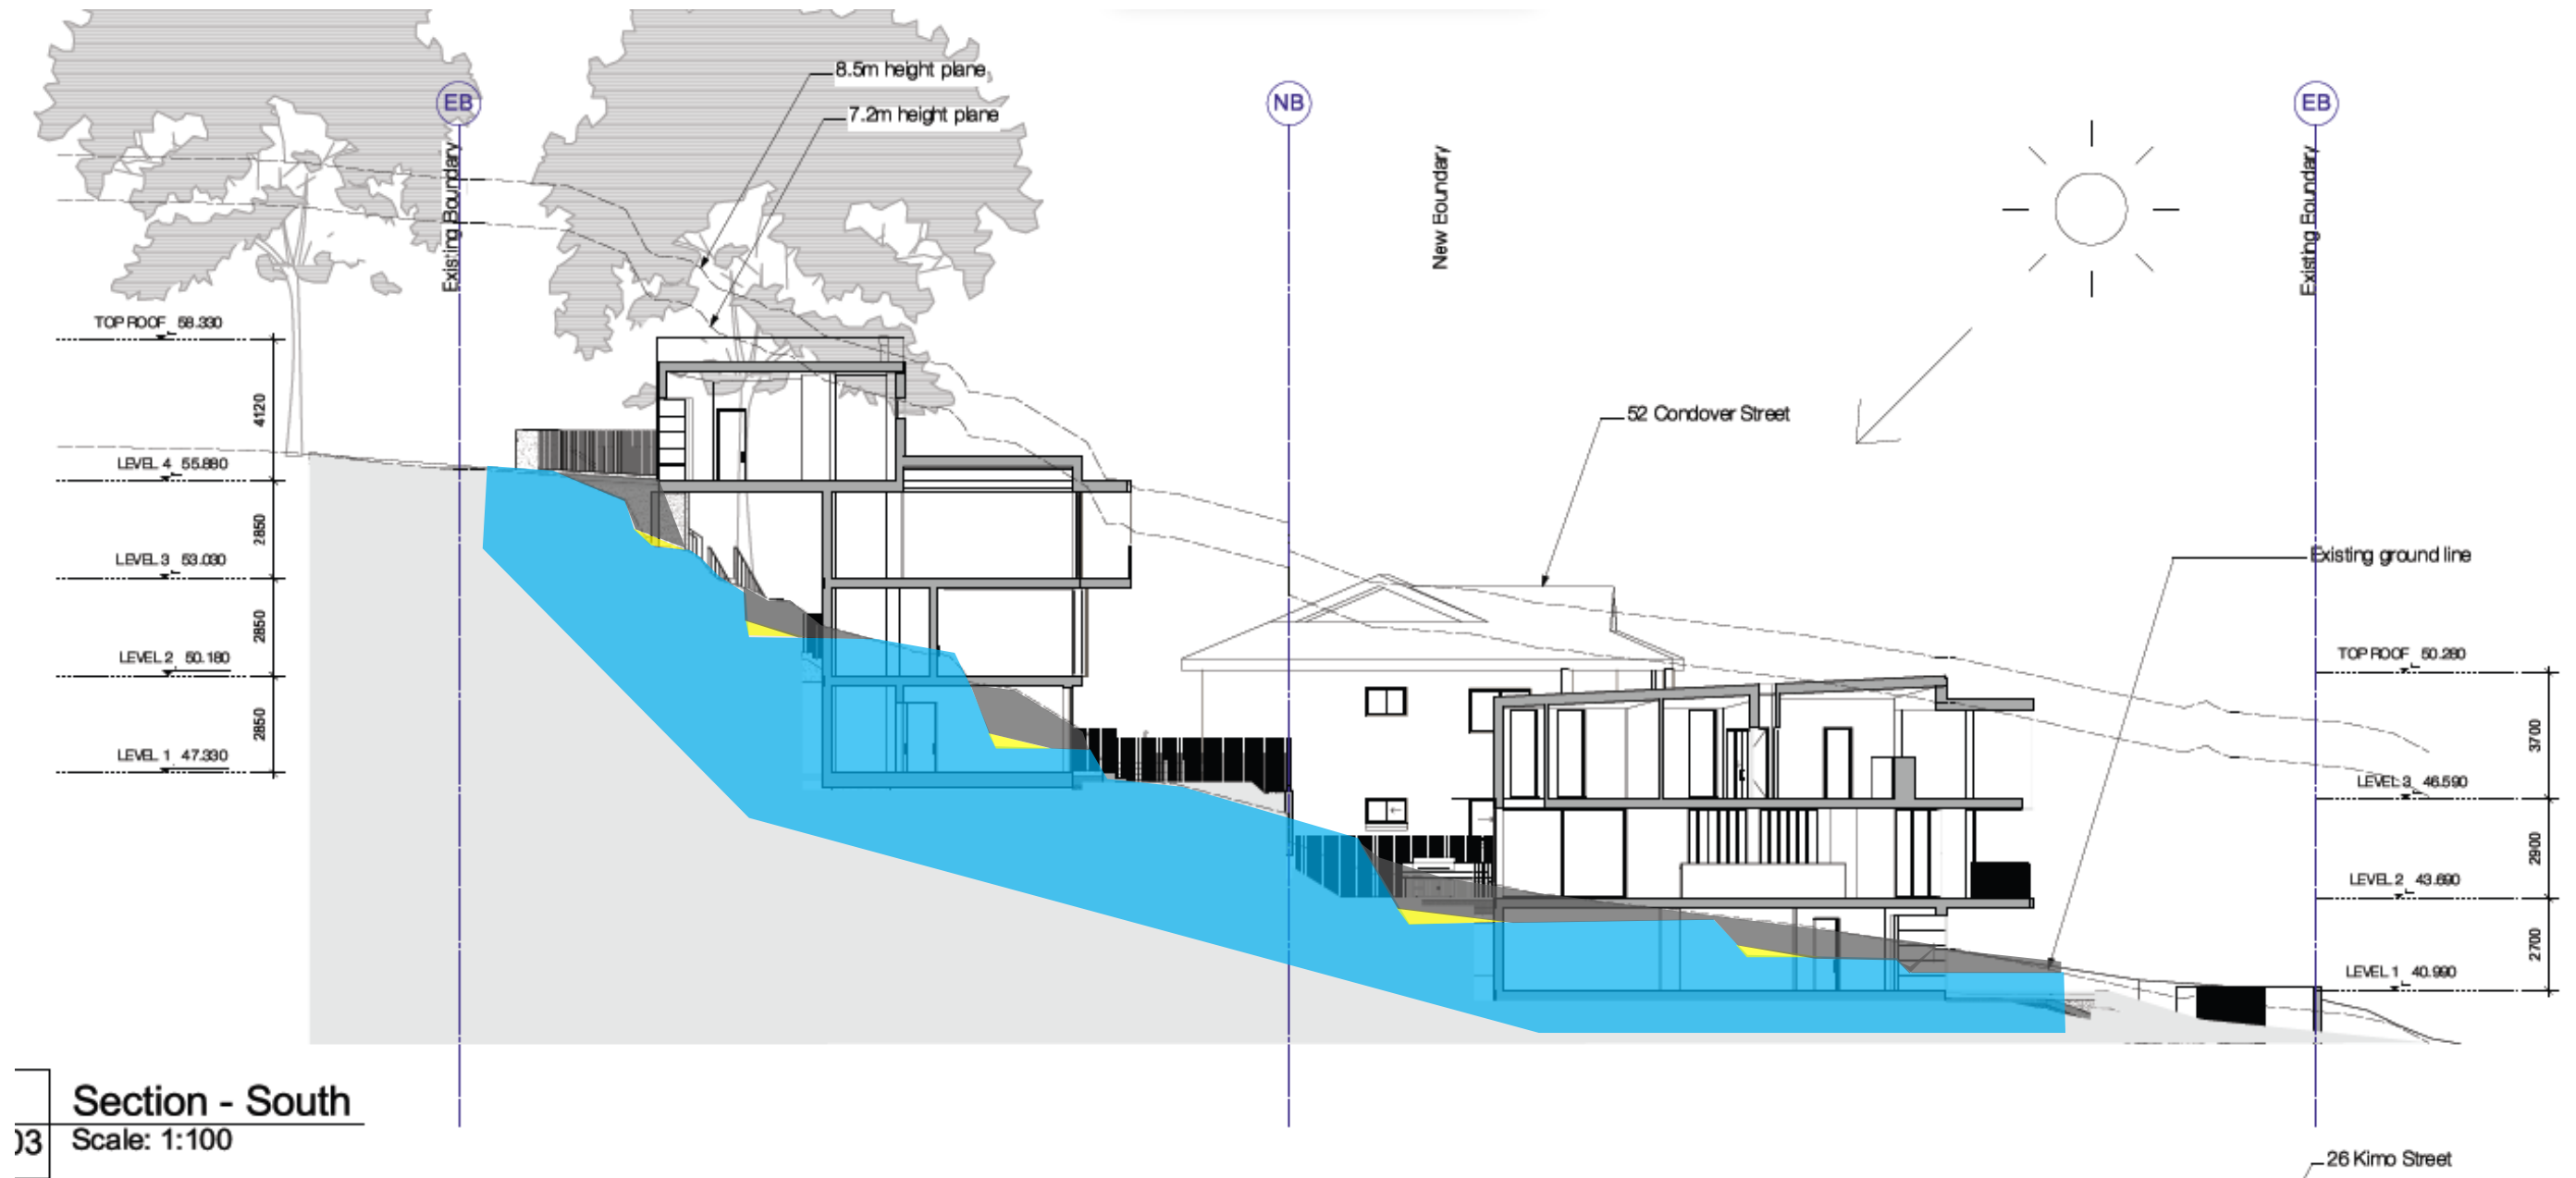
TYPE SECTION – Diagrammatical Interpretation of expected Ground Materials

sandstone on the property is estimated to be medium strength or better and similar strength rock is expected to underlie the entire site. See the Type Section attached for a diagrammatical representation of the expected ground materials.
