Geotechnical Assessment

Project: Alterations & Additions
76 Nandi Avenue, Frenchs Forest NSW

REF: AG 21001
20 January 2021

For **Alterations & Additions** at
76 Nandi Avenue, Frenchs Forest NSW

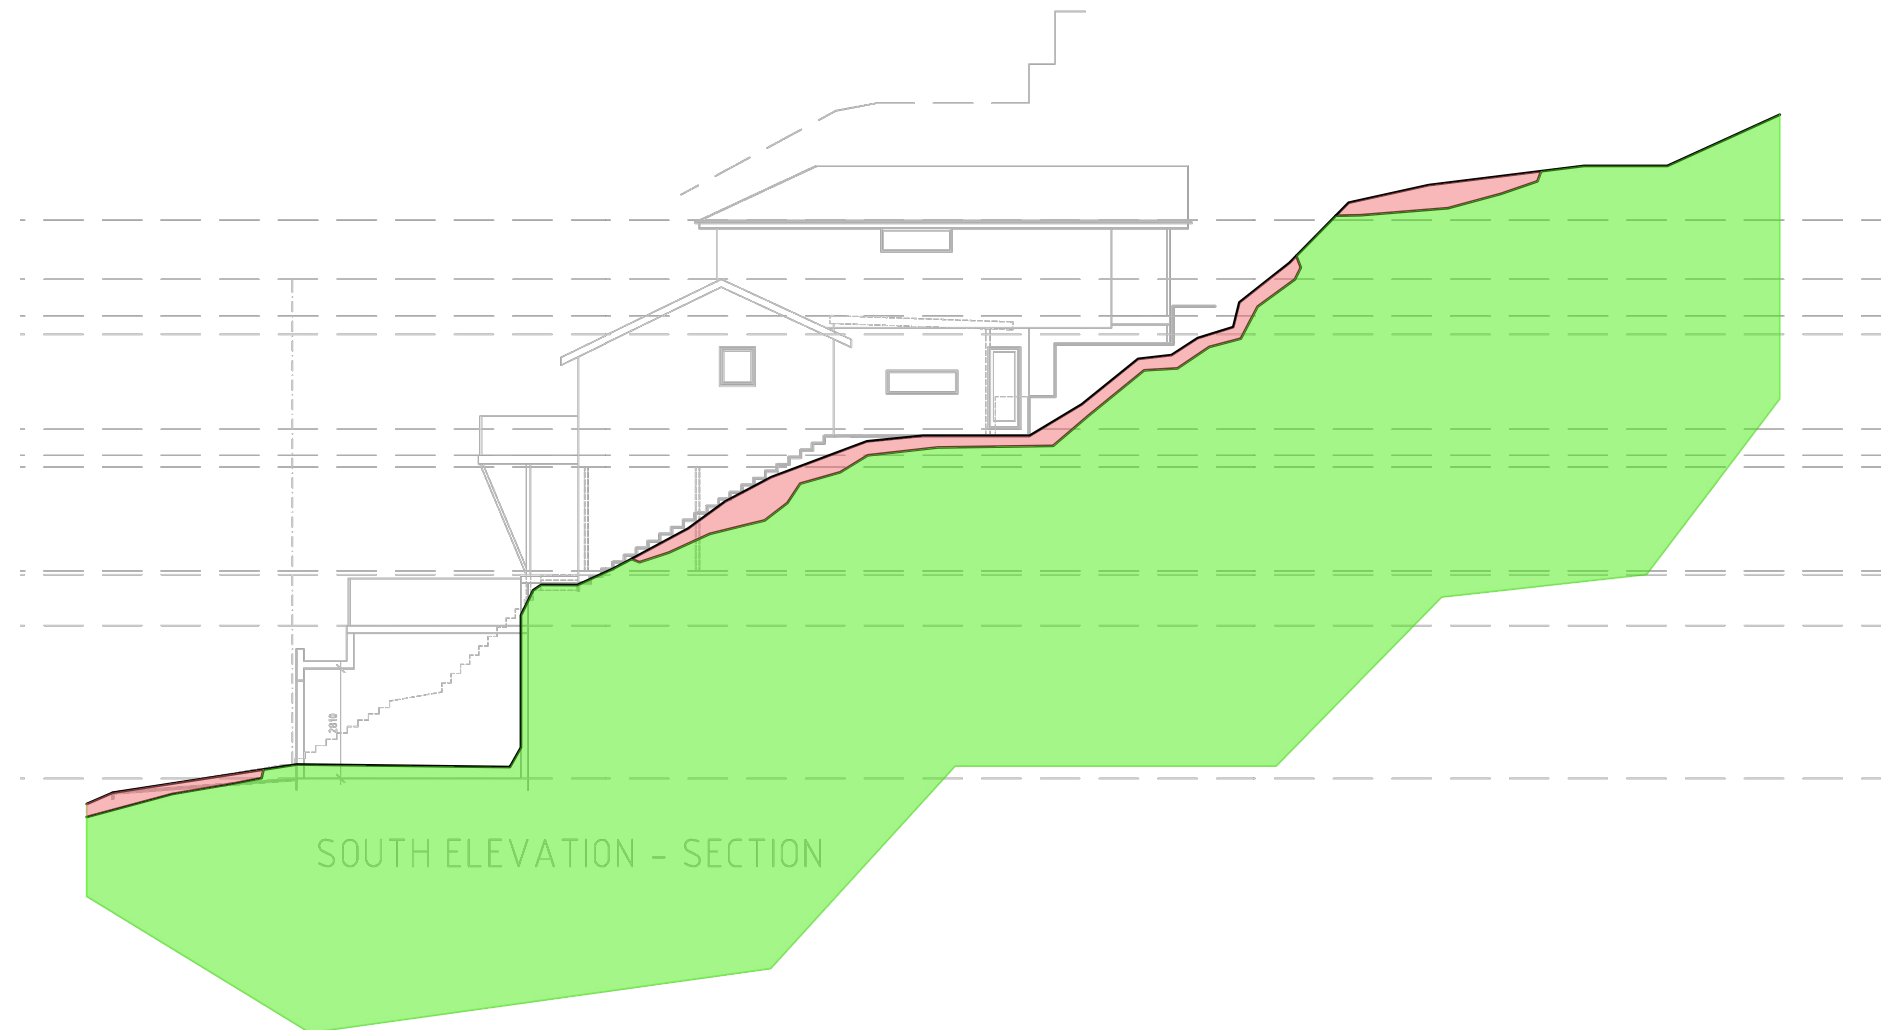
INFERRED GEOLOGICAL SECTION
SCALE NTS

INTERPRETED SUBSURFACE SECTION ONLY.
ACTUAL GROUND CONDITIONS MAY VARY.
