**STANDFAST TREE SERVICES**  
ESTABLISHED 1979

22/11/2022

Re Section 4.55 (1A) modification to consent DA2019/0152  
T29 and T34

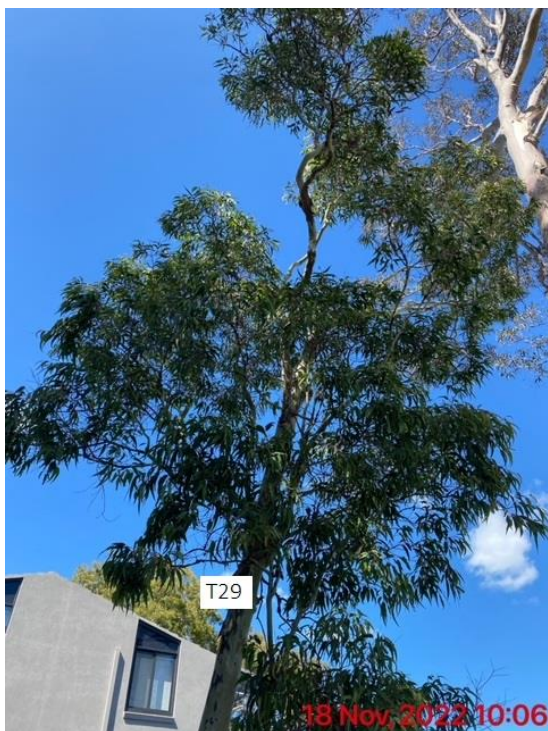
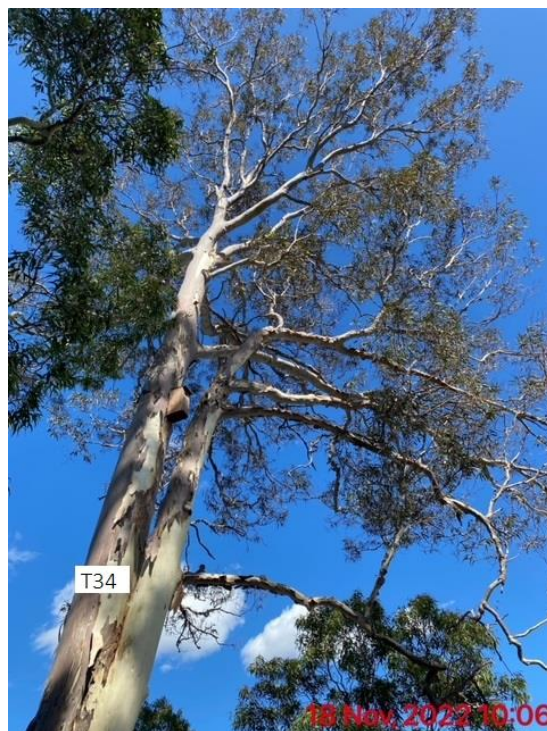
*T29 and T34 canopies*

The health of T29 has improved since it was assessed for the AIA dated 09/02/2019. At that time it was in very poor health, suppressed and with poor form but now the canopy is full and form has improved.

T34, in good health in early 2019 is now in poor health with a sparse canopy.

- The ground around the base of the two trees would be lightly turned over without exposing any tree roots to reduce soil compaction and to improve aeration and water absorption
- A mixture of Seasol organic fertiliser diluted to recommended strength and rooting hormone (available at plant nurseries or Bunnings) would be placed in shallow holes approximately 75mm deep, usually dug with a bar and spaced approximately 1m apart.
- With the landscapers preparing to apply topsoil around T29 and T39 within the next month it is recommended that vintage leaf mulch is spread to a depth of 50mm on top of the loosened ground surface
- Care must be taken to ensure that the maximum area available within the TPZ of T39 is cultivated, fertilised and then covered with vintage leaf mulch

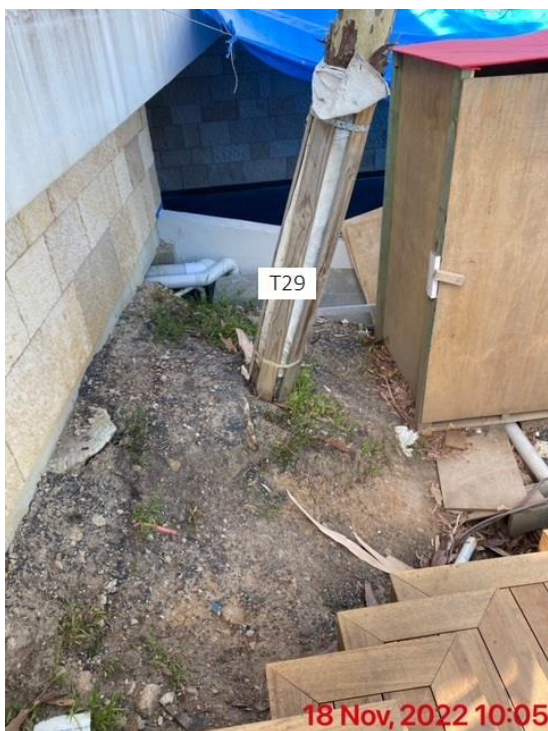
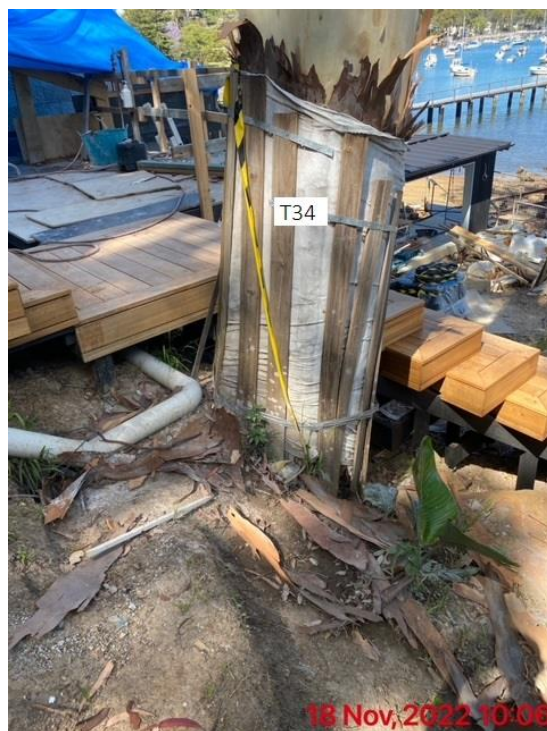
*T29 and T34 ground level*
