Preliminary Geotechnical Assessment

Project: Alterations & Additions
263 Sydney Road, Fairlight NSW

REF: AG 21441
14 December 2021

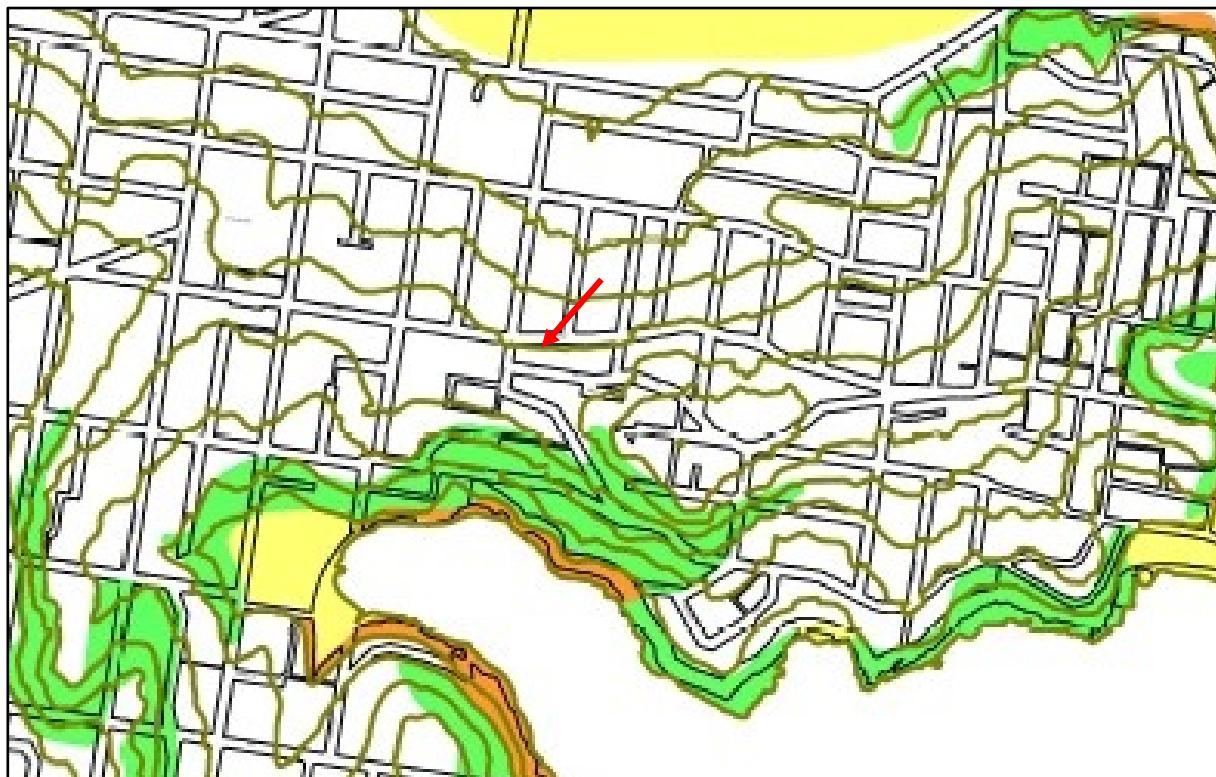
The site is classified as **Area G4** with reference to Schedule 1, Map C, Potential Landslip Hazard Areas, Appendix 1B of the Manly Development Control Plan (**Image 1**).

Image 1. Manly Landslip Hazard Map: 263 Sydney Road,
Fairlight NSW (© NBC Maps) – red arrow
