**GEOTECHNICAL RISK MANAGEMENT POLICY FOR PITTWATER
FORM NO. 1 – To be submitted with Development Application**

Report Title: Geotechnical Report 11 Gilwinga Drive, Bayview
Report Date: 9/2/22

GEOTECHNICAL INVESTIGATION:

Additions and Alterations at 11 Gilwinga Drive, Bayview

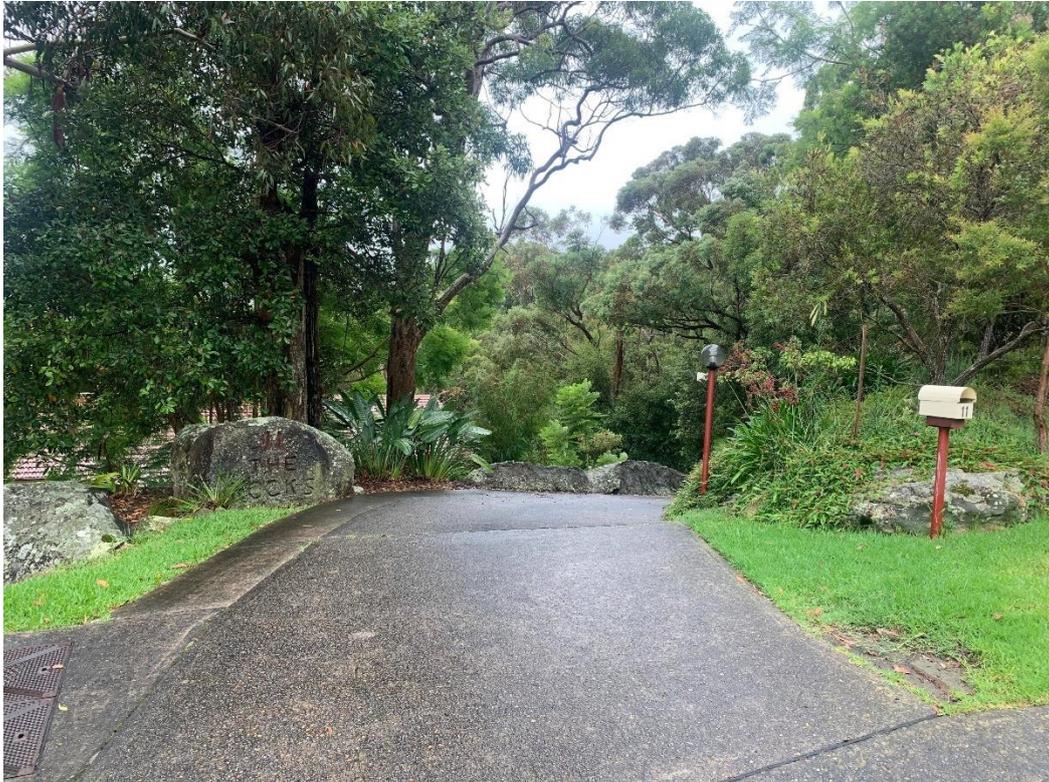
Photo 1

- 2.3** At the road frontage, a concrete driveway runs down the slope to a garage on the uphill side of the house (Photo 1). The cut for the driveway has been partly taken through outcropping Medium Strength Sandstone (Photo 2). A series of stable low-lying sandstone rock walls terrace the slope between the road frontage and the house (Photo 3). Sandstone floaters outcrop through the slope in several places. Competent Medium Strength Sandstone bedrock can be seen stepping down the property in this location. The two-storey brick house is supported on brick walls. The external supporting brick walls of the house show no significant signs of movement. A large council stormwater pipe discharges water into a channel cut into the slope down the

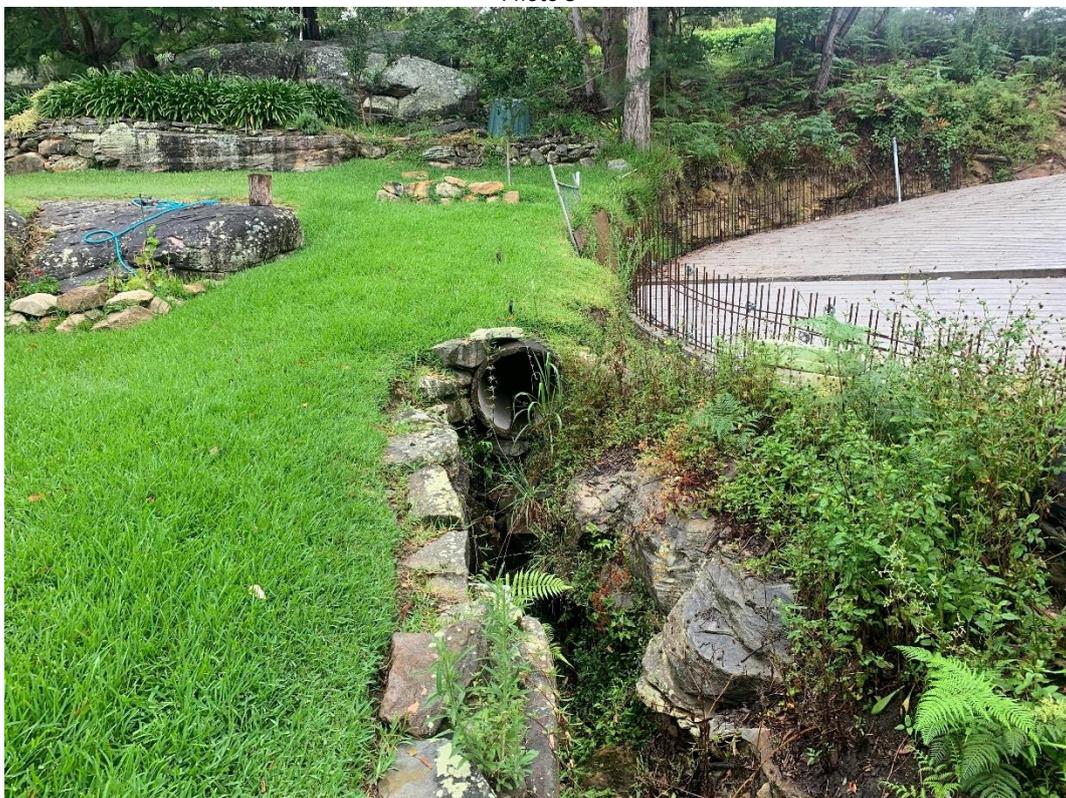
Photo 4

Apart from the large council stormwater pipe that discharges onto the slope to the W of the house and natural watercourse that runs across the downhill side of the block, no evidence of significant surface flows were observed on the property during the inspection. Normal sheet wash from the slope above will be intercepted by the street drainage system for Gilwinga Drive above.

The fall is away from the street. Roof water from the development is to be piped to the existing stormwater channel on the W side of the property through any tanks that may be required by the regulating authorities.

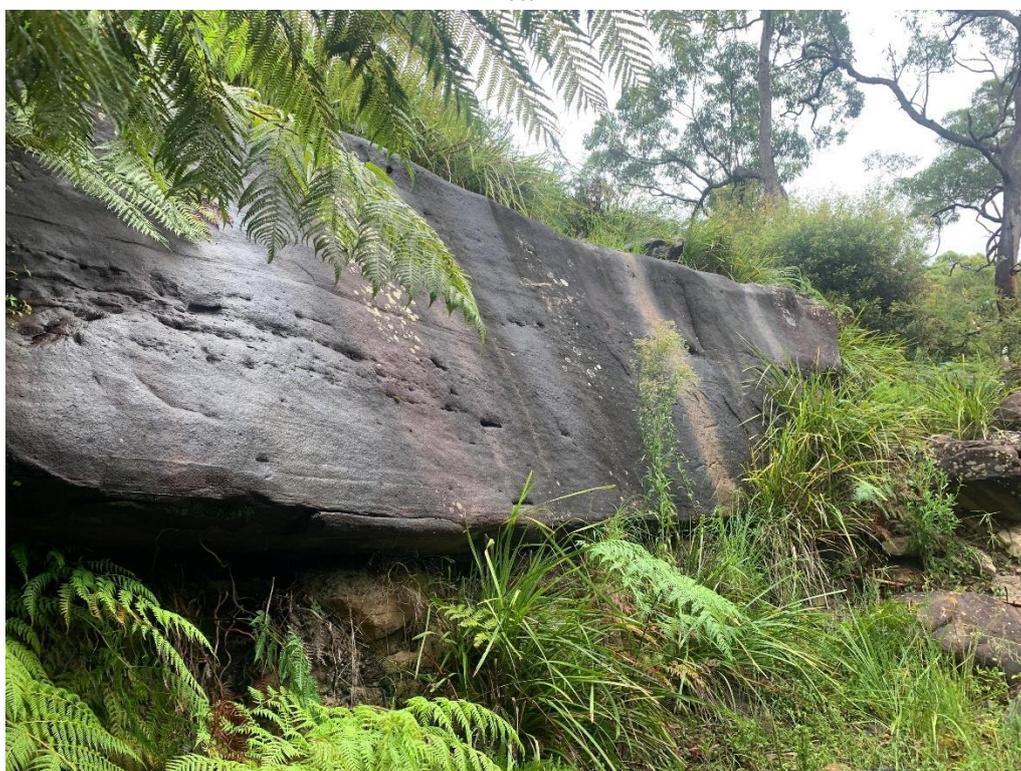
Photo 8

No geotechnical hazards were observed beside the property. The moderate to steeply graded slope that falls across the property and continues above and below is a potential hazard (**Hazard One**). The large sandstone face that steps ~3.0m down the slope is a potential hazard (**Hazard Two**).

HAZARDS	Hazard One	Hazard Two
TYPE	The moderate to steep slope that falls across the property and continues above and below failing and impacting on the proposed works.	The sandstone face that steps ~3.0m down the slope failing and impacting on the proposed works (Photo 8).
LIKELIHOOD	'Unlikely' (10^{-4})	'Unlikely' (10^{-4})
CONSEQUENCES TO PROPERTY	'Medium' (15%)	'Medium' (25%)
RISK TO PROPERTY	'Low' (2×10^{-5})	'Low' (2×10^{-5})
RISK TO LIFE	9.1×10^{-7} /annum	2.9×10^{-7} /annum
COMMENTS	This level of risk is 'ACCEPTABLE'.	This level of risk is 'ACCEPTABLE'.

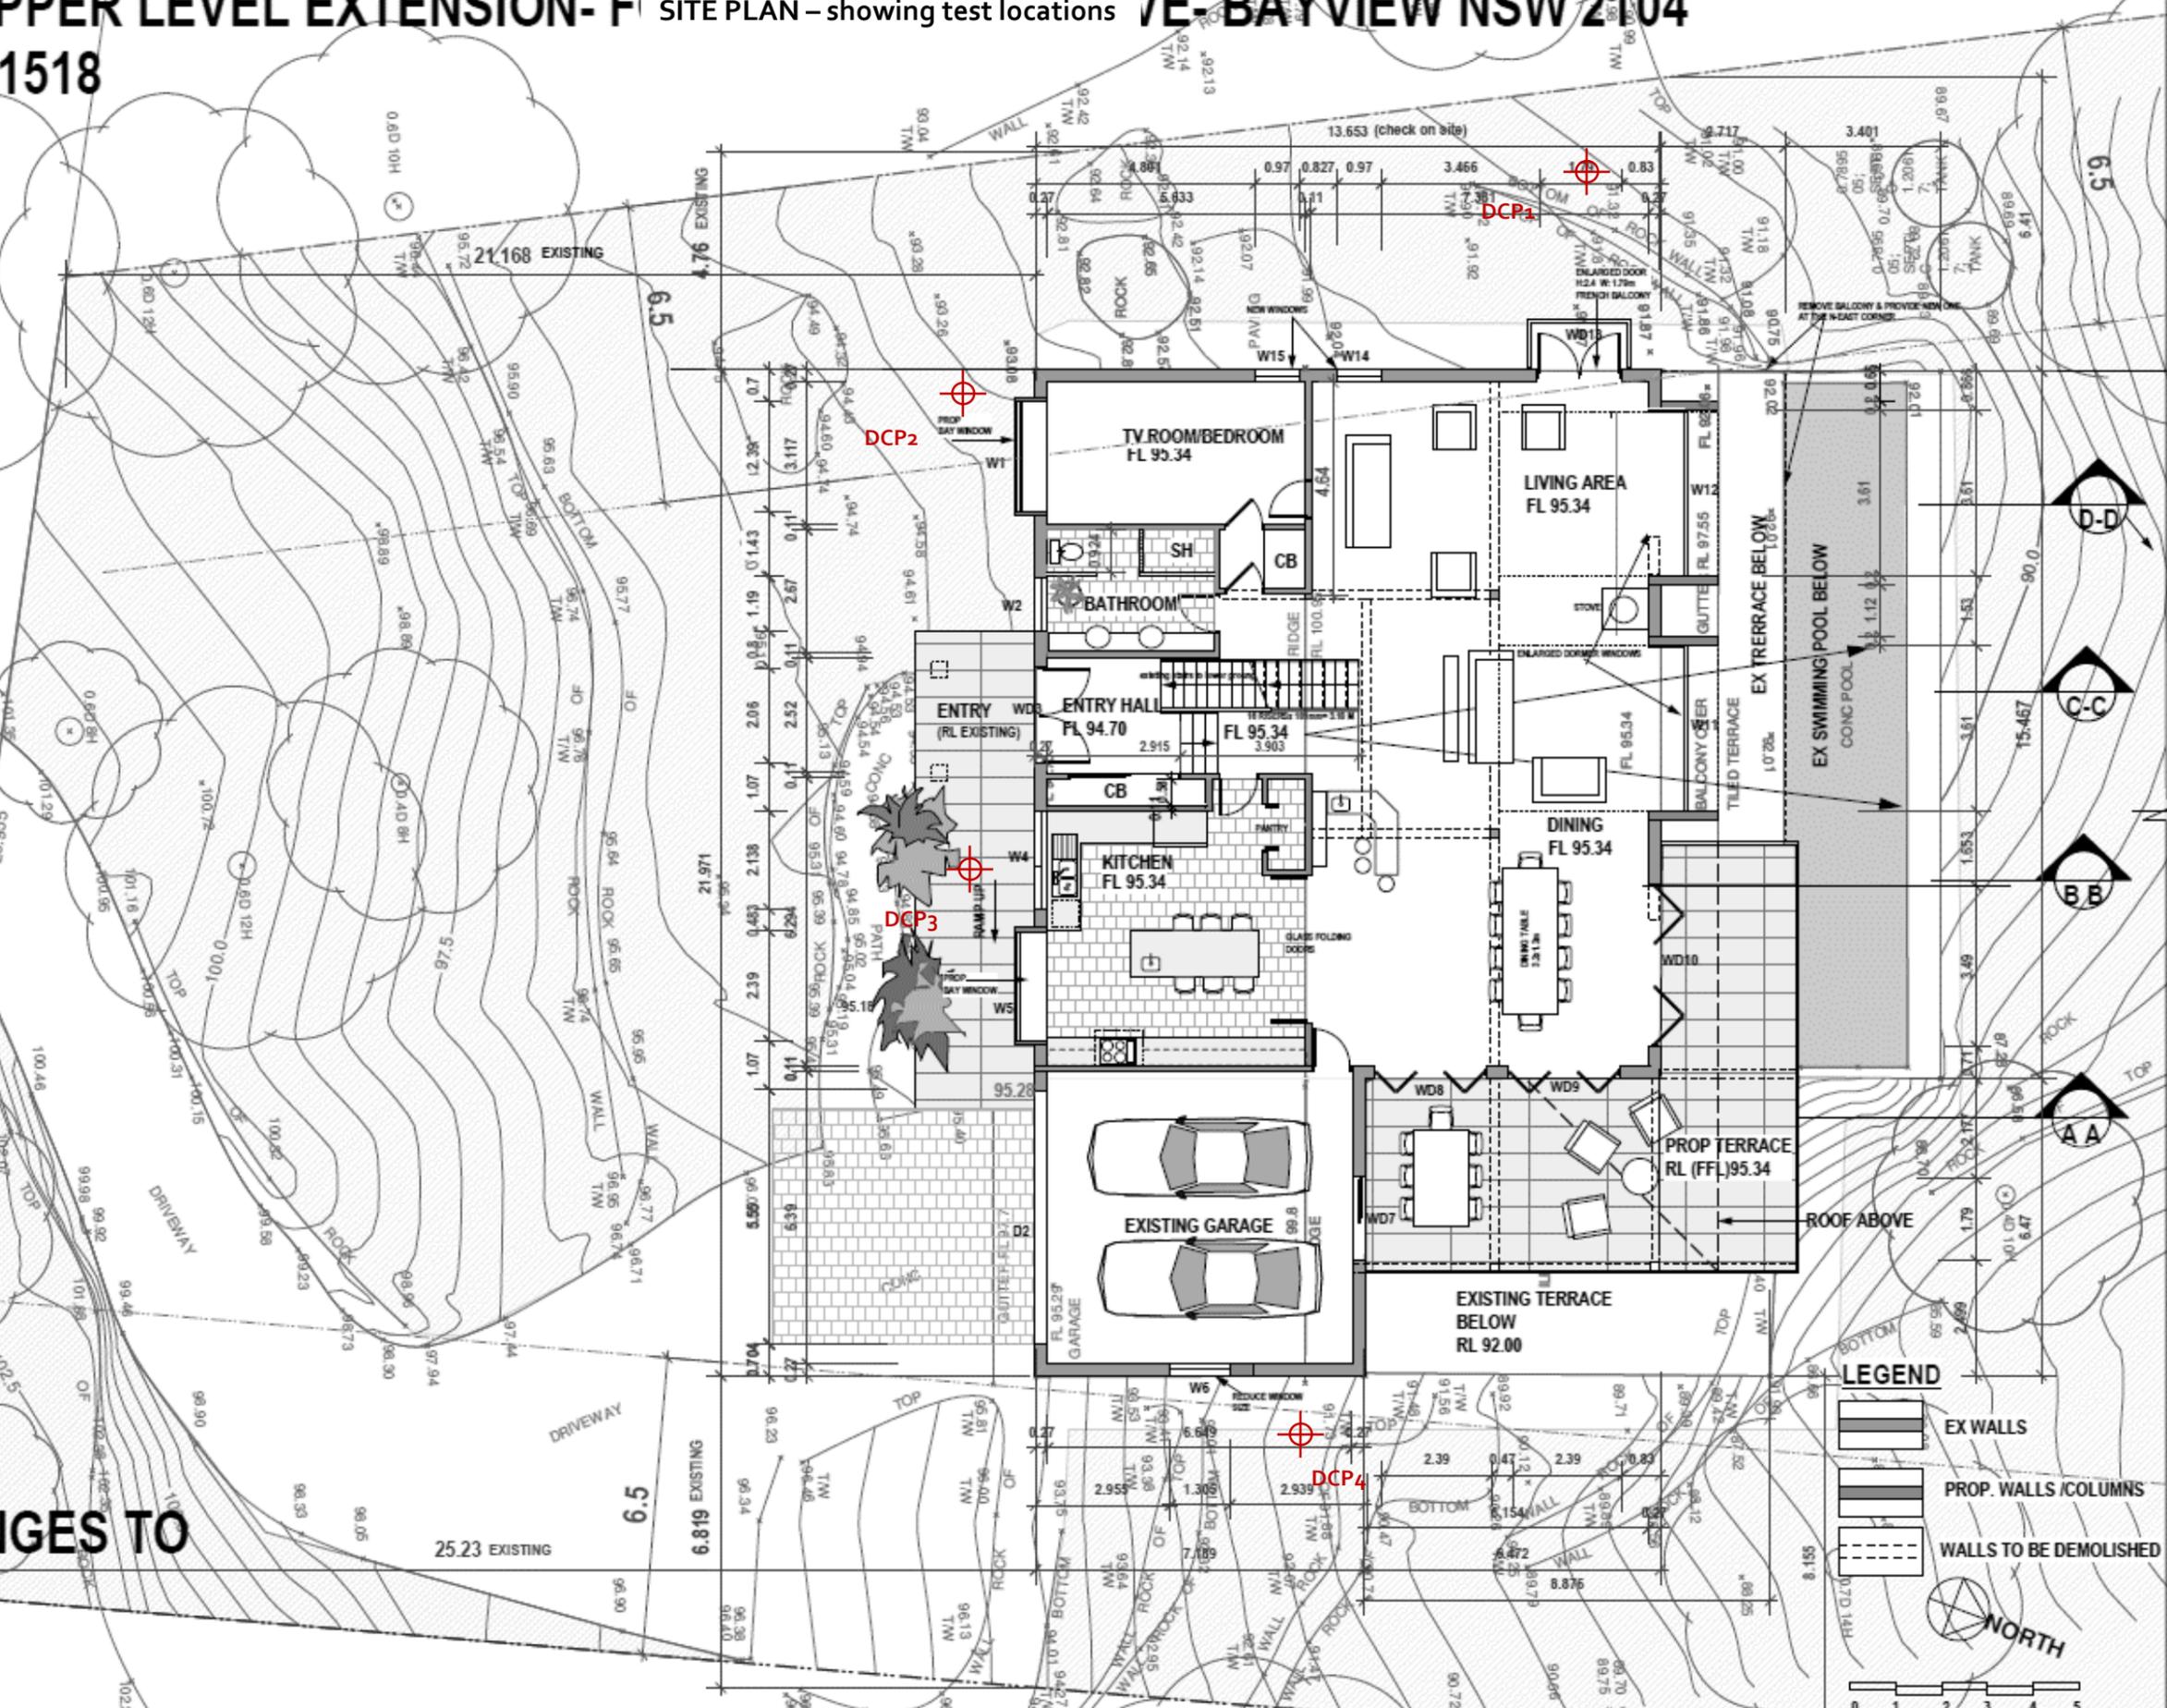
PROPOSED DA -UPPER LEVEL EXTENSION- F1 SITE PLAN – showing test locations /E- BAYVIEW NSW 2104

Four Dynamic Cone Penetrometer (DCP) tests were put down to determine the relative density of the overlying soil and the depth to bedrock. The locations of the tests are shown on the site plan attached. It should be noted that a level of caution should be applied when interpreting DCP test results. The test will not pass through hard buried objects so in some instances it can be difficult to determine whether refusal has occurred on an obstruction in the profile or on the natural rock surface. This is not expected to be an issue for the testing on this site. However, excavation and foundation budgets should always allow for the possibility that the interpreted ground conditions in this report vary from those encountered during excavations. See the appended "Important information about your report" for a more comprehensive explanation. The results are as follows:

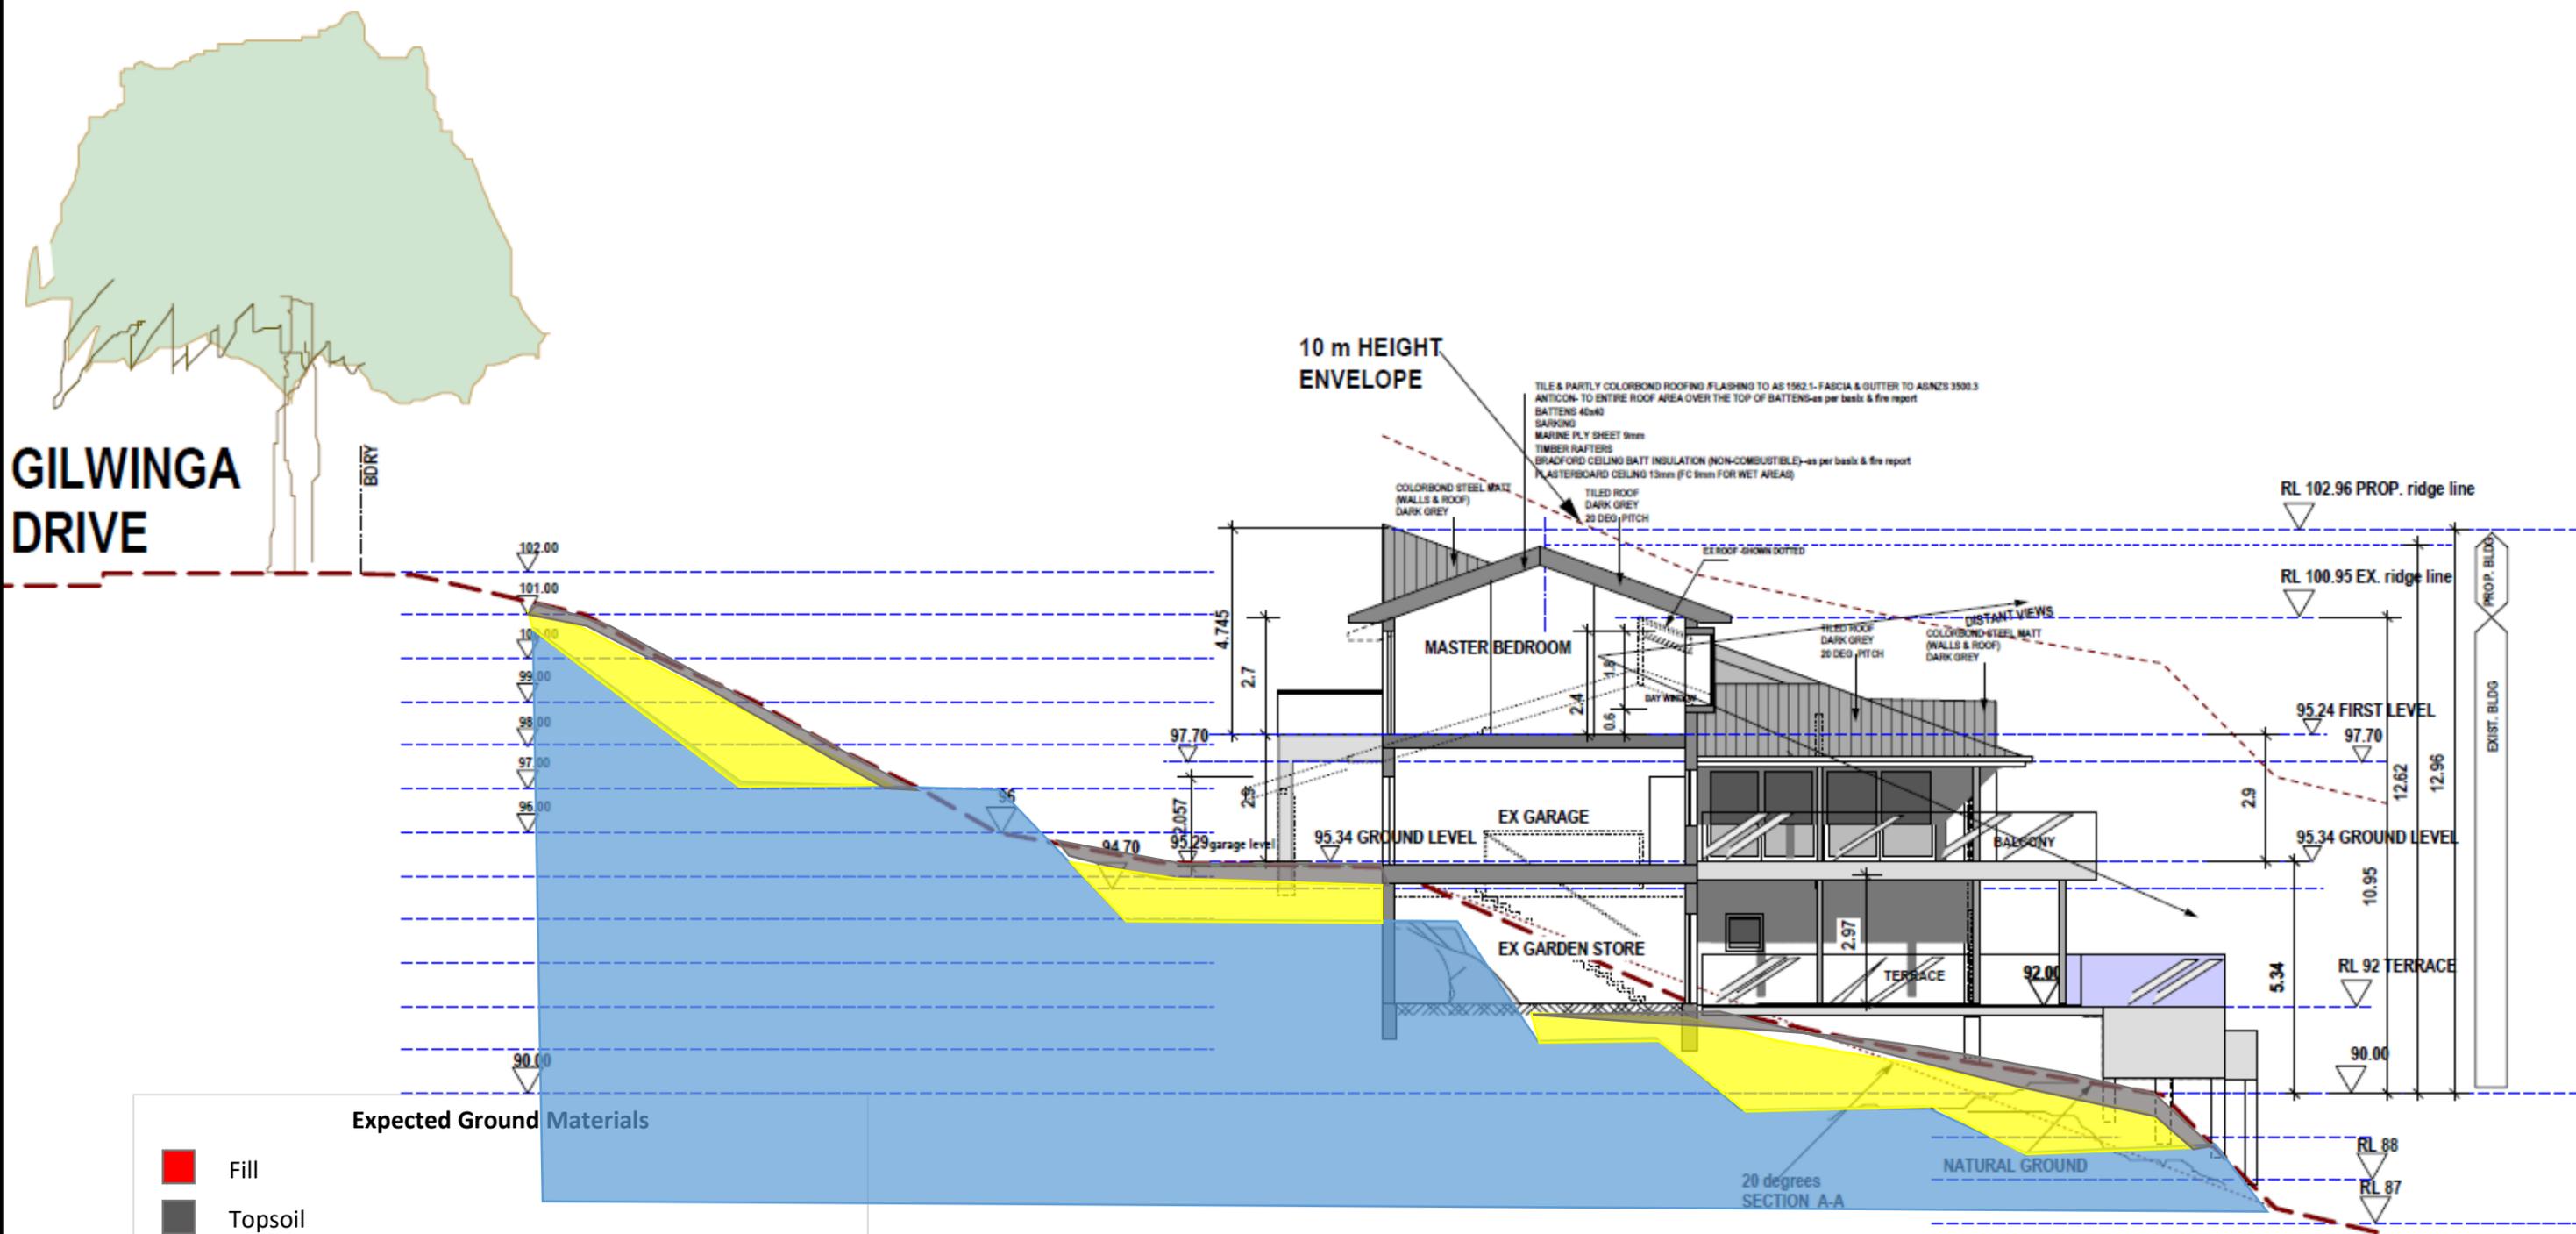
PROPOSED DA -UPPER LEVEL EXT TYPE SECTION – Diagrammatical Interpretation of expected Ground Materials **NSW 2104**
LOT 39 SEC DP 241518

The surface features of the block are controlled by the outcropping and underlying sandstone bedrock that steps down the property forming sub-horizontal benches between the steps. Where the grade is steeper, the steps are larger and the benches narrower. Where the slope eases, the opposite is true. Where the rock is not exposed, it is overlain by soils and sandy clays that fill the bench step formation. Filling has been placed beside the house for landscaping. In the test locations, where the rock was not exposed, it was encountered at depths of between 0.3m and 1.5m below the current surface, being slightly deeper due to the presence of fill and the stepped nature of the underlying bedrock. The outcropping sandstone on the property is estimated to be medium strength or better and similar strength rock is

expected to underlie the entire site. See Type Section attached for a diagrammatical representation of the expected ground materials.
