J1886. 14th August, 2018. Page 1.

GEOTECHNICAL INVESTIGATION:

For Alterations and Additions at 21 Wattle Avenue, Fairlight

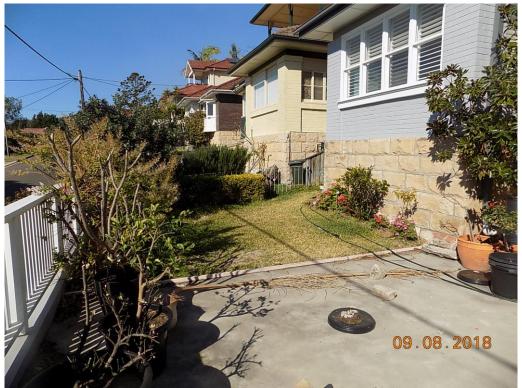
Photo 3

HAZARDS	Hazard One	Hazard Two	Hazard Three
TYPE	A loose boulder, wedge, or similar geological defect toppling onto the work site during the excavation process.	The proposed excavations undercutting the footings of the house causing failure (Photos 3 & 4).	The vibrations produced during the proposed excavations impacting on the surrounding structures and boundaries.
LIKELIHOOD	'Possible' (10 ⁻³)	'Possible' (10 ⁻³)	'Possible' (10 ⁻³)
CONSEQUENCES TO PROPERTY	'Medium' (20%)	'Medium' (35%)	'Medium' (15%)
RISK TO PROPERTY	'Moderate' (2 x 10 ⁻⁴)	'Moderate' (2 x 10 ⁻⁴)	'Moderate' (2 x 10 ⁻⁴)
RISK TO LIFE	6.3 x 10 ⁻⁵ /annum	5.3 x 10 ⁻⁵ /annum	5.3 x 10 ⁻⁷ /annum
COMMENTS	This level of risk to life and property is 'UNACCEPTABLE'. To move risk to 'ACCEPTABLE' levels the recommendations in Section 13 are to be followed.	This level of risk to life and property is 'UNACCEPTABLE'. To move risk to 'ACCEPTABLE' levels, the recommendations in Section 13 are to be followed.	This level of risk to property is 'UNACCEPTABLE'. To move risk to 'ACCEPTABLE' levels the recommendations in Section 12 are to be followed.

to flush with the downhill supporting wall of the house (Photo 3). Thus, the supporting walls

to be underpinned if they are not already supported on competent rock.

If the foundations are found to be supported on competent rock, the excavation may

commence. If they are not on rock, the walls/piers will need to be underpinned prior to the

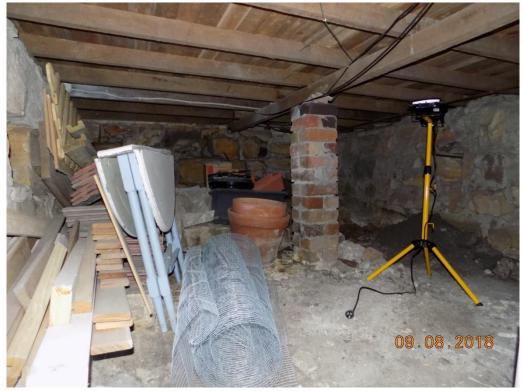
Photo 4

the house (Photo 4) and the proposed excavation for the garage extension will be taken close

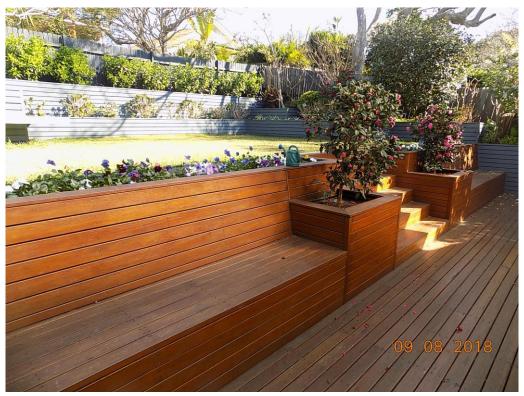
Photo 5

side of the house. The cut is supported by a ~1.2m high retaining wall that has been

dressed in timber cladding (Photo 5). Another cut has been made in the slope for a

condition of these retaining walls was unable to be determined due to the timber

dressing.

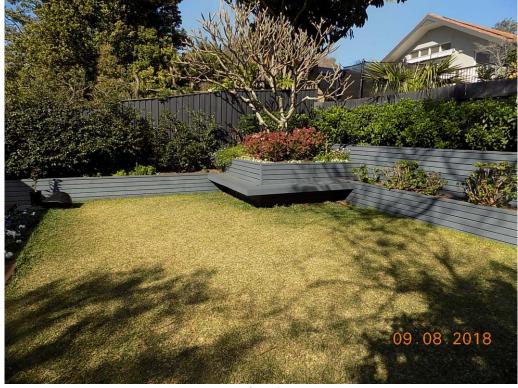
Photo 6

level lawn area above the house. This cut is supported by another ~1.2m high retaining

wall that has been dressed in timber cladding (Photo 6). The construction material and

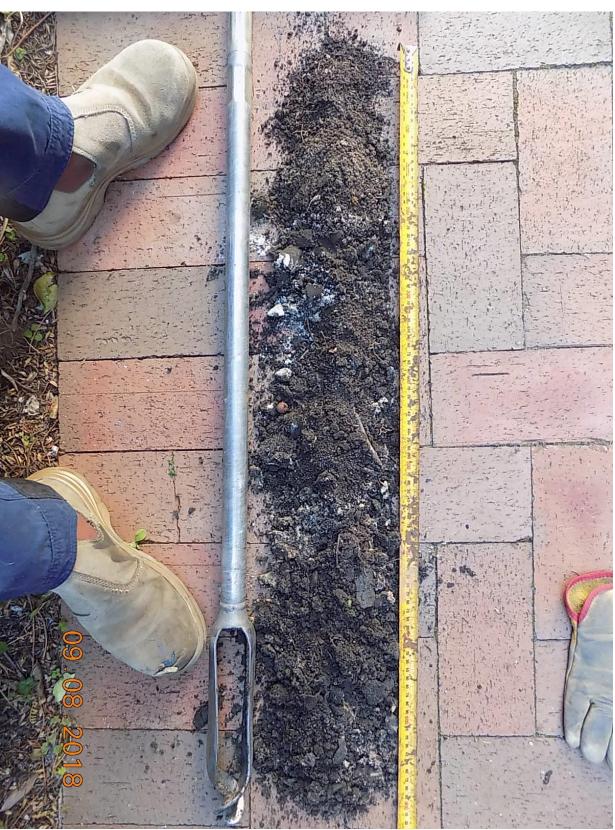
AUGER HOLE 1 (~RL21.4) – AH1 (Photo 7)

0.0 to 0.9

FILL, disturbed sand, dark brown and white, medium to coarse

grained with fine trace organic matter and rock fragments.

End of hole @ 0.9m, auger grinding on rock surface. No watertable encountered.

Photo 7: AH1 – Downhole is from top to bottom.
