39 Seaforth Cres, Seaforth

Geotechnical Comments for Section 4.55

GEOTECHNICAL INVESTIGATION:

New Incline Lift and Landscaping at **39 Seaforth Crescent, Seaforth**

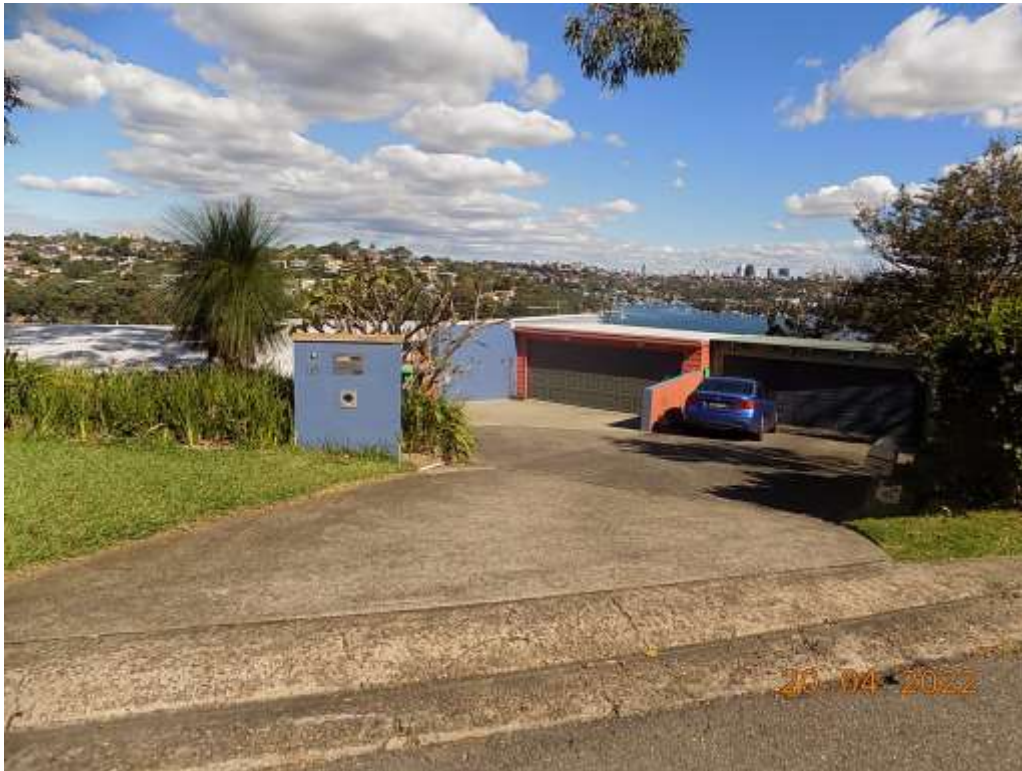
Photo 1

- 2.1** The site was inspected on the 20th April, 2022.
- 2.2** This waterfront residential property is on the low side of the street and has a S aspect. It is located on the steeply graded lower reaches of a hillslope. The slope falls across the property at an average angle of ~30° to the waterfront. The slope above the property eases to moderate angles.
- 2.3** At the road frontage, a shared concrete driveway runs down the slope to a garage on the uphill side of the property (Photo 1). The garage is partially seated on outcropping Medium Strength Rock that is slightly undercut to ~2.0m (Photo 2). The garage extends ~1.0m over the undercut area. Given the thickness of the supporting cantilever arms with no visible defects, the undercut rock is considered to be stable.

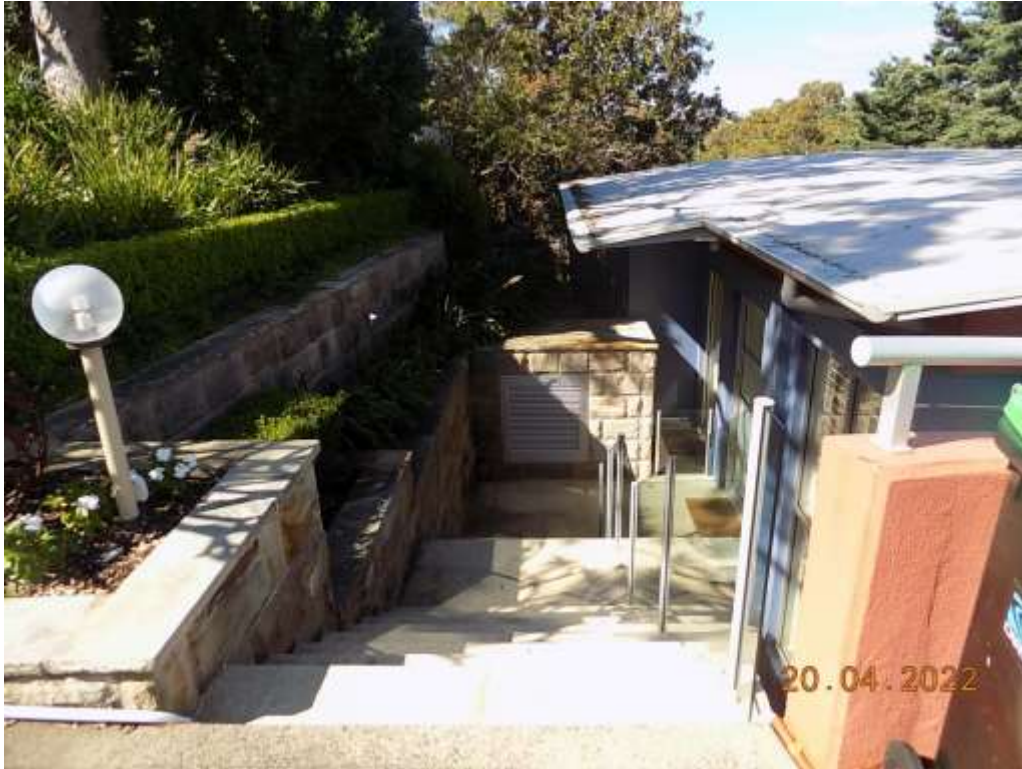
Photo 3

A series of stable sandstone block retaining walls reaching up to ~1.8m high terrace the slope in between the road frontage and the house (Photo 3). A ~9.0m high cut to create a level platform for the house has been taken entirely through outcropping Competent Medium Strength Sandstone (Photo 4). A portion of the cut face has been protected with sprayed concrete (Photo 5). The three-storey rendered masonry house is supported on masonry walls and concrete piers (Photo 6). The masonry walls show no significant signs of movement and the concrete piers stand vertical. A partially suspended pool extends off the downhill side of the house (Photo 7). No significant movement has occurred in the concrete shell of the pool as indicated by the water level against the pool tiles. A series of low sandstone block retaining walls terrace the steep slope that extends to the lower common boundary (Photo 8). A ~1.5m high sandstone block retaining wall supports a fill for a moderately sloping lawn area (Photo 9). The wall is covered in vegetation but from what could be seen, appears to be in good condition. It is supported directly off outcropping Competent Medium Strength Sandstone. Sandstone bedrock outcrops and steps down the property to the waterfront (Photos 10 & 11).

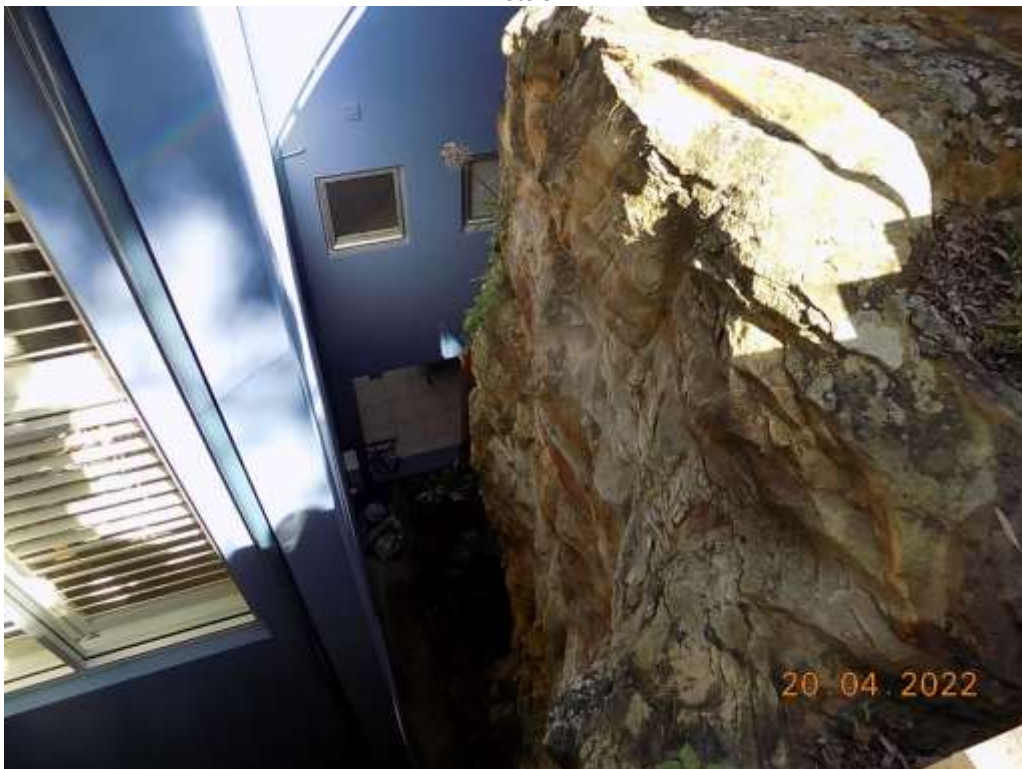
Photo 4

No geotechnical hazards were observed beside the property. The steeply graded slope that falls across the property and continues above is a potential hazard (**Hazard One**). The large sandstone cut face that steps ~9.0m down the slope is a potential hazard (**Hazard Two**). The proposed fills for the lawn areas are a potential hazard until retaining walls are in place (**Hazard Three**). The vibrations from the proposed excavation are a potential hazard (**Hazard Three**). The proposed excavation is a potential hazard until retaining walls are in place (**Hazard Four**).

HAZARDS	Hazard One	Hazard Two	Hazard Three
TYPE	The steep slope that falls across the property and continues above failing and impacting on the proposed works.	The existing sandstone cut face that steps ~9.0m down the slope failing and impacting on the proposed works (Photo 4).	The proposed fills failing and impacting the proposed works.
LIKELIHOOD	'Unlikely' (10^{-4})	'Unlikely' (10^{-4})	'Possible' (10^{-3})
CONSEQUENCES TO PROPERTY	'Medium' (15%)	'Medium' (25%)	'Medium' (15%)
RISK TO PROPERTY	'Low' (2×10^{-5})	'Low' (2×10^{-5})	'Moderate' (2×10^{-4})
RISK TO LIFE	9.1×10^{-7} /annum	2.9×10^{-7} /annum	6.0×10^{-5} /annum
COMMENTS	This level of risk is 'ACCEPTABLE', provided the recommendations in Section 7 & 17 are followed.	This level of risk is 'ACCEPTABLE'.	This level of risk to life and property is 'UNACCEPTABLE'. To move risk to 'ACCEPTABLE' levels the recommendations in Section 11 are to be followed.

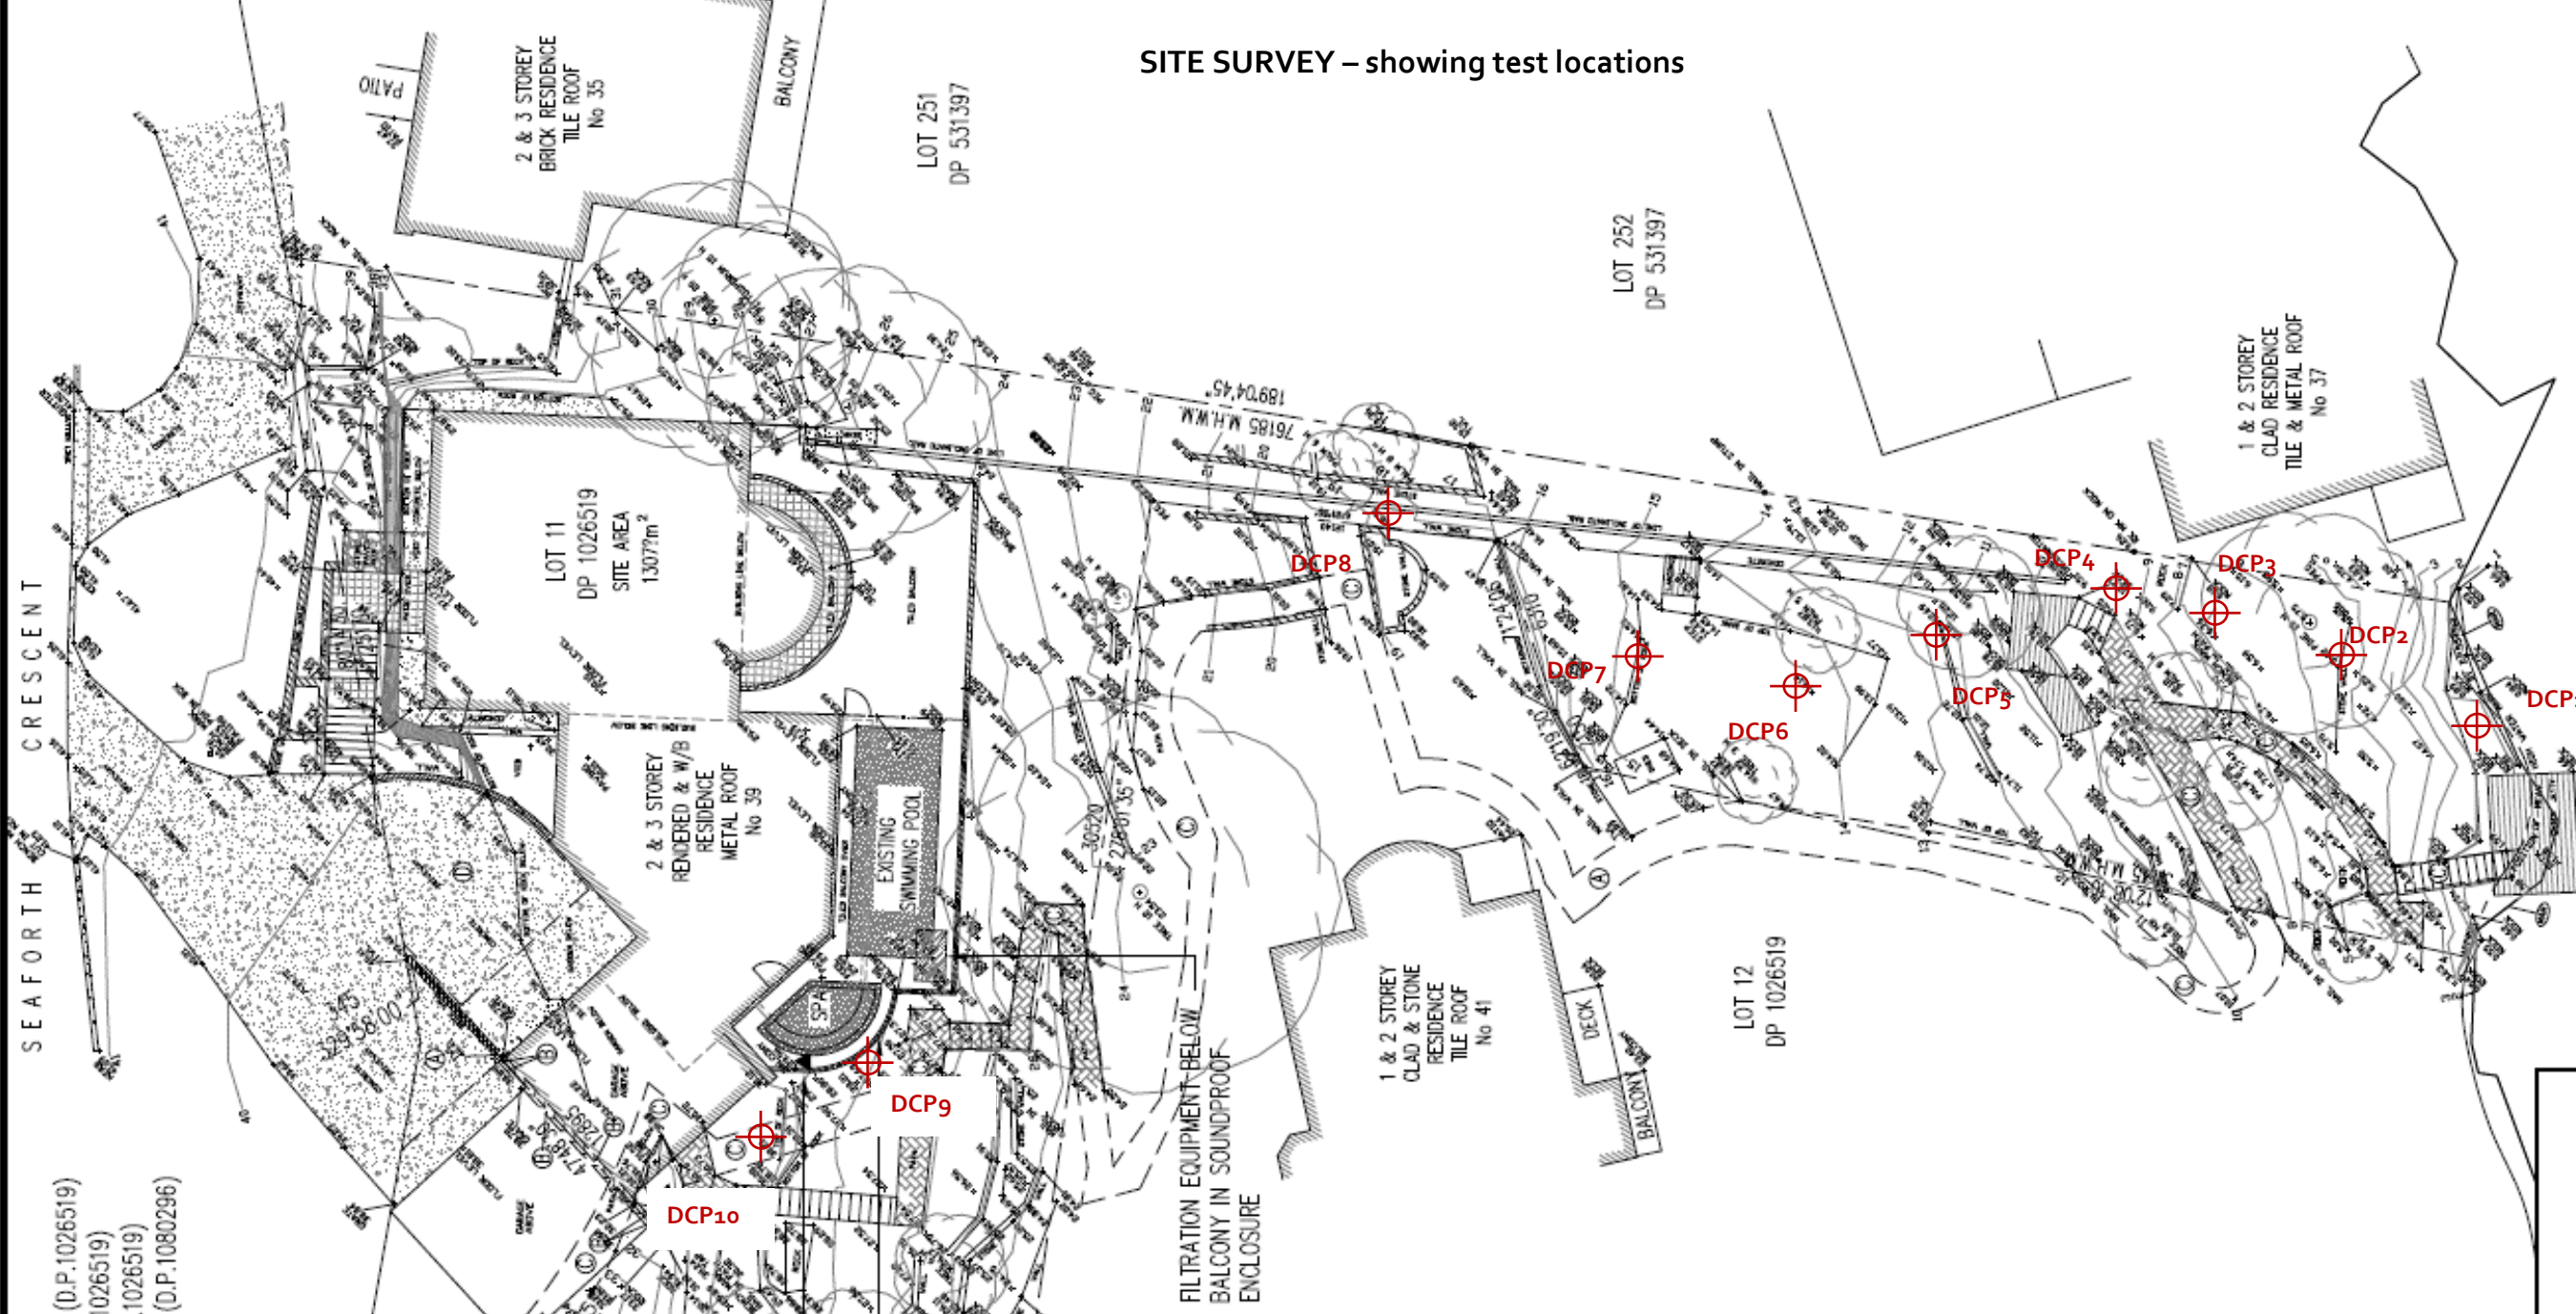
SITE SURVEY – showing test locations

Ten Dynamic Cone Penetrometer (DCP) tests were put down to determine the relative density of the overlying soil and the depth to bedrock. The locations of the tests are shown on the site plan attached. It should be noted that a level of caution should be applied when interpreting DCP test results. The test will not pass through hard buried objects so in some instances it can be difficult to determine whether refusal has occurred on an obstruction in the profile or on the natural rock surface. This is not expected to be an issue for the testing

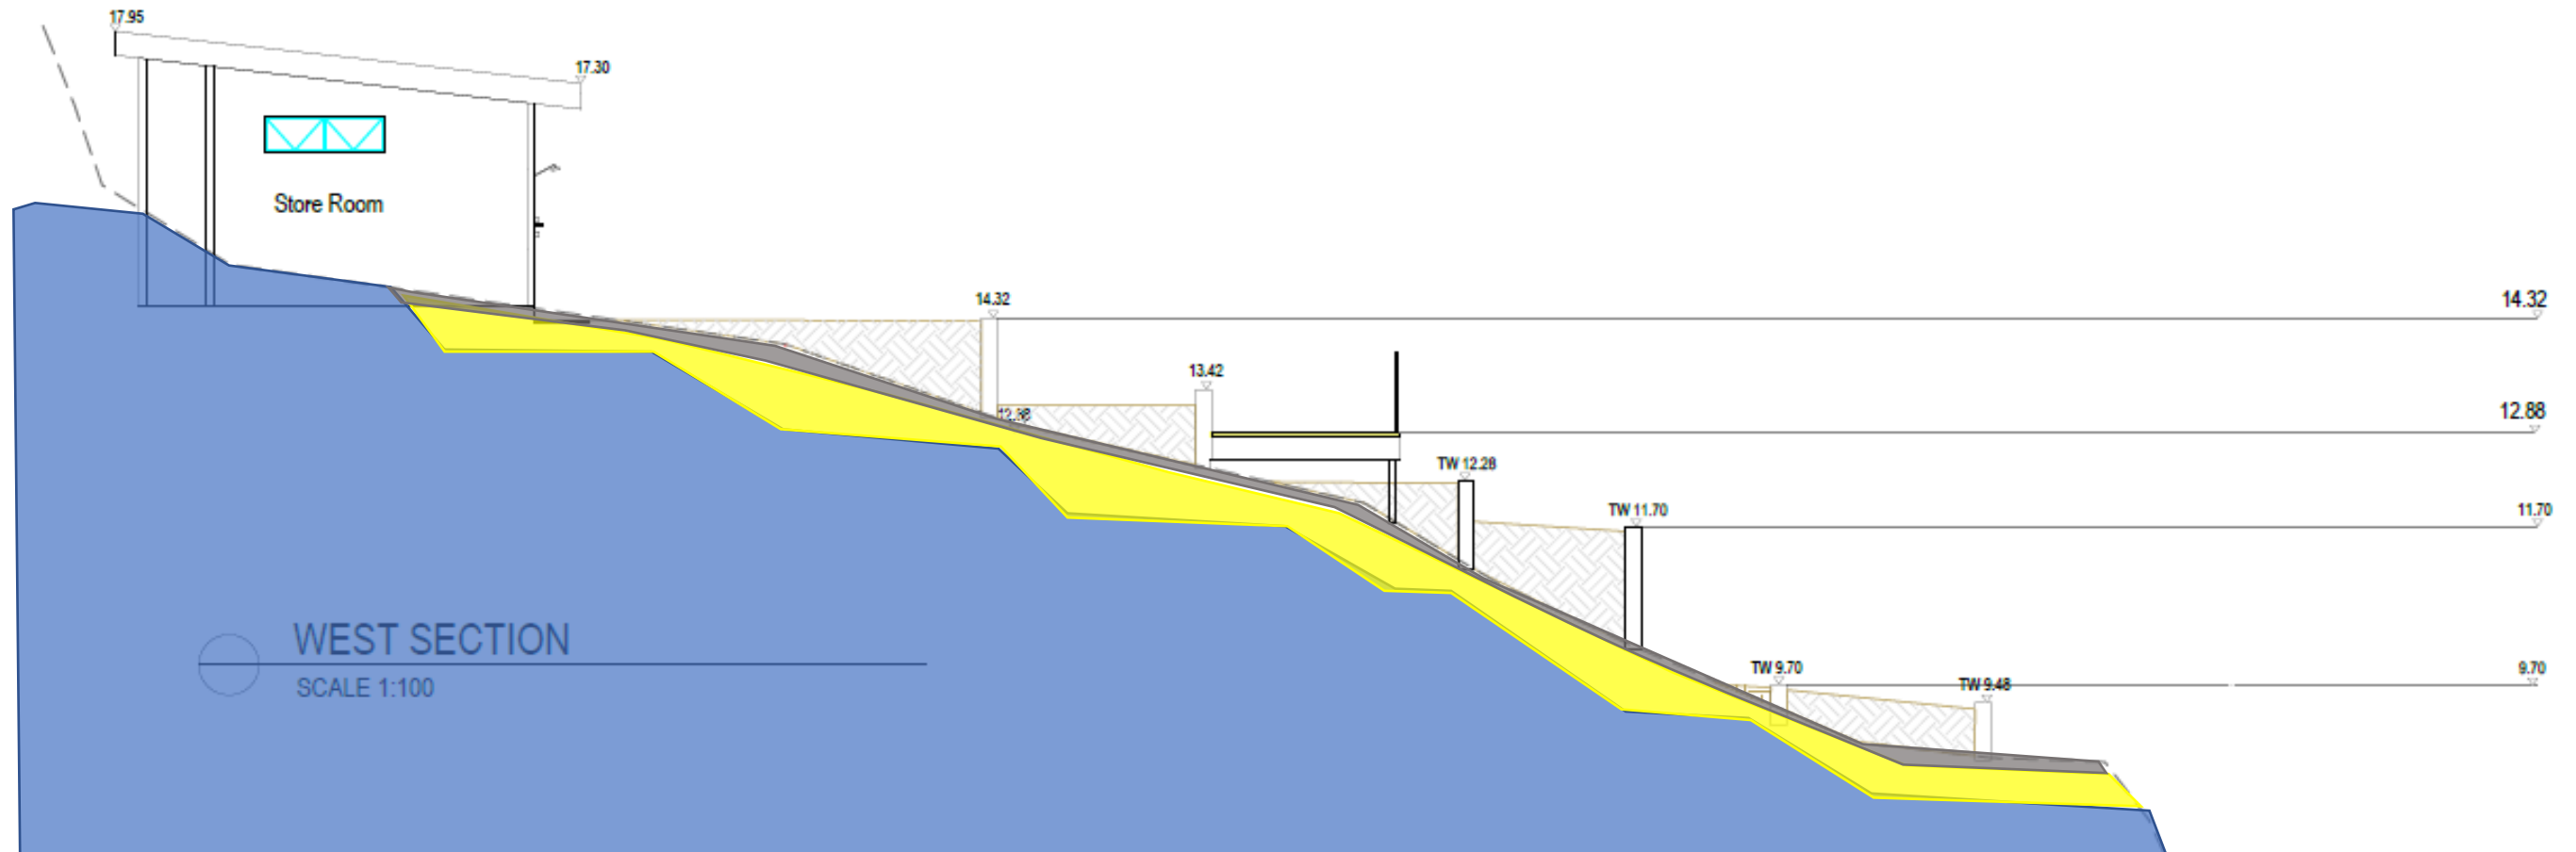
TYPE SECTION – Diagrammatical Interpretation of expected Ground Materials

The surface features of the block are controlled by the outcropping and underlying sandstone bedrock that steps down the property forming sub-horizontal benches between the steps. Where the grade is steeper, the steps are larger and the benches narrower. Where the slope eases, the opposite is true. Where the rock is not exposed, it is overlain by shallow soils over sandy clays that fill the bench step formation. In the test locations, where the rock is not exposed, it was encountered at depths of between ~0.3 to ~0.9m below the current surface, being slightly deeper due to the stepped nature of the underlying bedrock. The outcropping sandstone on the property is estimated to be Medium Strength or better and similar strength rock is expected to underlie the entire site as all the DCP tests bounced at refusal. See Type Section attached for a diagrammatical representation of the expected ground materials.
