Project name	9 EVELYN PLACE BELROSE
Project date	2/07/2020
Job End Date	3/07/2020

Section Inspection - 2/07/2020 - SPI01992

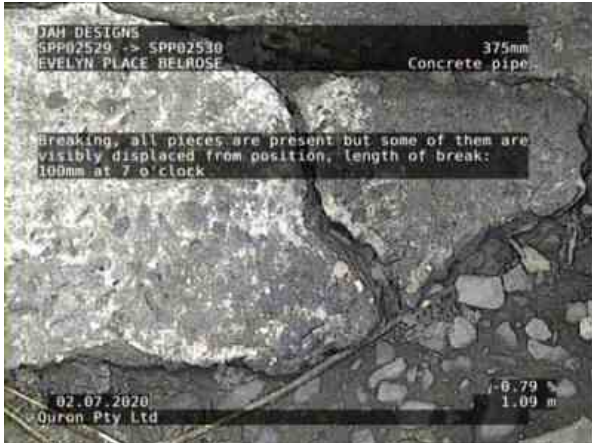
SPI01992_8b654be4-ce45-454c-993e-9086569f6f1d_20200702_122251_886.jpg, 00:01:03, 1.09
Breaking, all pieces are present but some of them are visibly displaced from position, length of break: 100mm at 7 o'clock

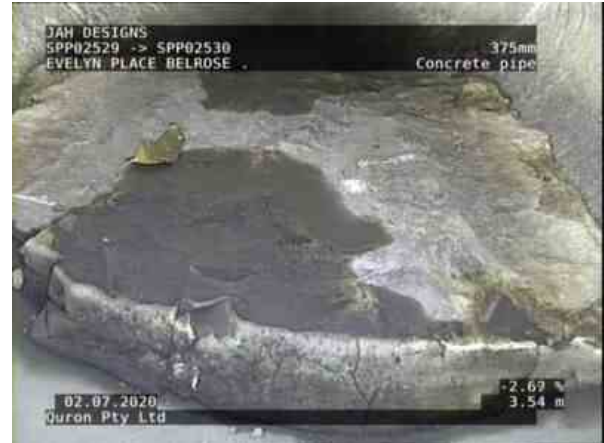
SPI01992_ea245793-be85-4723-9209-d3fc2e3f99bb_20200702_122349_851.jpg, 00:01:46, 3.54
Deposits in the invert, hard compacted material, concrete, Obstruction: 5-20% from 5 o'clock to 7 o'clock
