Report Title: Geotechnical Report 61 Dress Circle Road, Avalon
Report Date: 4/9/20

GEOTECHNICAL INVESTIGATION:

Additions and Alterations at **61 Dress Circle Road, Avalon**

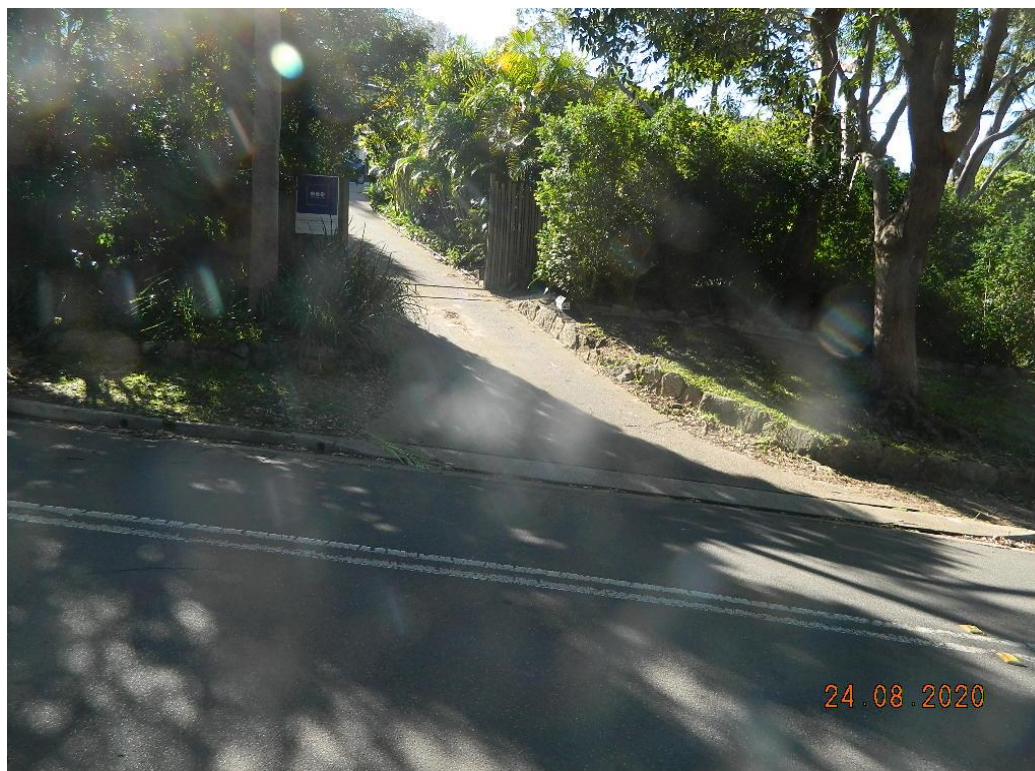
Photo 1

2.3 At the road frontage a concrete driveway runs up the slope to a parking area on the downhill side of the house (Photos 1 & 2). Fill has been placed to form level lawn areas on the NE side of the driveway and below the parking area (Photo 3). The lower lawn fill is unsupported but is battered back at stable angles. Some of the fill was not planted with lawn or other vegetation but we note that this will be removed as part of the proposed driveway excavation (Photo 4). The upper lawn is supported by a low timber retaining wall. SW of the driveway is a swimming pool in good condition (Photo 5). The part two storey rendered brick house is supported by brick walls and a concrete slab (Photos 6 & 7). The house is cut into the slope on the uphill side. The visible portion of the cut for the house is supported by a stable concrete retaining wall reaching ~2.3m high (Photo 8). Garden and lawn areas are located above the cut. No signs of slope instability were observed on the property. The adjoining neighbouring properties were observed to be in good order as seen from the street and subject property.

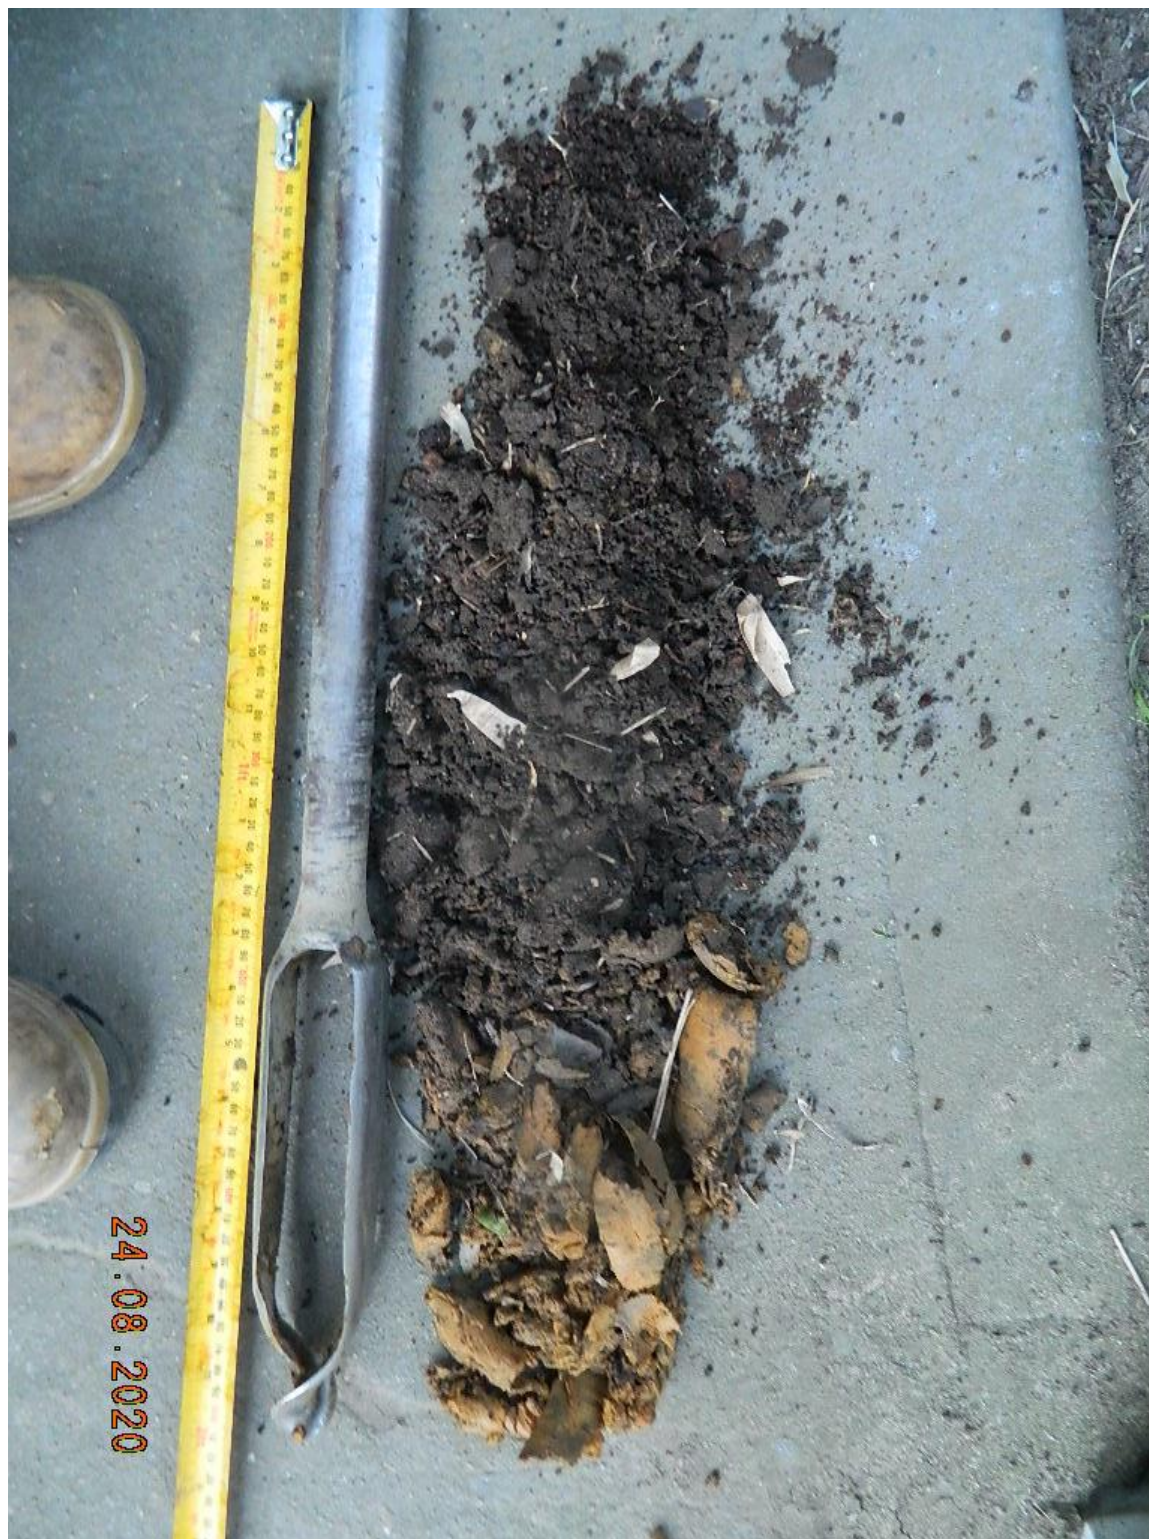
AUGER HOLE 1 (~RL33.7) – AH1 (photo 9)

Depth (m)	Material Encountered
0.0 to 0.4	TOPSOIL , sandy soil, dark brown, moist fine to medium grained with fine trace organic matter.
0.4 to 0.6	SANDY CLAY , orange, firm to stiff, moist.

End of hole @ 0.6m in firm to stiff sandy clay. No watertable encountered.

Photo 9: AH1 – Downhole is from top to bottom.

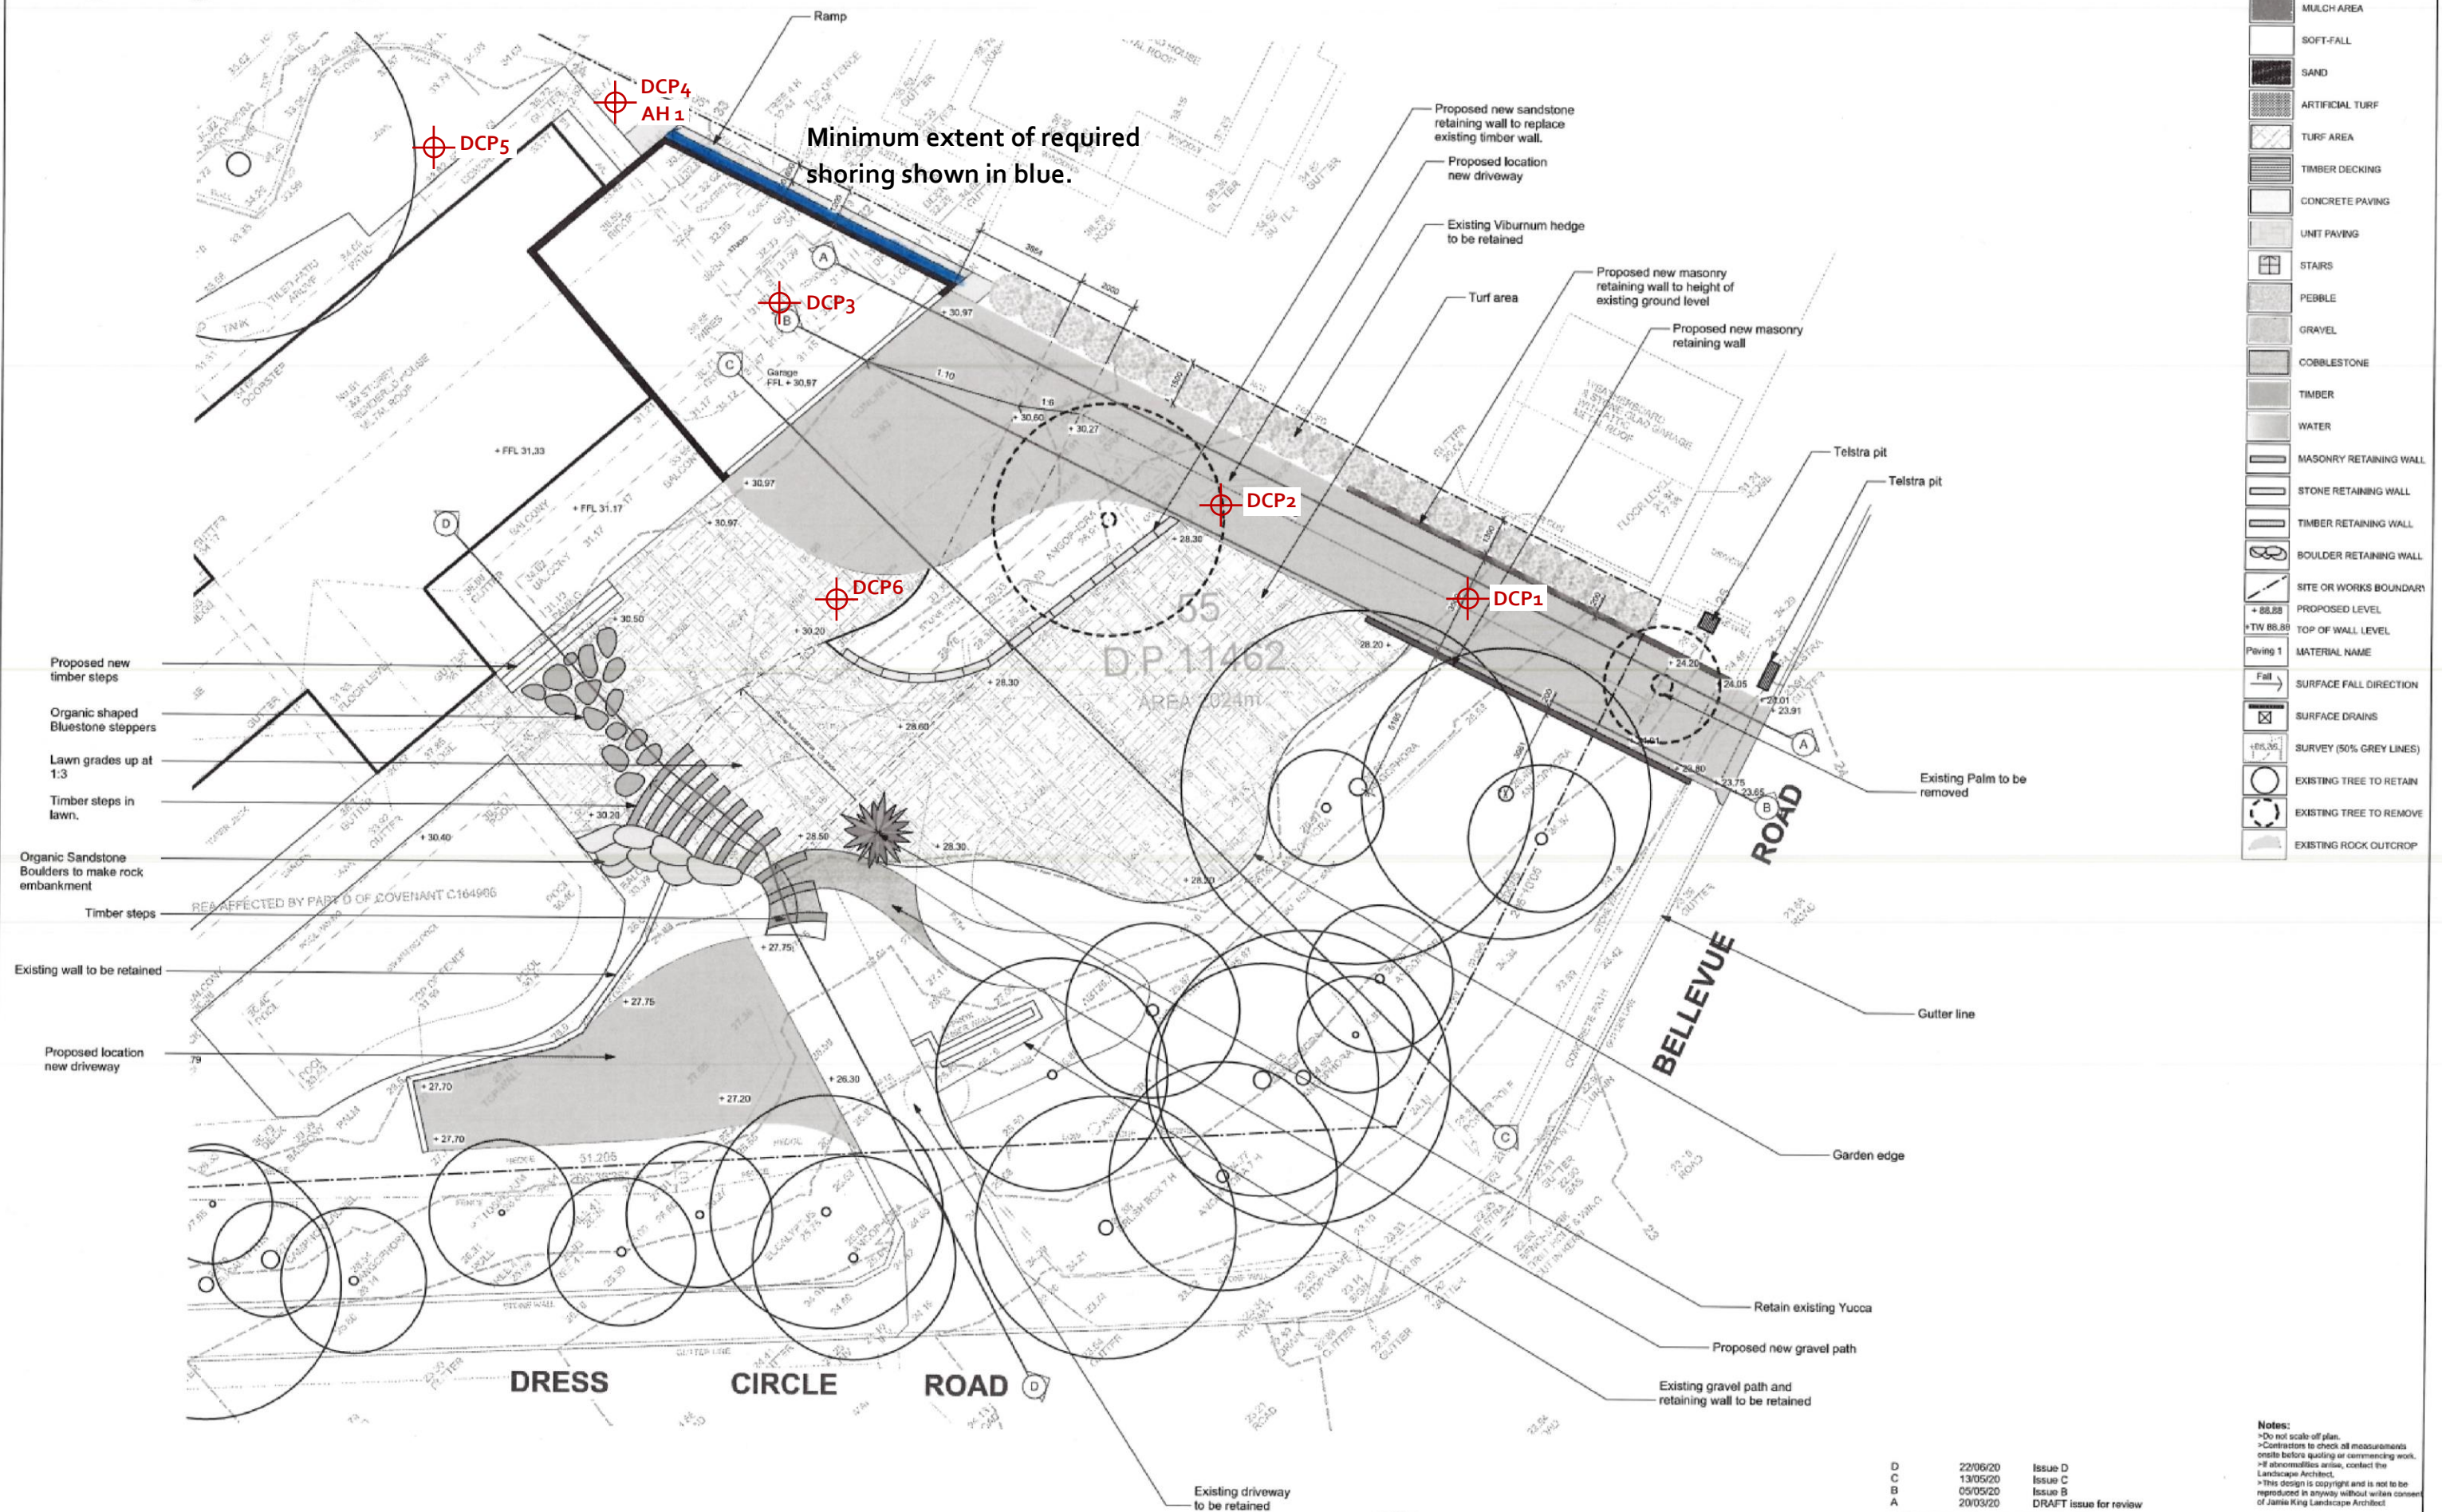
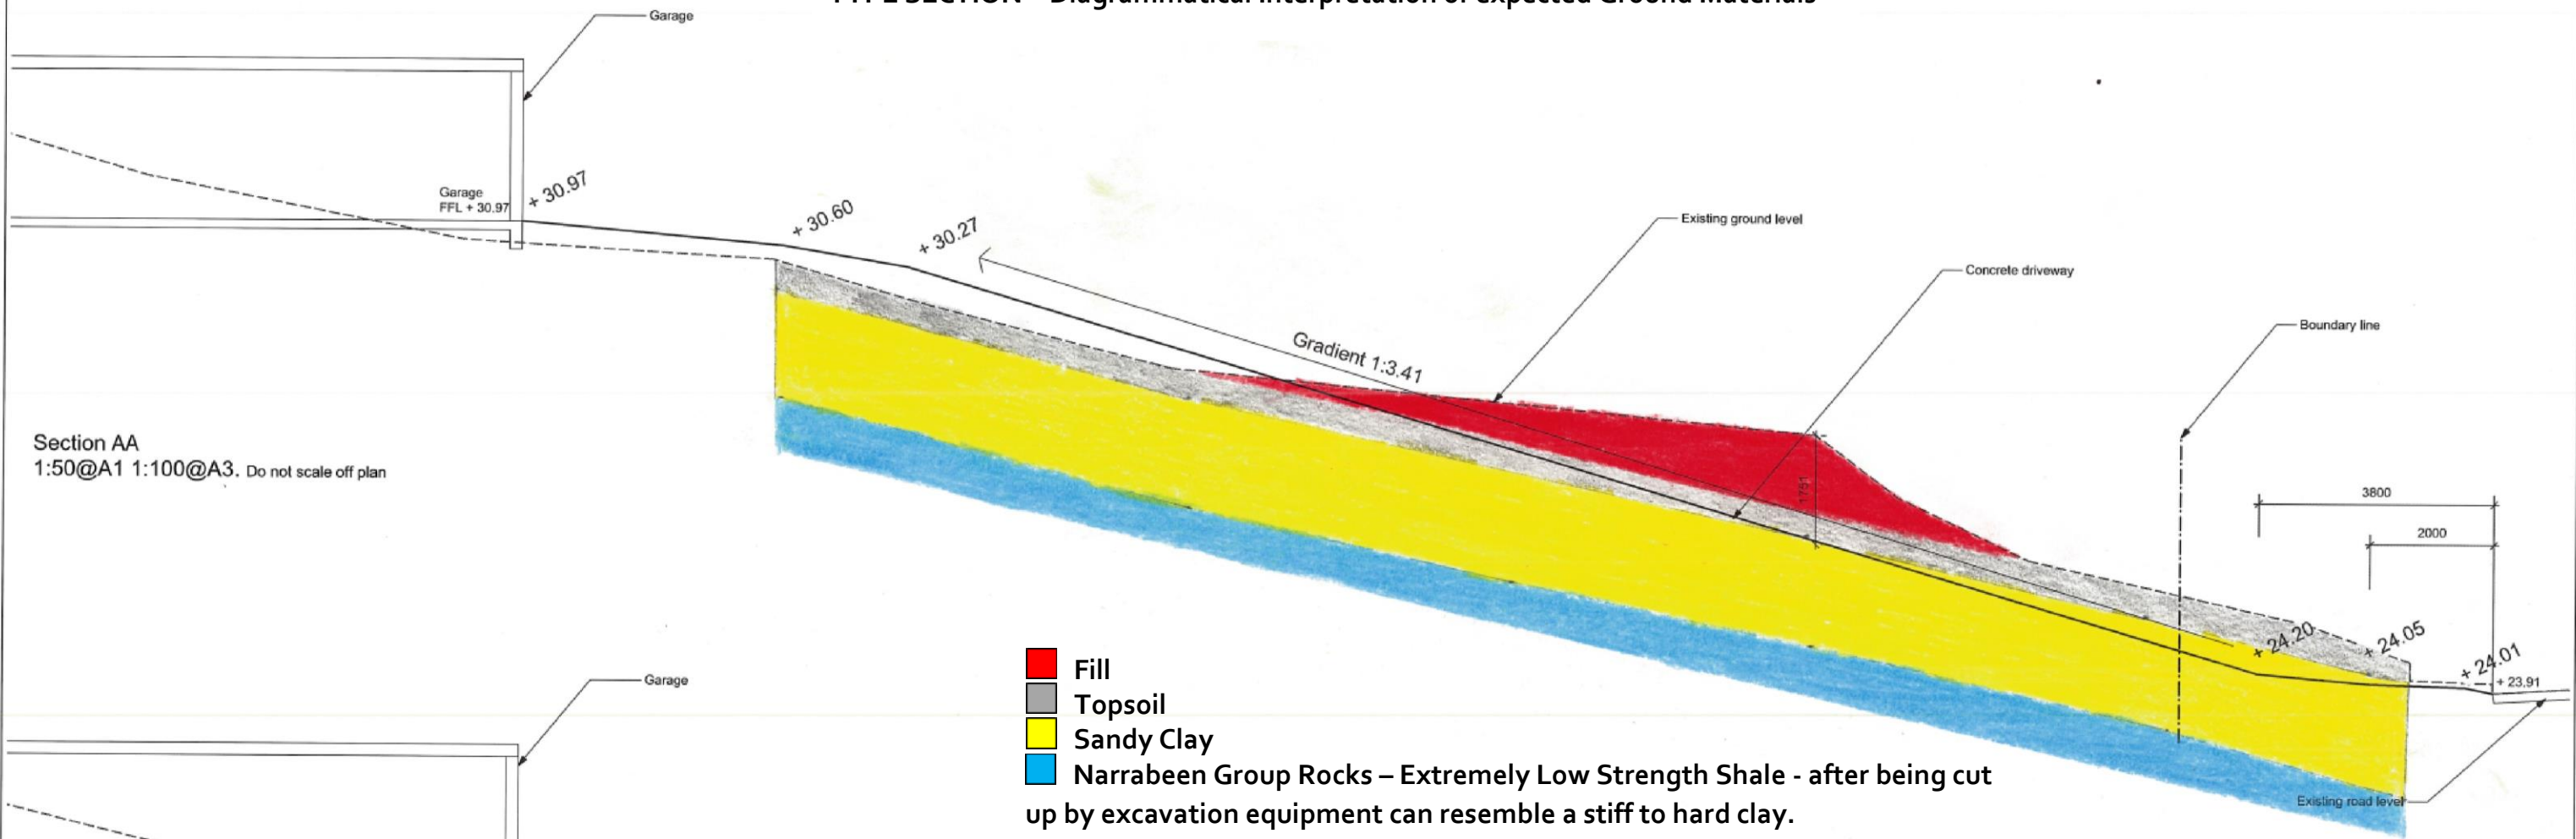
TYPE SECTION – Diagrammatical Interpretation of expected Ground Materials

The slope materials are colluvial at the near surface and residual at depth. In the test locations, the ground materials consist of fill and a thin sandy topsoil over sandy clays. Fill has been placed to form level lawn areas on the downhill side of the property. The clays merge into the weathered zone of the under lying rocks at depths of between 1.1m to 3.3m below the current surface, being deeper in the filled areas. The weathered zone of the underlying rock is interpreted as Extremely Low to Low Strength Rock. It is to be noted that this material is a soft rock and can appear as a mottled stiff clay when it is cut up by excavation equipment. See Type Section attached for a diagrammatical representation of the expected ground materials.
