Project name 52-54 Brighton St Freshwater
Project date 13/04/2023
Job End Date 13/04/2023

Project name	Project number	Project date
52-54 Brighton St Freshwater	Pre-Dilapidation	13/04/2023

Section Inspection - 13/04/2023 - SPI 12531

Section Inspection - 13/04/2023 - SPI 11866

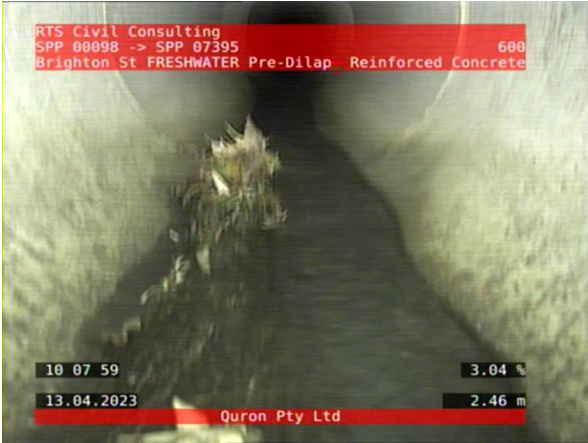
2.46	S01 RT	Tap roots--a small number of major roots (10mm or greater) without a significant mass of fine root, at joint, Obstruction: 5-20% from 6 o'clock to 8 o'clock, Start #	00:00:59	1

1, 00:00:59, 2.46
Tap roots--a small number of major roots (10mm or greater) without a significant mass of fine root, at joint, Obstruction: 5-20% from 6 o'clock to 8 o'clock, Start #

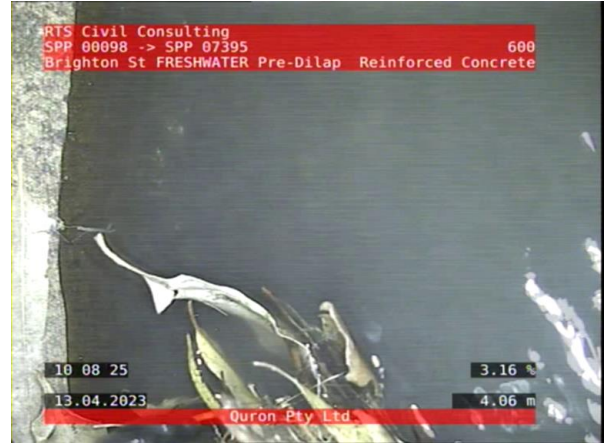
4.06	F01 RT	Tap roots--a small number of major roots (10mm or greater) without a significant mass of fine root, at joint, Obstruction: 5-20% from 6 o'clock to 8 o'clock, Finish #	00:01:26	2	3

2, 00:01:26, 4.06
Tap roots--a small number of major roots (10mm or greater) without a significant mass of fine root, at joint, Obstruction: 5-20% from 6 o'clock to 8 o'clock, Finish #

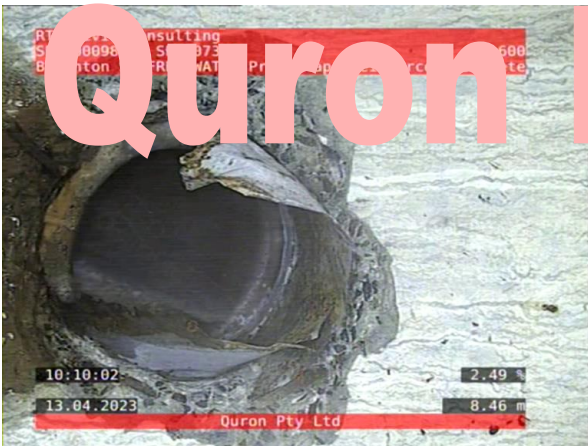
3, 00:02:47, 8.46
Connection, poor workmanship, connection appears to be open, height: 100mm at 11 o'clock

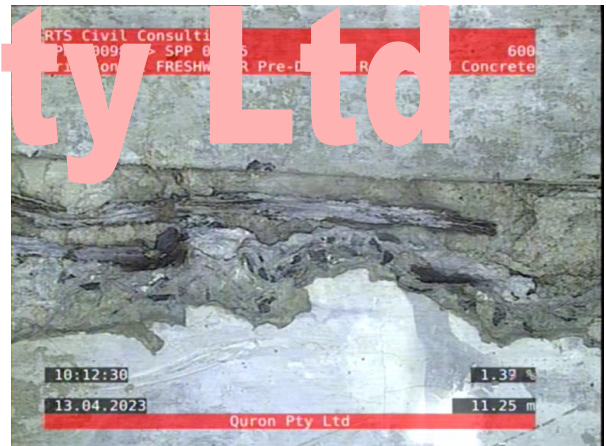
4, 00:03:49, 11.25
Reinforcement is exposed and corroded, at joint from 11 o'clock to 1 o'clock

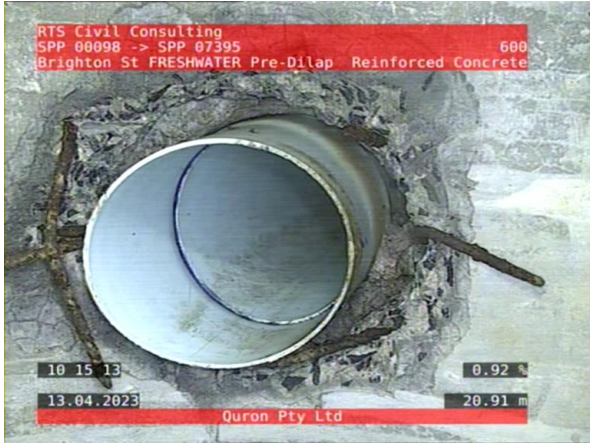
5, 00:06:10, 20.91
Connection, poor workmanship, connection appears to be open, height: 100mm at 1 o'clock

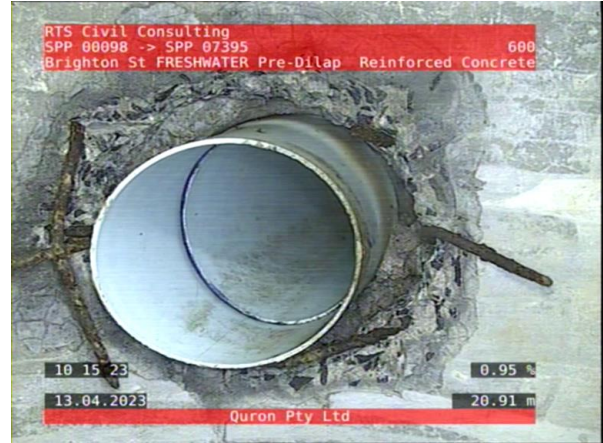
6, 00:06:14, 20.91
Reinforcement is exposed and corroded at 1 o'clock

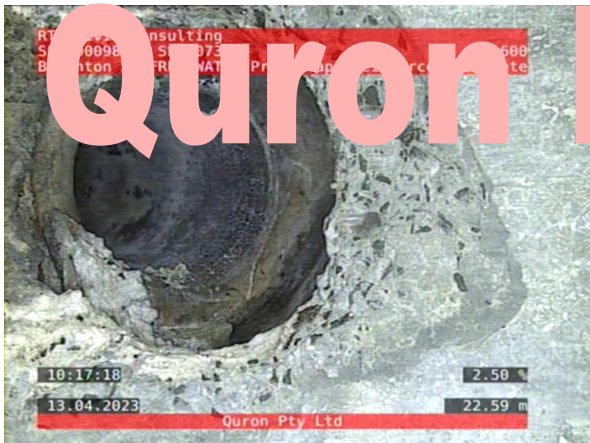
7, 00:07:02, 22.59
Connection, poor workmanship, connection appears to be open, height: 100mm at 10 o'clock

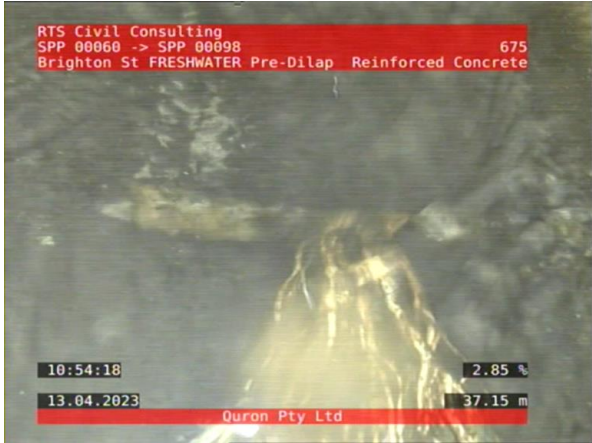
1, 00:14:50, 37.15
Fine roots--a relatively small number of flexible minor roots, at joint, Obstruction: <5% at 6 o'clock

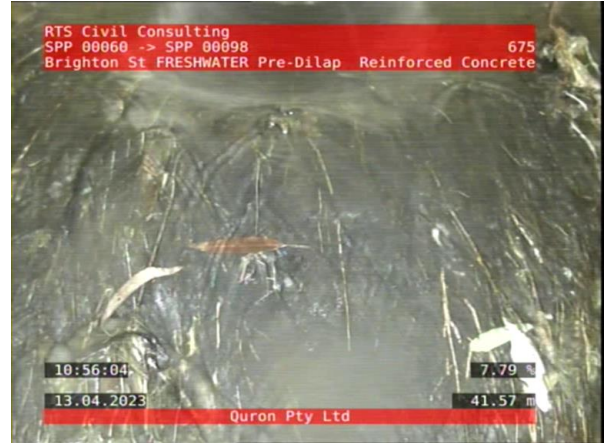
2, 00:15:41, 41.57
A mass of mostly fine roots, which has developed into an interwoven clump, at joint, Obstruction: 21-50% from 4 o'clock to 8 o'clock

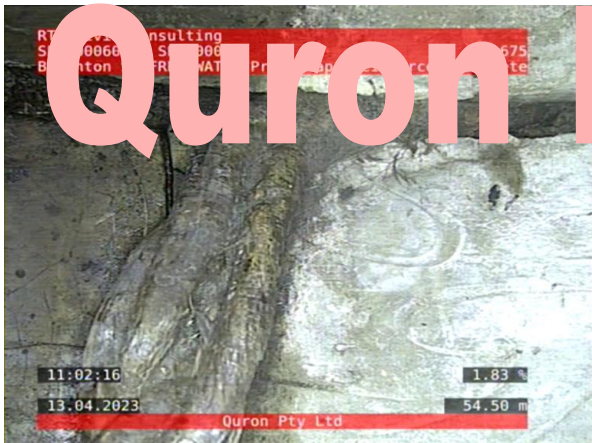
54.50	RT	Tap roots--a small number of major roots (10mm or greater) without a significant mass of fine root, at joint, Obstruction: <5% at 4 o'clock	00:19:16	3	3

3, 00:19:16, 54.50
Tap roots--a small number of major roots (10mm or greater) without a significant mass of fine root, at joint, Obstruction: <5% at 4 o'clock

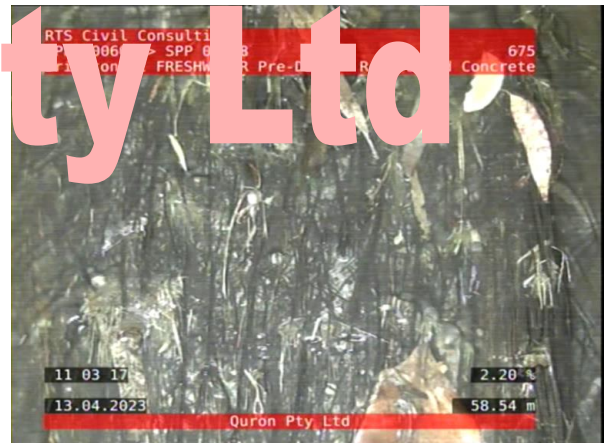
4, 00:20:04, 58.54
A mass of mostly fine roots, which has developed into an interwoven clump, Obstruction: 5-20% from 4 o'clock to 8 o'clock

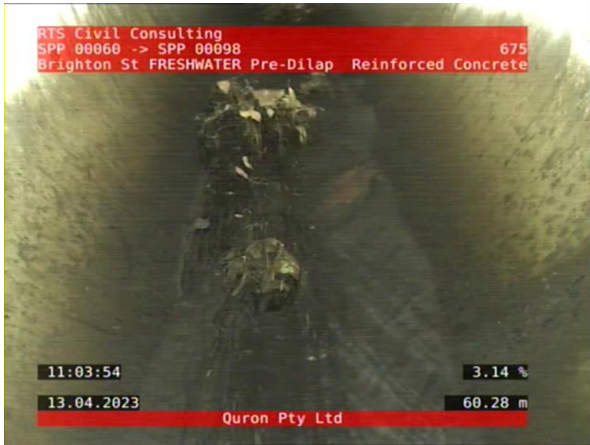
5, 00:20:25, 60.28
Fine roots--a relatively small number of flexible minor roots,
Obstruction: 5-20% from 5 o'clock to 7 o'clock, Start #

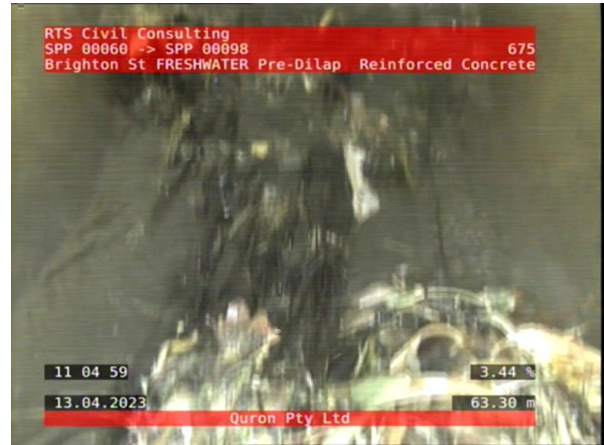
6, 00:21:14, 63.30
A mass of mostly fine roots, which has developed into an
interwoven clump, at joint, Obstruction: 5-20% from 4 o'clock to
8 o'clock
