**ALL ARBOR SOLUTIONS**

# Arboricultural Impact Assessment

96-97 North Steyne  
Manly  
NSW  
2095

13 July 2021

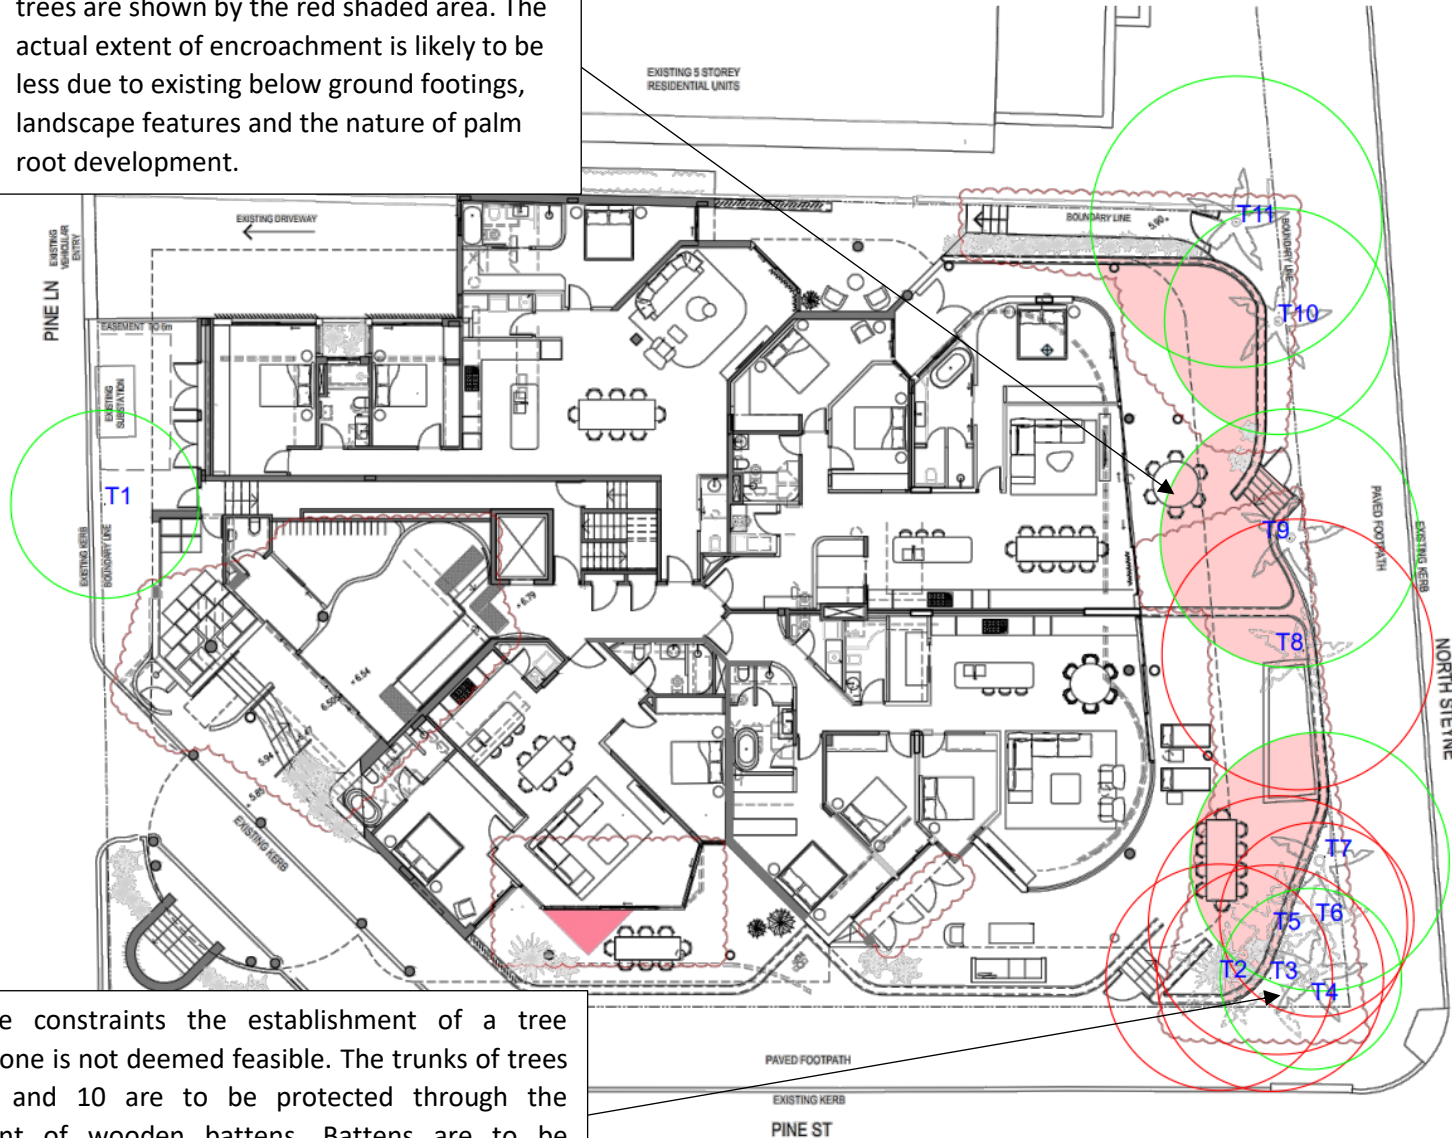
Extract from Demolition Proposed Ground Floor Plan, drawing DA1003 showing trees to be removed and retained. Trees indicated by green circles are to be retained, trees indicated by red circles are to be removed. TPZ's have been calculated in accordance with AS4970-2009 Protection of Trees on Development sites.

Due to site constraints the establishment of a tree protection zone is not deemed feasible. The trunks of trees 1, 4, 7, 9 and 10 are to be protected through the establishment of wooden battens. Battens are to be installed in accordance with **Appendix 7** point 8 under guidance of the project arborist.

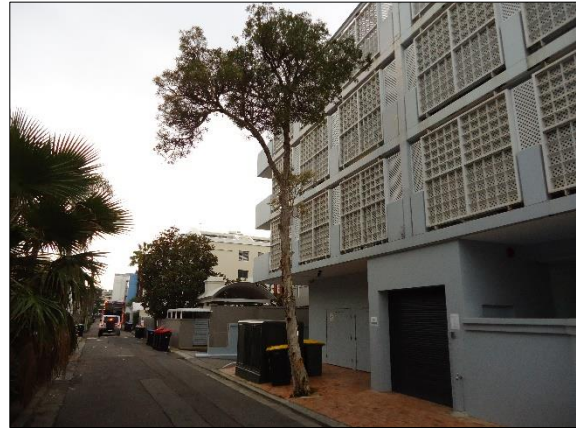
2.2.3 Tree 1 is a *Callistemon salignus* (Willow Bottlebrush) and is located on the Pine Lane frontage of the site. It is a planted specimen and has been assessed as having short useful life expectancy of five to fifteen years, low landscape significance and retention value. The tree has had significant branches removed from it to create build and road side clearances. Vehicle damage to the trunk of the tree was observed.

**Photograph 1:** Tree 1 *Callistemon salignus* (Willow Bottlebrush) located within Pine Lane.

- 3.1.2 The protection zone of tree 1 is clear of the proposed development works allowing for its retention. Its protection is to be established under guidance of a project arborist during construction works to ensure its viable retention.

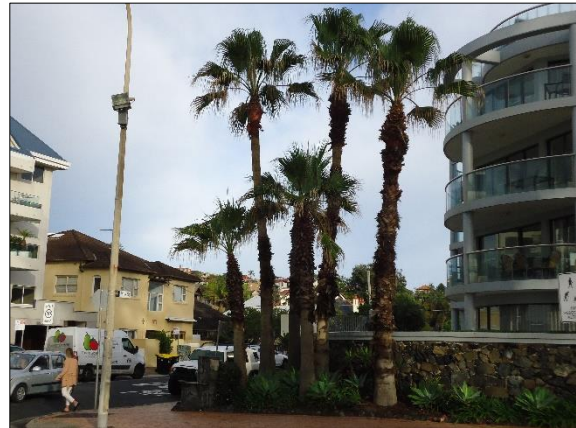
3.1.5 Although encroachments into the TPZ of tree 6 are likely to be manageable with respects to the proposed works the crack within its trunk predisposes the tree to failure under wind loading. As such, retention of the tree is not recommended.

**Photograph 2:** Trees 2, 3, 4, 5, 6 and 7 *Livistona australis* (Cabbage Palms) located at the corner of Pine Street and North Steyne.

3.2.1 Tree 2, 3, 5, 6 and 8 cannot be retained under the current design and shall require removal.

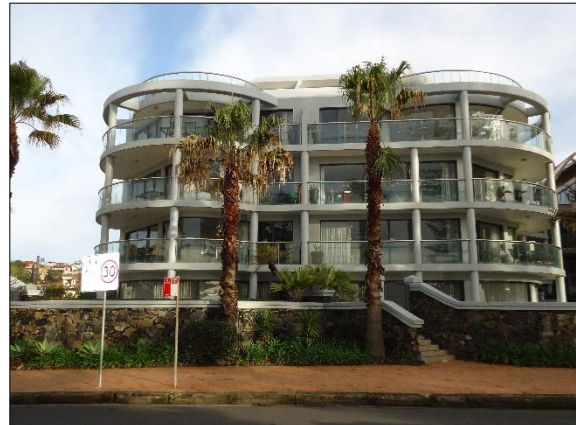
8	<i>Livistona australis</i> (Cabbage Palm)	Tree located within additional ground floor balcony/terraced area and cannot be retained under the current design.	Nil	Remove
9	<i>Livistona australis</i> (Cabbage Palm)	Removal of the existing wall balcony/terraced area constitutes an indicative encroachment of 37% into the TPZ. However, given the nature of palm root development it is likely that the existing wall footings have restricted the growth and development of roots reducing the extent of the encroachment. New balcony/terraced area poses an indicative encroachment of 49% into the TPZ.	Trunk of tree is to be protected through the installation of protective battens (refer <b>Appendix 7</b> point 8). The health and condition of the tree is to be monitored throughout the construction phase of the development. Removal of existing built features within the TPZ to be undertaken in accordance with <b>Appendix 7</b> point 15. All works within the TPZ to be supervised by the project arborist.	Retain

**Photograph 3:** Trees 8 and 9 *Livistona australis* (Cabbage Palms) located along the North Steyne frontage of the site.

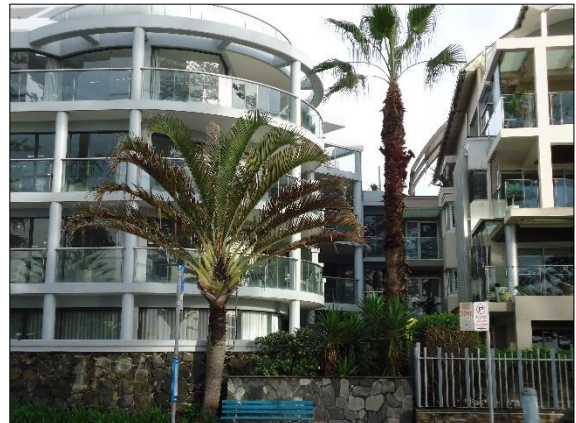
10	<i>Dypsis decaryi</i> (Triangle Palm)	Removal of the existing wall balcony/terraced area constitutes an indicative encroachment of 36% into the TPZ. However, given the nature of palm root development it is likely that the existing wall footings have restricted the growth and development of roots reducing the extent of the encroachment. New balcony/terraced area poses an indicative encroachment of 34% into the TPZ.	Trunk of tree is to be protected through the installation of protective battens (refer <b>Appendix 7</b> point 8). The health and condition of the tree is to be monitored throughout the construction phase of the development. Removal of existing built features within the TPZ to be undertaken in accordance with <b>Appendix 7</b> point 15. All works within the TPZ to be supervised by the project arborist.	Retain
11	<i>Livistona australis</i> (Cabbage Palm)	Tree located within footprint of new entry point adjacent northern boundary off North Steyne. Removal of the existing wall balcony/terraced area constitutes an indicative encroachment of 23% into the TPZ. However, given the nature of palm root development it is likely that the existing wall footings have restricted the growth and development of roots reducing the extent of the encroachment. New balcony/terraced area poses an indicative encroachment of 21% into the TPZ. Low free standing wall adjacent base of tree to be removed for new pedestrian access.	Trunk of tree is to be protected through the installation of protective battens (refer <b>Appendix 7</b> point 8). The health and condition of the tree is to be monitored throughout the construction phase of the development. Removal of existing built features within the TPZ to be undertaken in accordance with <b>Appendix 7</b> point 15. All works within the TPZ to be supervised by the project arborist.	Retain

**Photograph 4:** Tree 10 *Dypsis decaryi* (Triangle Palm) and tree 11 *Livistona australis* (Cabbage Palms) located along the North Steyne frontage of the site.

3.1.6 Tree 11 is located within the proposed pedestrian footpath and entry adjacent the northern boundary off of North Steyne. Works associated with the footpath are to be undertaken under supervision of the project arborist to ensure impacts are minimized. Any excavation within the TPZ to obtain working levels is to be undertaken under supervision of the project arborist.
