## **Geotechnical Assessment**

**Project:** Alterations & Additions  
60 Cabarita Road, Avalon Beach NSW.

**REF: AG 21211**  
2 July 2021

For **Alterations & Additions** at  
**60 Cabarita Road, Avalon Beach NSW**

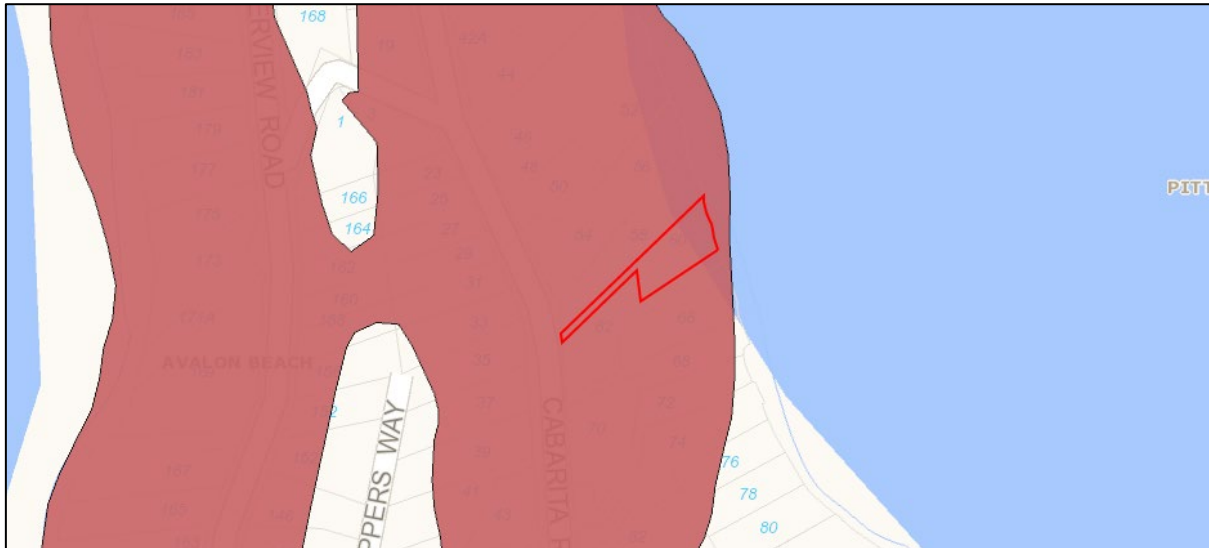
**Image 2.** PLEP Geotechnical Hazard Map  
– 60 Cabarita Road, Avalon Beach NSW

- No evidence of significant soil creep, tension cracks or landslip instability were identified across the site or on adjacent properties, as viewed from the subject site at the time of our inspection.
- The property is classified as **Geotechnical Hazard H1** with reference to Northern Beaches Council PLEP Geotechnical Hazard Map (**Image 2**).

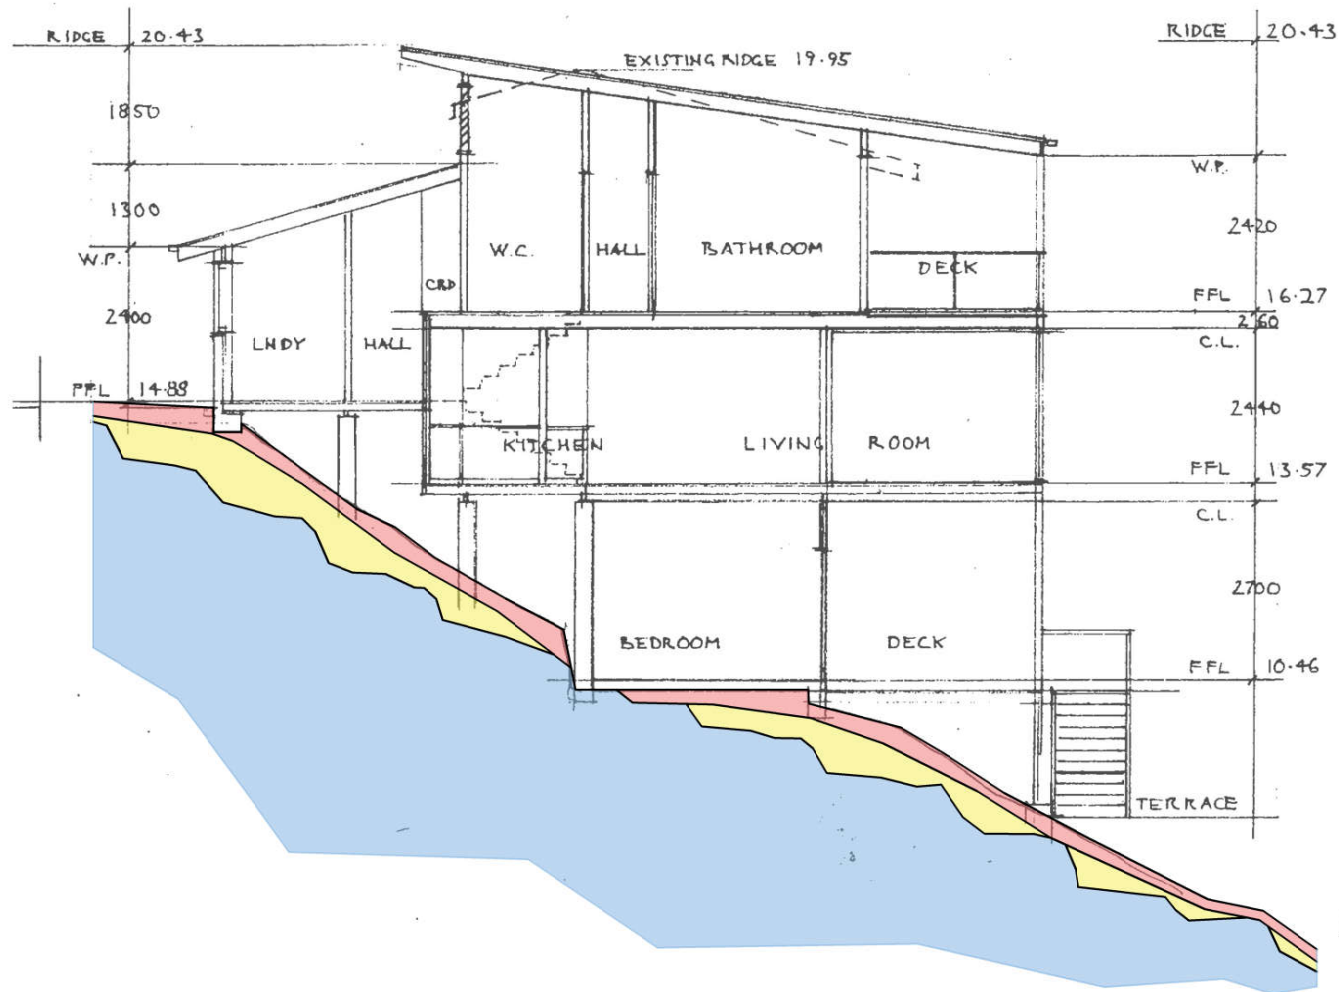
**INFERRED GEOLOGICAL SECTION**  
SCALE NTS

The soil profile consists of shallow uncontrolled fill and silty topsoil (O & A Horizons), silty clay (B Horizon), and weathered bedrock (C Horizon). Based on our observations and the results of testing on site, we would expect competent weathered bedrock, to be found within 1500–2000mm from current surface levels across the area of the proposed works, and deeper where filling has been carried out.

- SHALLOW UNCONTROLLED FILL / SILTY TOPSOIL
- SILTY CLAY
- NEWPORT FORMATION BEDROCK
