Geotechnical Investigation Report

Proposed Development at:

2 Prince Edward Road

G2535-1

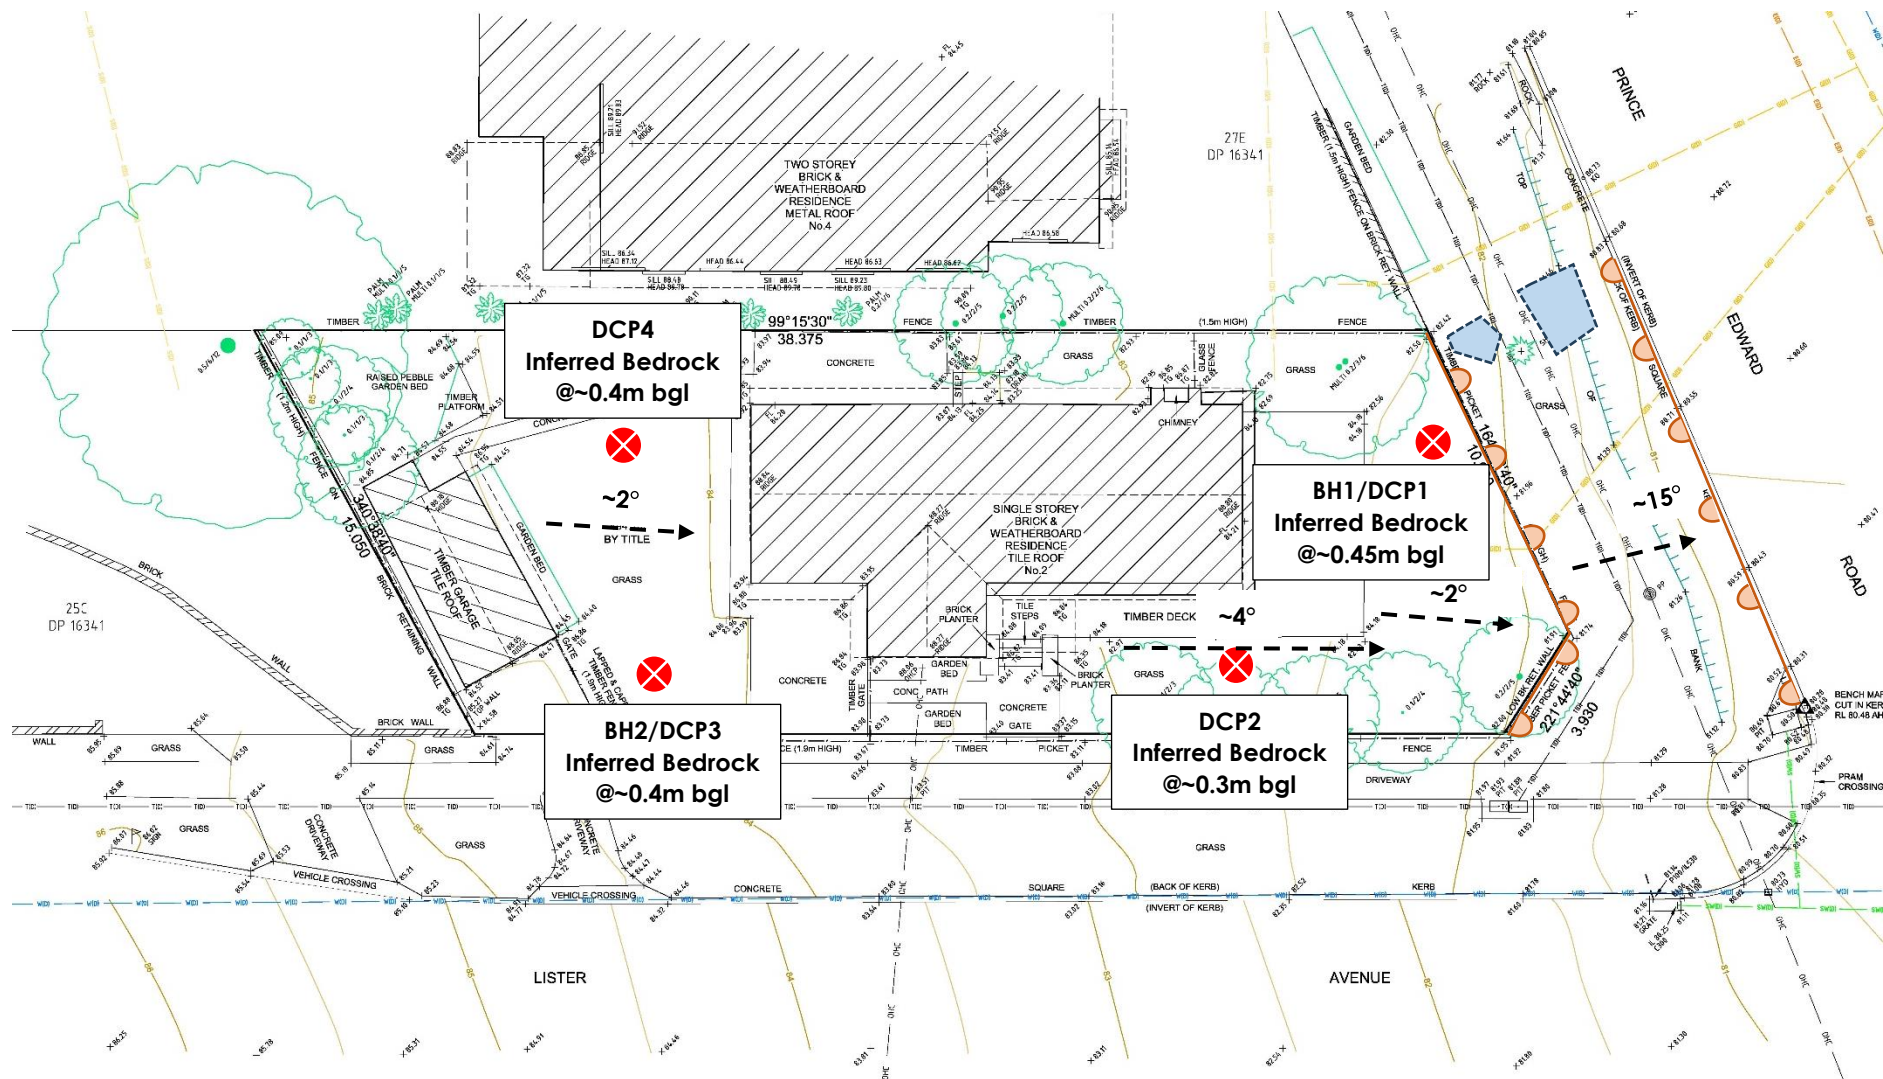
<div>GCA</div> <div>Geotechnical Consultants Australia</div>	Figure 1	Geotechnical Investigation	Drawn: AN	
	Site Plan		Date: 11/02/2025	
	Job No.: G2535-1	Naycon Building Solutions Pty Ltd 2 Prince Edward Road Seaforth NSW 2092	Scale: NTS

From the boreholes (BH1 and BH2) carried out within the site, the subsurface conditions at the test locations generally comprised:

- (Unit 1): FILL: Silty Clay material, low plasticity, from surface and observed to an average depth of up to 0.3m bgl, underlain by:
- (Unit 2): Natural Sandy CLAY, typically medium plasticity, fine to coarse sand, observed to depths of 0.4m to 0.45m bgl.

The geotechnical investigation found that the surface and subsurface conditions of the site generally comprise Silty Clay fill material observed to an average depth of 0.3m, overlying natural soils up to around 0.45m bgl, underlain by *inferred* Sandstone bedrock. Sandstone rock outcrops were observed near the site.
