Report Title: Geotechnical Report 9 Eungai Place, North Narrabeen

Report Date: 23/12/19

GEOTECHNICAL INVESTIGATION:

Alterations and Additions at **9 Eungai Pl, North Narrabeen.**

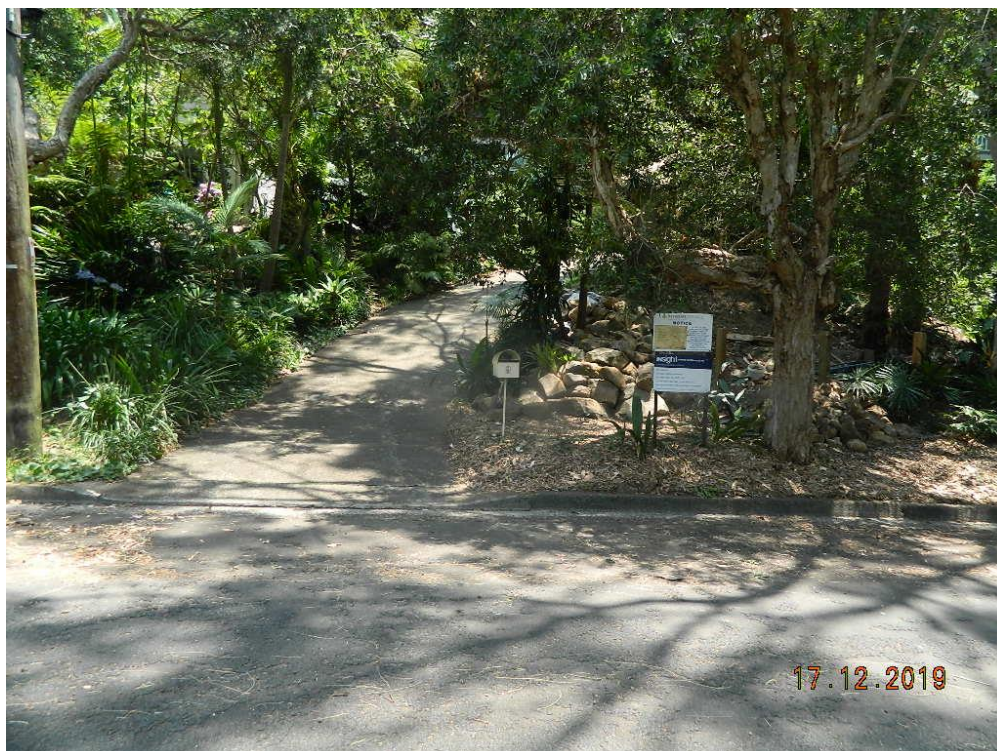
Photo 1

- 2.3** From the road frontage the existing concrete driveway runs up the slope to the house (photo 1). The driveway will be re-routed as part of the development so as to access the proposed garage. The part two storey brick house is supported on brick walls, brick piers and steel posts (photos 2 to 6). The supporting walls, piers and posts appear to be in good condition and show no significant signs of movement. Uphill of the house a sandstone boulder wall up to ~3m high lines the slope to the N and a

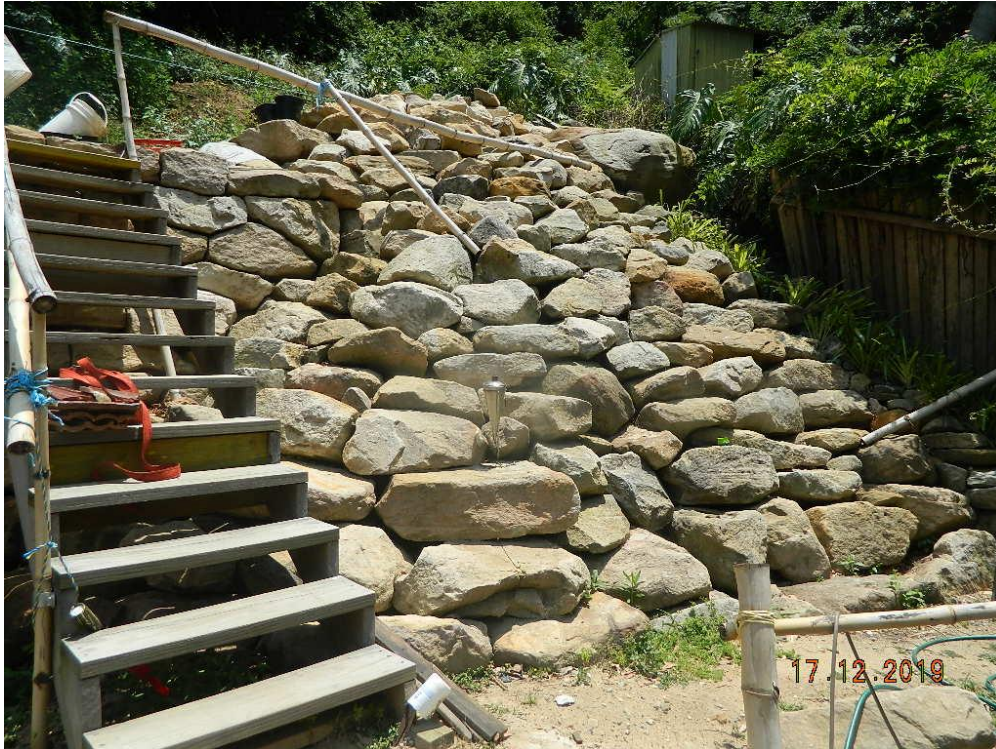
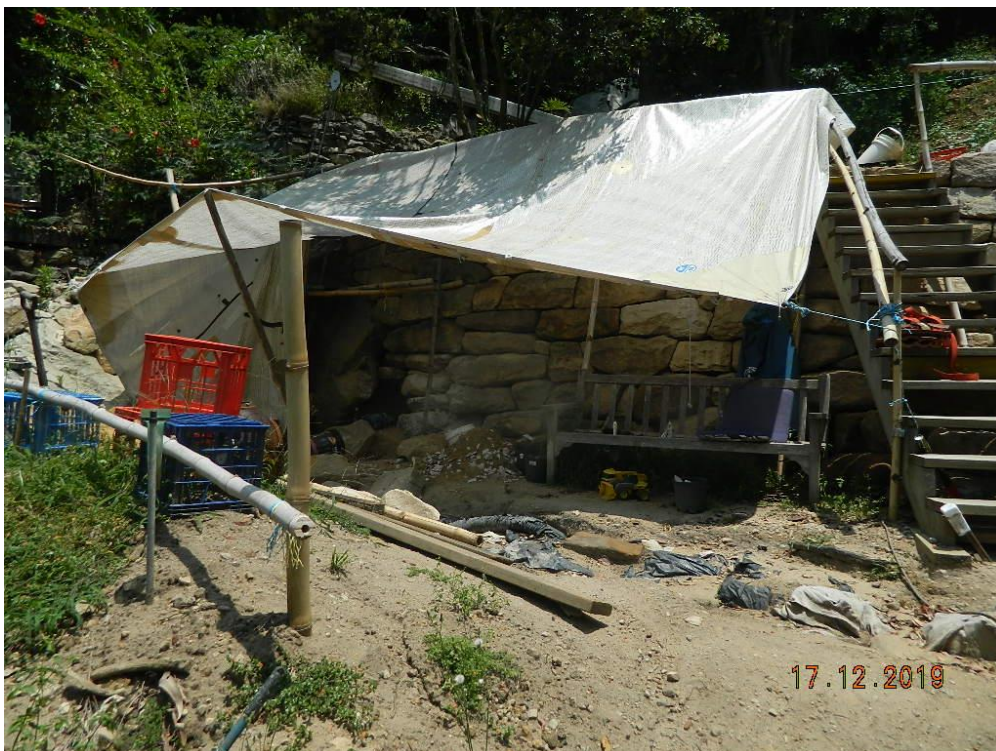
Photo 7

sandstone block wall supports the slope to the S (photos 7 & 8). The boulder wall is battered at an angle of ~40° to ~45°. The wall components are suitably placed and well sized. The sandstone block wall is battered back at ~6° from vertical and appears to be well made. An old ~1.3m mortared stack rock retaining wall supports forms a terrace along the S boundary and in the neighbouring S property (photo 9). At the W boundary loose sandstone boulders are scattered on the slope and are considered to be in stable conditions (photo 10).

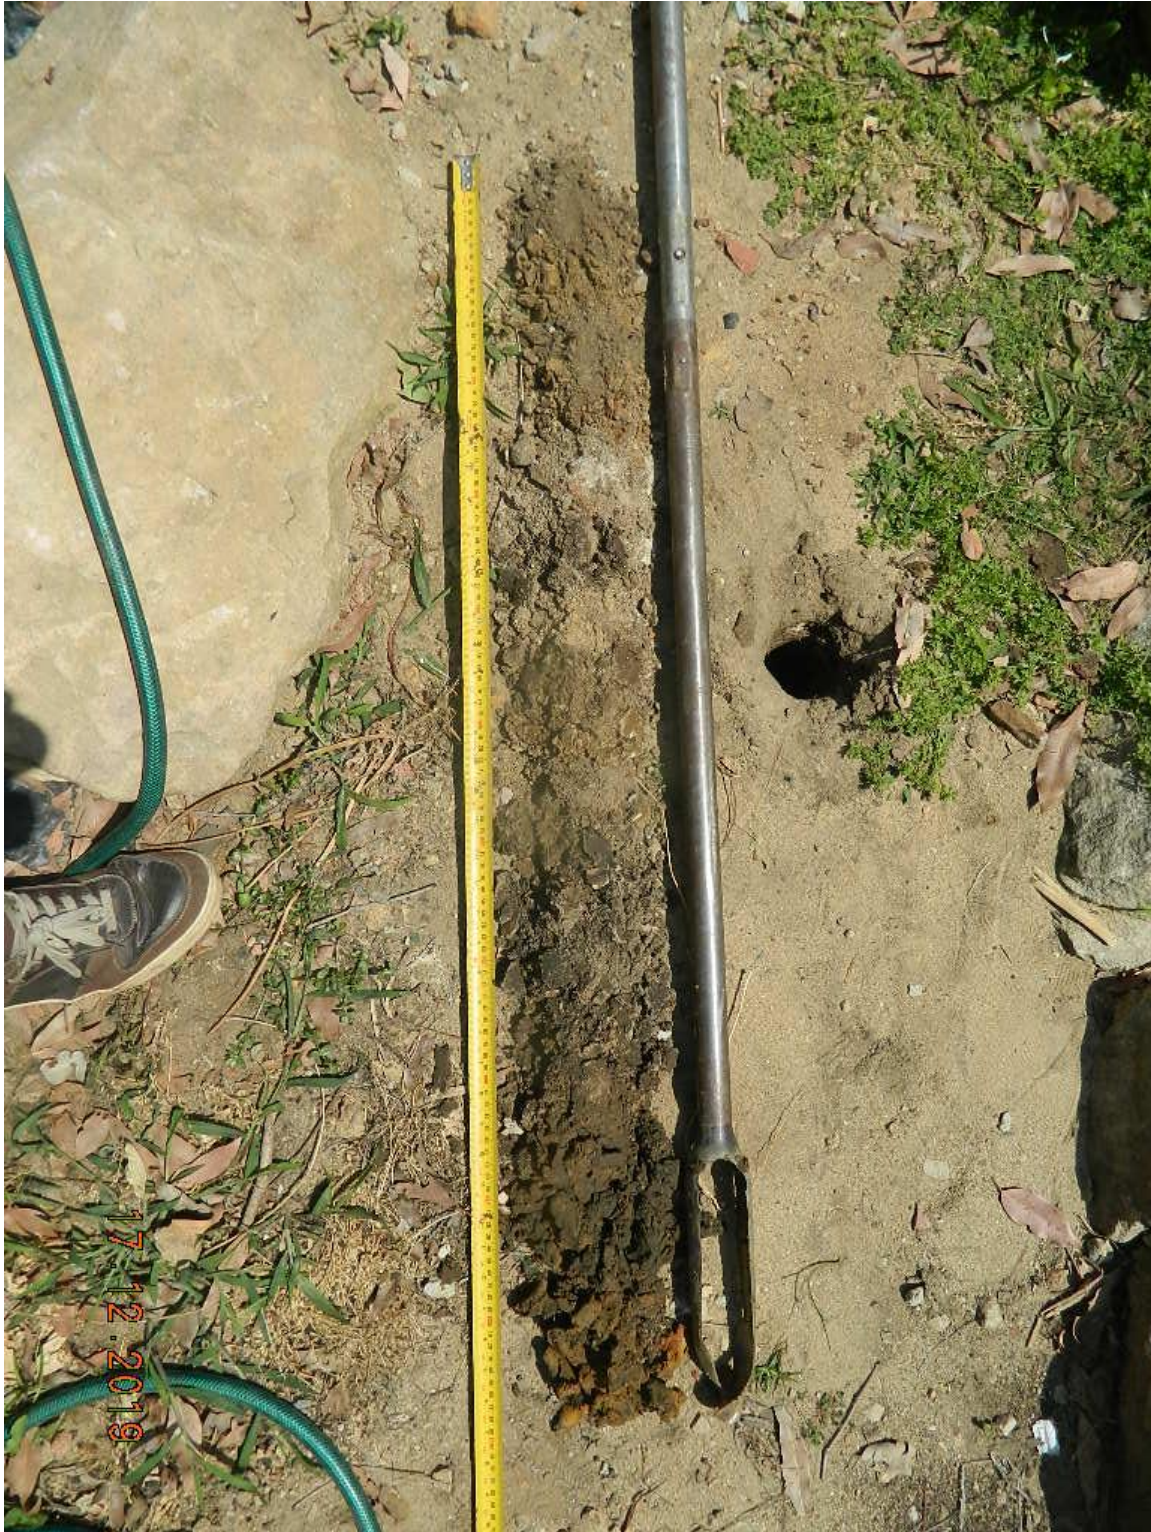
AUGER HOLE 1 (~RL15.7) – AH1 (photo 11)

Depth (m)	Material Encountered
0.0 to 0.8	CLAYEY SAND , brown and grey, fine to medium grained, loose, dry.
0.8 to 1.1	CLAY , brown and orange, firm to stiff, moist.

End of hole @ 1.1m in firm to stiff clay. No watertable encountered.

Photo 11: AH1 – Downhole is from top to bottom

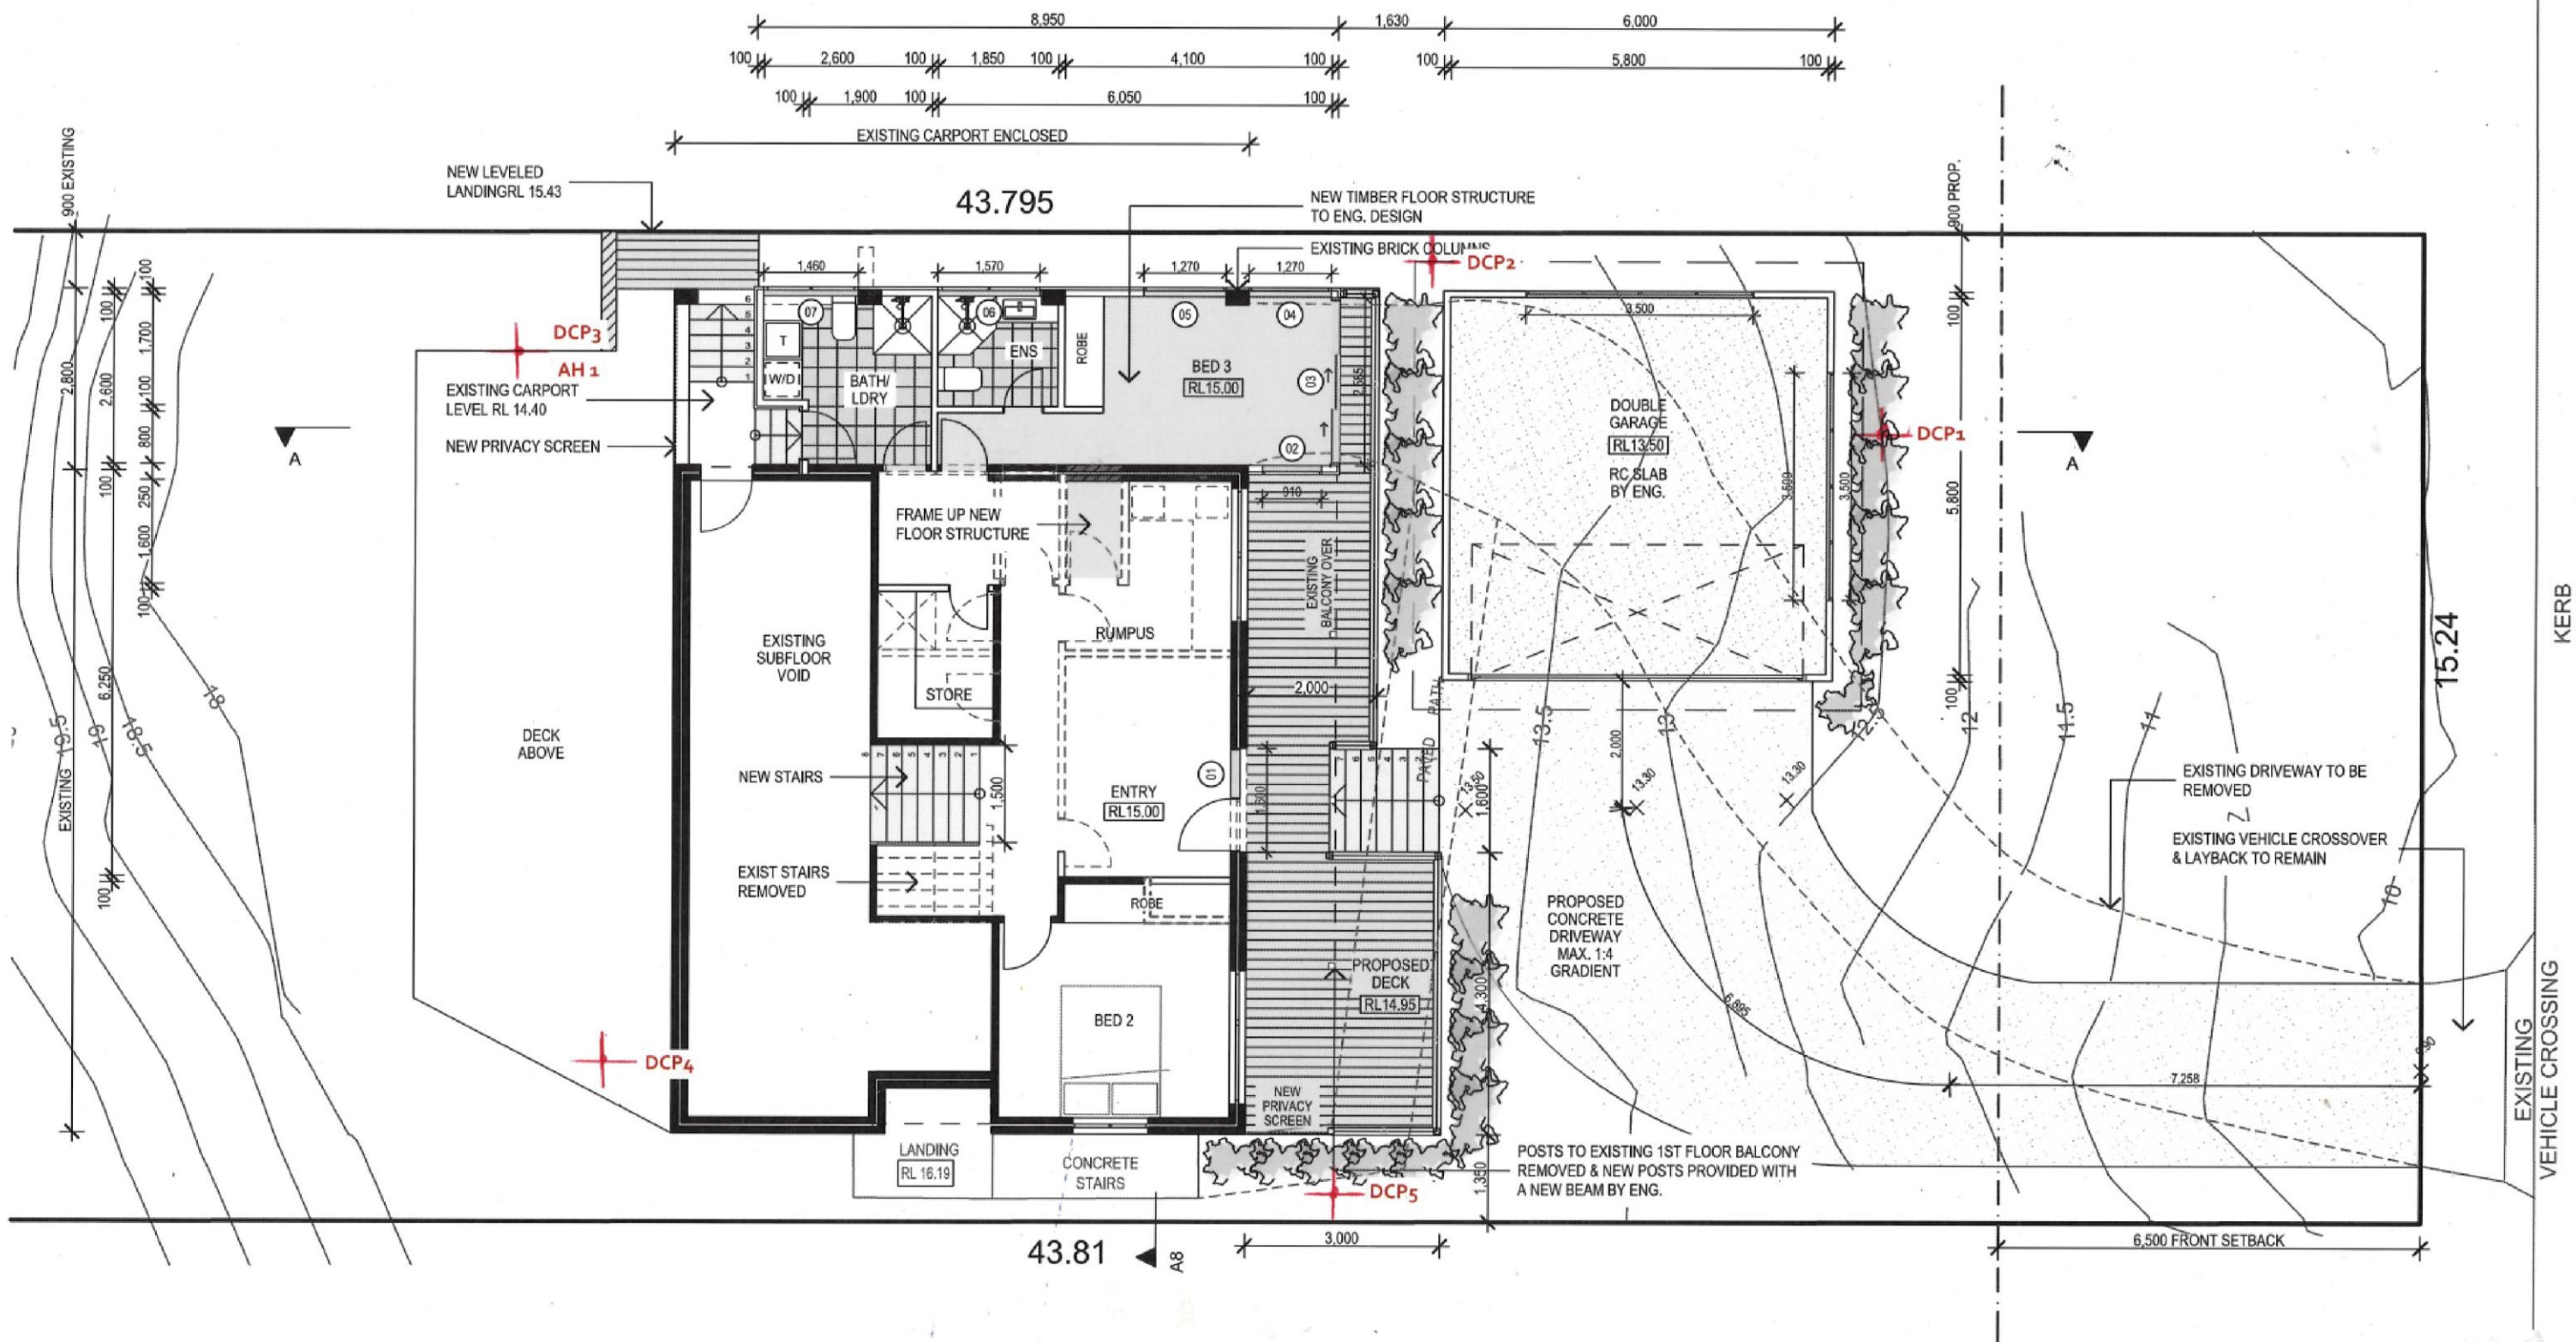
SITE PLAN – showing test locations

One auger hole was put down to identify the soil materials. Five Dynamic Cone Penetrometer (DCP) tests were put down to determine the relative density of the overlying soil and the depth to weathered rock. The locations of the tests are shown on the site plan. It should be noted that a level of caution should be applied when interpreting DCP test results. The test will not pass through hard buried objects so in some instances it can be difficult to determine whether refusal has occurred on an obstruction in the profile or on the natural rock surface. It should be noted that floating boulders are expected through the profile in this location. The results are as follows:

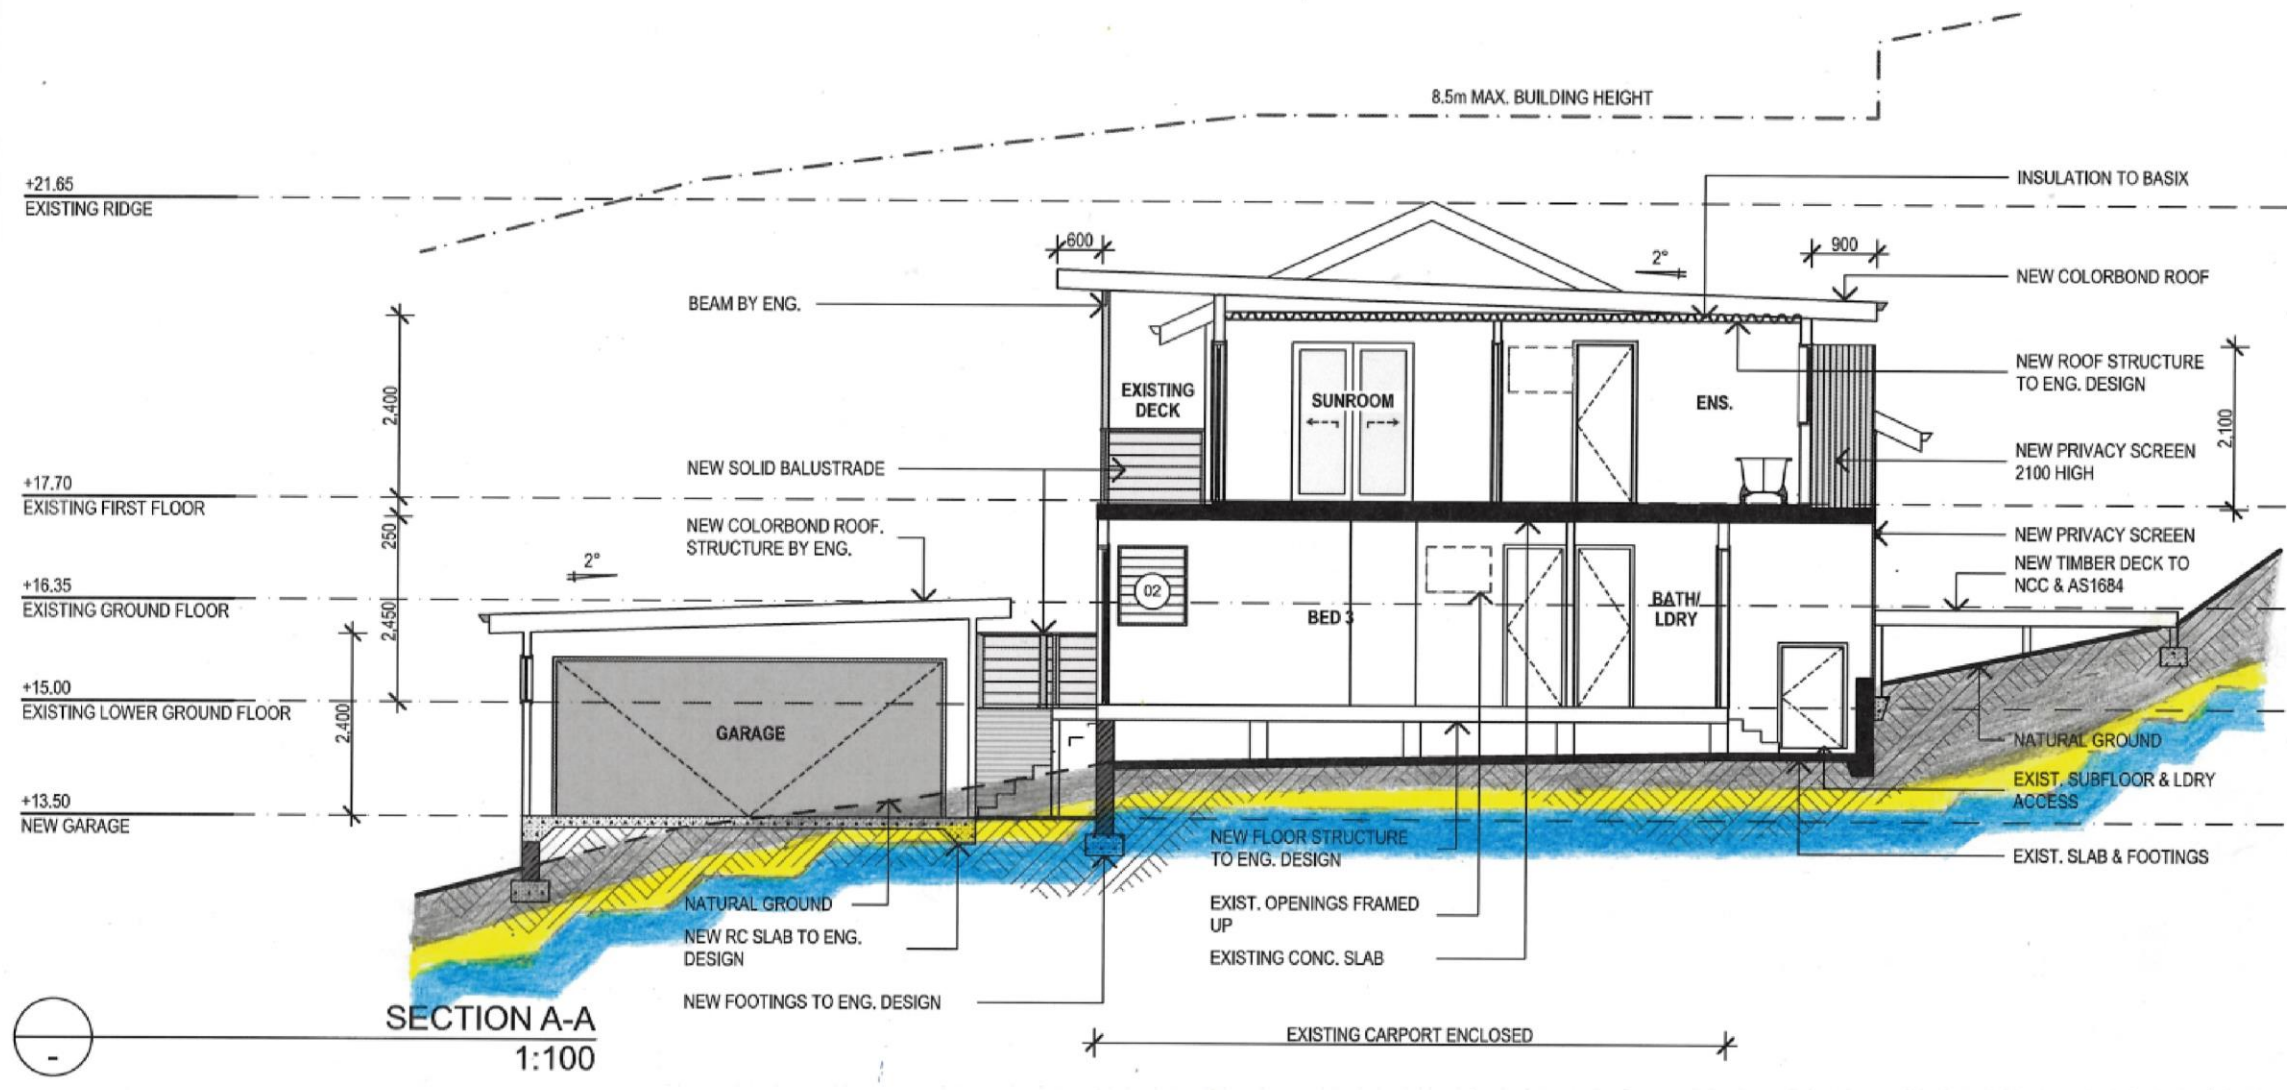
TYPE SECTION – Diagrammatical Interpretation of expected Ground Materials

The surface features of the block are controlled by the underlying sandstone bedrock that steps down the property forming sub-horizontal benches between the steps. Where the grade is steeper, the steps are larger and the benches narrower. Where the slope eases, the opposite is true. The rock is overlain by clayey sand (colluvium – geologically old) and insitu clays that fill the bench step formation. In the test locations, the depth to rock ranged between 0.4 to 1.9m below the current surface of the proposed works. It should be noted that floating boulders are expected through the profile so foundation depths may be variable and this should be accounted for in the budget and building plan. The sandstone underlying the property is estimated to be medium strength or better. See Type Section attached for a diagrammatical representation of the expected ground materials.

- Clayey Sand
- Clay – Firm to Stiff
- Hawkesbury Sandstone – Medium Strength
