## **ARBORICULTURAL IMPACT ASSESSMENT REPORT**

**3 Berith Street Wheeler Heights**

**12<sup>th</sup> June 2019**

**Prepared by: Ross Jackson**

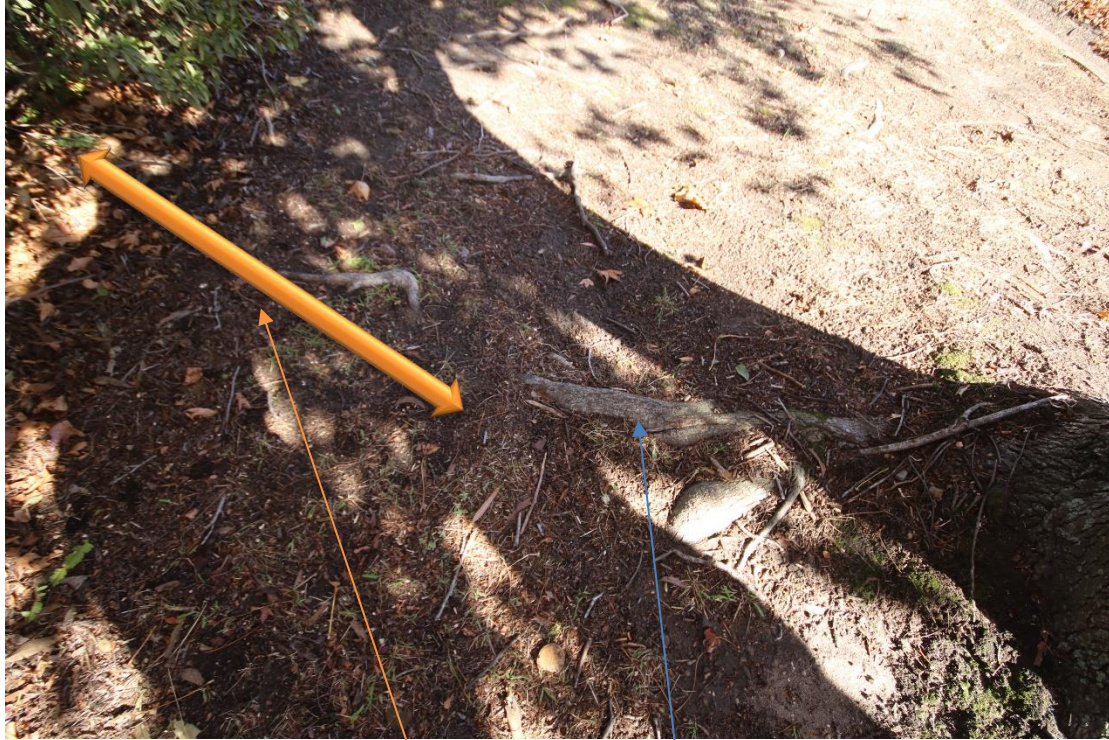
2. Tree 1 *Liquidambar styraciflua* shows good vitality with a single trunk supporting an upright form. The following structures are within the TPZ of this tree: new pedestrian footpath from the recycling area to the driveway, front fence and pathway to the front door – refer Annexure C. It is acknowledged there are surface roots emanating from this tree, but only one growing in an easterly direction – refer plate 1. The proposed public footpath can be constructed at or just above grade, using a combination of asphalt within the TPZ radius, then reverting to traditional concrete. Plus, the pathway can meander around this tree rather than being a straight path. By using asphalt, the roots will not require removal and if they heave the pathway, it can be easily removed and replaced to an even finish. The front fence can be constructed by using piers with beams in between to minimise potential root damage. The majority of the pathways on site are outside the TPZ radius of this tree, which will not

Plate 1: root from Tree 1 with pathway beyond this root

haver an adverse impact on this tree. By employing these design considerations, the retention of this tree will be achieved. Note this tree for retention and trunk protection in the TMP.

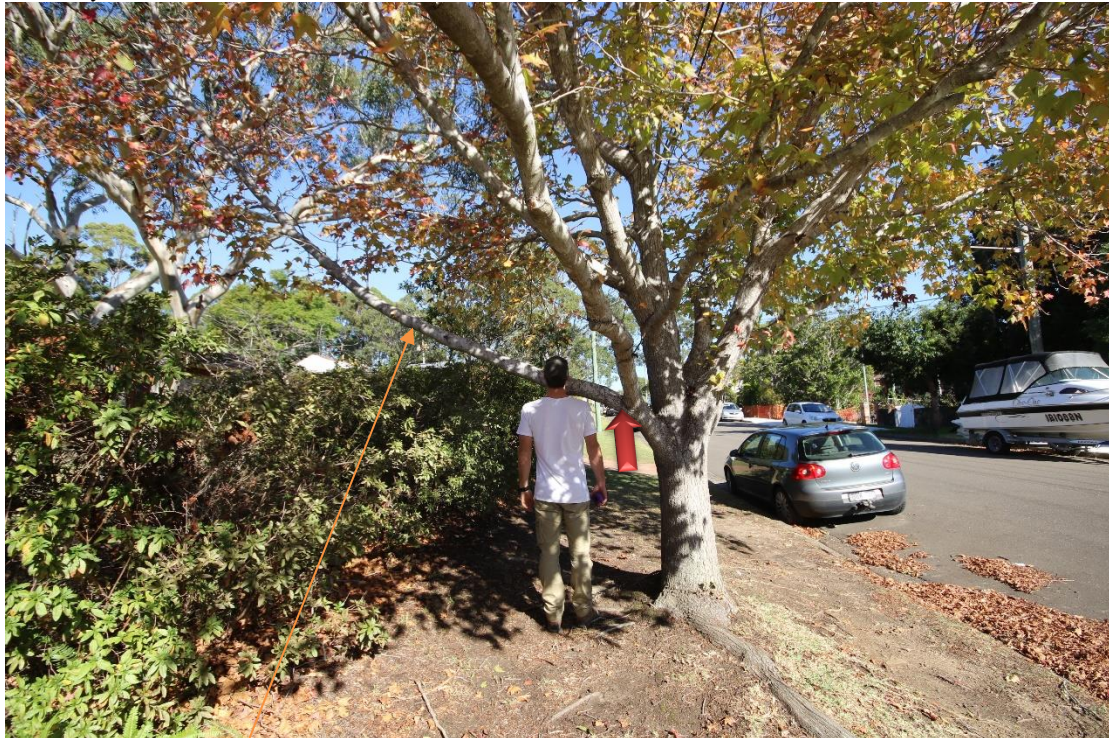
It was also observed that one (1) branch will require pruning to allow a safe passage of the future residents and user of the new public pathway – refer plate 2. The pruning of this branch will not spoil the shape, form and weight distribution of this tree and it represents less than 10% of the live canopy. Permission to prune this tree shall be obtained from Council. All pruning shall conform with AS 4373 – 2007 *Pruning of amenity trees* Section 2.40 & 7.2.4 *Selective pruning*.

Plate 2: Tree 1 branch pruning at red arrow. Note linear root structure

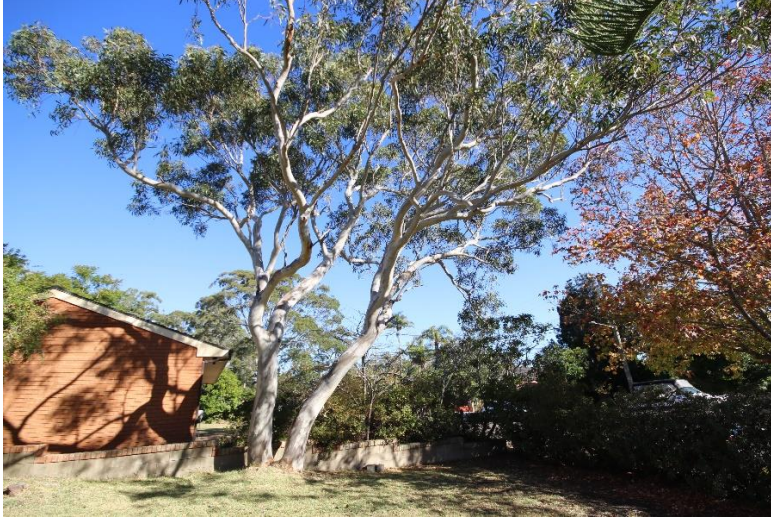
Plate 3: tree 2

3. Tree 2 *Eucalyptus haemastoma* shows good vitality with minor deadwood, located along the front southern boundary – refer plate 3. The development works have an encroachment within this trees TPZ of 15% - refer Annexure C. A 10% encroachment is considered acceptable in AS 4970 – 2009, above this level, it is considered to be a major to be a “major” encroachment. However, there is not definition as to what is acceptable above the threshold of 10% in AS 4970 – 2009. To minimise the extent of impacts the pathway and recycling can be constructed at or just above grade to limit the extent of excavations. There is an exiting boundary fence that will be retained. By employing these construction methods, the retention of this tree will be achieved. This tree should be “deadwood” to ensure the safety of the future residents in accordance with AS 4373 – 2007. Note this tree for retention and trunk protection in the TMP;

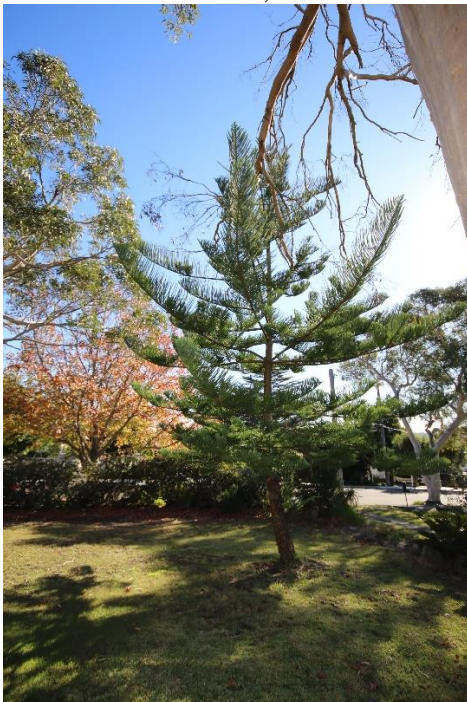
Plate 4: tree 3

4. Tree 3 *Araucaria heterophylla* is just a mature specimen with good vitality – refer plate 4. This tree is within the OSD area and has a drainage pit / pipework within its TPZ – refer Annexure C. In this situation this tree is assessed to be of low landscape retention value as it can be easily replaced in the proposed landscape works and it will need to be removed to undertake the proposed works. Removal is supported. Note for removal in the TMP;

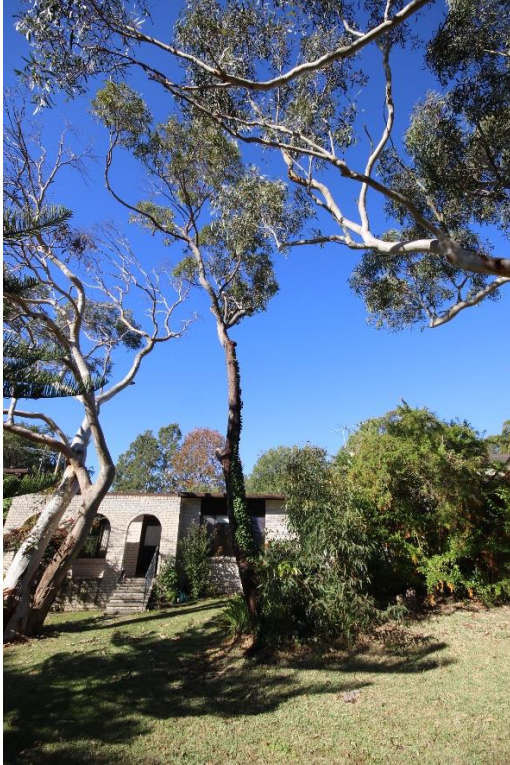
Plate 5: Tree 4

5. Tree 4 *Corymbia gummifera* shows fair to good vitality but with a very small canopy form (apparently this was originally a twin trunked tree – the second trunk has been pruned some time ago as epicormic branchlets are growing from the stump) - refer plate 5. The proposed development works are located on all sides of this tree which will lead to the demise of this tree. While this tree is assessed as fair to good vitality, its form has been spoiled by the loss of the second trunk and the removal of all branches to 6m, thus resulting in the small canopy. Therefore, it is suggested this tree be removed and replaced with a new tree in a more appropriate location to provide the on-going benefit of trees in this location. Note for removal in the TMP;

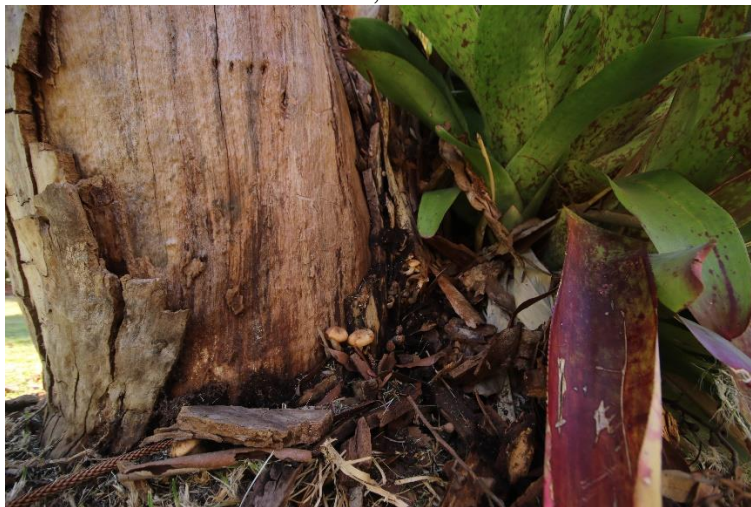
6. Tree 5 *Eucalyptus haemastoma* shows poor vitality with only one stem showing live foliage and with possible attack by the Armillaria fungus and a suspect lightning strike – refer plate 6 & 7. This tree has an ULE Rating 4a “Dead, dying, suppressed or declining tree because of disease or inhospitable conditions”, which supports its removal despite being within the building footprint. Removal is highly recommended. Note for removal in the TMP;

Plate 6 – mushrooms at base of tree 5

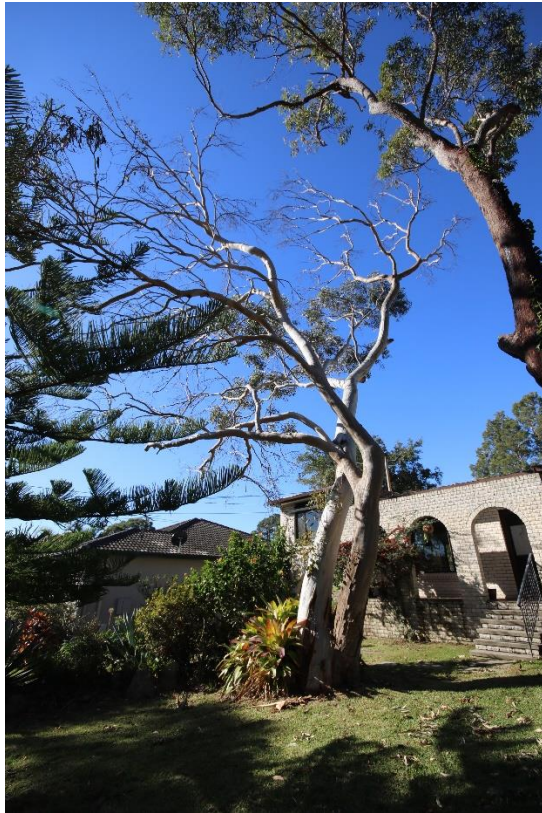
Plate 7: tree 5 showing 1 live branch & loss of bark from lightning strike

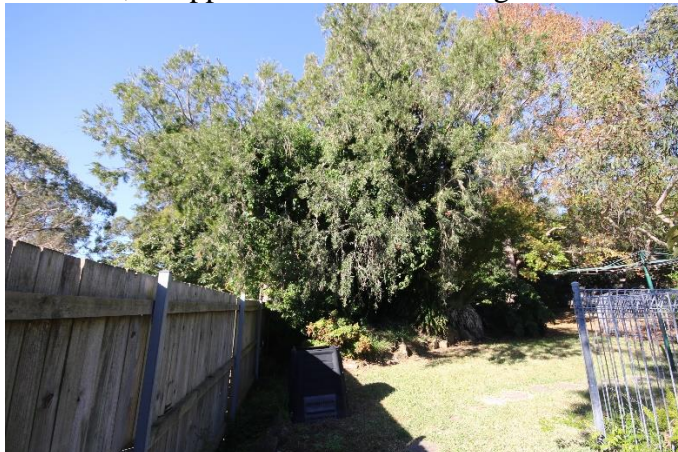
Plate 8: tree 6

a. Tree 6 has fair vitality with extensive suppression by English Ivy that has reduced this trees vitality – refer plate 8. Plus, it has twin trunks that have created a rounded bun form, as opposed to its natural single trunk – refer plate 9;

For the identified facts above, all these trees are recommended for removal in this development application. Note for removal in the TMP;

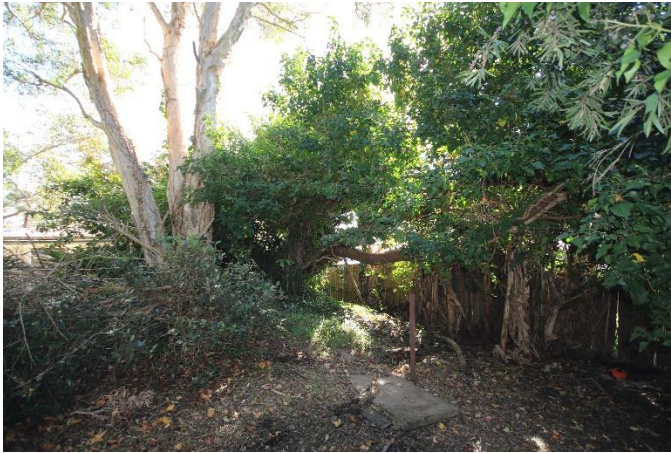
b. Tree 7 has twin trunks with bifurcation between their stems and then the northern stem has bifurcation at 1.5m & 5m – refer plate 9. This is a structural defect that can fail at any time, especially with the removal of the surrounding trees that have reduced the winds.

Plate 9: tree 7 with multiple bifurcations & tree 6 in background

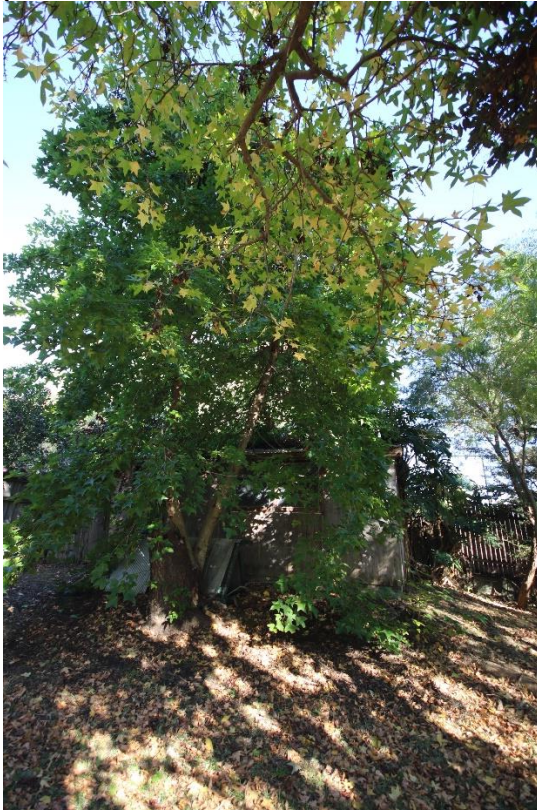
Plate 10 – tree 13

c. Tree 13 is related to the exempt tree Liquidambar and should be considered as an undesirable species. However, this tree has had a complete failure with the stems being epicormic regrowth which has a weak attachment to the decaying stump – refer plate 10. Remove this tree to make safe this site.

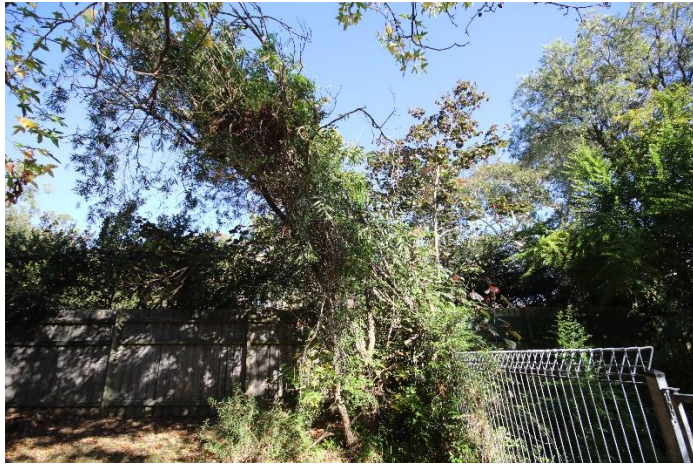
d. Tree 14 has poor form and is covered with a vine that has contributed to its low landscape rating – refer plate 11.  
e. Tree 15/16 has also suffered a partial trunk failure and isn't recoverable – refer plate 11 & 12.

Plate 11; tree 14 & 15/16 in background

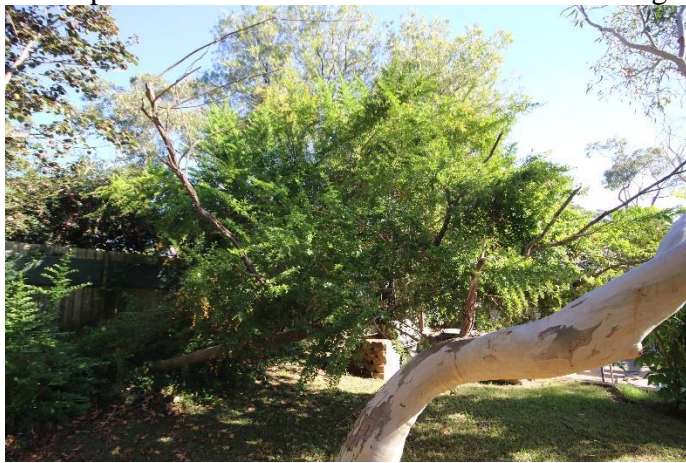
f. Tree 17 shows good vitality and is considered a large shrub – refer plate 12. Although in good vitality it isn't considered to be a restriction on the proposed development due to its small size and exotic heritage (American tropics).

Plate 12: tree 17 & tree 15/16 in foreground

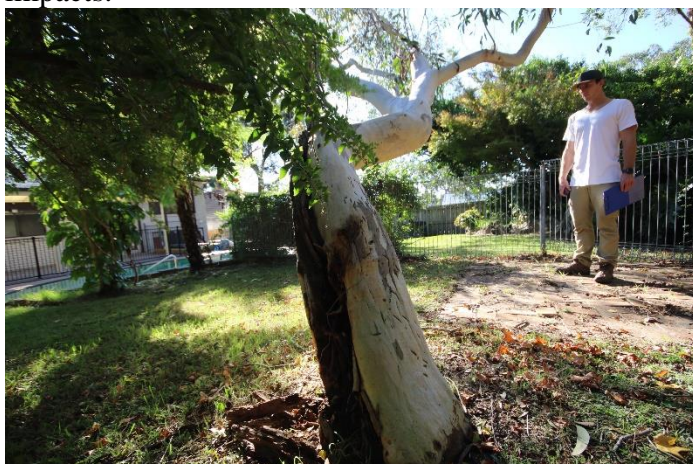
Plate 13: tree 18

g. Tree 18 has been suppressed in form with all canopy on a long low stem, plus it has a large open injury from 1m to ground level with decay into the heartwood – refer plate 13. No amount of sound horticultural care could restore this tree's structural integrity and long-term viability. Removal is warranted despite any development impacts.

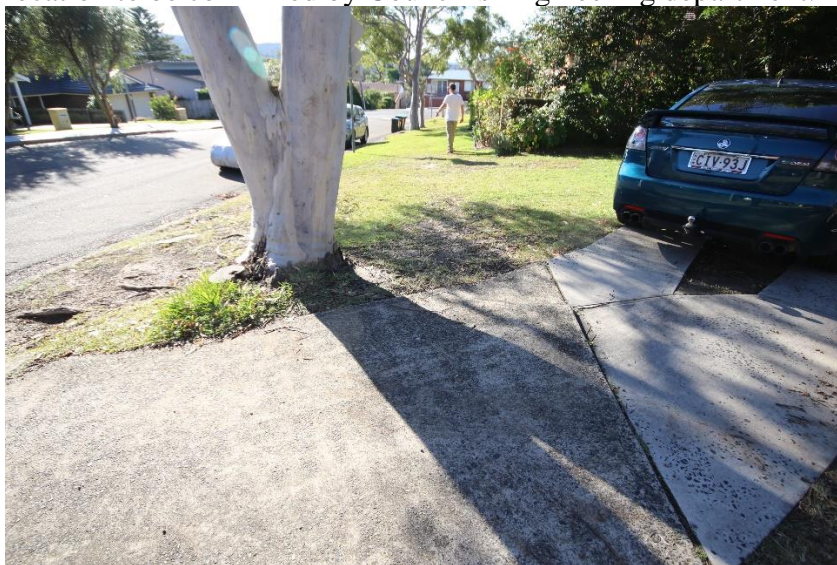
11. The following are street trees in Berith Street: Tree 20 *Eucalyptus racemosa*, tree 21 & 22 *Angophora costata*. Tree 23 *Eucalyptus racemosa* is in the front yard of the corner residence in Berith Street. Our examination of the street trees and the neighbour's tree has concluded the majority of the roots from Trees 20, 21 & 22 are on the street side of the root plate and the roots of tree 23 are not evident – refer plate 14 & 15. The same construction methodology can be used within these trees as for tree 1, i.e. use asphalt within their TPZ radii then reverting to concrete outside these dimensions – plus some meandering can be used near tree 20. It appears there is an informal track (footpath) along this street – refer plate 14. By employing these design considerations, the retention of these trees will be achieved. N.B no canopy pruning is required. Note these trees for retention and trunk protection in the TMP. Footpath location to be confirmed by Council's Engineering department.

Plate 14: tree 20 with informal footpath on the east

- a. Retain the following street trees: Tree 1, 20, 21 & 22;
- b. That the footpath along Berith Street be constructed on the east side of these trees using asphalt within the TPZ radii of these trees (Tree 1: 4.2m, tree 20: 6.8m, tree 21: 4.3m & tree 22: 2.9m), then reverting to concrete. The path shall meander around these trees to avoid being against their trunks and to avoid potential root damage by being at or just above grade. Details to be provided by Council's Engineers;

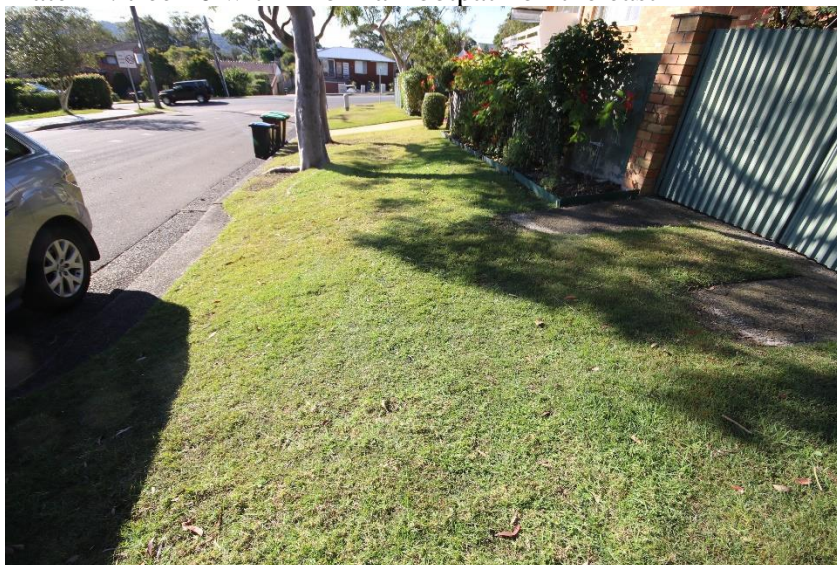
Plate 15: tree 21, 22 & 23
