GEOTECHNICAL INVESTIGATION:

New Boat Ramp at 1744 Pittwater Road, Bayview

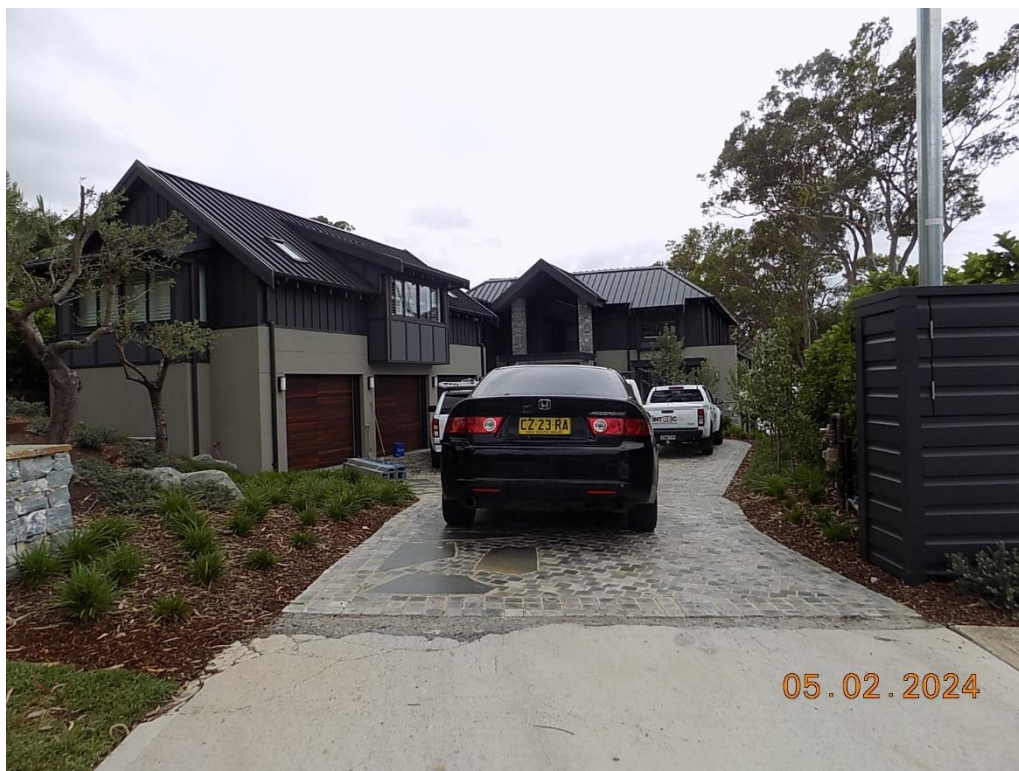
Photo 1

- 2.3** A paved driveway runs down the slope to a garage on the uphill side of the property (Photo 1). In between the road frontage and the house is a moderately sloping garden area. The retaining wall that supports the cut for the garage was not complete at the time of inspection. The materials to complete this wall were on site and we recommend this be completed as soon as possible (Photo 2). The part three-storey house is supported on rendered masonry walls (Photo 3). The walls show no significant signs of movement. A level lawn area extends off the downhill side of the house to a pool. The cut for the level lawn area is supported by a stable ~1.5m high sandstone log retaining wall (Photo 4). The pool shows no significant signs of movement as indicated by the water level against the tiles (Photo 5). A boatshed is cut

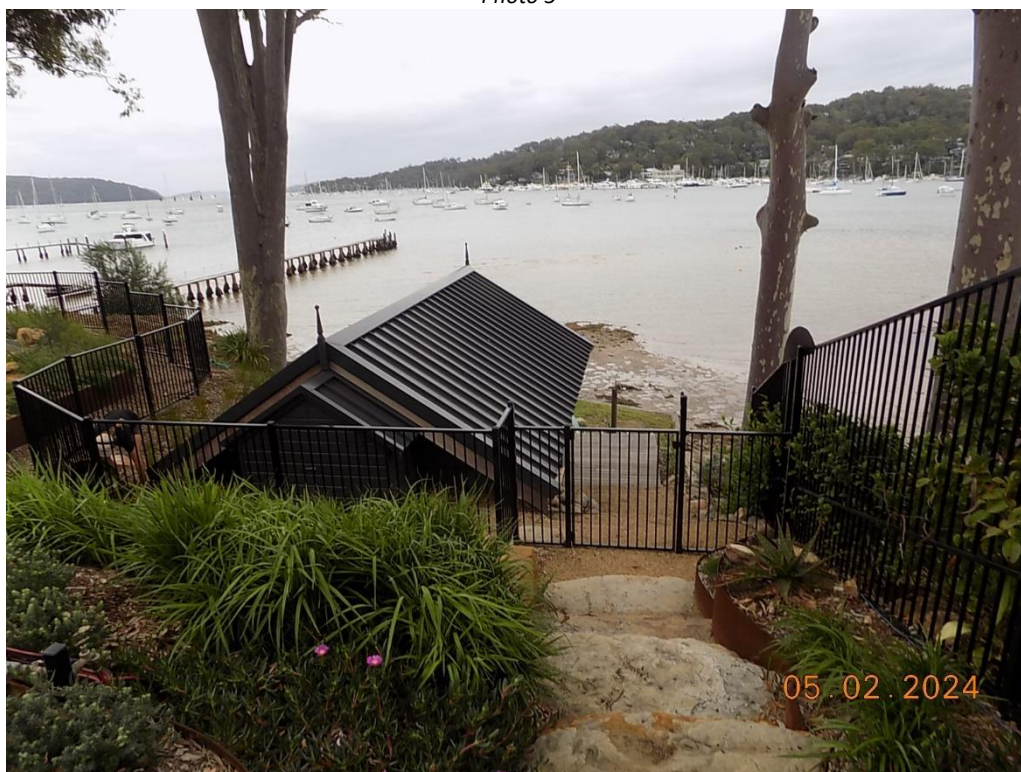
Photo 6

into the slope and extends to a level lawn area at the downhill boundary (Photo 6). The ~1.7m cut is supported by the dintel walls of the boat shed (Photo 7). The fill for the level lawn area at the lower boundary is supported by a low stack rock sea wall (Photo 8). The upper section of the wall is to be replaced as part of the proposed works.

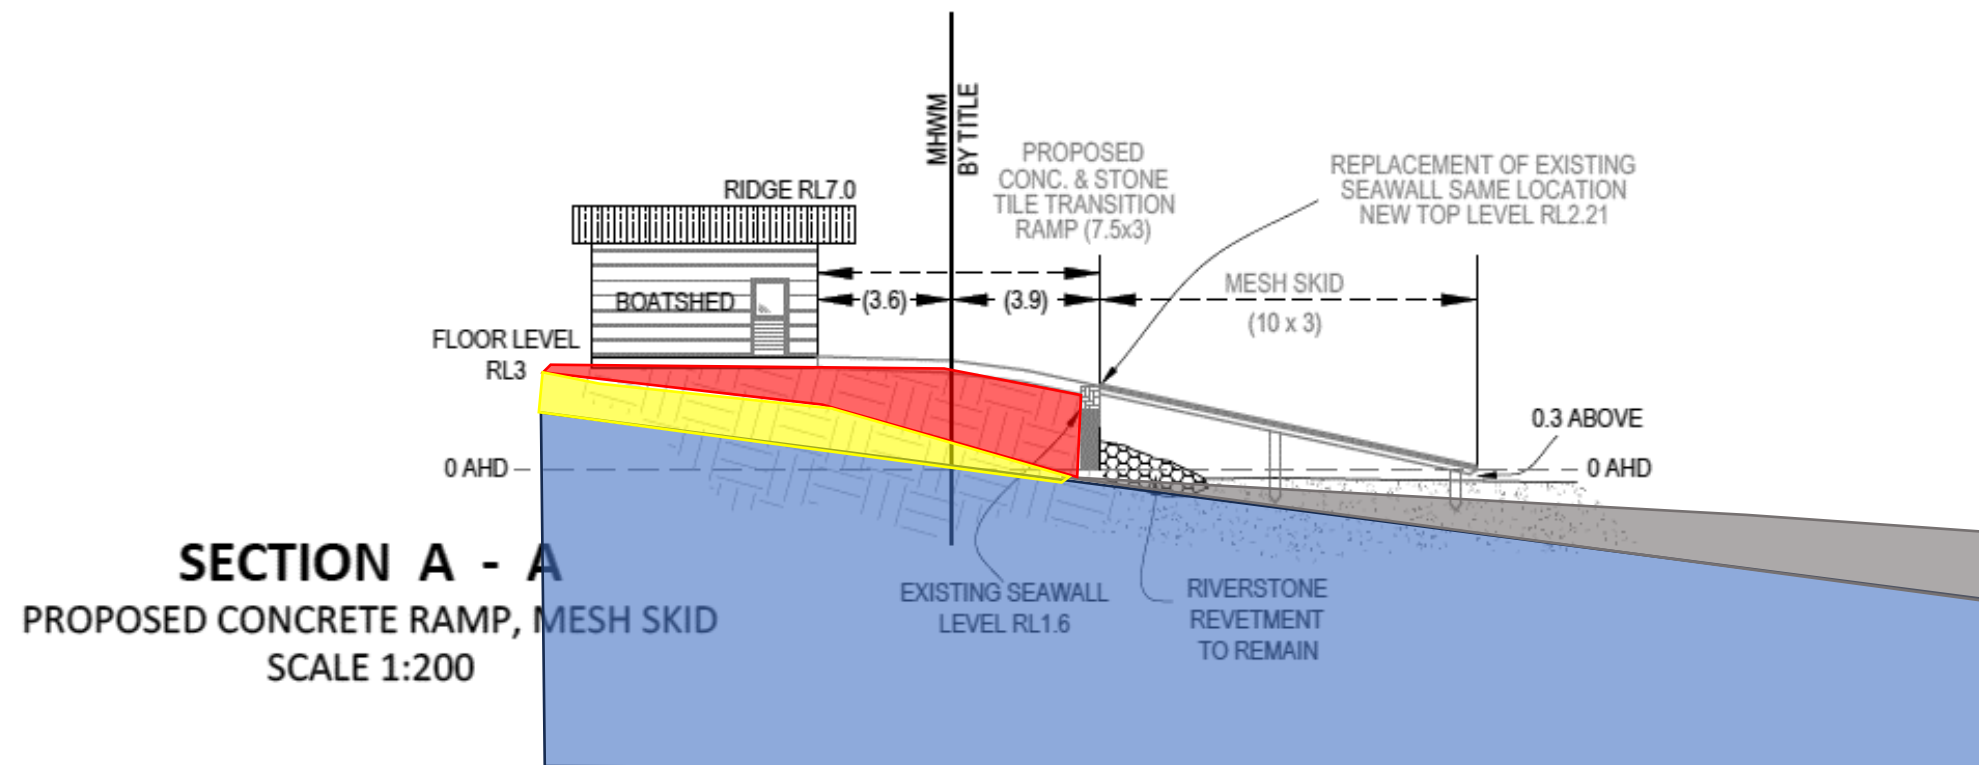
TYPE SECTION – Diagrammatical Interpretation of expected Ground Materials

As the bulk of the proposed works take place over Pittwater, it is likely sediment will be encountered at increasing depths overlying the Extremely Low to Medium Strength Rock underneath. The depth to Extremely Low to Medium Strength Rock ranged between ~2.0m at 20m from the shoreline to 2.5m at 40m from the shoreline. The underlying rock is likely to drop away at similar angles as it extends into Pittwater.
