35 Norma Road, Palm Beach

Comments on Updates to Plans

GEOTECHNICAL INVESTIGATION:

Alterations and Additions at 35 Norma Road, Palm Beach

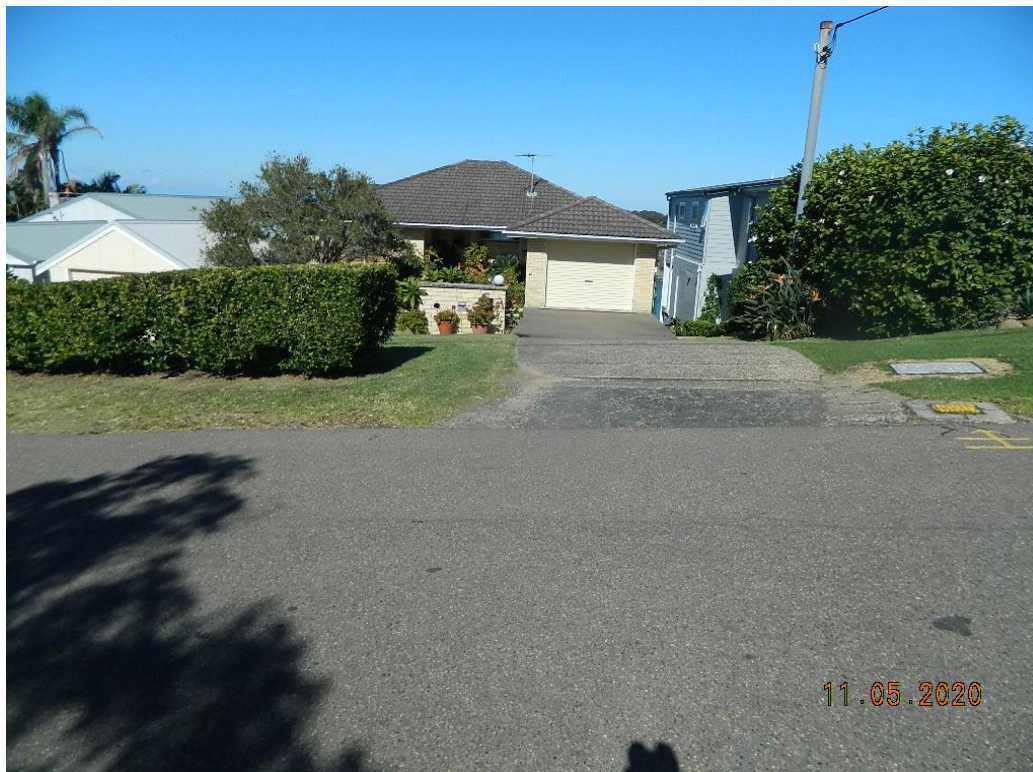
Photo 1

2.3 At the road frontage, a concrete driveway runs to a garage on the upper ground floor of the existing house (Photo 1). Between the road frontage and the house is a gently sloping lawn (Photo 2). E of the lawn is a concrete driveway and fibro garage that will be demolished as part of the proposed works (Photo 3). The cut for the driveway/garage is supported by a stable ~1.0m high sandstone dressed concrete retaining wall. The part two storey brick house is supported on brick walls (Photos 2 & 4). The external brick walls show no significant signs of movement.

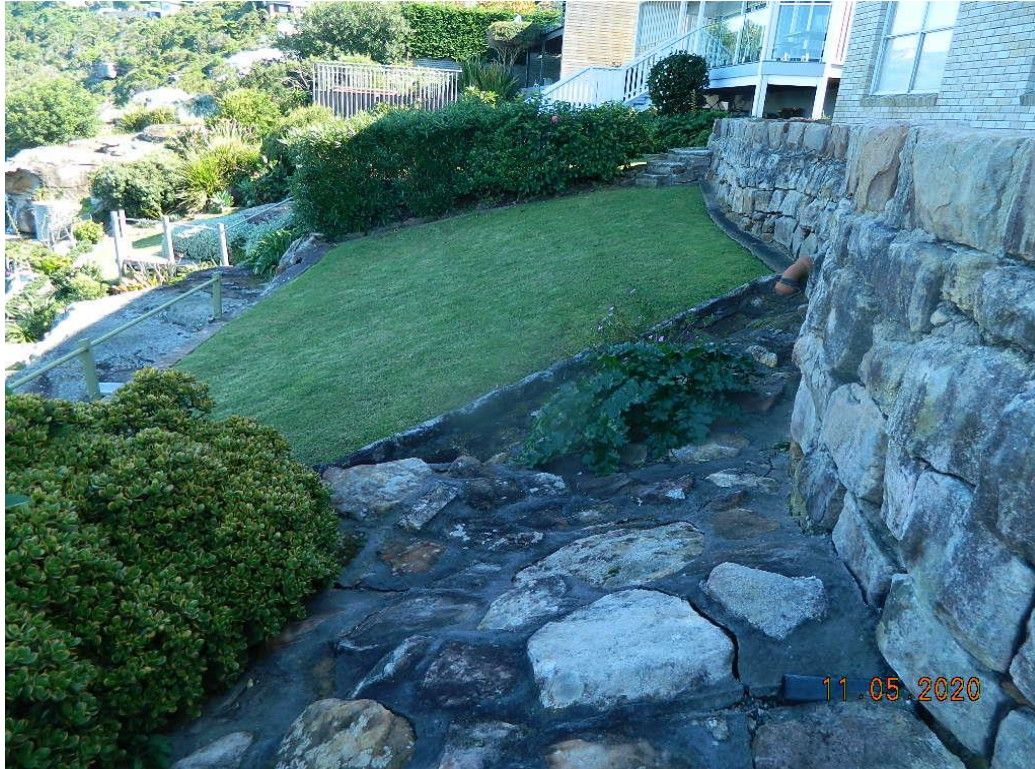
Photo 5

A sandstone pavement extends off the downhill side of the house. A stable sandstone block retaining wall up to ~1.6m high supports the fill underneath the pavement (Photo 5). A moderately sloping lawn extends downhill from the retaining wall. Fill at the SE corner of the lawn is supported by a ~1.3m high brick retaining wall in good condition. Sandstone bedrock is outcropping at the SW corner of the lawn (Photo 6). A portion of the rock is undercut ~1.5m (Photo 7). Given the thickness of the cantilever arm and no visible presence of defects in the arm, the undercut is considered to be stable. The outcropping sandstone bedrock steps down the property (Photos 8 & 9). A lawn extends from the bottom of the outcropping rock to a concrete block retaining wall (Photo 10). The retaining wall supports the lawn fill and is in good condition. Sandstone boulders around and on the lawn are considered to have come to rest in their current positions before the lawn area was developed. They are considered to be in stable positions. The overall slope across the property is considered stable.

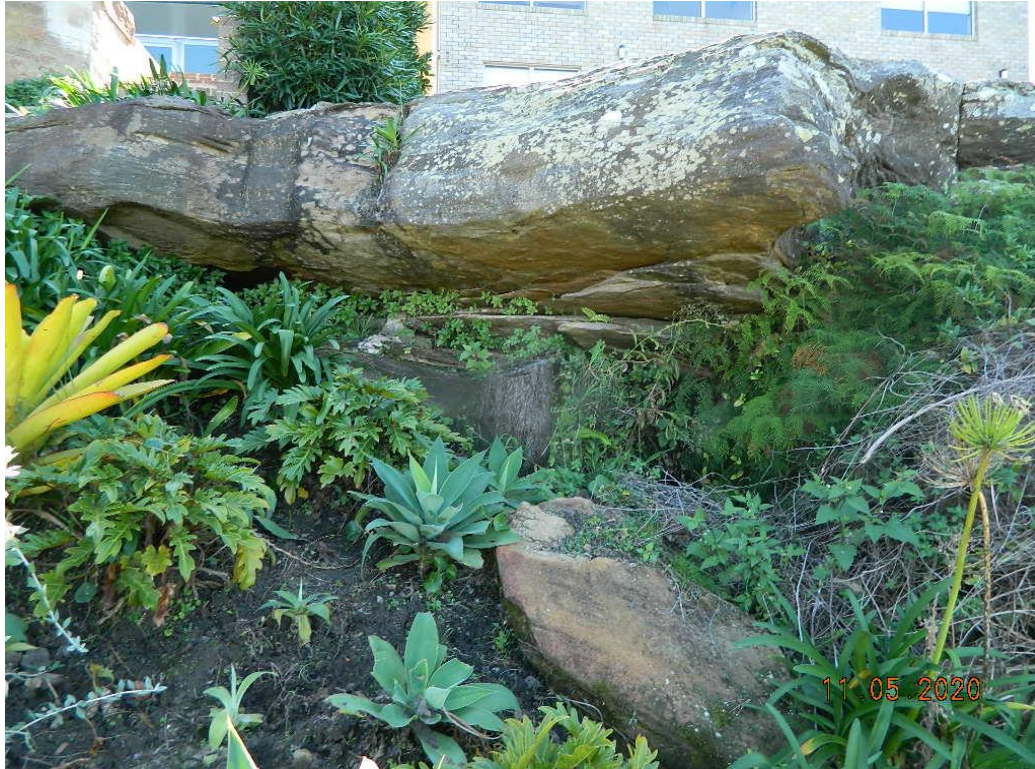
Photo 7

We estimate the foundations for the proposed retaining wall to support the fill on the downhill side of the property will be in the close vicinity to outcropping undercut rock immediately downslope (Photo 7). No foundations are to extend over undercut rock. If this can't be avoided the undercut rock is to be supported with blade walls designed by the structural engineer in consultation with the geotechnical consultant.

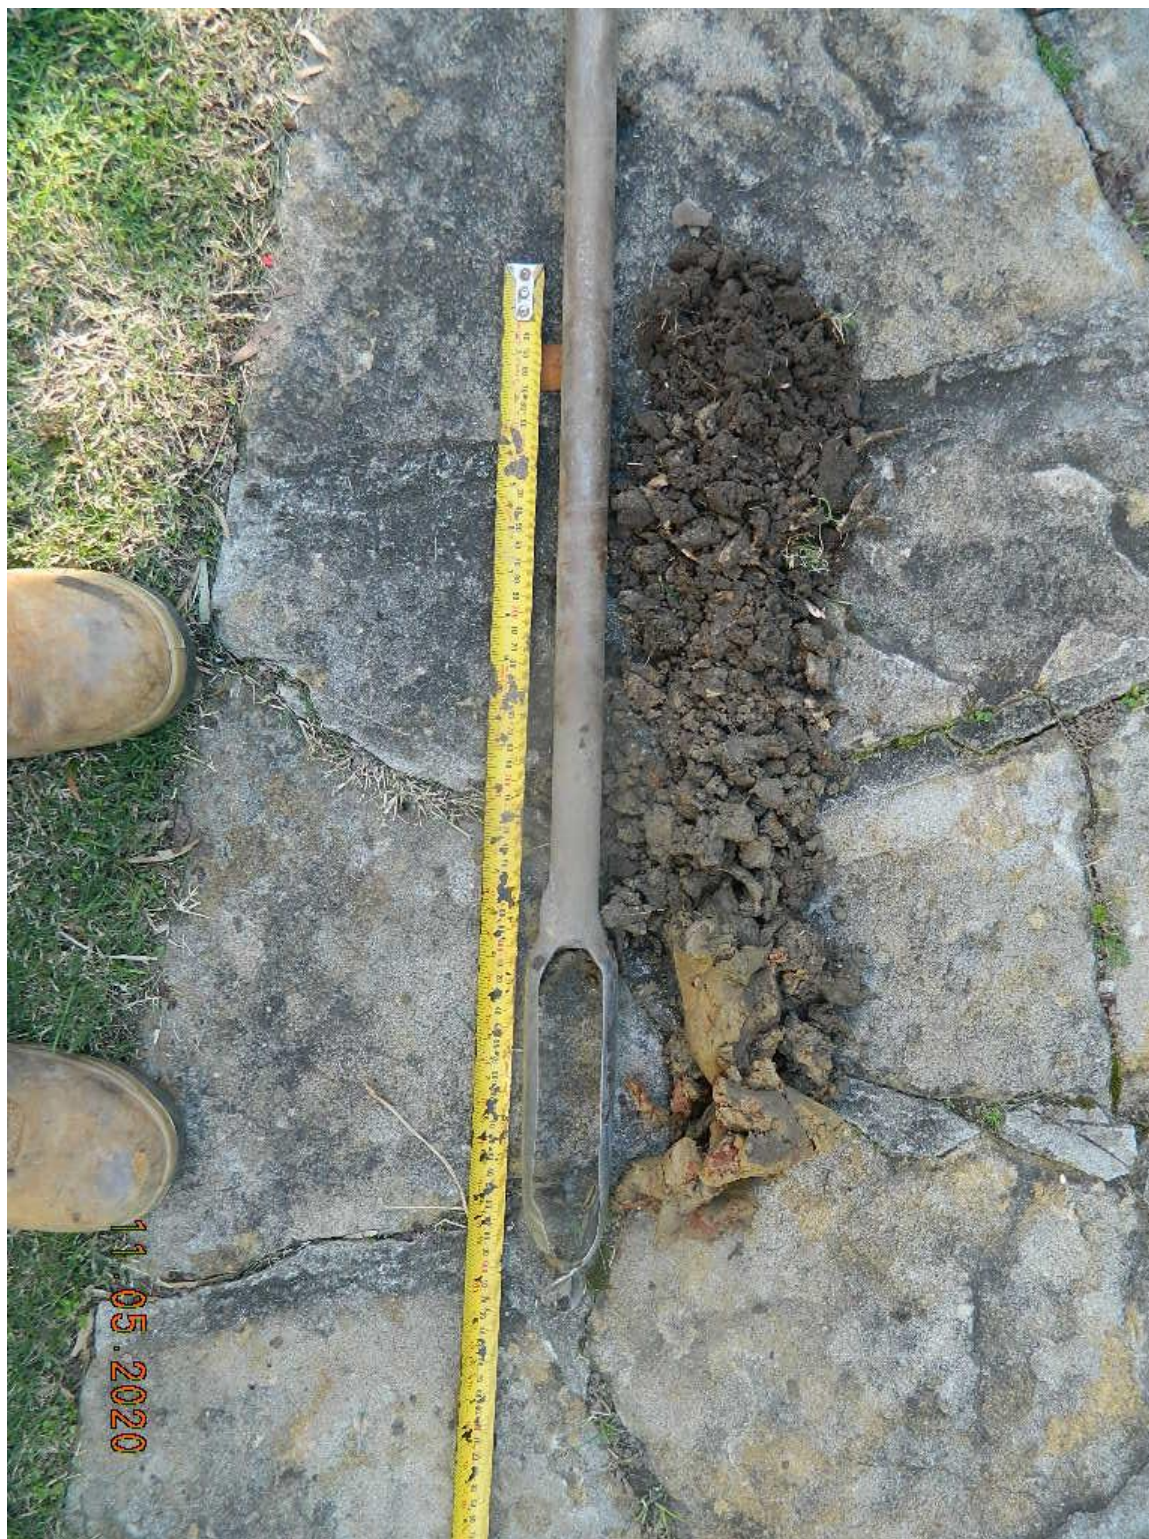
AUGER HOLE 1 (~RL72.8) – AH1 (photo 11)

Depth (m)	Material Encountered
0.0 to 0.3	TOPSOIL , sandy soil, brown, damp, fine to medium grained with fine trace organic matter.
0.3 to 0.4	CLAYEY SAND , grey, damp, fine to medium grained.
0.4 to 0.6	CLAY , orange brown, firm to stiff, moist.

End of Test @ 0.6m in firm to stiff clay. No watertable encountered.

Photo 11: AH1 – Downhole is from top to bottom

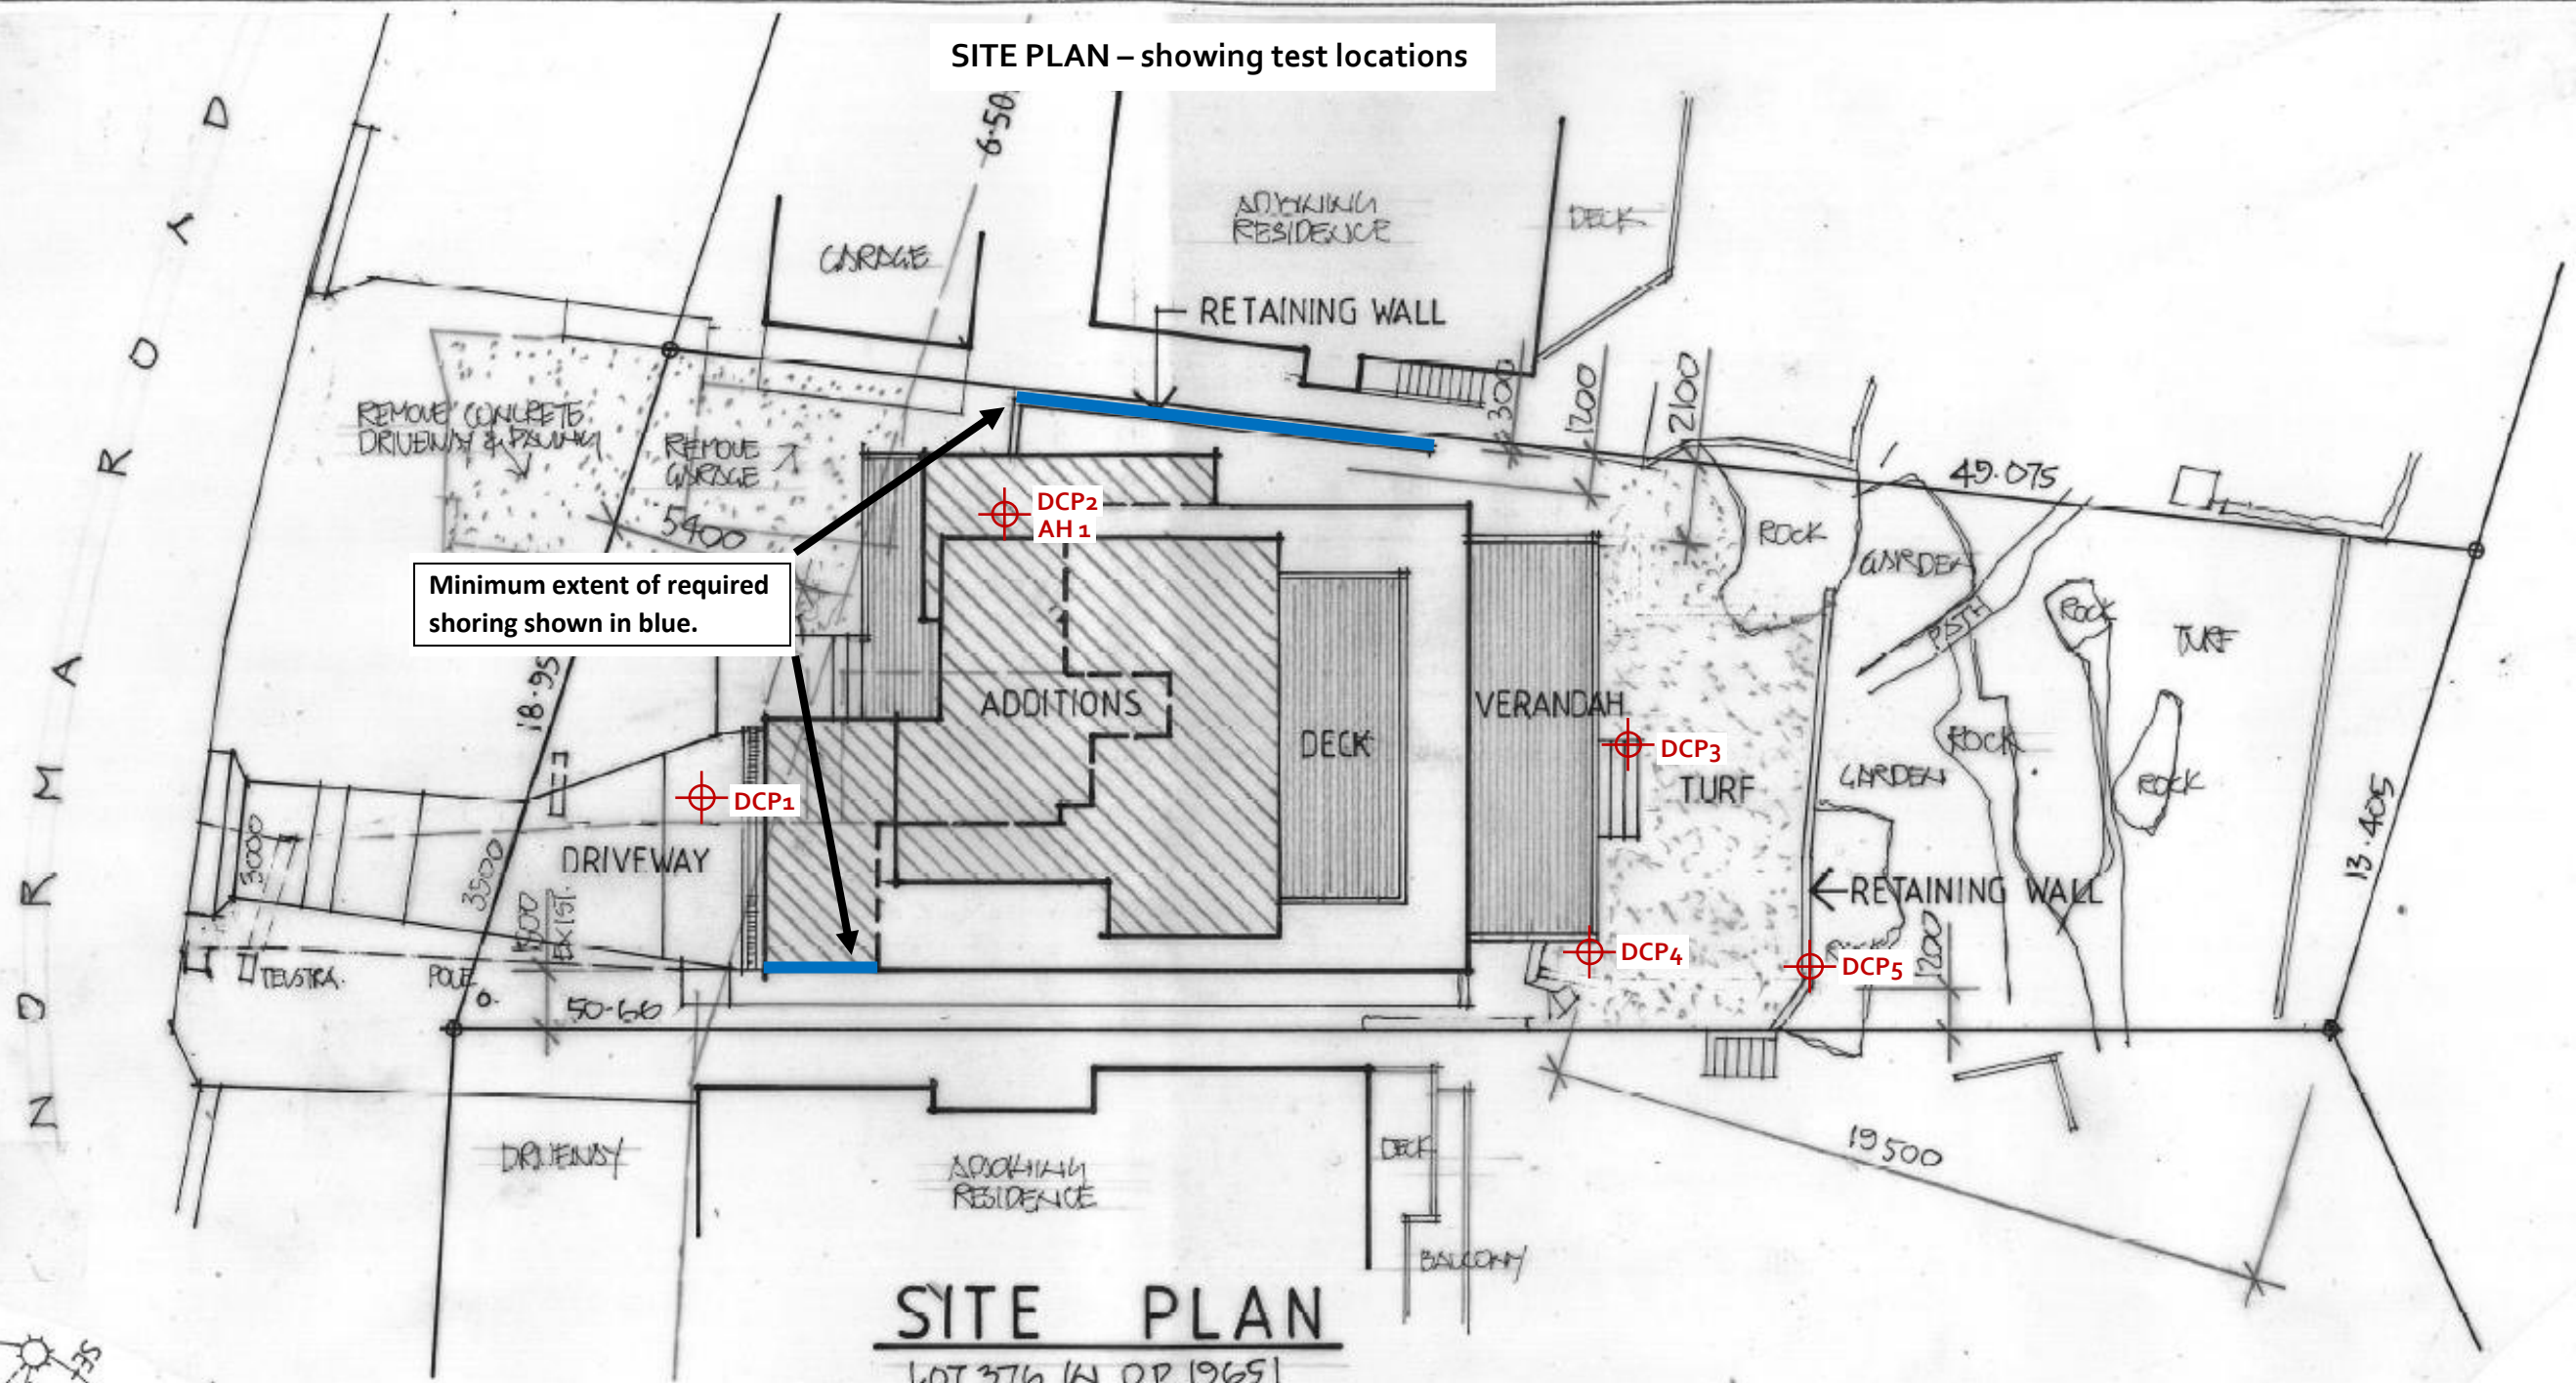
SITE PLAN – showing test locations

One auger hole (AH) was put down to identify the soil materials. Five Dynamic Cone Penetrometer (DCP) tests were put down to determine the relative density of the overlying soil and the depth to bedrock. The locations of the tests are shown on the site plan attached. It should be noted that a level of caution should be applied when interpreting DCP test results. The test will not pass through hard buried objects so in some instances it can be difficult to determine whether refusal has occurred on an obstruction in the profile or on the natural rock surface. This is not expected to be an issue for the testing on this site. But due to the possibility that the actual ground conditions vary from our interpretation there should be allowances in the excavation and foundation budget to account for this. We refer to the appended "Important Information about Your Report" to further clarify. The results are as follows:

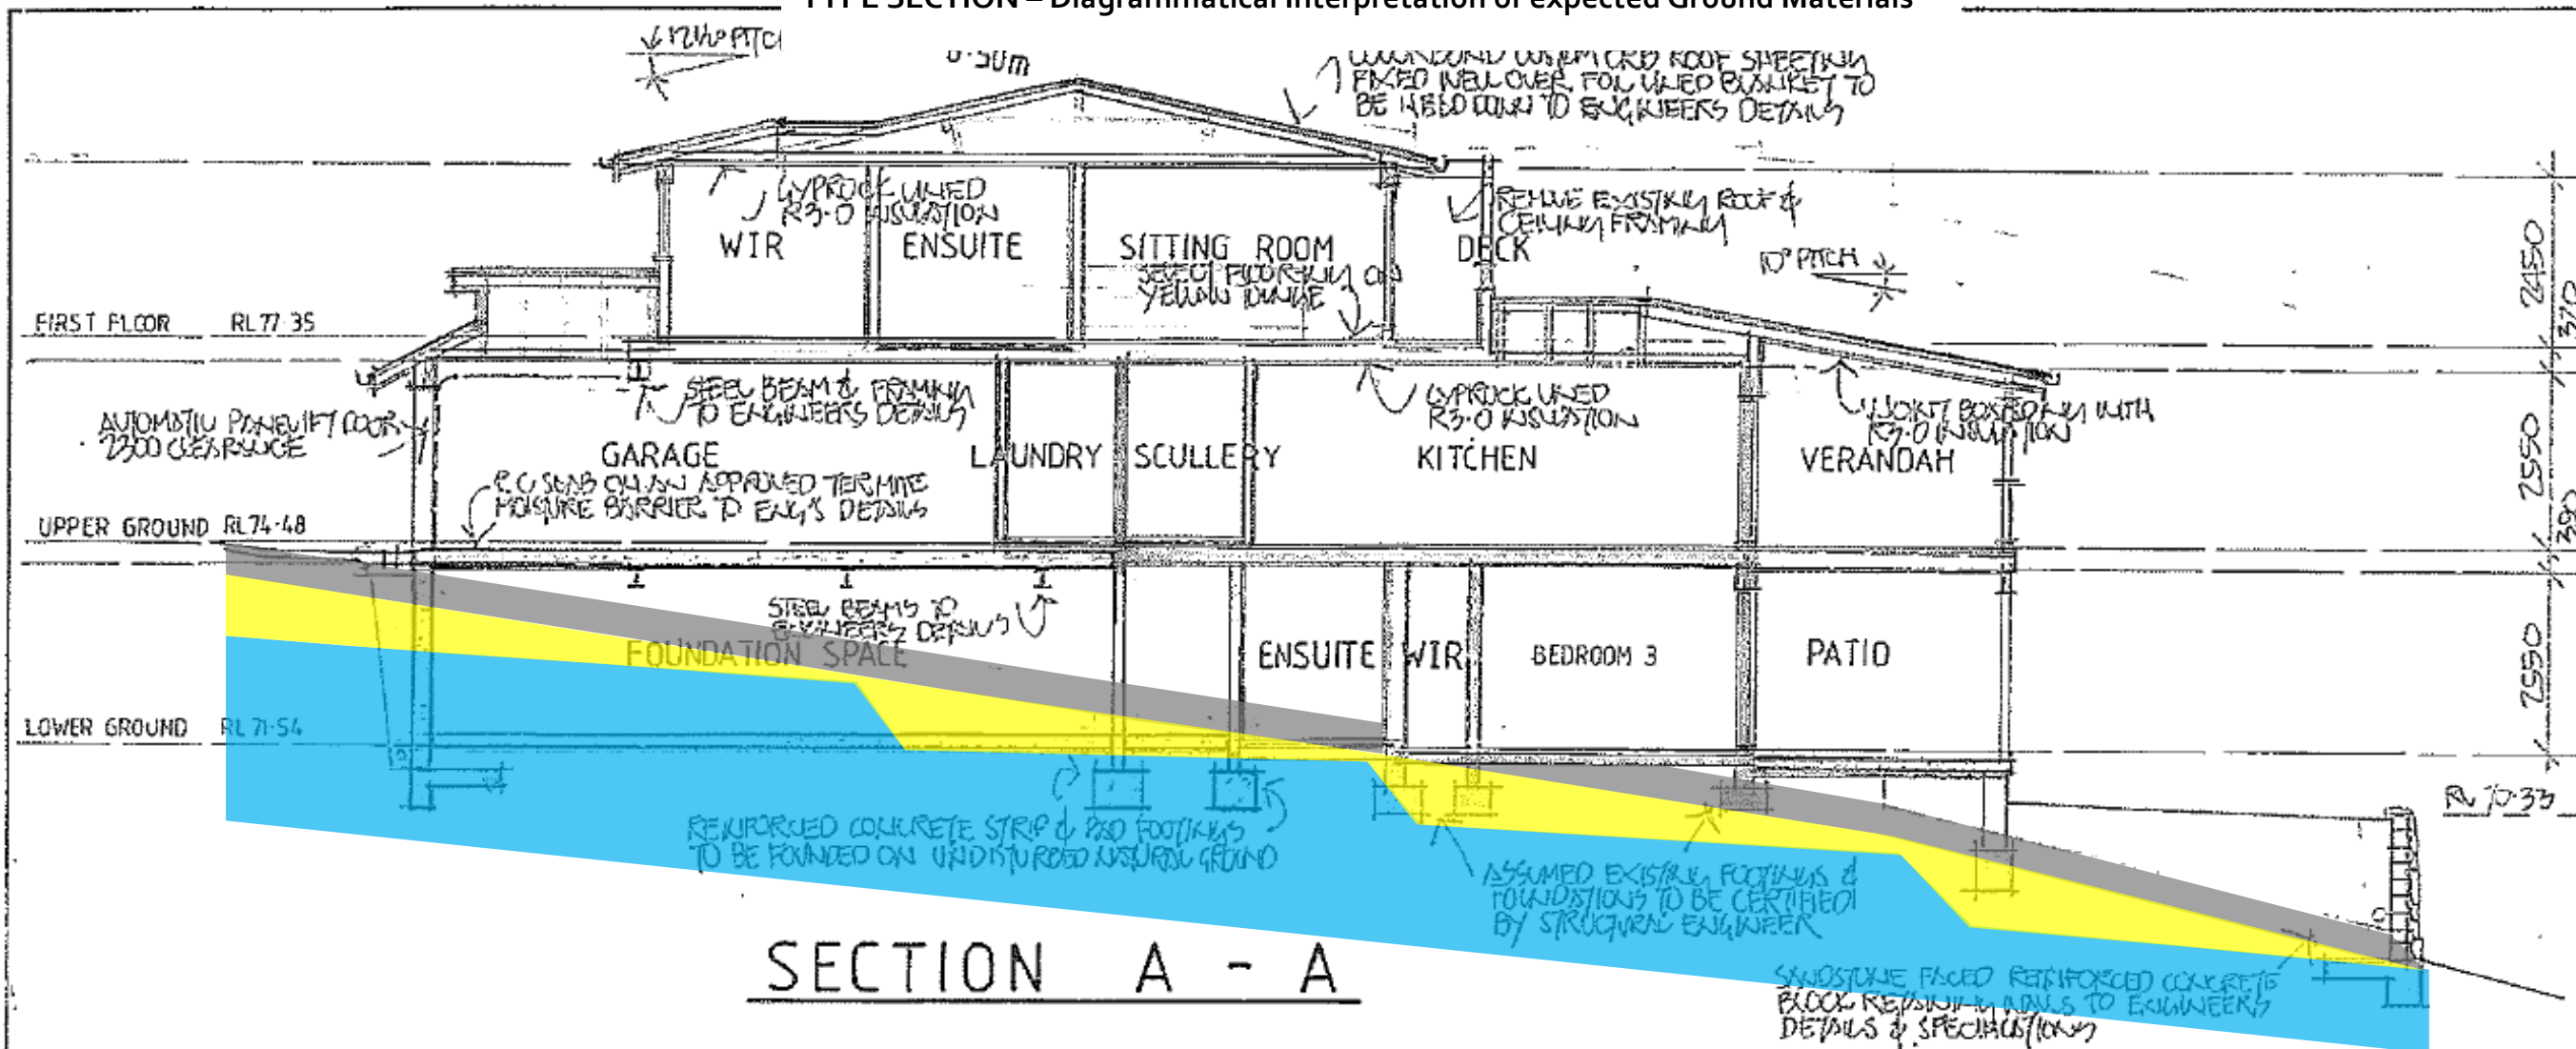
TYPE SECTION – Diagrammatical Interpretation of expected Ground Materials

is estimated to be Low to Medium Strength. See Type Section attached for a diagrammatical representation of the expected ground materials.

- Topsoil and Clayey Sand
- Clay – Firm to Stiff
- Hawkesbury Sandstone – Low to Medium Strength
