Date: 9th September 2021

Project No.: 2021-196

Preliminary Landslip Assessment for 6 Stephen Street, Beacon Hill, NSW

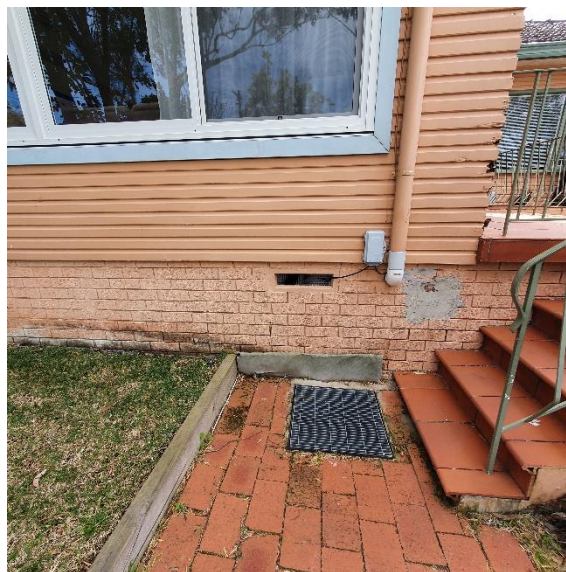
lawn, which allows access to a set of tiled stairs that lead to a tiled deck and the main site-structure. A drainage pit is located within the northern end of the paved area (Photograph-1).

Photograph-1: Drainage pit directly to the front of the dwelling. View looking north.

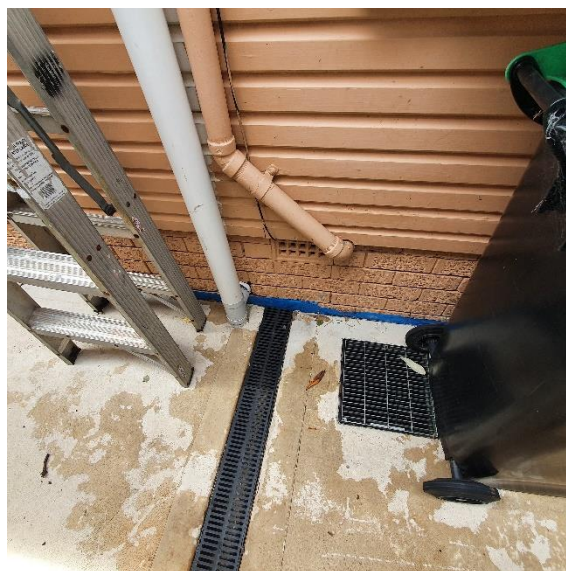
Photograph-2: Drainage pit within the side concrete pathway. View looking east.

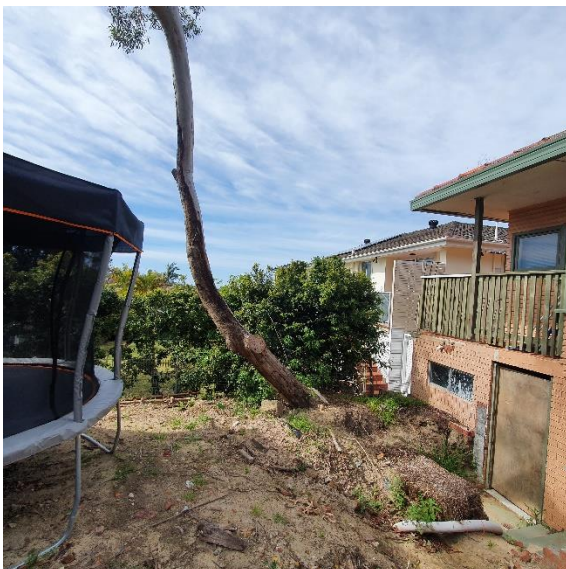
The northern portion of the site contains a grass lawn within the western side and is supported by an approximately $\leq 0.20\text{m}$ high timber lagging retaining wall along the eastern side. The north-eastern portion of the site is currently non-grassed, gently east and south dipping with a depression (approximately $\leq 1.5\text{m}$ lower than the grass lawn) within the southern end. The ground exposes a silty sandy clayey, disturbed (likely unnatural) soil with numerous gravels in the surface and appears currently supported along the eastern

boundary by a metal fence which contains a minor outward deflection as a result of the soil lateral pressure. The south-east corner of the non-grassed area contains an approximately $\leq 10\text{m}$ high inclined tree ($\leq 2.5\text{m}$ north from the site-dwelling, Photograph-3). Directly to the south of the depression zone are stacked hay bales which appear to provide filtration to the run-off coming from the slightly higher non grassed area (up to $< 1.5\text{m}$ higher than the dwelling garage). Between the hay blocks and dwelling is a small concrete platform which allows access to the rear of the garage and contains a small drainage pit (Photograph-4). Apart from the minor ground movement along the eastern side of the non-grassed area, the rear of the site contained no other sign of ground movement, ground instability or underlying geotechnical issues and appeared in good condition.

Photograph-3: Non-grassed area within the north-eastern portion of the site. View looking east.

It is considered that a detailed Landslip Risk Assessment is not required for this Development Application. However, remediation works along the rear eastern boundary must be undertaken to either remove or support the soils placed along the fence line whilst an arborist should be engaged to assess the inclined tree.

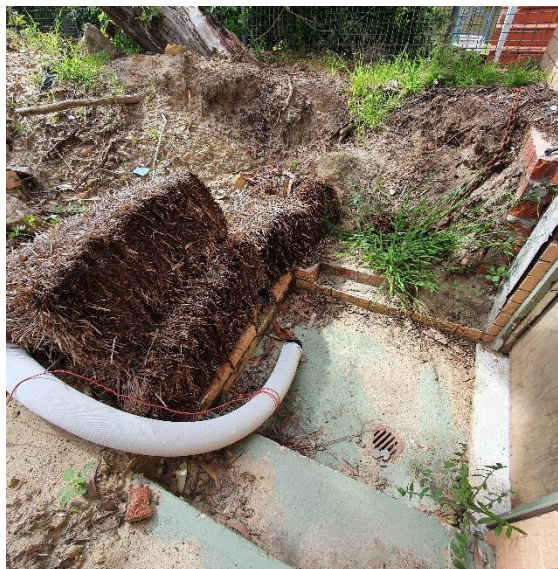
Photograph-4: Area between stacked hay and rear entry to the garage. View looking east.
