23 Reynolds Crescent, Beacon Hill

Notice of Intention to Issue an Order
Ref No LGA2020/0049

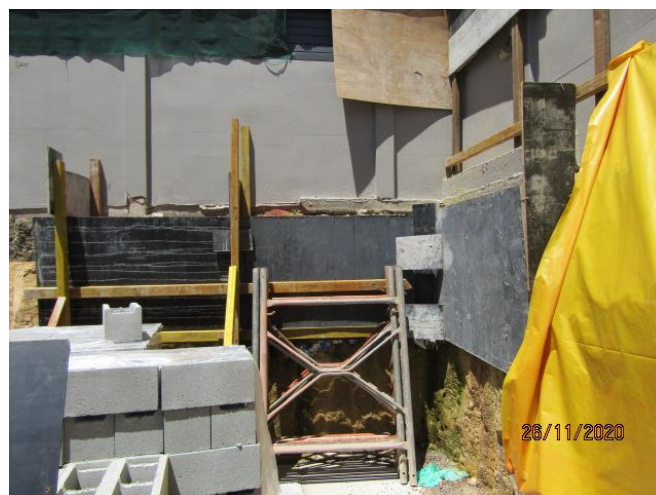
Photo 1

The existing shoring (Photo 1 & 2) recommended by this firm was proposed as short term solution where seepage was moving through the soil overlying the bedrock causing the soil to erode/reel back slightly. The soil on the Western face is some 0.3 to 0.7m deep. The remaining exposed soil on the Southern face is up to 0.3m deep. The owner informs us since our last inspection he has dug some exploration pits along the western boundary beside the neighbours' brick boundary wall. The pits indicate the boundary wall is founded on the rock.

The soil portion of the cut batters on the W and S faces appear stable. The shoring requires a little bit of work to ensure it will stand for a longer period of time than originally envisaged. See the recommendations to follow.

- The existing backfill is of a fine diameter and has not been wrapped in Geotextile fabric. As such during the recent heavy rainfall some of the backfill has washed through the gap between the base of the shoring and rock face. It is recommended a

suitable mesh (of finer grade than the backfill diameter) be fixed across the gap at the base of the shoring between the timber and the rock so no more backfill can move through the gap. The mesh is to stop the gravel movement but is to allow seepage to continue to flow through the gap. The mesh is to be of adequate strength that it will not tear or brake over time. Alternatively the gravel can be removed from behind the shoring and wrapped in geotextile fabric to prevent further movement of the gravel.

- The existing shoring is to be propped to provide additional lateral support. A slab has now been constructed at the base of the shoring. The slab edge is set back sufficiently from the excavation face that it can provide the toe (lateral) support for the props. The props are to be robust and are to be fixed to a plate attached to the existing form ply face. All fasteners used are to be heavy gauge coach screws or similar. Nails are not considered adequate for this work.
- Where the gravel levels have been depleted by the water movement through the gaps at the base of the shoring, the gravel is to be topped up behind the shoring so the gravel level is equal to the soil level immediately behind the shoring.

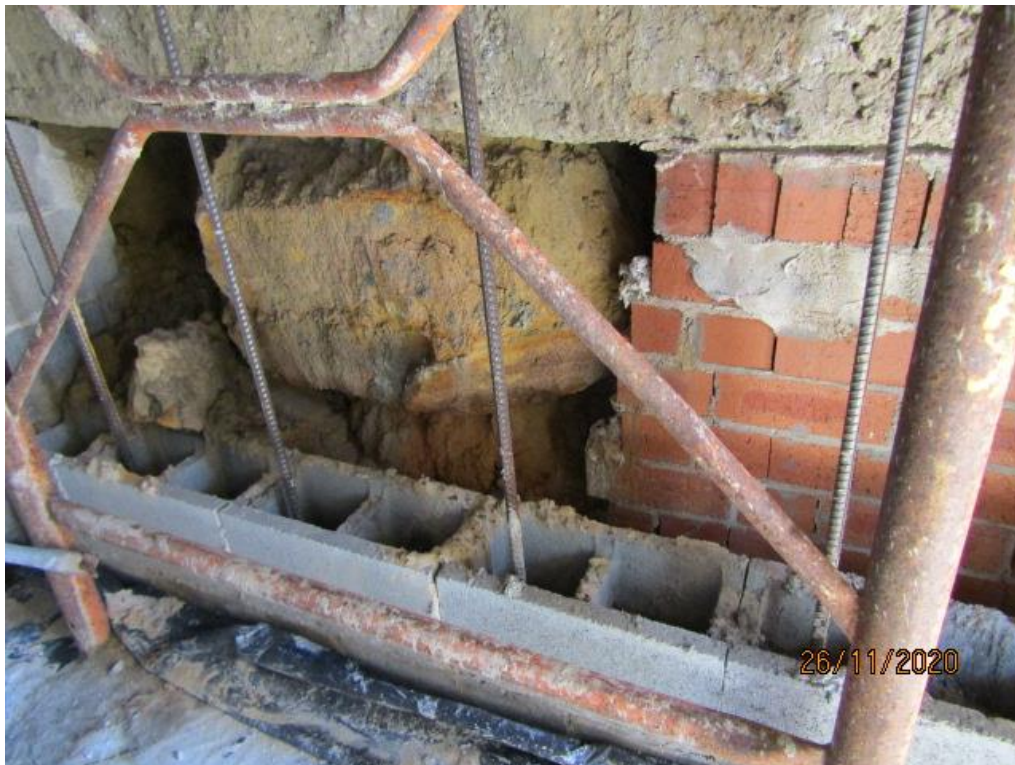
Photo 3

In our original recommendations the cut batter on the N boundary in the location of the pool plant room was to be supported as a matter of priority. The face was partly filled in with brick work as a temporary measure but this did not extend over a floating boulder in the cut face. The starter bars for the proposed retaining wall are in place but the wall has not been built or backfilled. There is some reeling back of the clays around the boulder where seepage has been moving through the cut face (Photo 3). To prevent the potential movement of the

boulder it is recommended this small wall be constructed as matter of priority and under emergency measures if required. During the construction it is imperative that the wall be backfilled properly with gravel, and that the backfill fills all the voids in the cut face behind the wall.
