2 March 2018  
Our ref: AB/S1033

## **Proposed Driveway Rehabilitation + Pool – 63 Gordon Street, Clontarf, NSW**

### *Geotechnical Assessment*

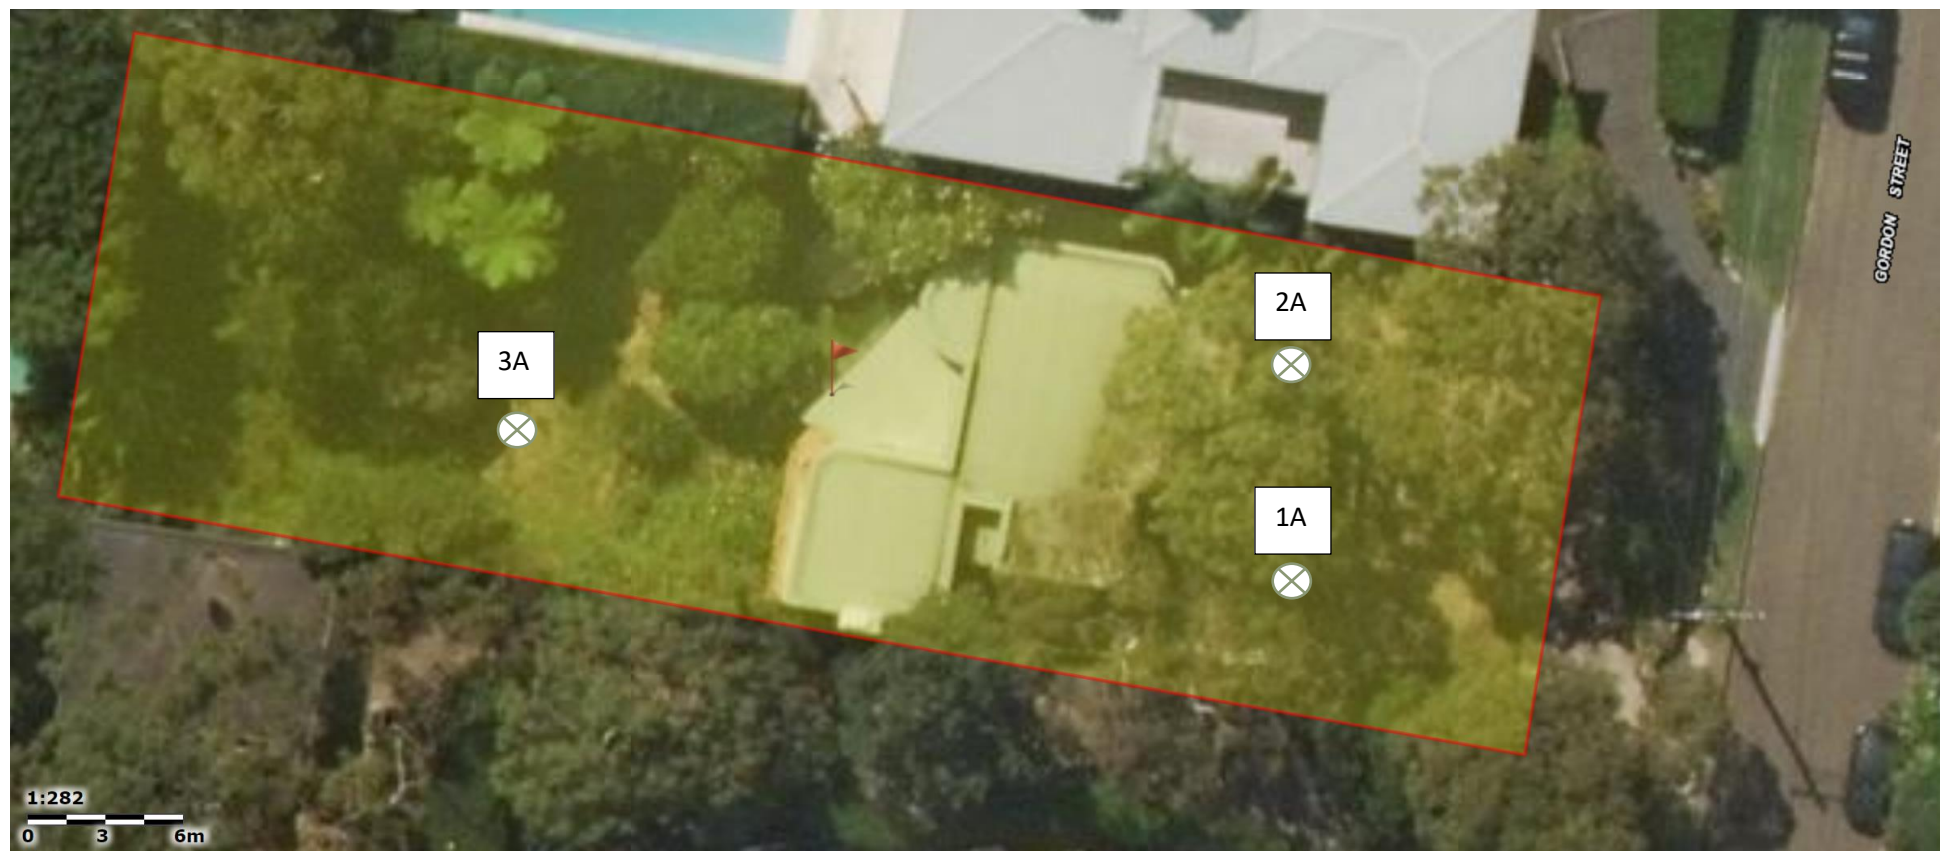
FIGURE 1

The 1:100,000 Sydney Geology map indicates the area to be underlain by Triassic age, Triassic age, Wianamatta Group, Hawkesbury Sandstone bedrock which includes medium to coarse-grained quartz sandstone, very minor shale and laminate lenses. Figure 1 is a recent aerial photograph showing the approximate borehole locations as designated by the client.

AERIAL PHOTOGRAPH AND BOREHOLE LOCATION
