Report on  
Geotechnical Investigation

Proposed New Residence  
9 Ocean Road  
Palm Beach

Project 86970.00  
January 2020

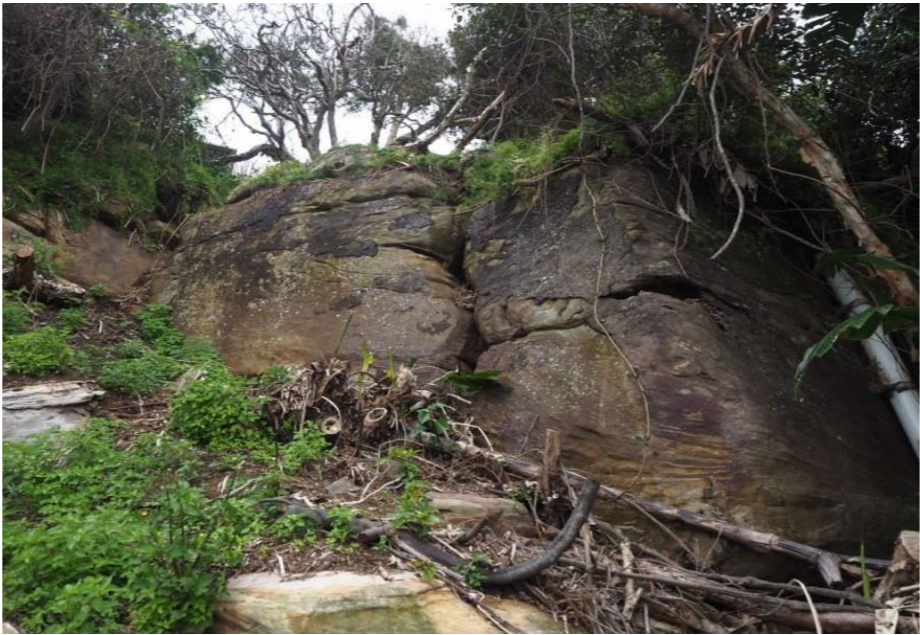
- there is no evidence of any recent collapse from the sandstone cliff line (Photo 2). A open joint within the cliff-line infers that a section of the cliff-line is detached (refer to Photo 4). The block is supported on the colluvium slope below and is tilted back onto the sandstone cliff face but it has not been established whether this section of cliff-line is founded on bedrock or colluvium;

Photo 2: Sandstone cliff-line located upslope of residence

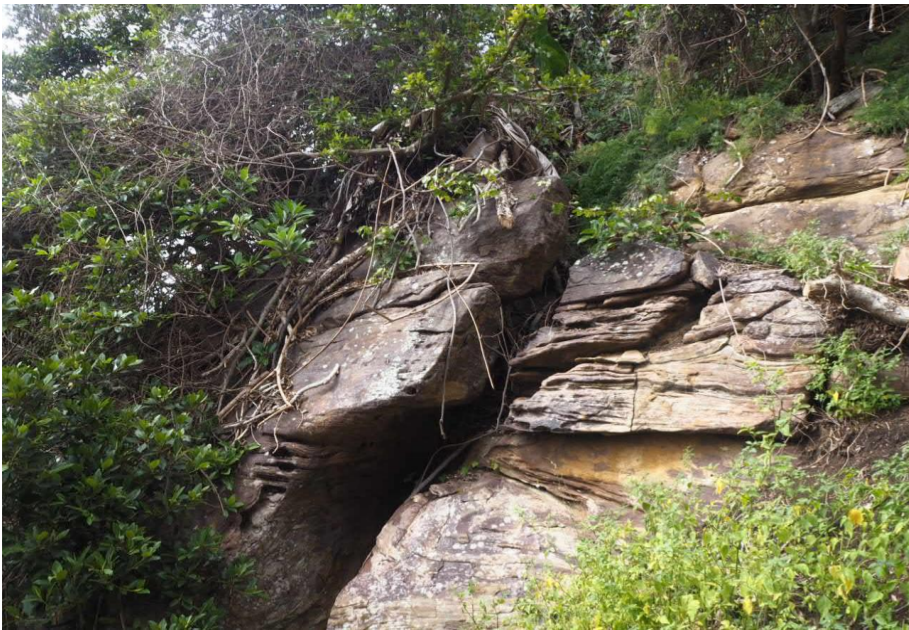
Photo 4: Open joint in sandstone cliff-line

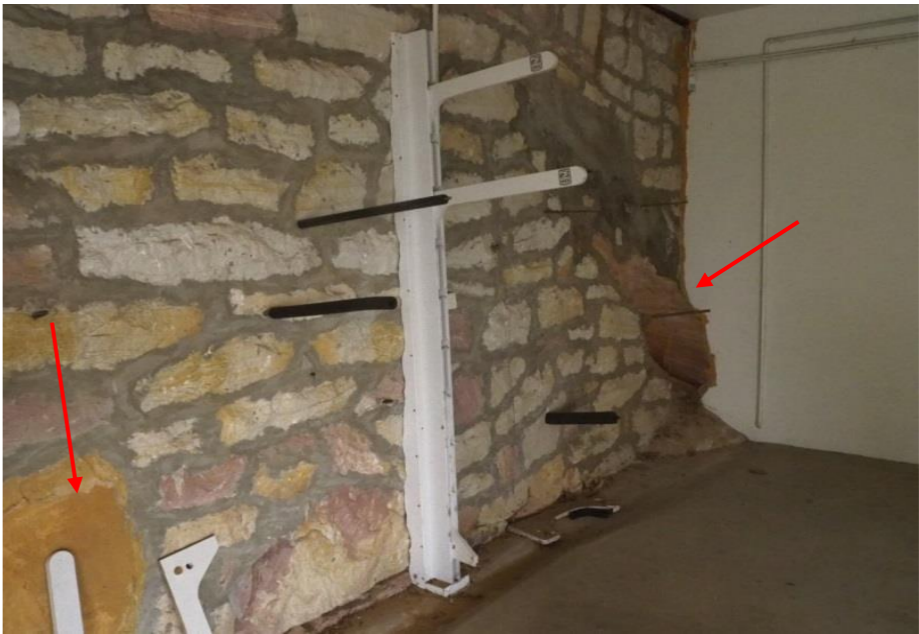
Where found to be present, the colluvium will need to be progressively retained (removed or underpinned in the case of large sandstone boulders) as the existing walls are removed and the excavation extended. Some of the boulder-sized sandstone “float stones” near the edge of the proposed excavation footprint are probably bearing on colluvial soil.

Photo 6: Detached sandstone boulders ('floaters') visible in rear garage wall

The investigation has indicated that colluvium prevails over most of the proposed excavation with BH5 indicating some bedrock close to the surface along the southern boundary. Therefore, it is recommended that any existing retaining walls onsite be removed in short sections so that the sub-surface profile can be progressively uncovered, and the appropriate shoring system(s) determined.
