REPORT ON GEOTECHNICAL SITE INVESTIGATION

PROPOSED DEVELOPMENT

**41 UPPER CLIFFORD,
FAIRLIGHT
NSW**

Project No.: 2019-212.1

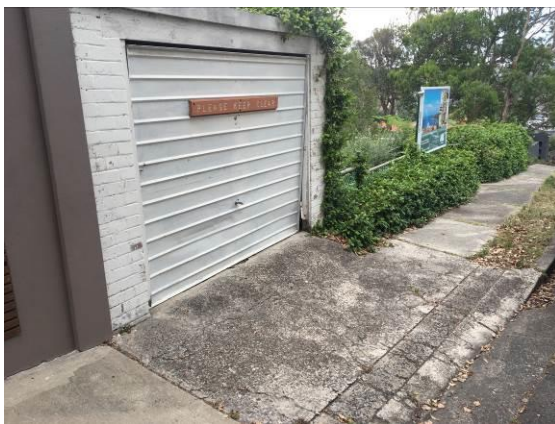
Upper Clifford Avenue is formed with a gently west dipping bitumen pavement with concrete kerb and gutter and then concrete footpath adjacent to the site. The road pavement appears slightly deteriorated however there were no indications of significant ground movement.

The front boundary of the site is formed with a steel fence. Below the fence is a sandstone block retaining wall of up to 1.0m in height that supports the road reserve above the level of the site. In the north-east corner of the site is a single car brick garage which is supported on its western and southern sides off a large outcrop of sandstone, considered to be bedrock. This outcrop extends to the south with a sub-vertical cliff marking its western edge within the site. The sandstone is characterised as being medium grained, massive, of at least medium strength and forms a 4.0 to 5.0m high sub-vertical cliff adjacent to the north-east corner of the existing site house.

Upper Clifford Avenue boundary, viewed to west.

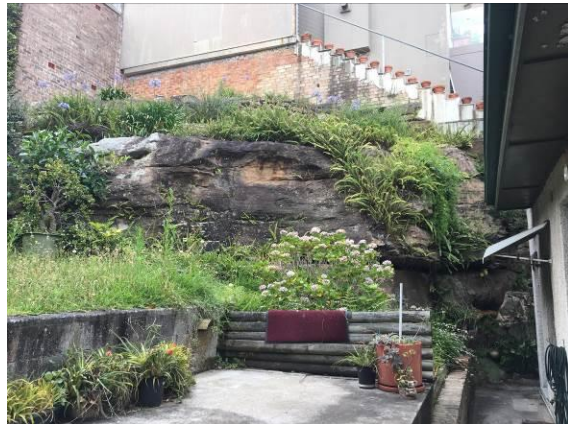
Sandstone outcrop on east boundary, garage to left.

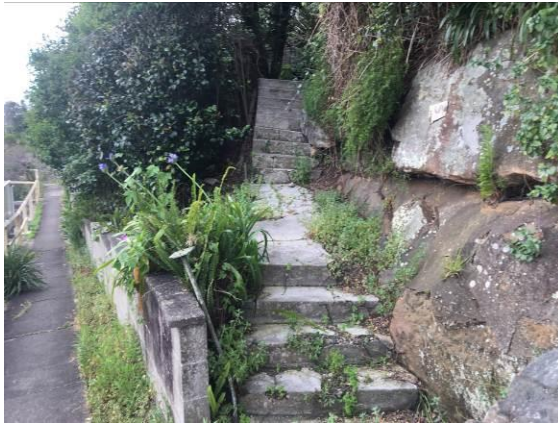
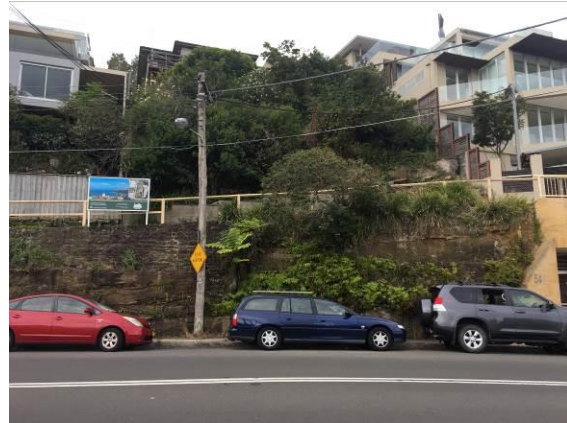
Lauderdale Avenue is formed with a gently east dipping bitumen pavement with concrete kerb and gutter on its northern side. Rising up from the kerb is a sandstone bedrock cliff outcrop of between 2.0m and 5.0m in height with a cemented sandstone rock retaining wall of up to 2.0m in height at its crest for the western part where the cliff is lower. This wall is formed near vertical to steeply south dipping and supports a concrete footpath that runs along the sites southern boundary. The sandstone bedrock is characterised as

being moderately weathered, low to medium strength and with closely (<0.50m) spaced bedding defects. It shows increased weathering along defects with some iron stained/coated defects evident.

Southern boundary showing cliff and boundary wall. Lauderdale Avenue with site above.

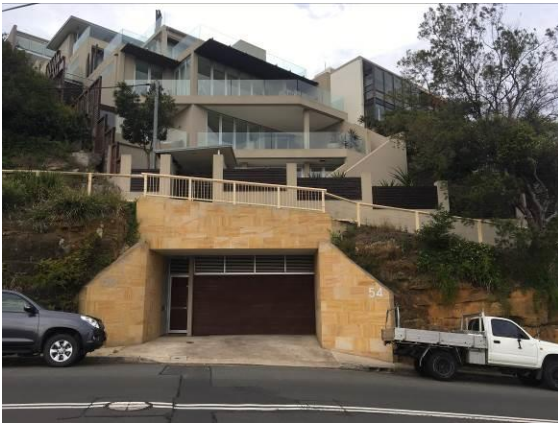
To the east are two neighbouring properties, No. 39 Upper Clifford Avenue and No. 54 Lauderdale Avenue. Access to No. 54 is provided via a basement level garage formed at Lauderdale Avenue that is excavated into the slope through the road reserve with the footpath re-formed above the garage entry. A multi-level rendered masonry residential structure then steps up the slope above the garage towards the north within 1.50m of the common boundary with the site. The structure appears < 10 years of age and inspection of the garage excavation in relation to other works indicated Medium Strength sandstone excavation has been done to allow the complete construction of the basement level garage.

No. 54 viewed from south showing garage entry

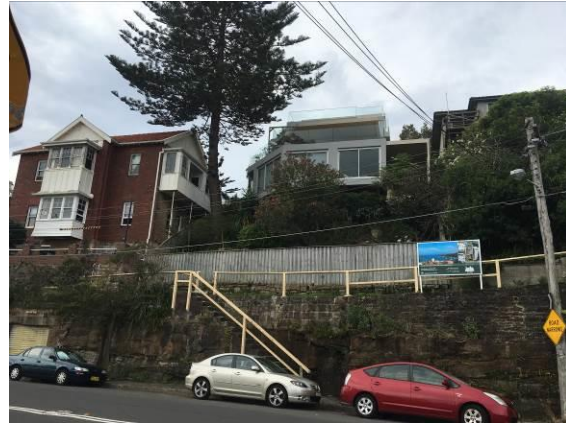
To the west is a single property (No. 43 Upper Clifford Avenue) which contains a three and four-storey residential development that steps down the slope towards Lauderdale Avenue. The structure within this property is accessed via a driveway from Upper Clifford Avenue. The second storey (Unit 3) has a FFL of approximately 49.46m (similar floor level as front of No.41 site house), it extends north and has a lower level than the northern portion of south dipping No.41 site. This indicates that prior excavation could have been done on No.43 to accommodate construction. The lower level is formed below the southern end of the house on natural slope ground surface.

No. 43 viewed from Lauderdale Avenue
