## **Geotechnical Assessment**

**Project:** New Pool and Associated Works  
12 Goodwin Road, Newport NSW.

**REF: AG 20034**  
20<sup>th</sup> February, 2020

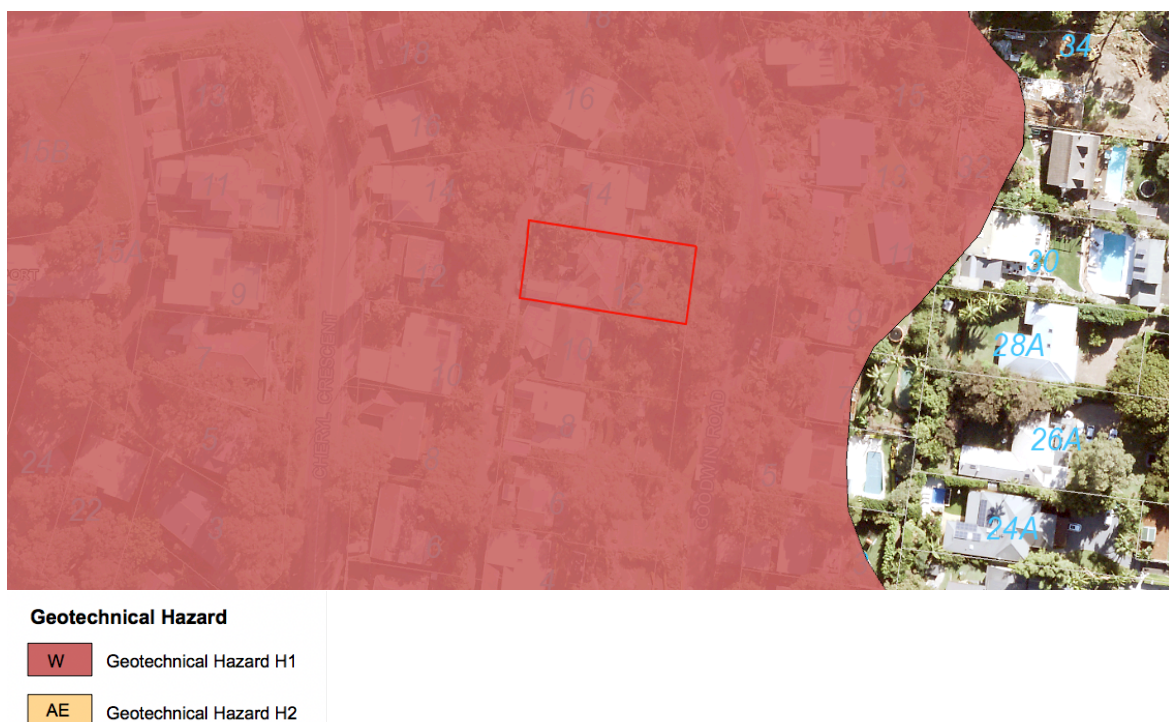
**Image 2:** 12 Goodwin Road, Newport NSW – **Geotechnical Hazard Map**– Red polygon (PLEP 2014)

- No evidence of significant soil creep, tension cracks or other indicators of slope instability were identified at the time of our inspection.
- The existing structure displayed no evidence of significant cracking or settlement that could be attributed to slope instability.
- The property is classified '**Geotechnical Hazard H1**' in Northern Beaches Council PLEP Geotechnical Hazard Map (PLEP Geotechnical Hazard Map **Image 2** below).

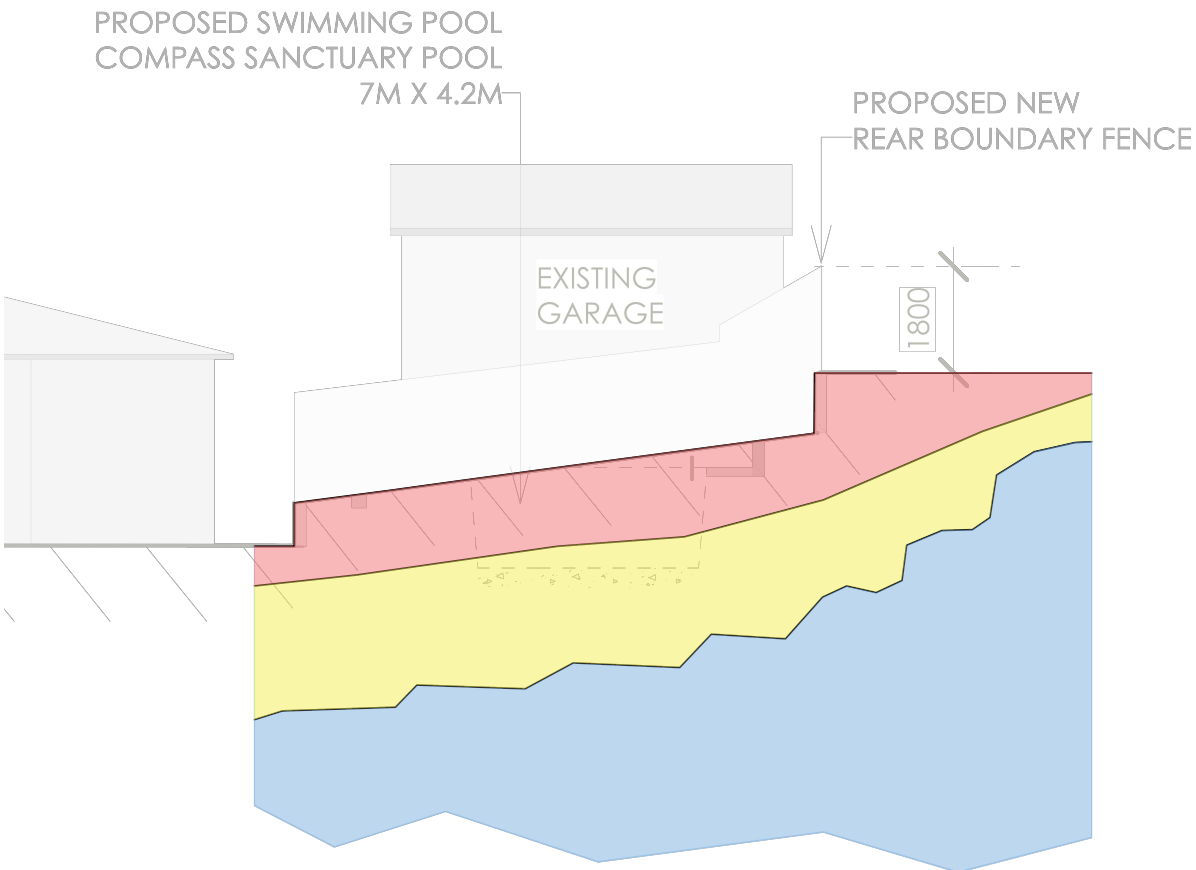
**INFERRED GEOLOGICAL SECTION**  
SCALE NTS

INTERPRETED SUBSURFACE SECTION ONLY.  
ACTUAL GROUND CONDITIONS MAY VARY.
