GEOTECHNICAL REPORT

PROPOSED STUDIO WITH CAR PLATFORM

20 THE SERPENTINE, BILGOLA BEACH, NSW

Project No.: 2023-022

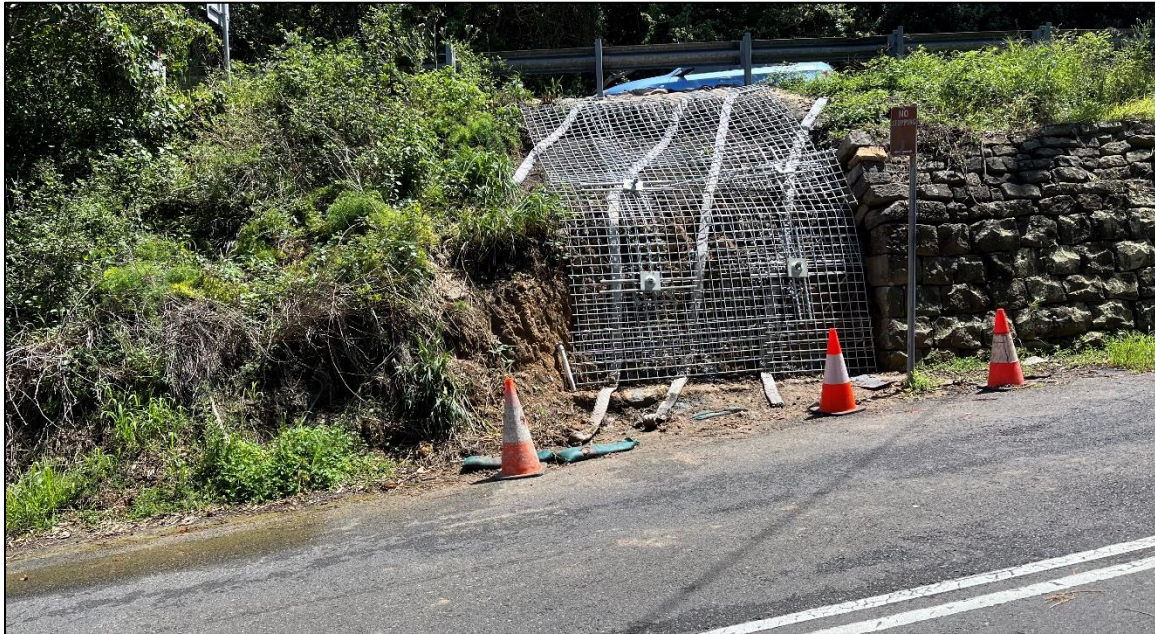
No.20 The Serpentine lies to the east of the carriageway which comprises a gently south dipping asphalt pavement and appears in good condition where it passes the site. Within an embankment located to the west of the The Serpentine and to the east of Barrenjoey Road, a previous failure of the embankment was observed which appears to be in the process of remediation. It is understood the failure occurred within the latter part of 2022 and no additional indications of instability were observed within the embankment (See Photograph 2).

Photograph 2: View of the previous embankment failure to the west of the site

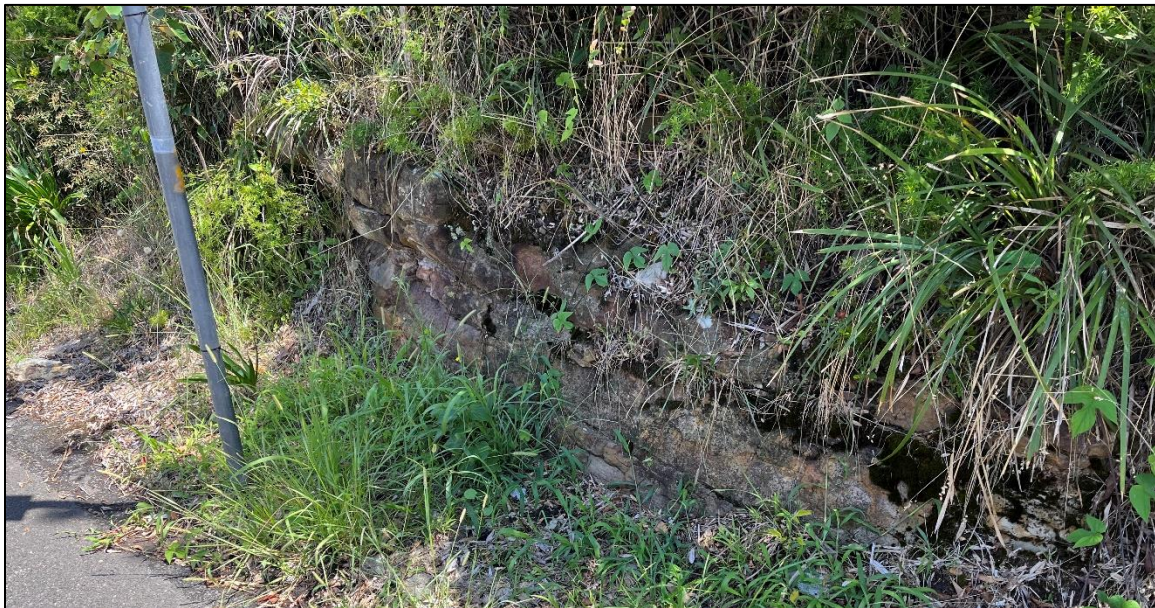
Bedrock outcrops were observed within the roadway cutting to the north of The Serpentine carriageway and comprised low to medium strength siltstone/sandstone and thought to represent deposits of the Newport Formation.

Photograph 3: View of bedrock outcrops to the west of the site

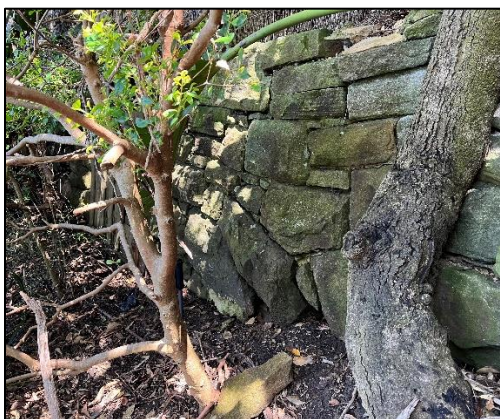
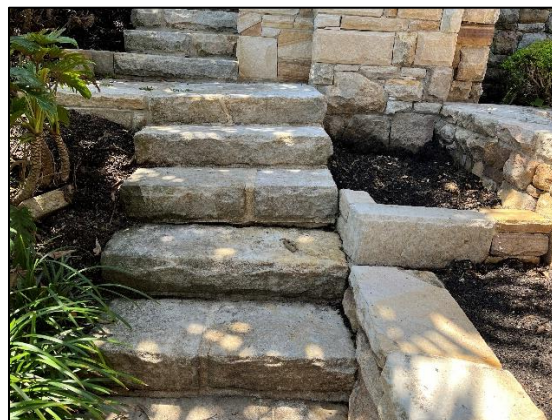
Some minor settlement was observed in a section of external steps and some bulging of the dry stone wall supporting the eastern boundary was observed. (See Photographs 4 and 5). Neither of these features are thought to relate to a deep-seated geotechnical issue and likely a result of settlement of near surface soils or degradation with age.

Photograph 3 and 4: View of slight bulging of the retaining wall supporting the Serpentine easement and minor settlement of steps

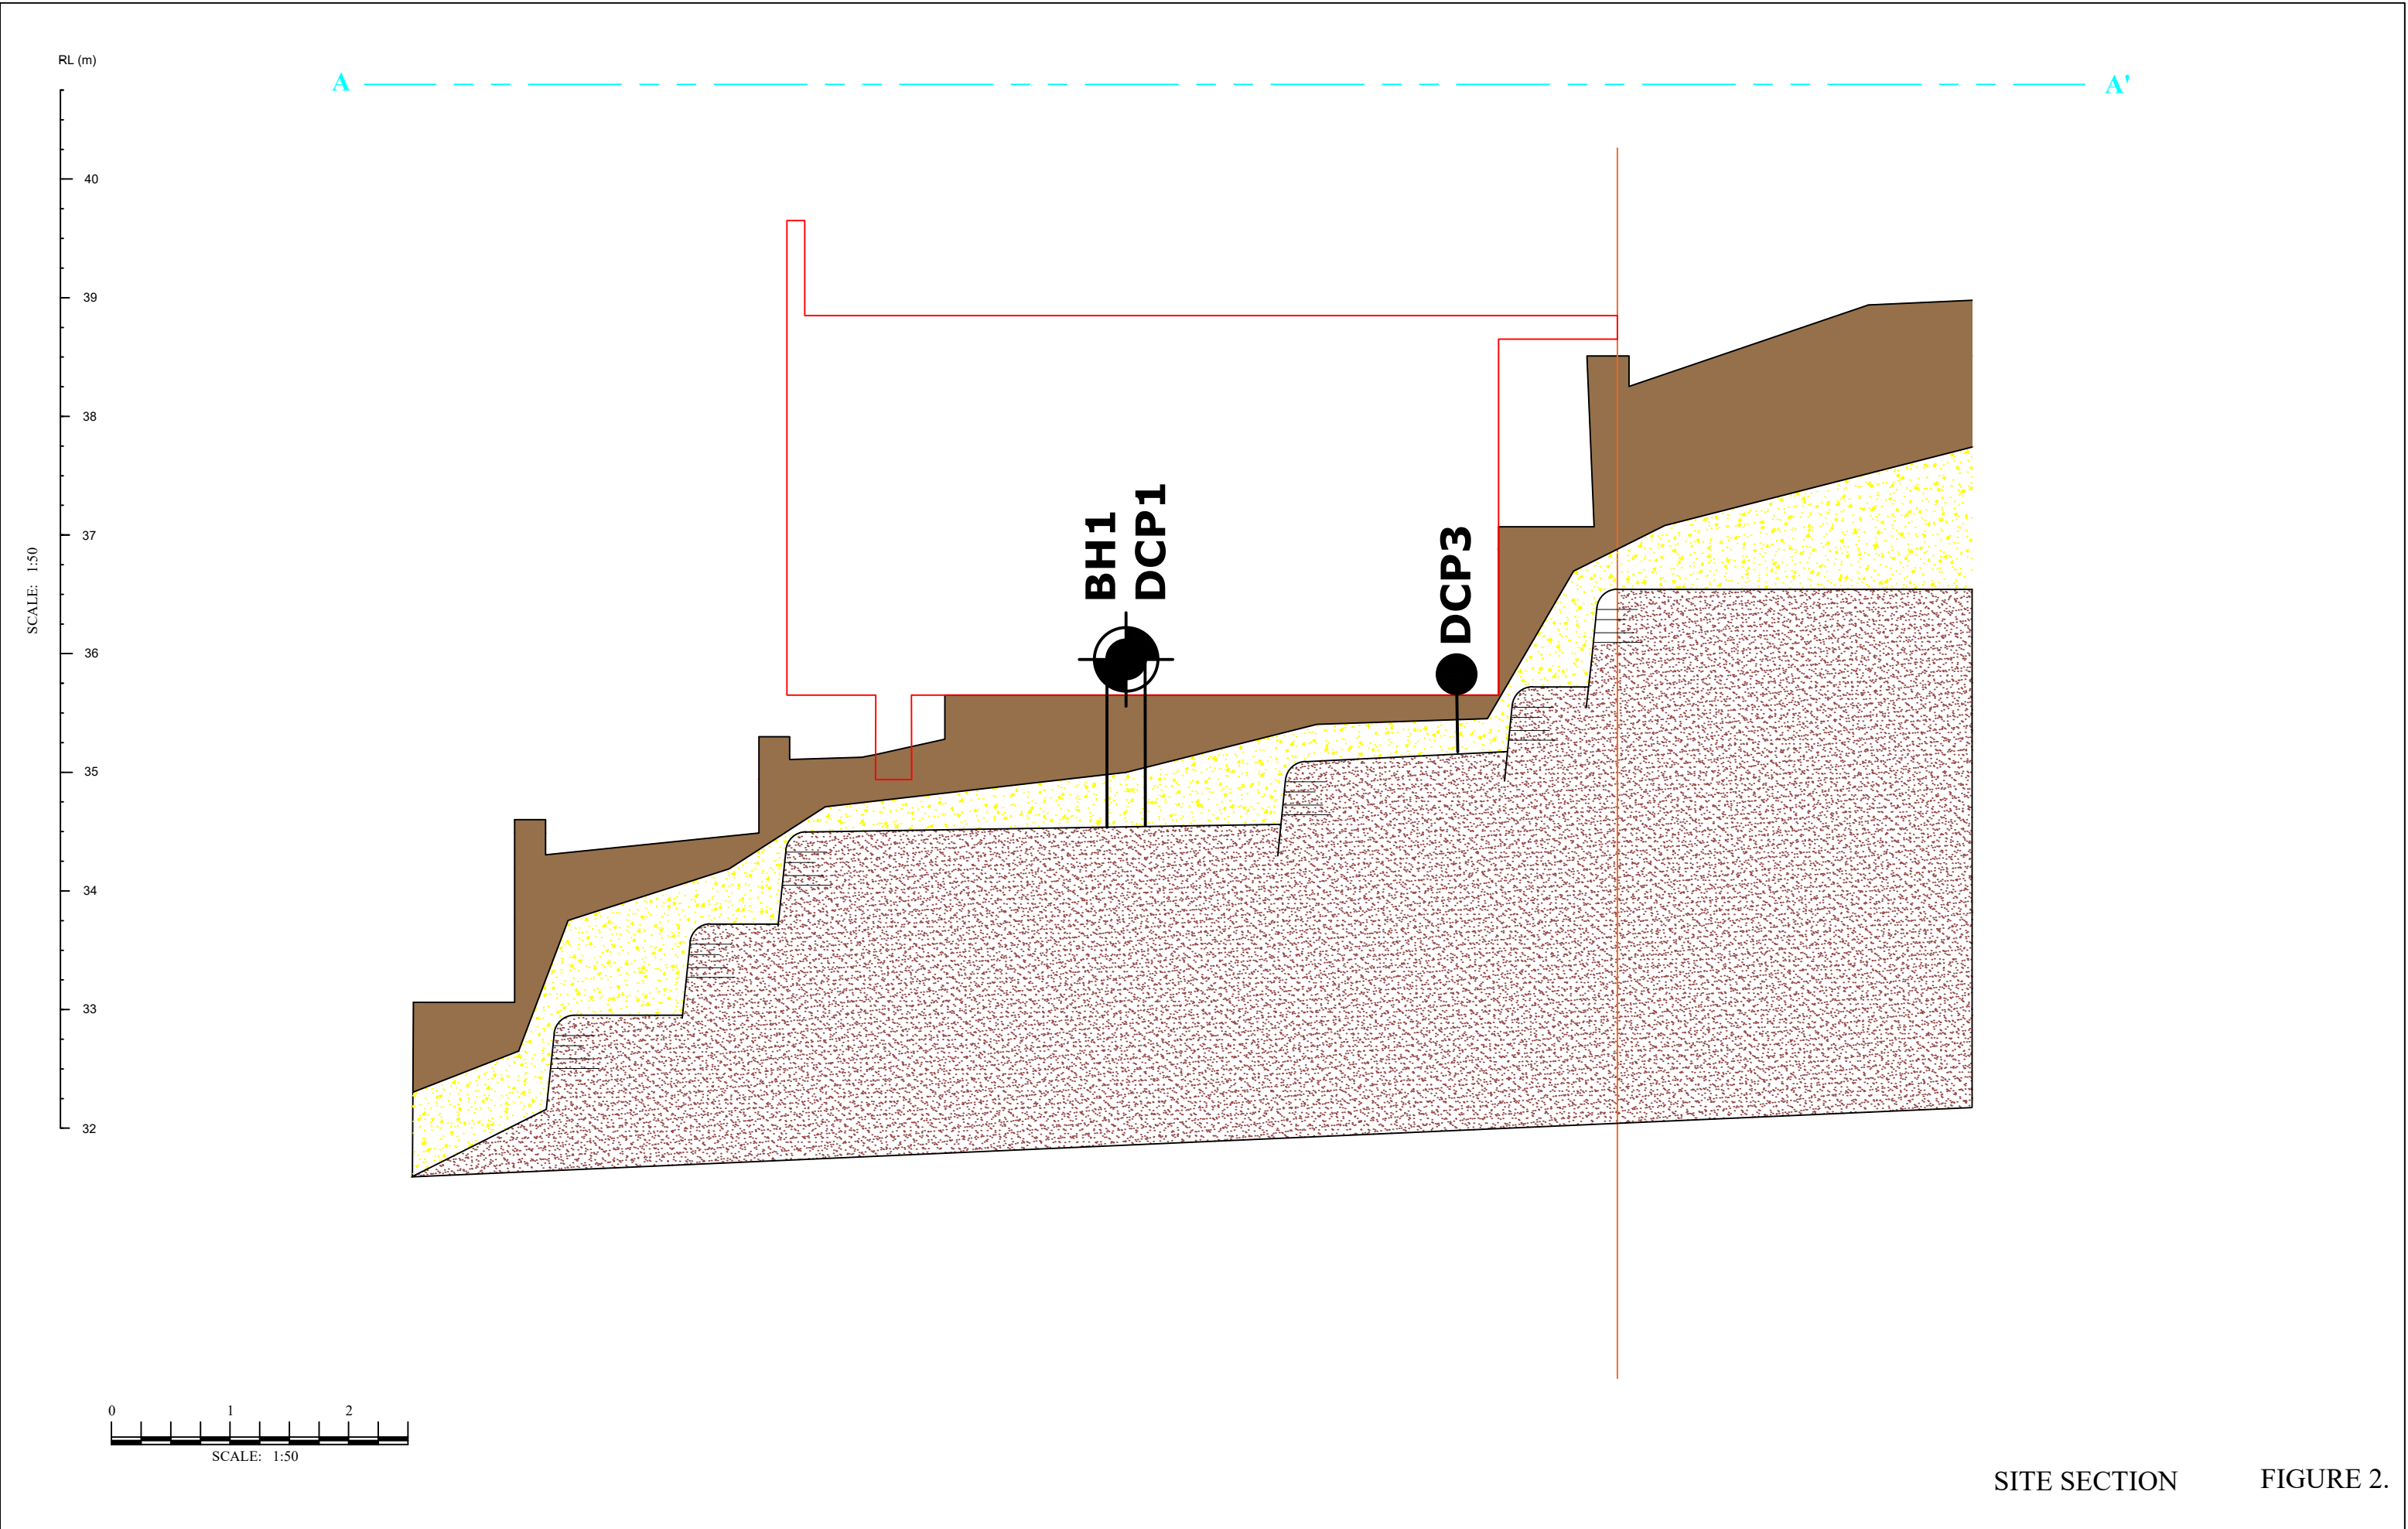
SITE SECTION FIGURE 2.

Based on the subsurface investigation it is anticipated that the ground conditions underlying the site will comprise an upper layer of fill soils up to approximately 0.80m depth underlain by potentially stiff to very stiff residual clay soils to a maximum depth of 1.90m (BH1) underlain by interpreted very low strength bedrock. It is anticipated that the bedrock may grade to low to medium strength however this is unconfirmed.
