Notice to council of determination of application for a certificate

Lot 74 DP 737370 No 174 Prince Alfred Parade Newport 2106

15 May 2014
Ref No 27333SYlet

REPORT

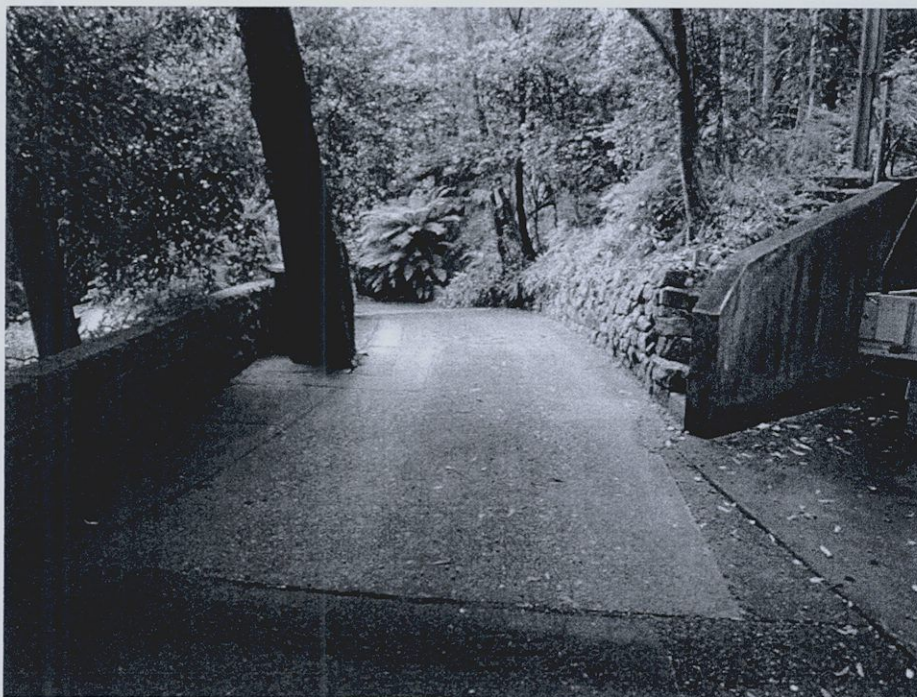
View looking north along the ROW at the tree which restricts the width of the ROW to approximately 2.5 metres.

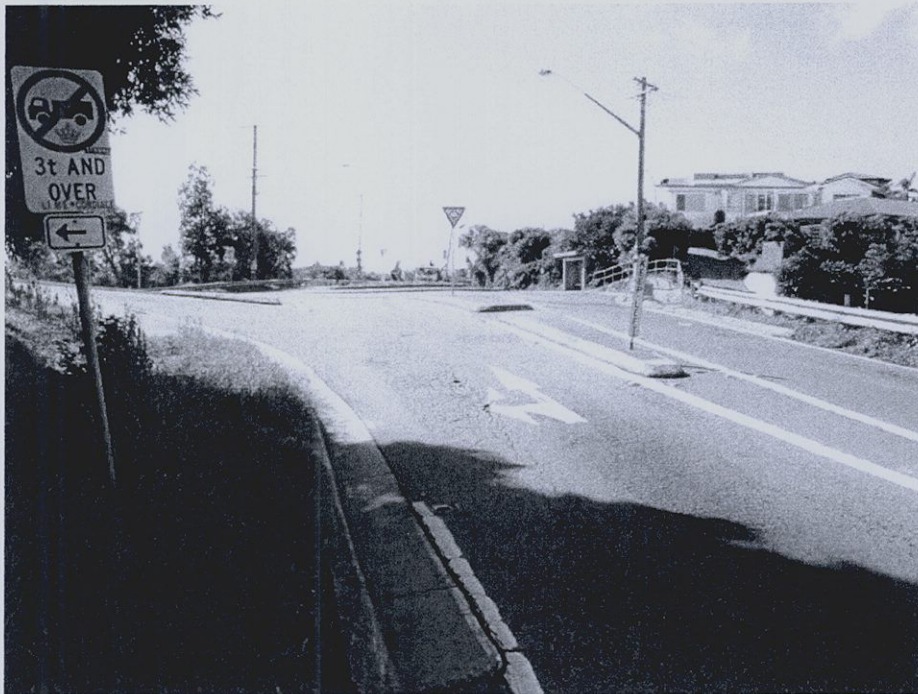
View looking north along Barrenjoey Road on approach to its intersection with Plateau Road and Old Barrenjoey Road. Note the Load Limit restriction applying to Plateau Road, to the left.

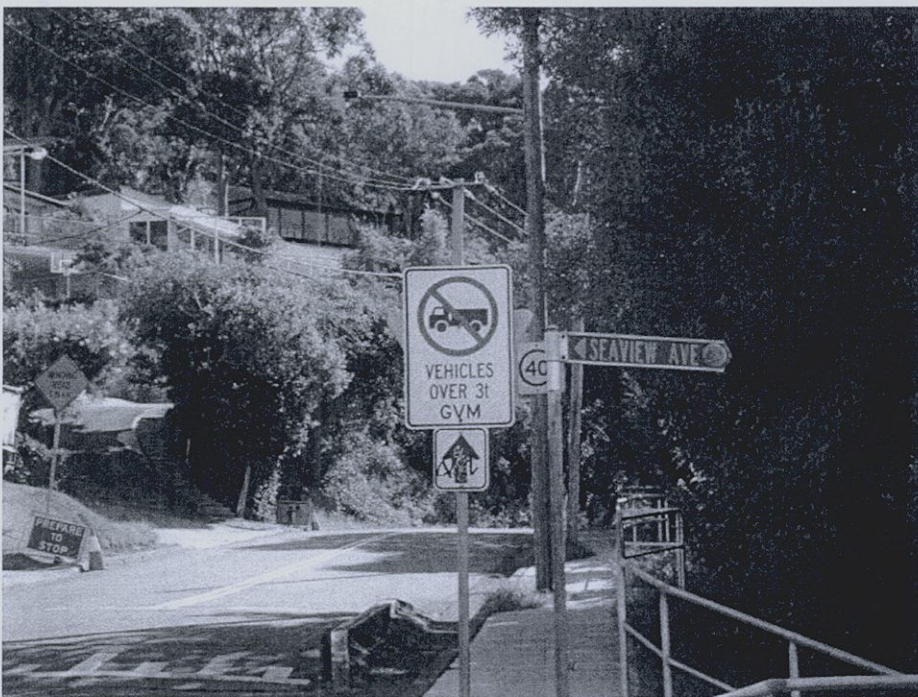
View looking west along Grandview Drive from Seaview Avenue. Note that Load Limit restriction applying to Grandview Drive.

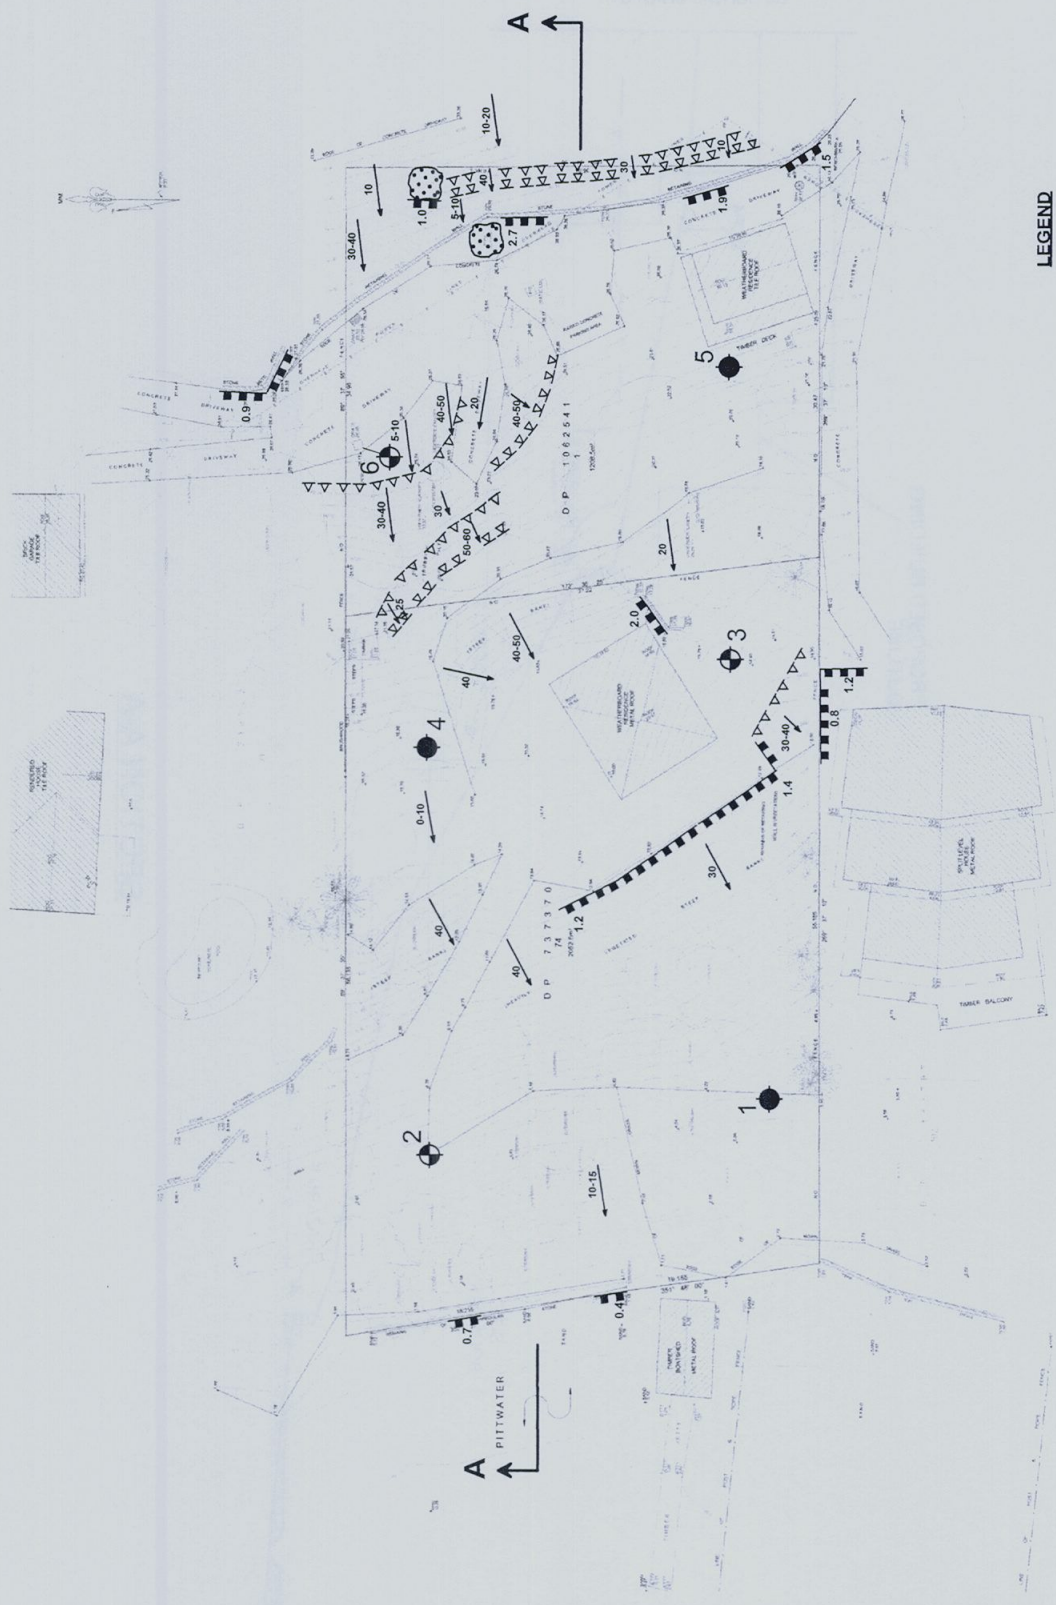
The attached Figure 1 presents our Investigation Location and Geotechnical Mapping Plan showing the principal geotechnical features present at the site. These figures are based on the survey plan prepared by Project Surveyors (Ref: B1570, Drawing No: B1570-1 dated March 2014). Additional features on these figures have been measured by hand held inclinometer and tape measure techniques and hence are only approximate. Should any of the features be critical to the proposed development, we recommend they be located more accurately using instrument survey techniques. Figures 2A and 2B present a typical cross-section through the site based on the survey data augmented by our mapping observations. The mapping symbols used are defined in Figure 3.
