# DILAPIDATION REPORT

**Warriewood Road, Warriewood**

**Prepared by: Rezoning Pty Ltd t/as Effective Building & Consultancy**

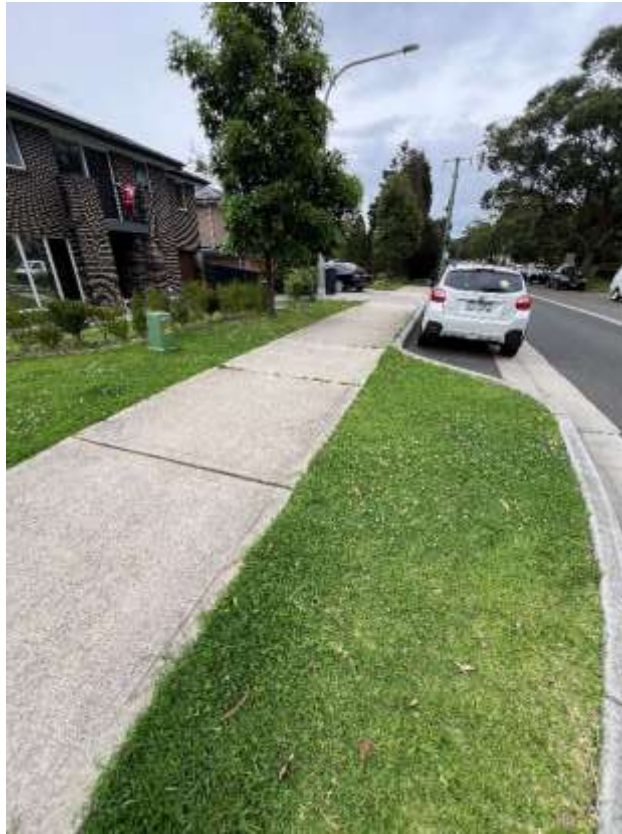
*Figure 1 – General condition of the nature strip/footpath.*

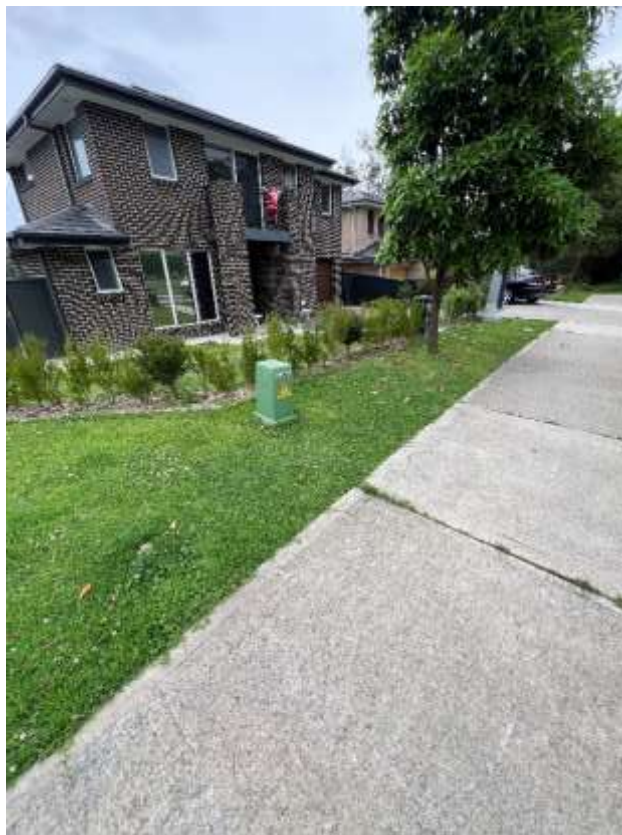
*Figure 2 – General condition of the nature strip/footpath.*

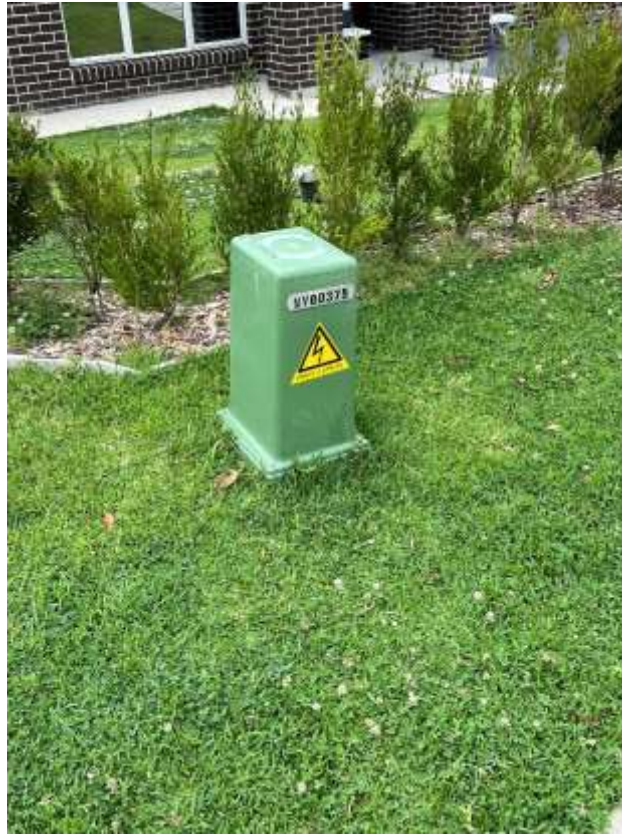
*Figure 3 – General condition of the transformer box.*

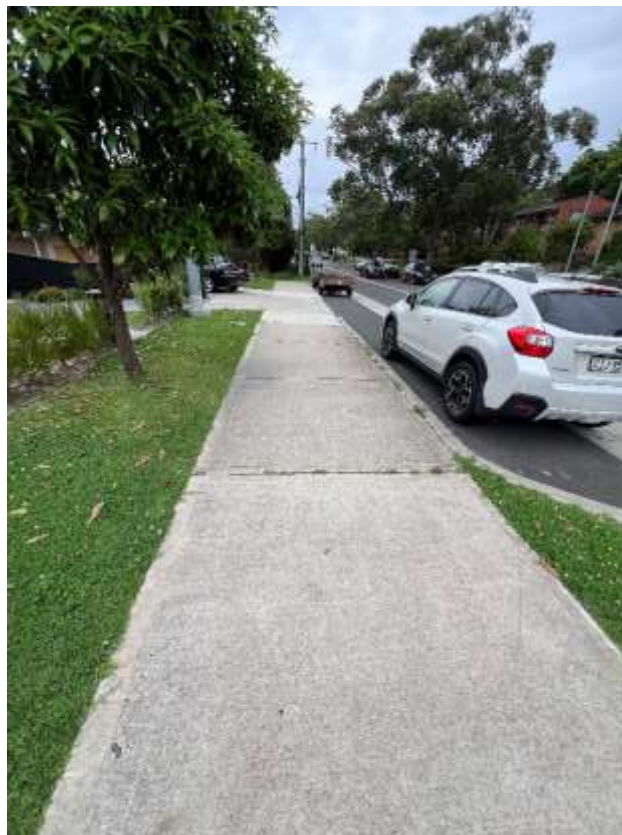
*Figure 4 – General condition of the footpath.*

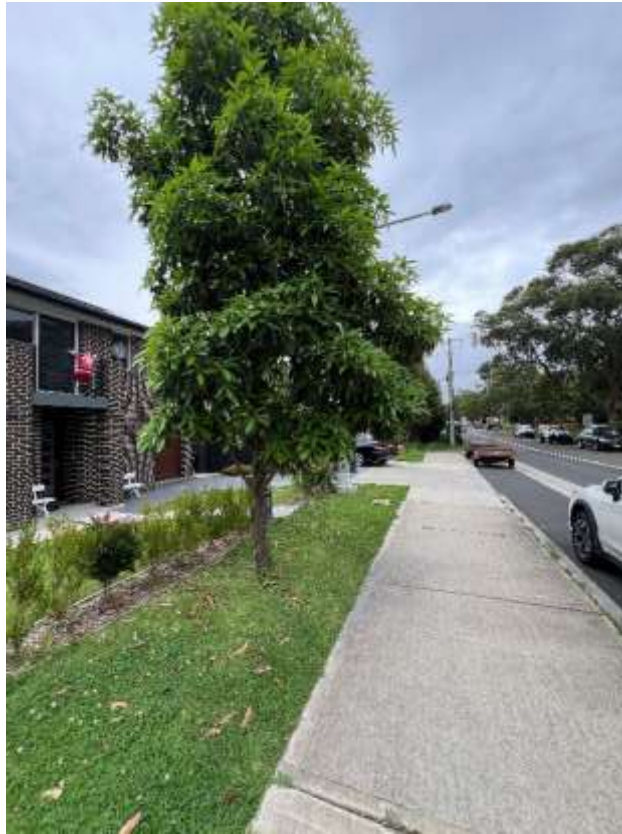
*Figure 5 – General condition of the tree.*

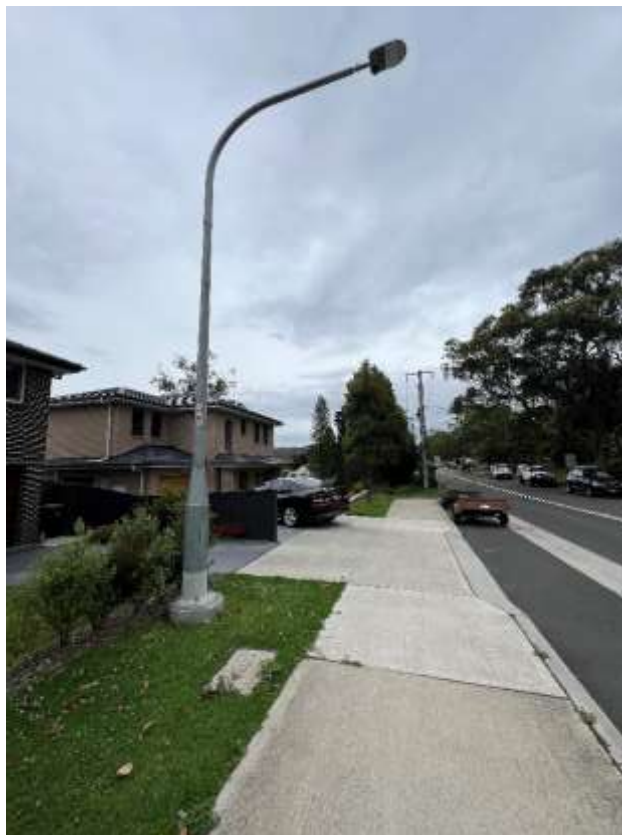
*Figure 6 – General condition of the nature street light.*

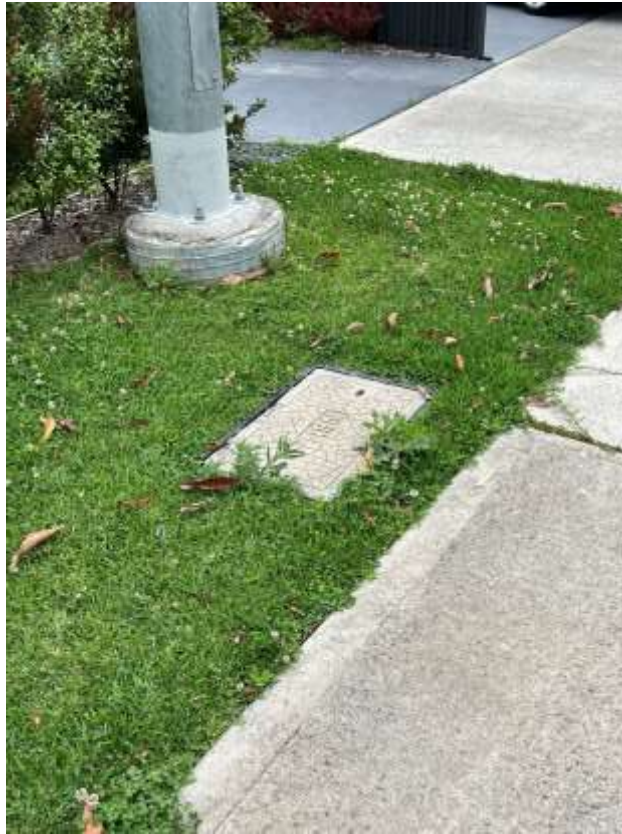
*Figure 7 – General condition of the pit.*

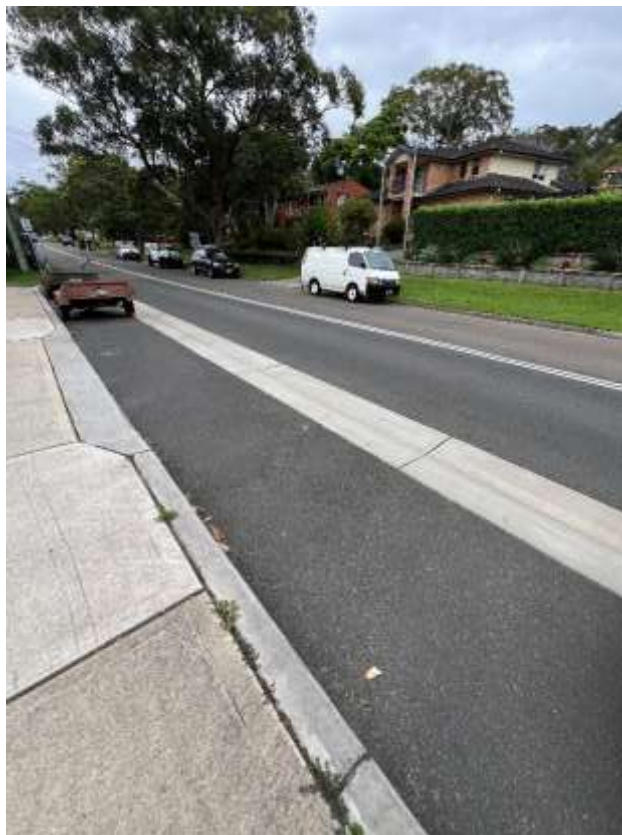
*Figure 8 – General condition of the kerb/road.*

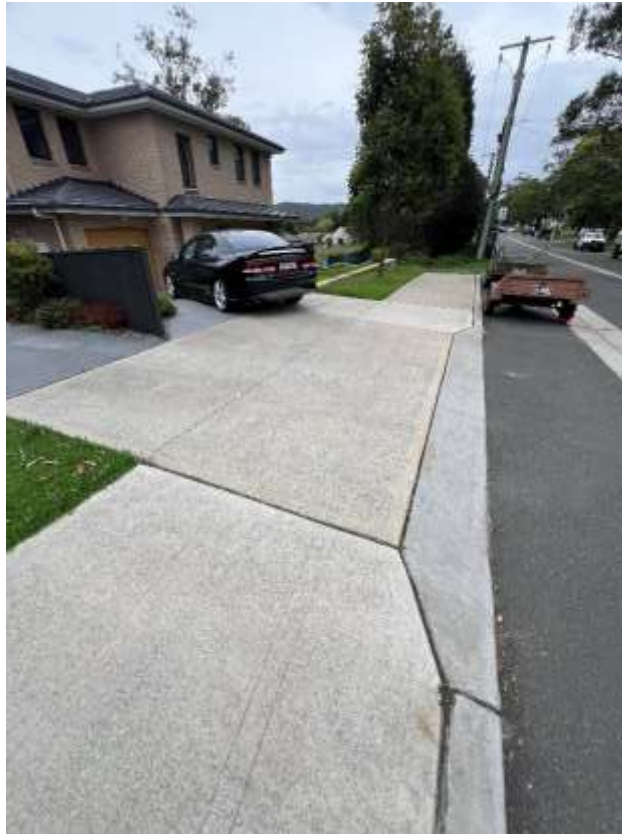
*Figure 9 – General condition of the driveway.*

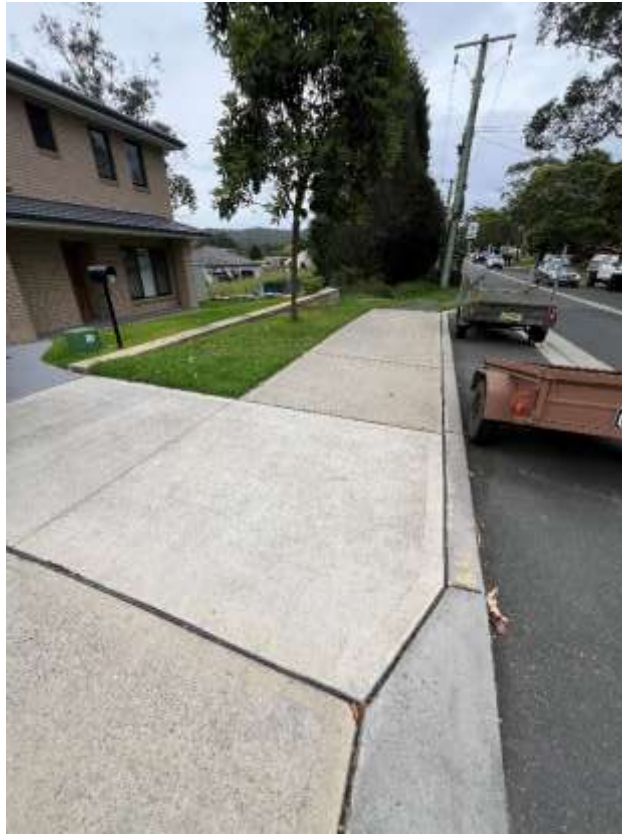
*Figure 11 – General condition of the footpath.*

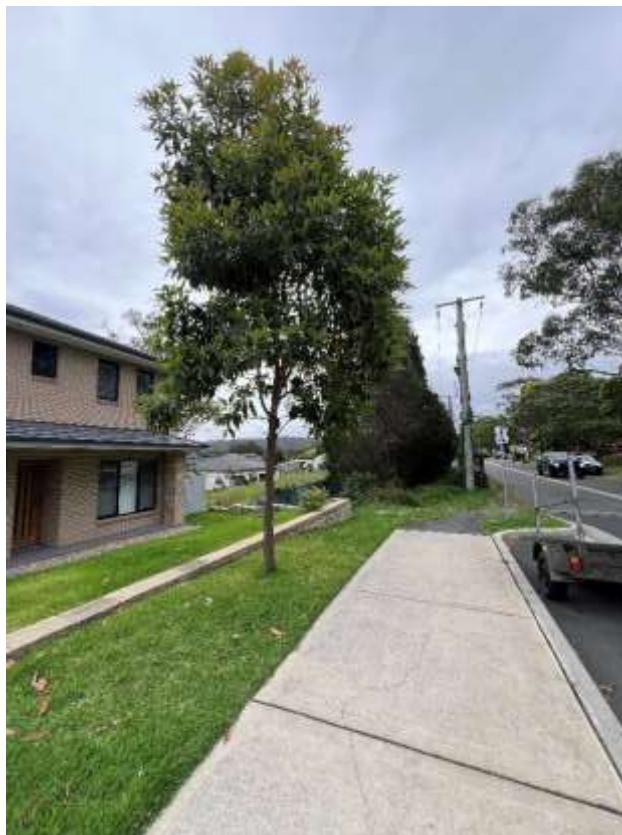
*Figure 12 – General condition of the tree.*

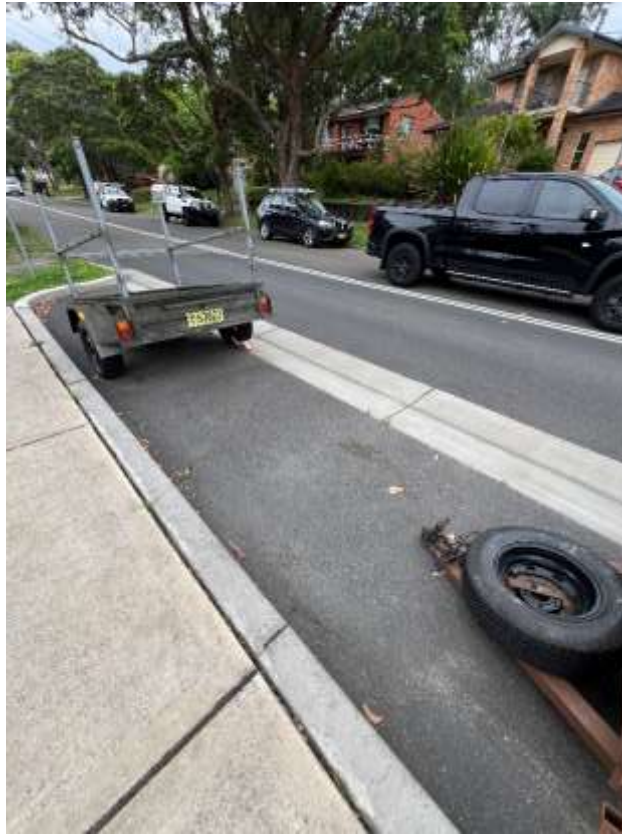
*Figure 13 – General condition of the kerb/road.*

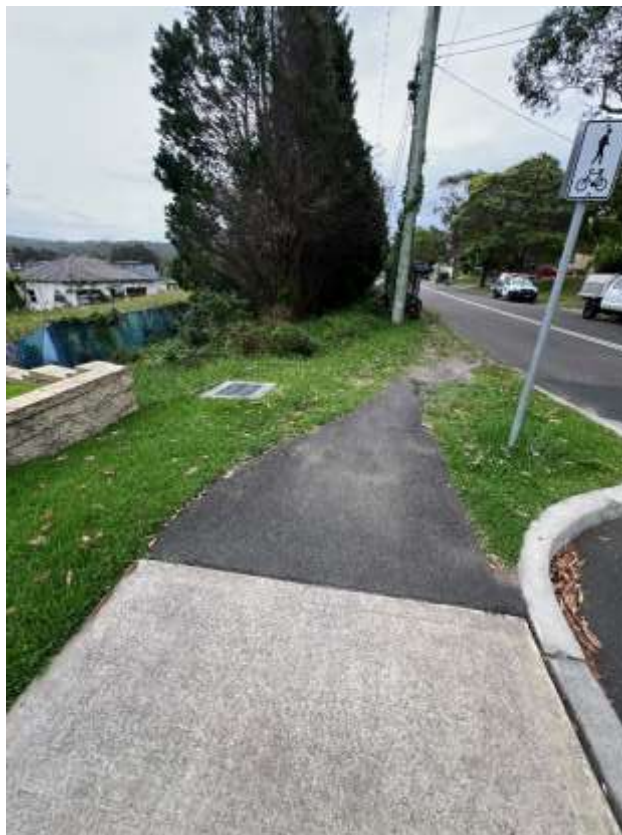
*Figure 14 – General condition of the footpath.*

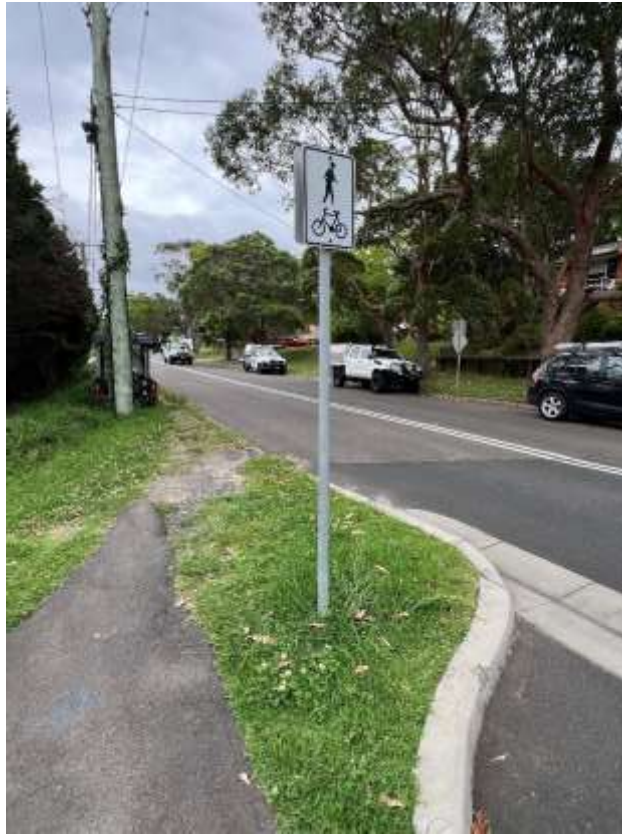
*Figure 15 – General condition of the traffic signpost.*

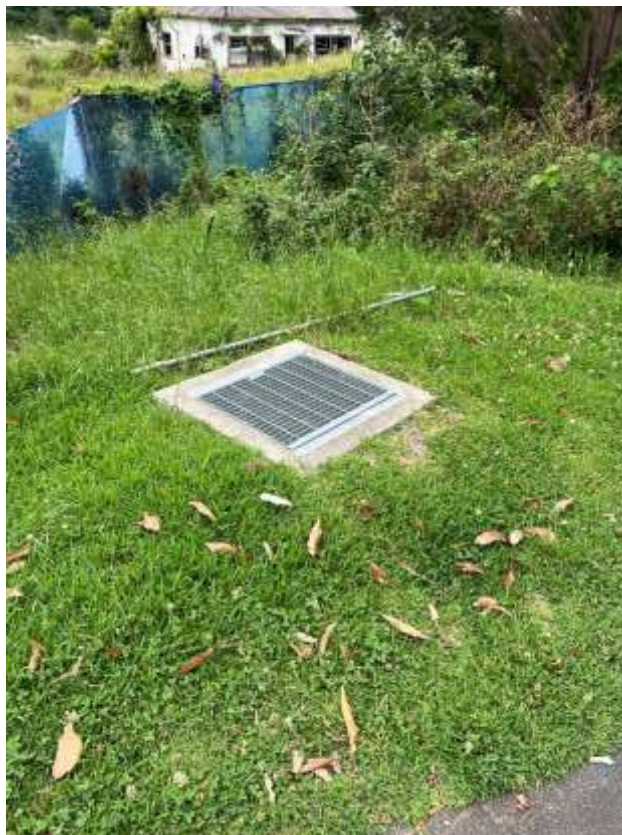
*Figure 16 – General condition of the pit.*

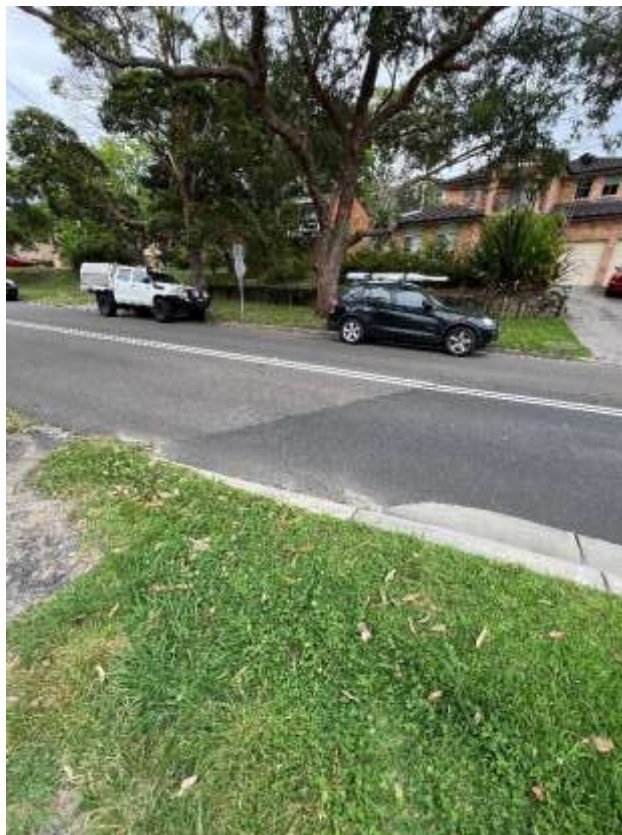
*Figure 18 – General condition of the kerb/road.*

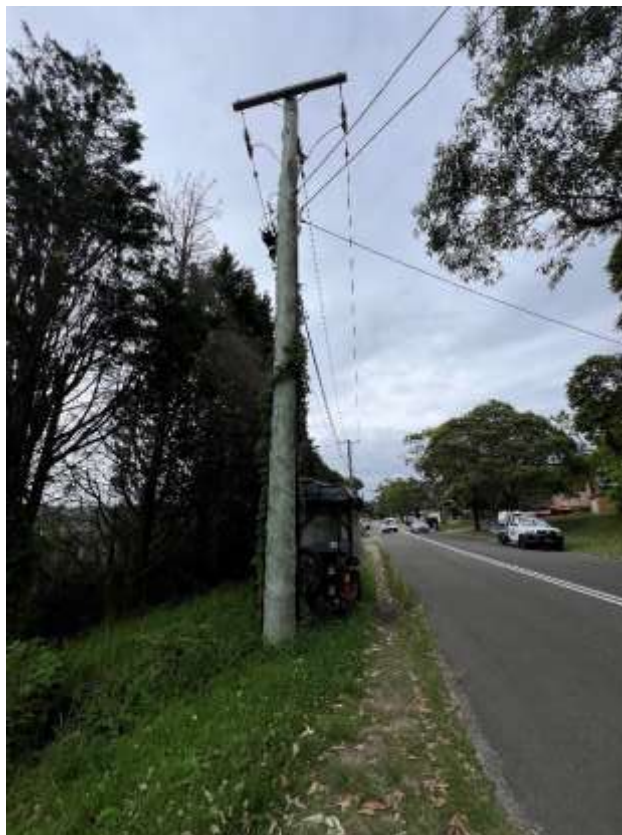
*Figure 20 – General condition of the electrical post.*

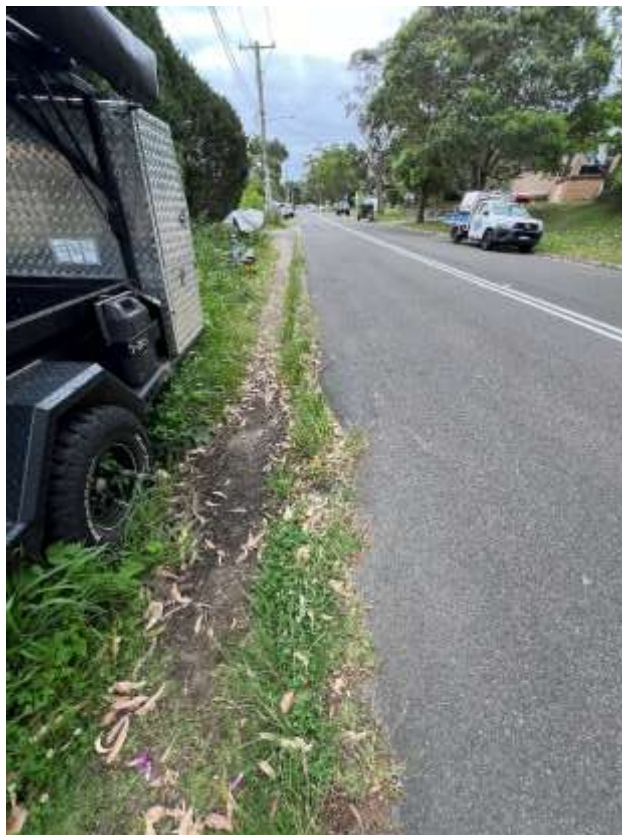
*Figure 22 – General condition of the nature strip.*

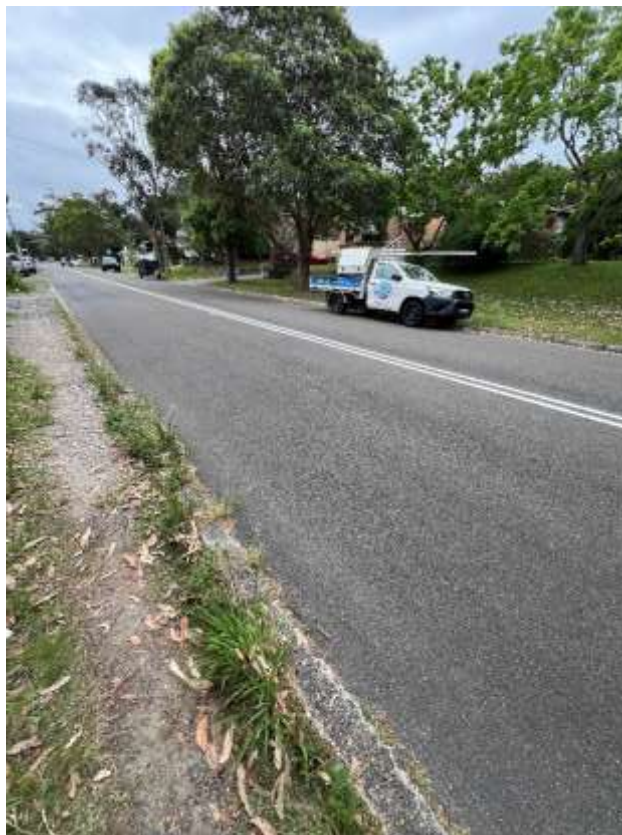
*Figure 24 – General condition of the kerb/road.*

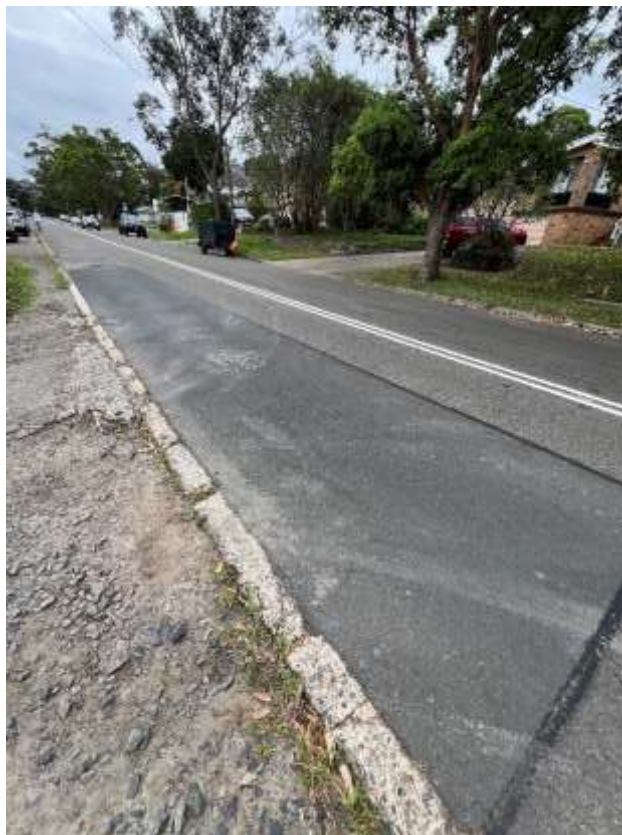
*Figure 26 – General condition of the road.*

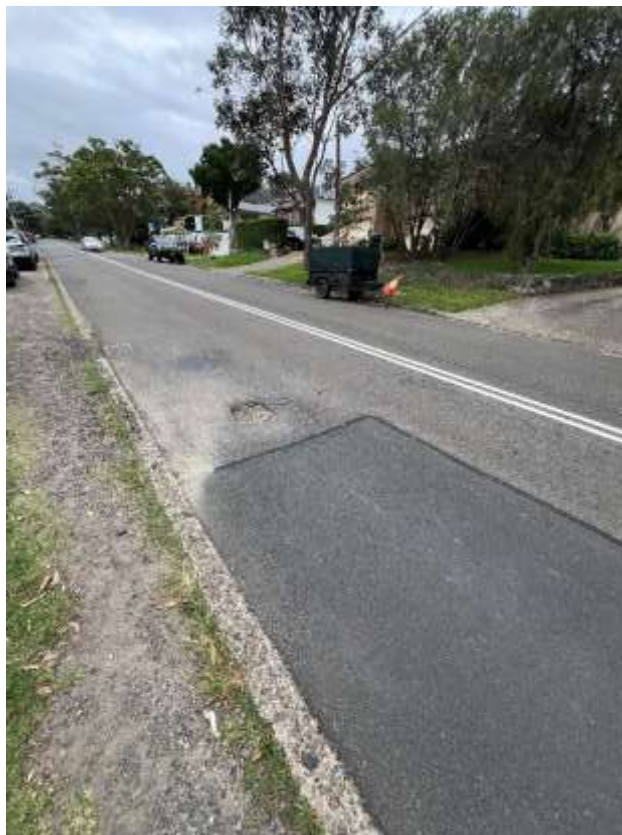
*Figure 28 – Pothole is evident to the road outside 45A Warriewood Road Warriewood.*

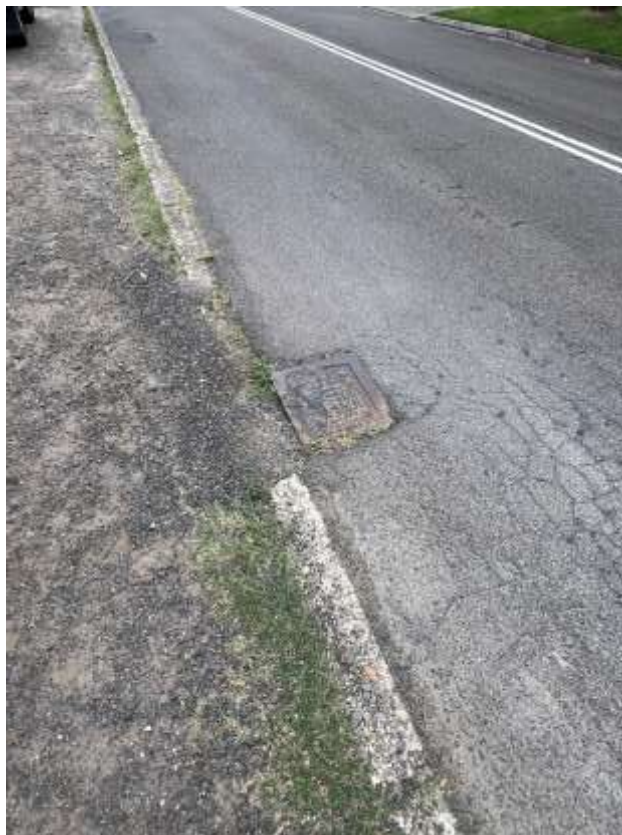
*Figure 30 – General condition of the utility lid.*

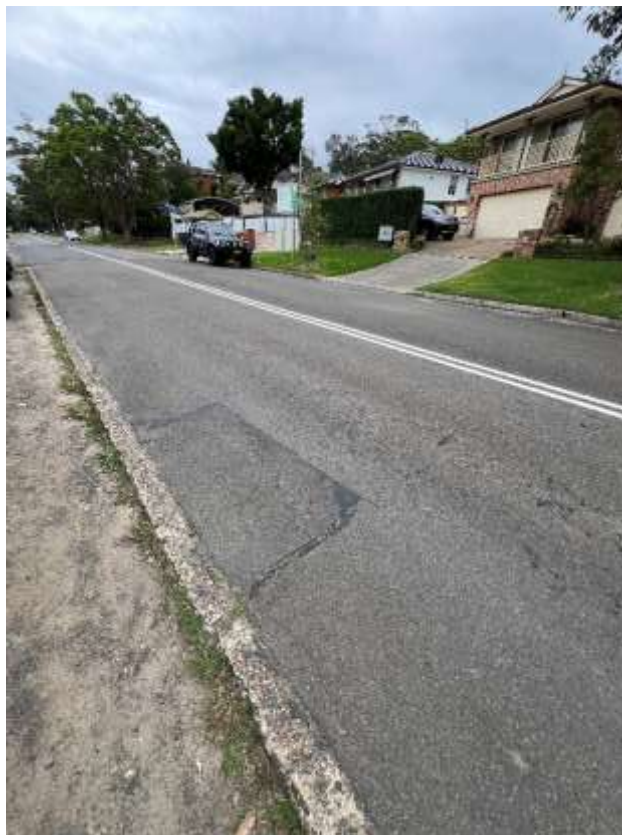
*Figure 32 – Crack is evident to the road outside 45A Warriewood Road Warriewood.*

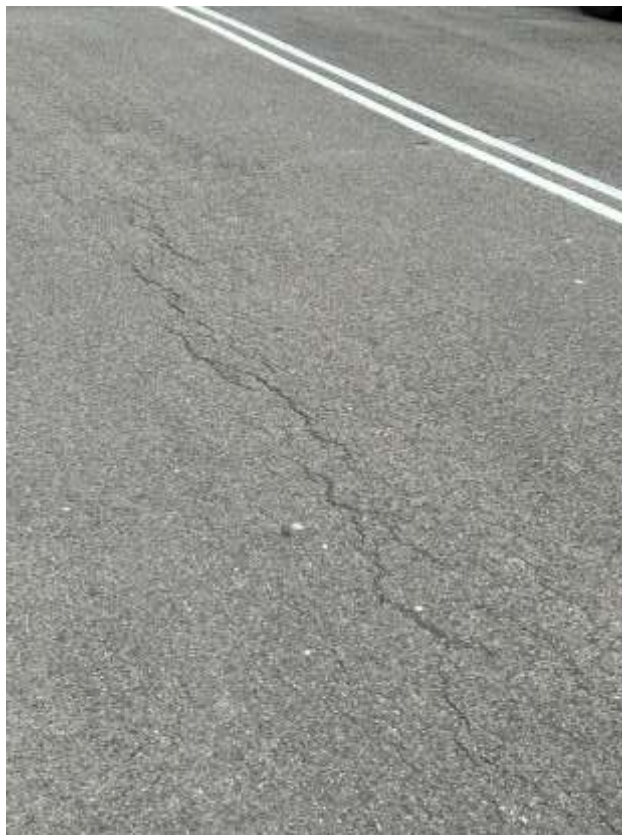
*Figure 34 – Crack is evident to the road outside 45A Warriewood Road Warriewood.*

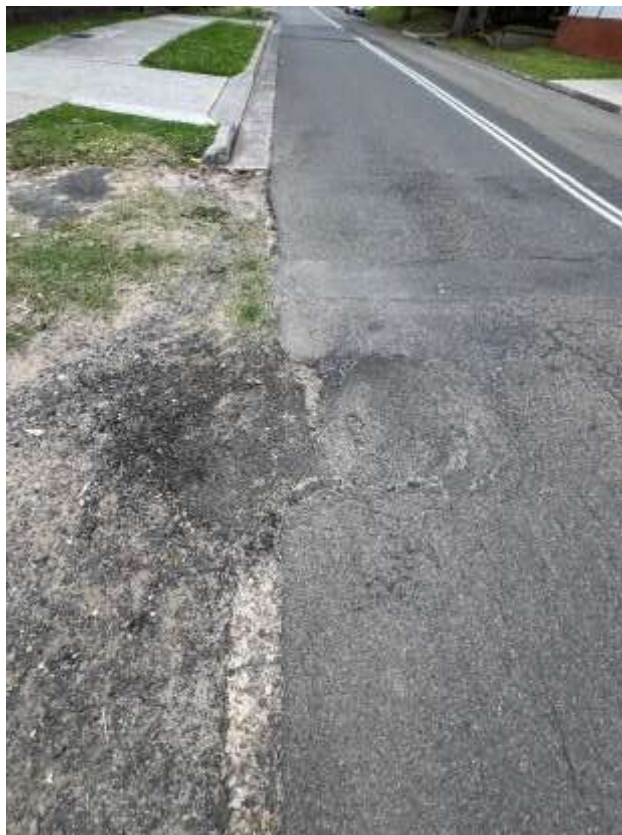
*Figure 36 – Crack is evident to the road outside 49 Warriewood Road Warriewood.*

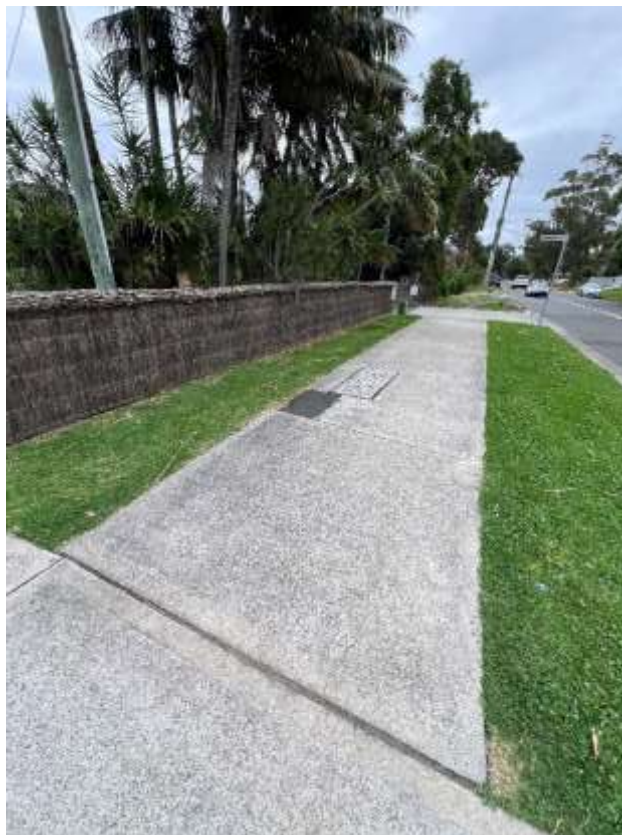
*Figure 38 – General condition of the footpath.*

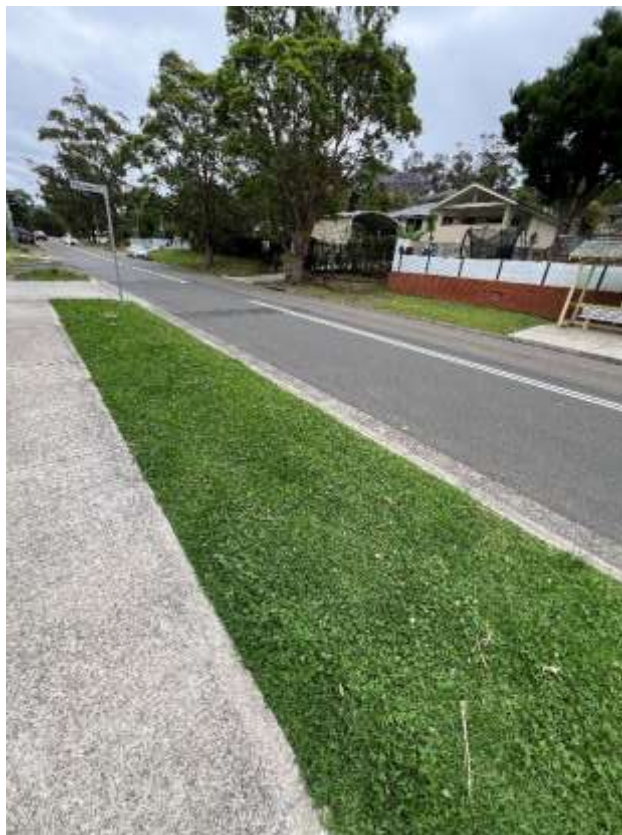
*Figure 40 – General condition of the nature strip.*

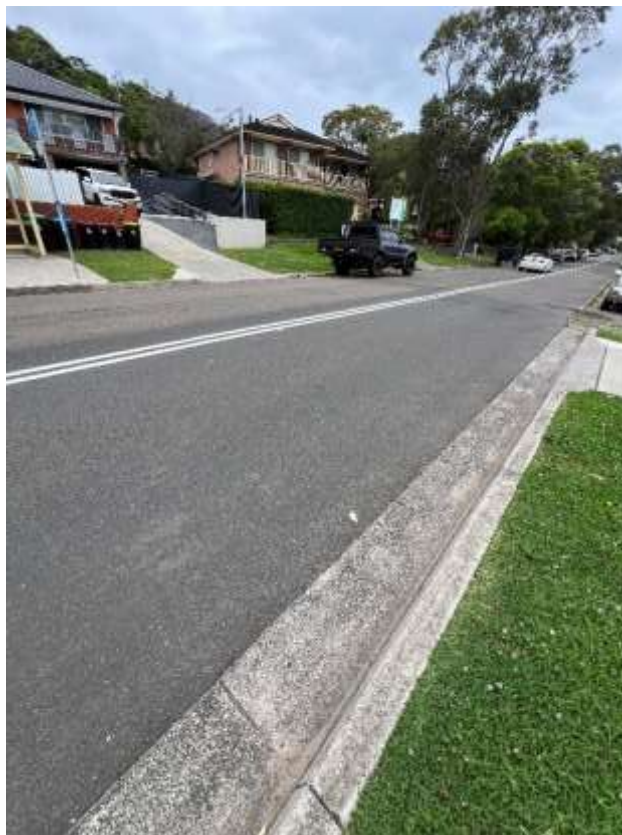
*Figure 42 – General condition of the kerb/road.*

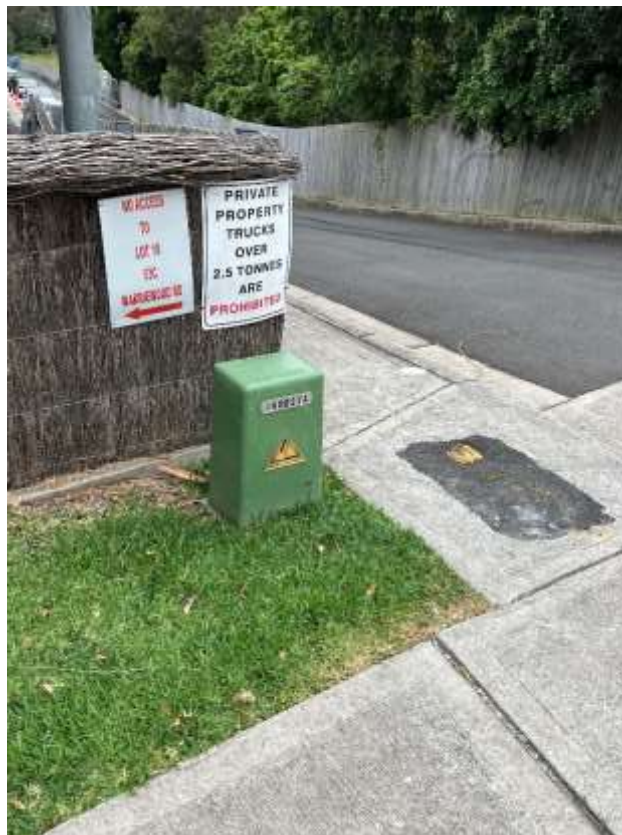
*Figure 44 – General condition of the transformer box.*

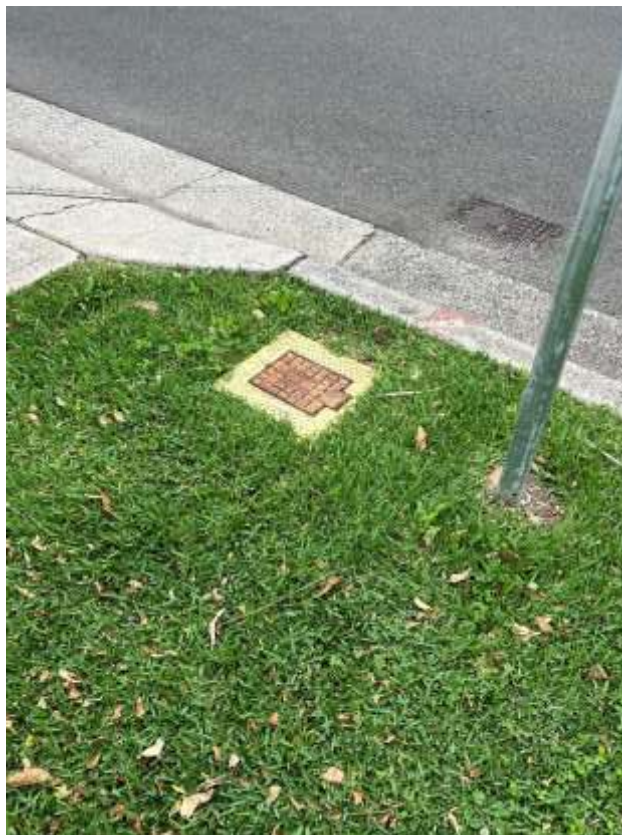
*Figure 46 – General condition of the utility lid.*

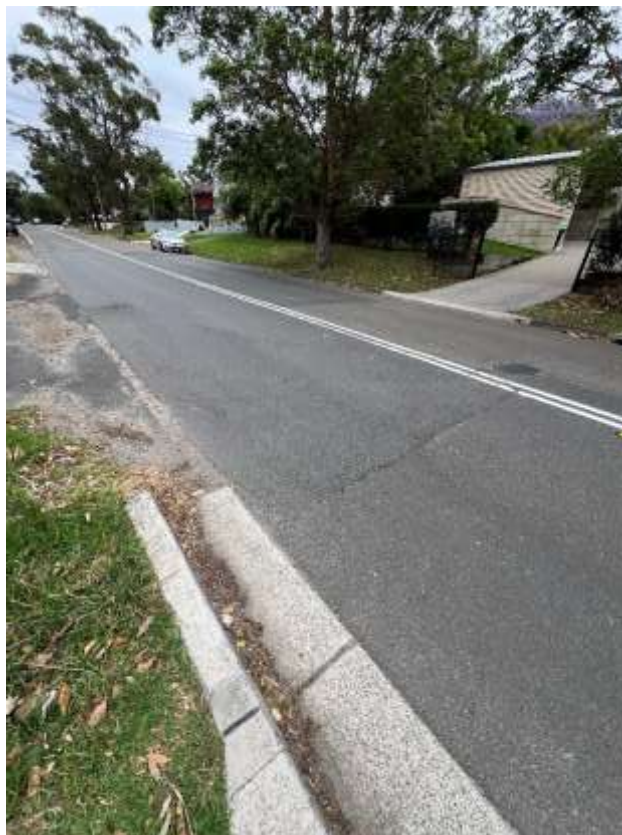
*Figure 48 – Crack is evident to the road outside 49 Warriewood Road Warriewood.*

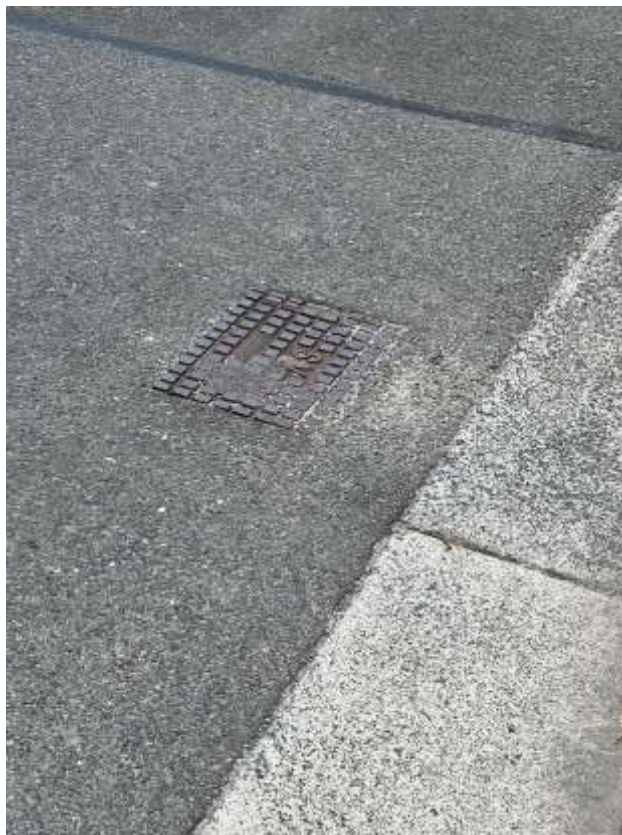
*Figure 50 – General condition of the utility lid.*

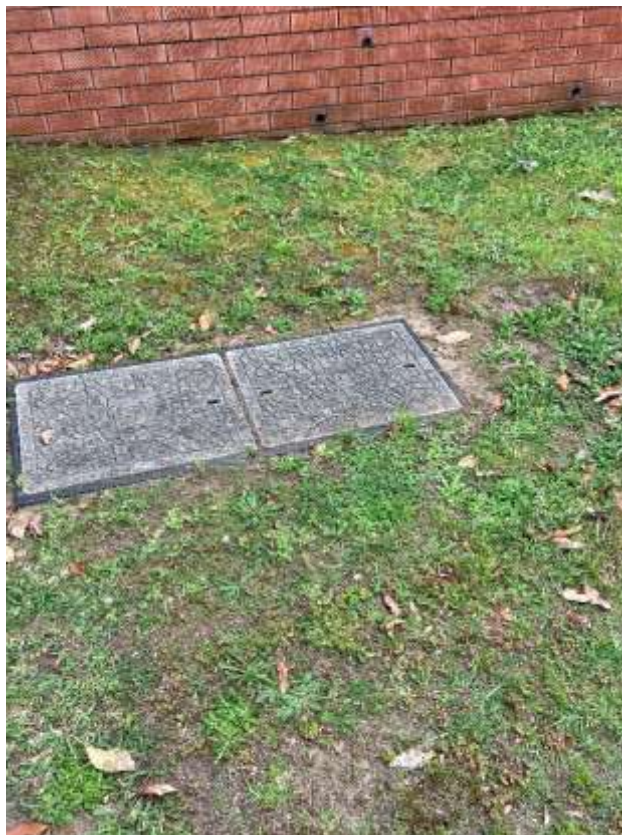
*Figure 52 – General condition of the pit.*

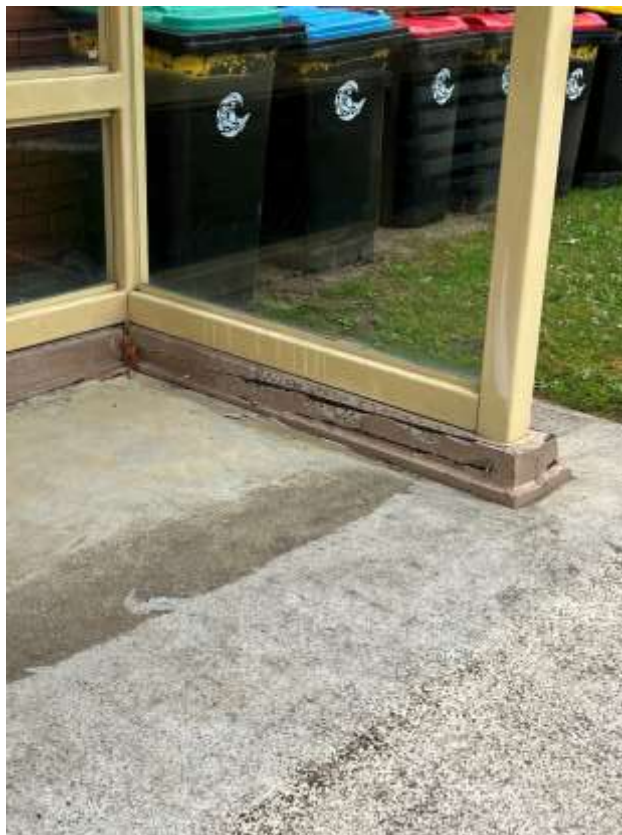
*Figure 60 - Crack is evident to the concrete at bus stop outside 92 Warriewood Road Warriewood.*

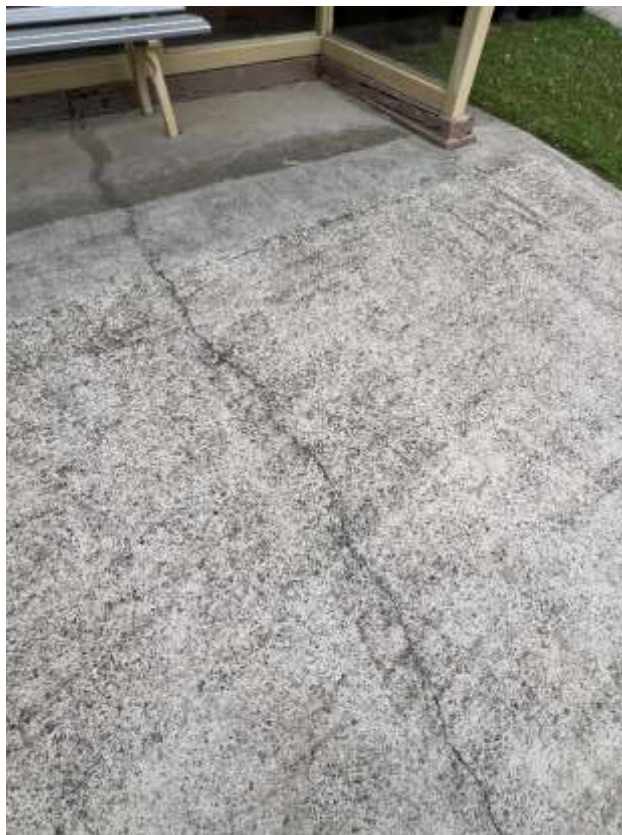
*Figure 62 – Crack is evident to the concrete at bus stop outside 92 Warriewood Road Warriewood.*

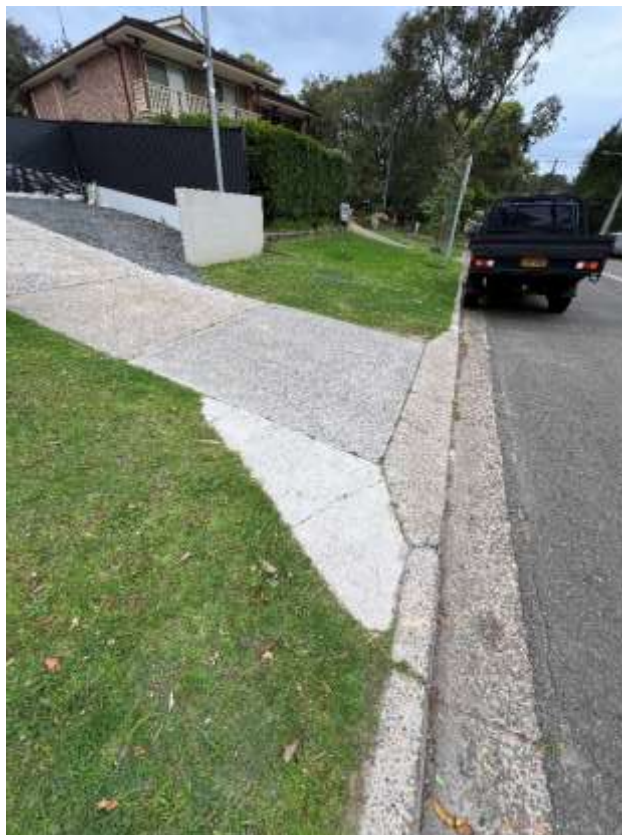
*Figure 64 – Crack is evident to the layback outside 92 Warriewood Road Warriewood.*

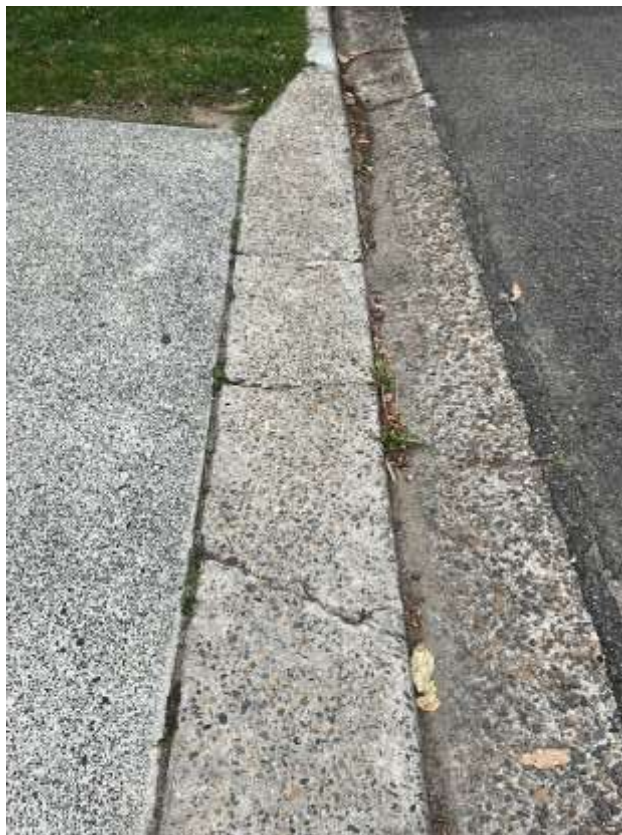
*Figure 66 – Crack is evident to the layback outside 92 Warriewood Road Warriewood.*

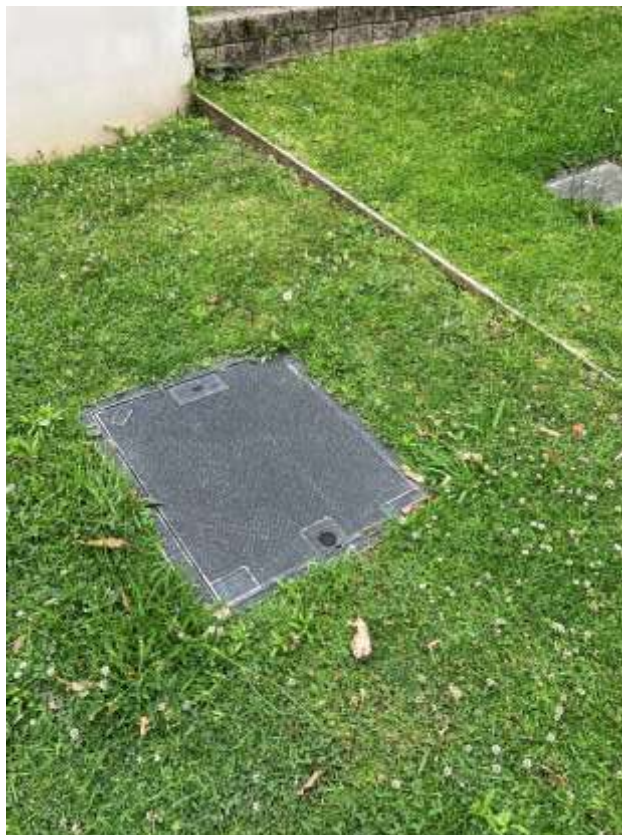
*Figure 68 – General condition of the pit.*

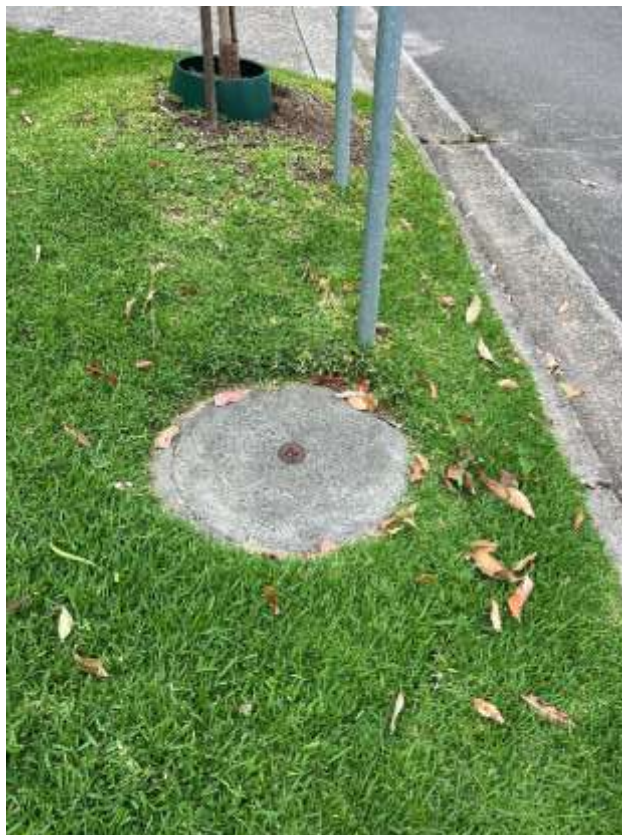
*Figure 70 – General condition of the pit.*

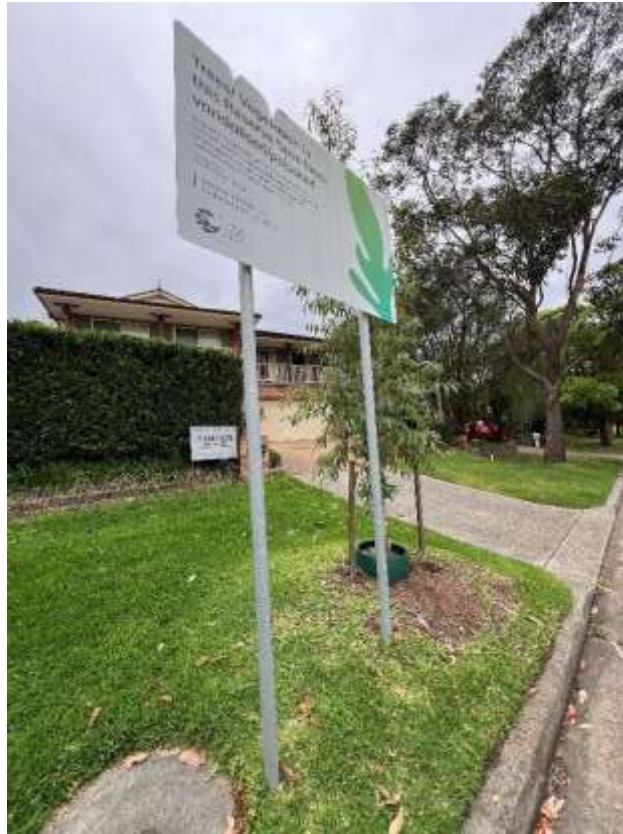
*Figure 71 – General condition of the street signpost.*

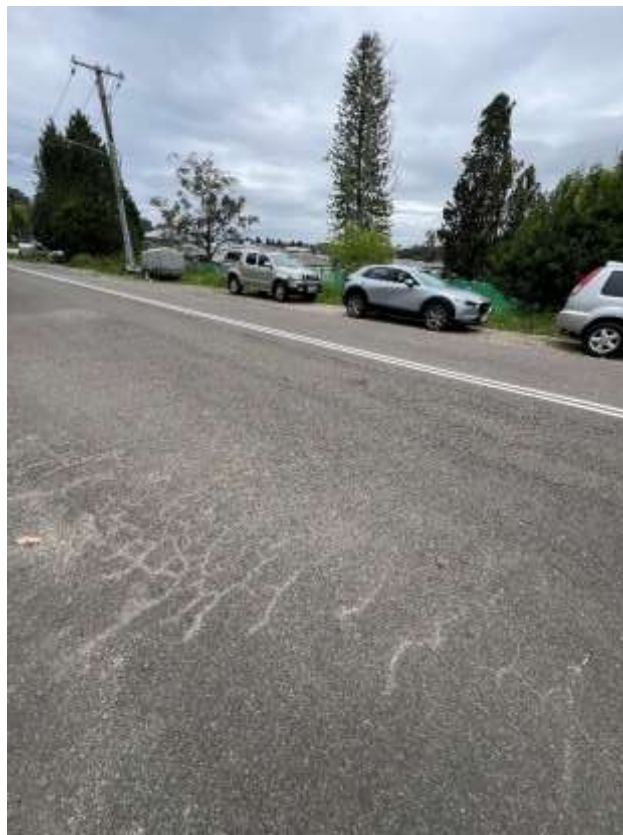
*Figure 72 – Crack is evident to the road outside 92 Warriewood Road Warriewood.*

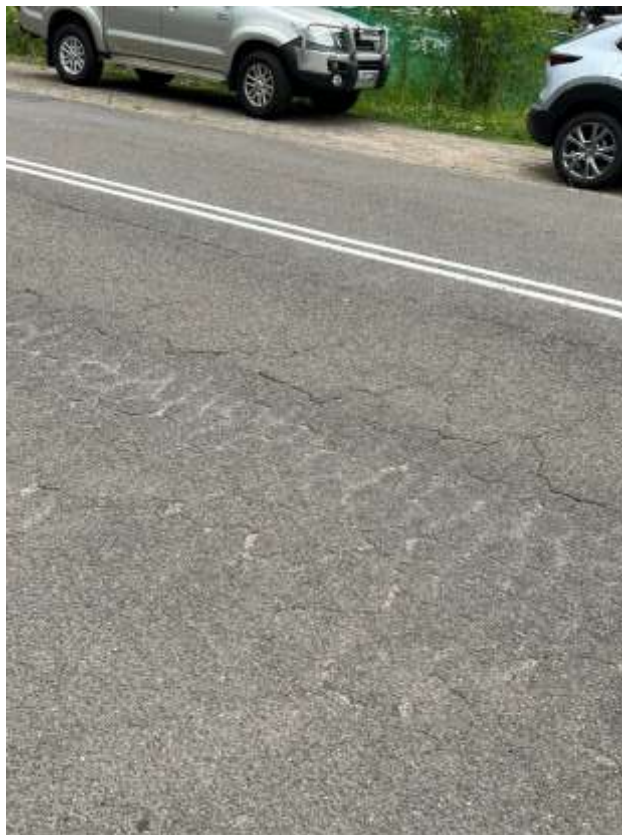
*Figure 74 – Crack is evident to the road outside 90 Warriewood Road Warriewood.*

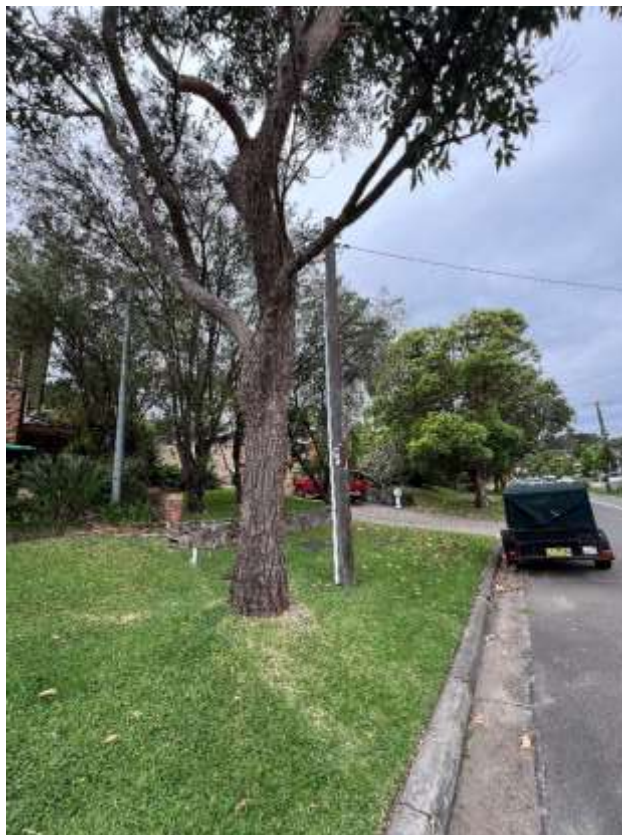
*Figure 76 – General condition of the tree.*
