# DILAPIDATION REPORT

**Warriewood Road, Warriewood**

**Prepared by: Rezoning Pty Ltd t/as Effective Building & Consultancy**

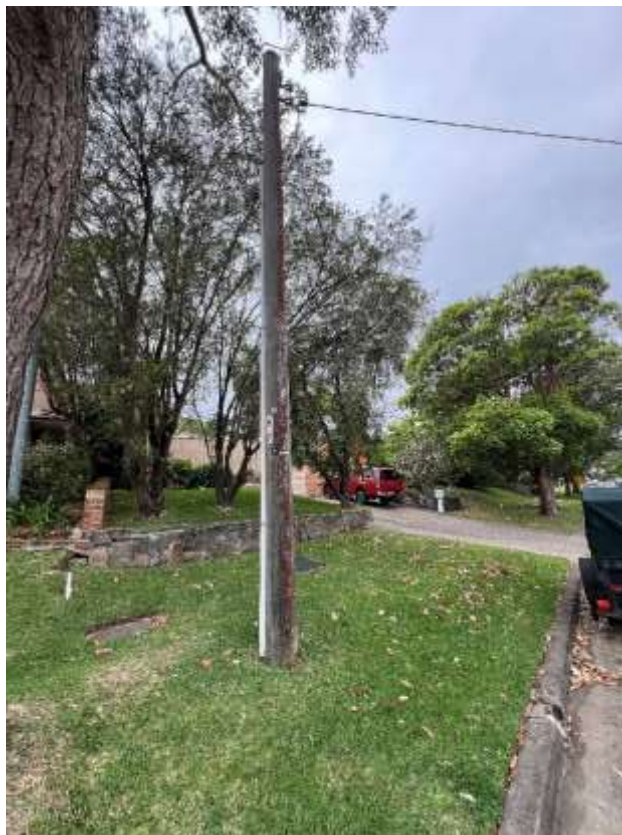
*Figure 78 – General condition of the electrical post.*

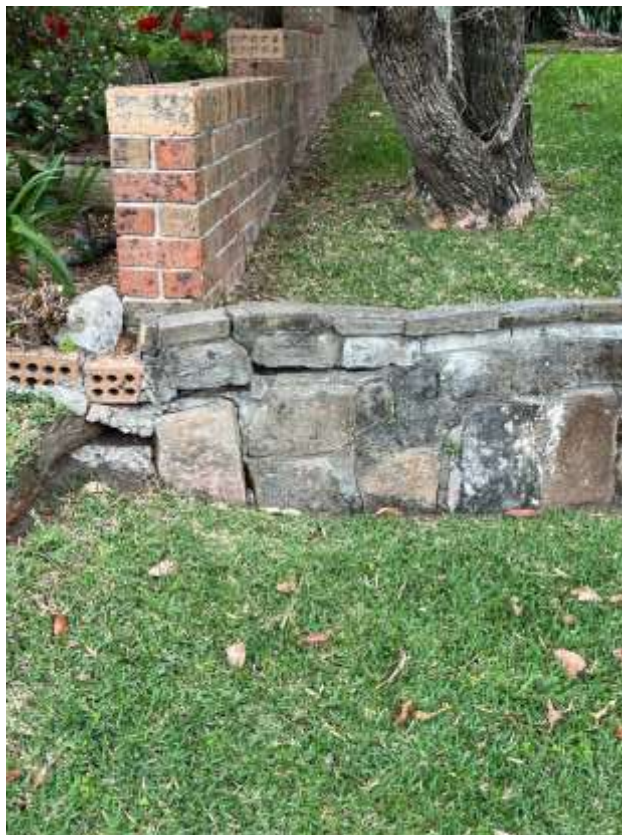
*Figure 80 – General condition of the retaining wall.*

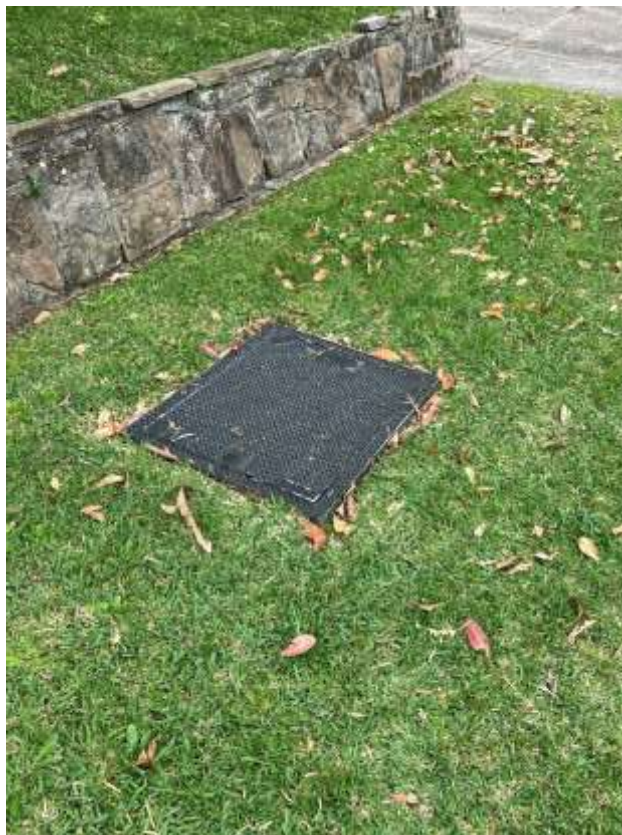
*Figure 82 – General condition of the pit.*

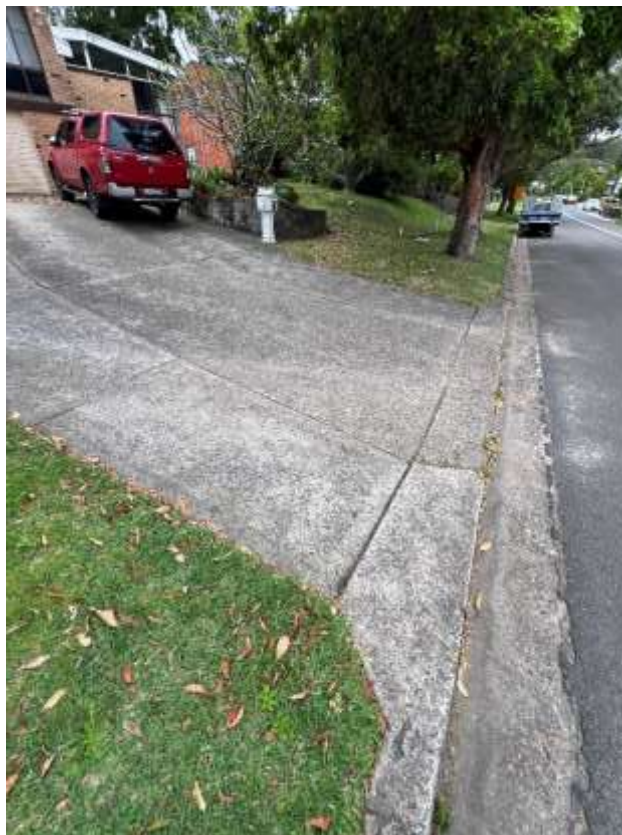
*Figure 84 – General condition of the driveway.*

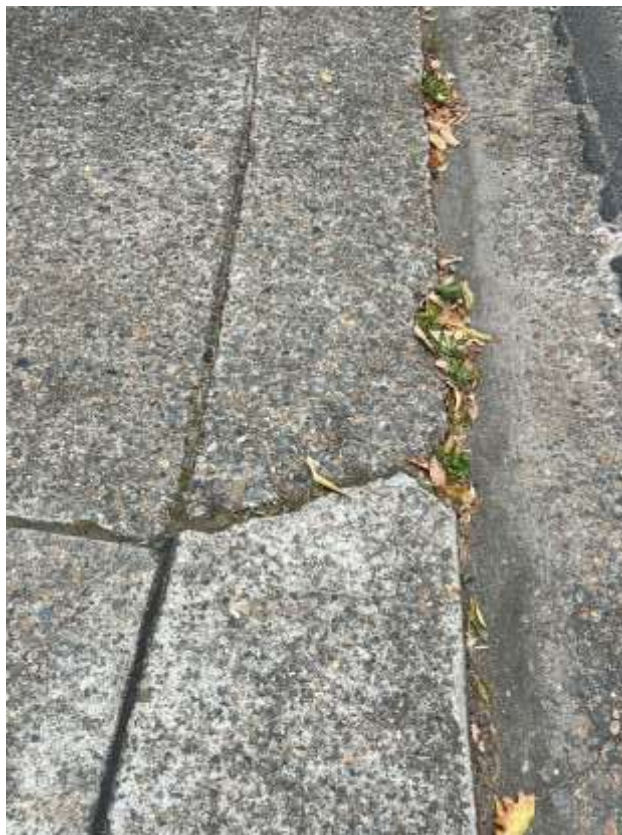
*Figure 86 – Crack is evident to the layback outside 88 Warriewood Road Warriewood.*

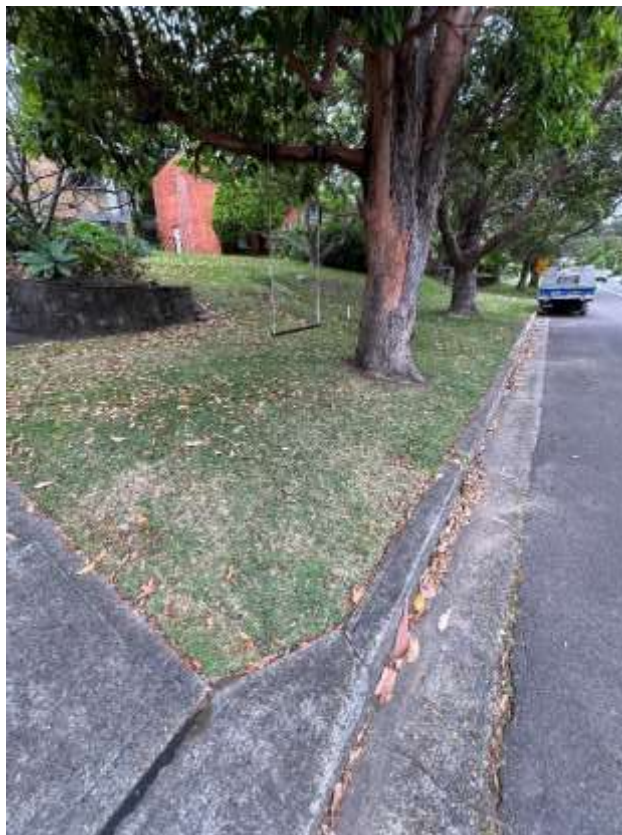
*Figure 88 – General condition of the nature strip.*

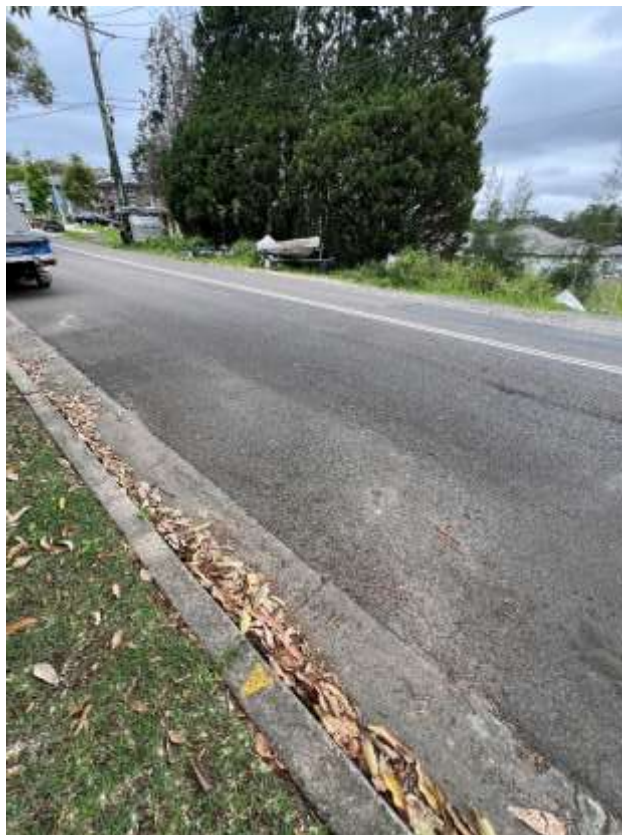
*Figure 94 – General condition of the kerb/road.*

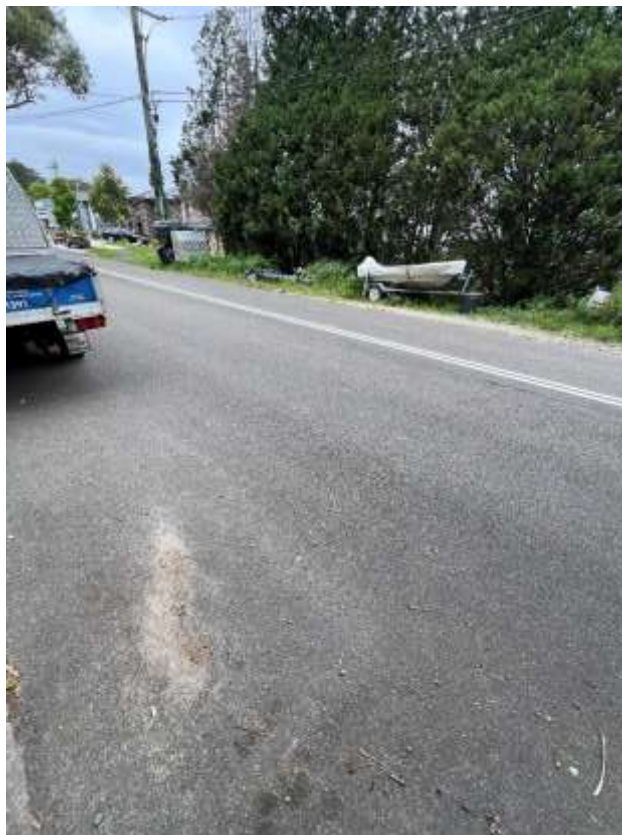
*Figure 98 – General condition of the road.*

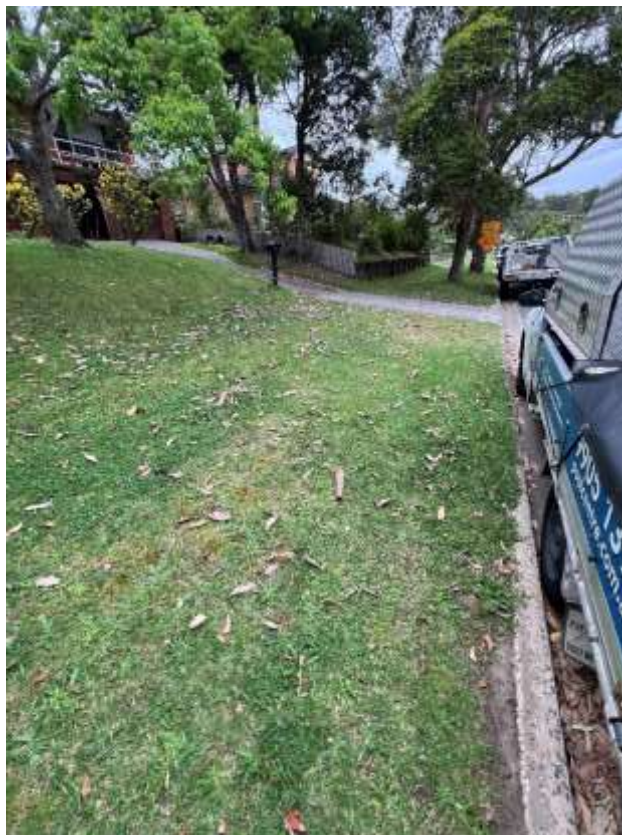
*Figure 100 – General condition of the nature strip.*

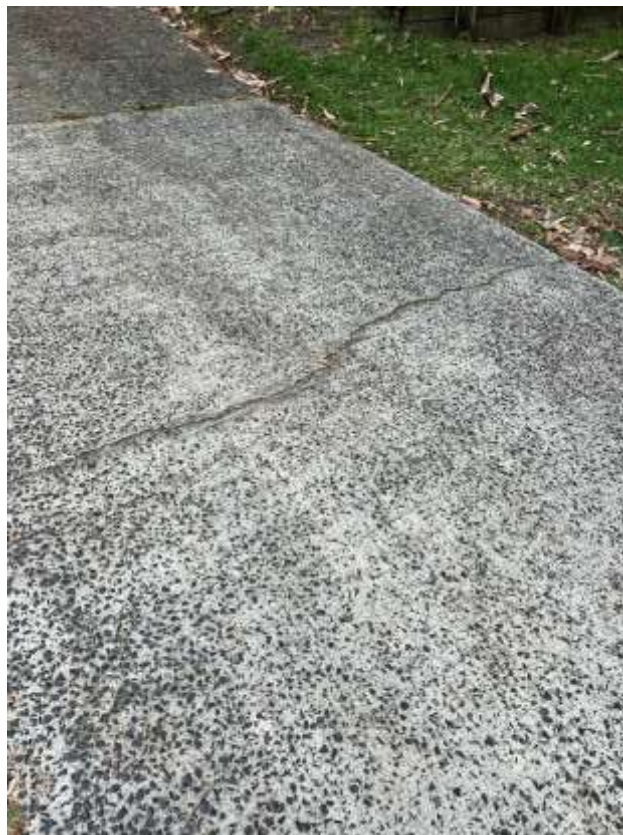
*Figure 104 – Crack is evident to the driveway outside 86 Warriewood Road Warriewood.*

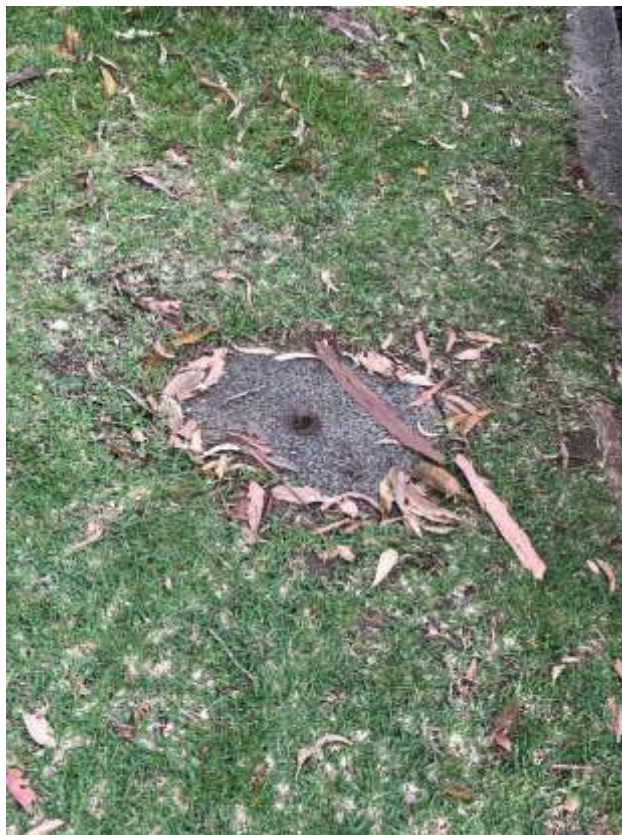
*Figure 106 – General condition of the pit.*

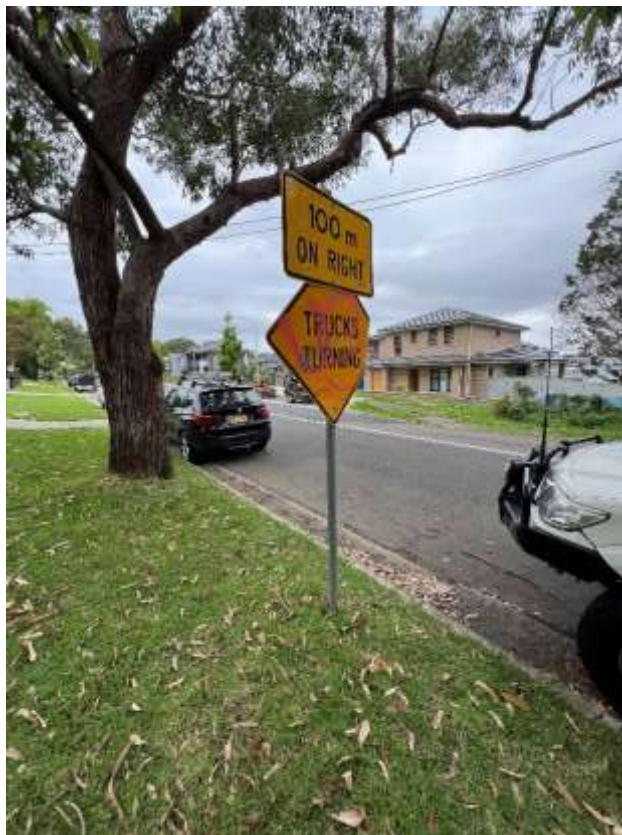
*Figure 110 – General condition of the traffic signpost.*

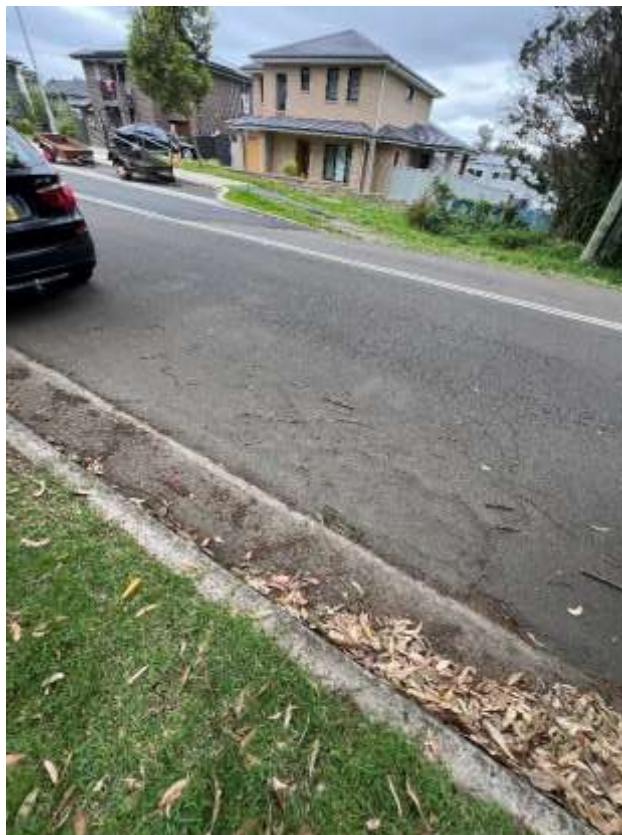
*Figure 112 – Crack is evident to the road outside 84 Warriewood Road Warriewood.*

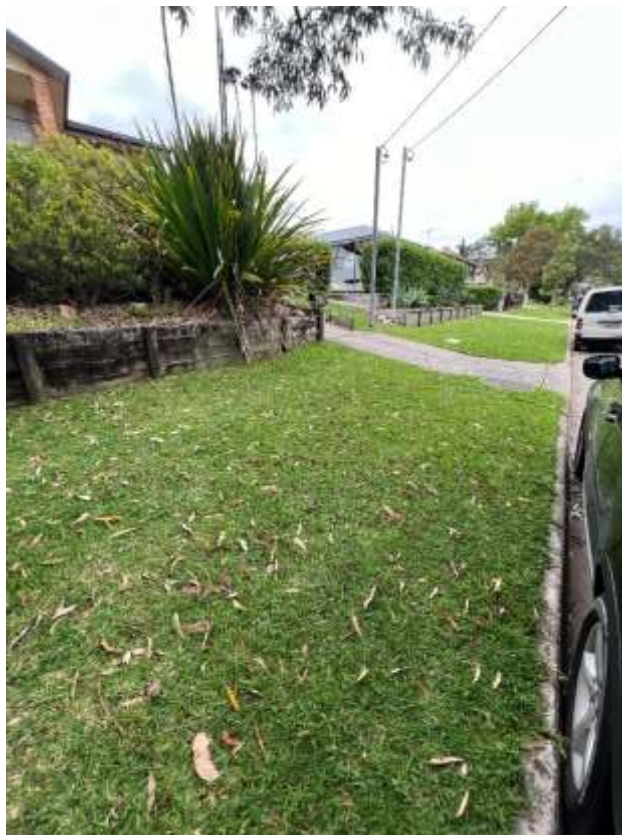
*Figure 114 – General condition of the nature strip.*

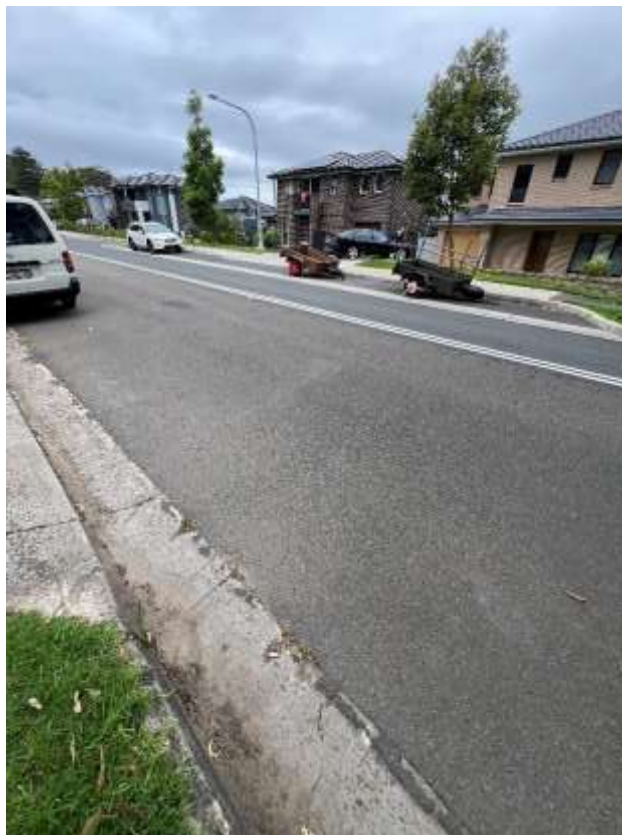
*Figure 116 – General condition of the kerb/road.*

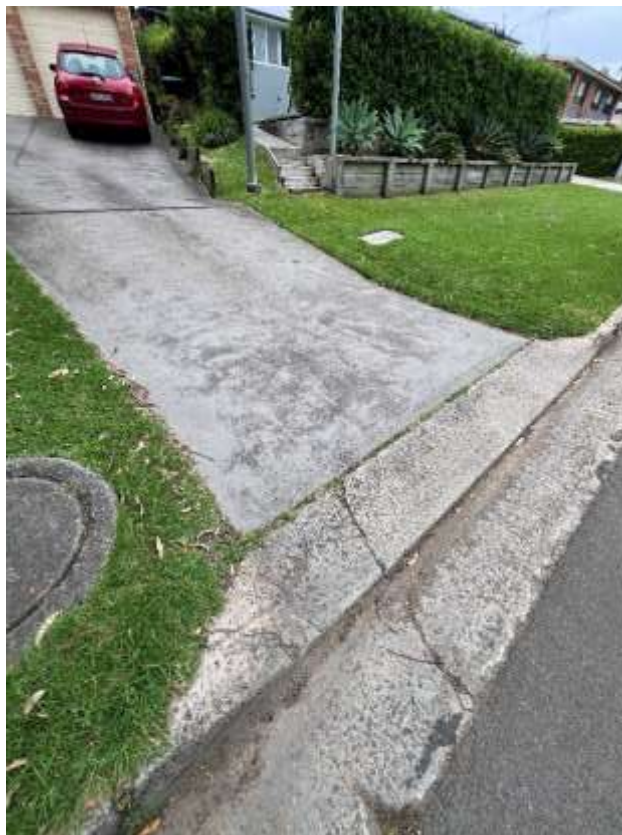
*Figure 118 – Crack is evident to the layback outside 84 Warriewood Road Warriewood.*

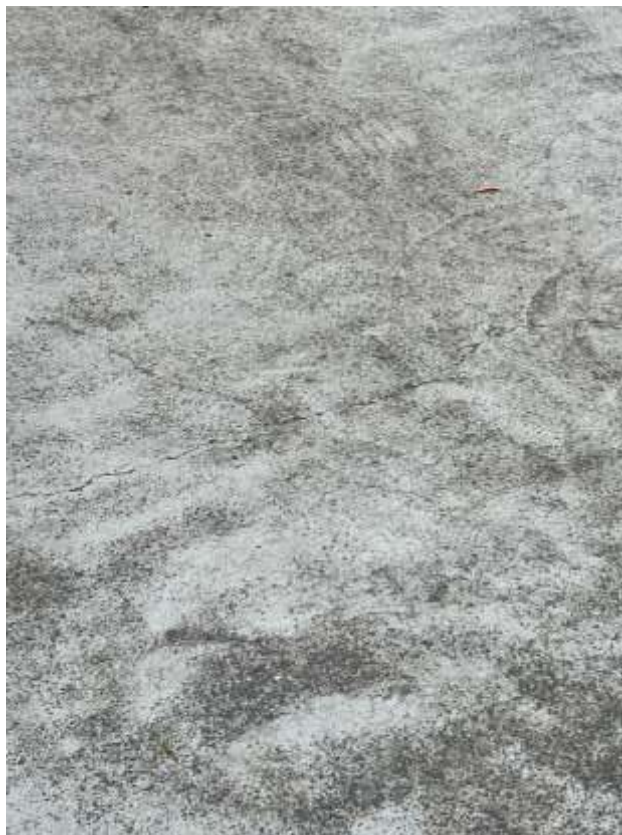
*Figure 120 – Crack is evident to the driveway outside 84 Warriewood Road Warriewood.*

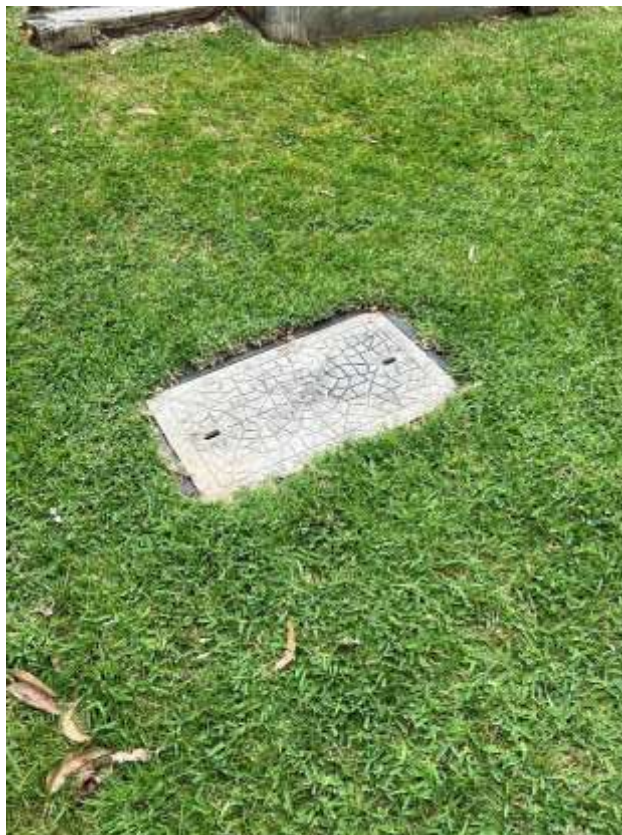
*Figure 122 – General condition of the pit.*

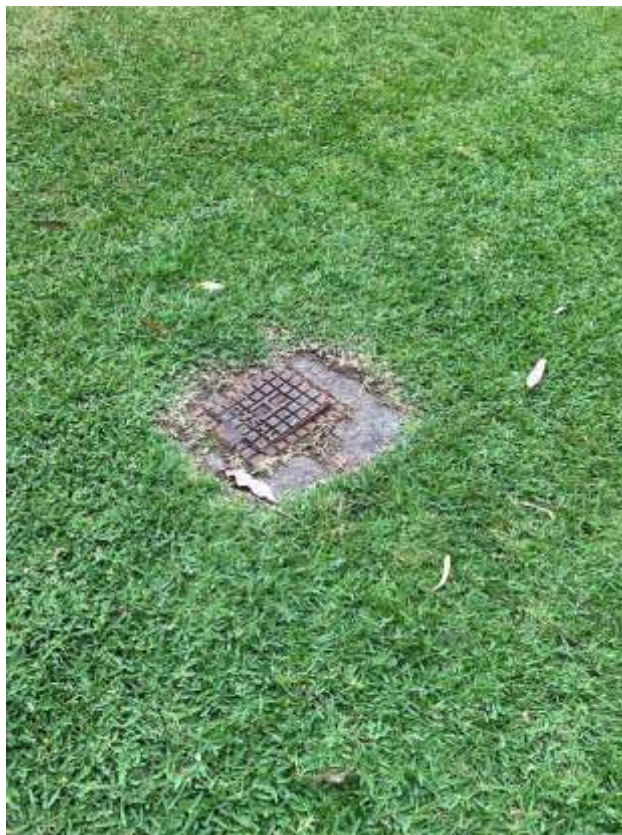
*Figure 124 – General condition of the utility lid.*

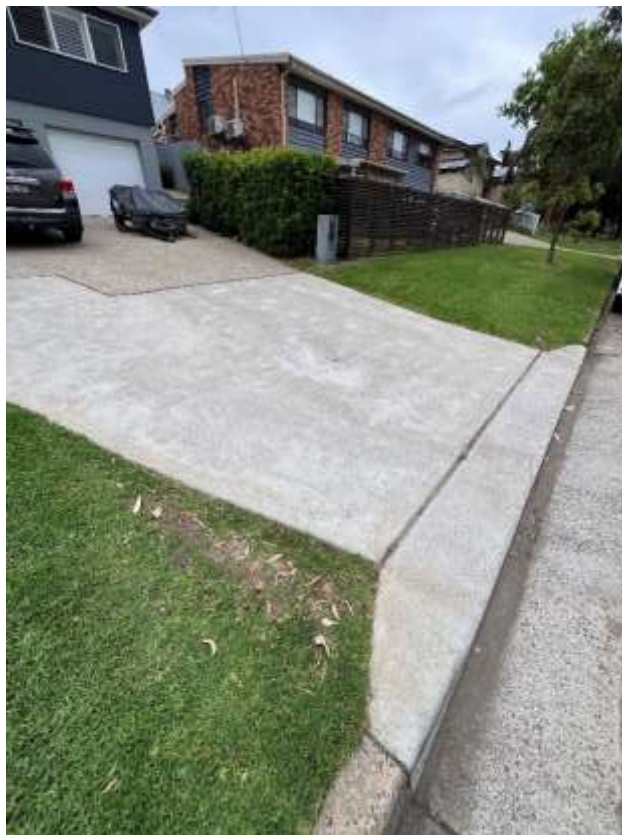
*Figure 126 – General condition of the driveway.*

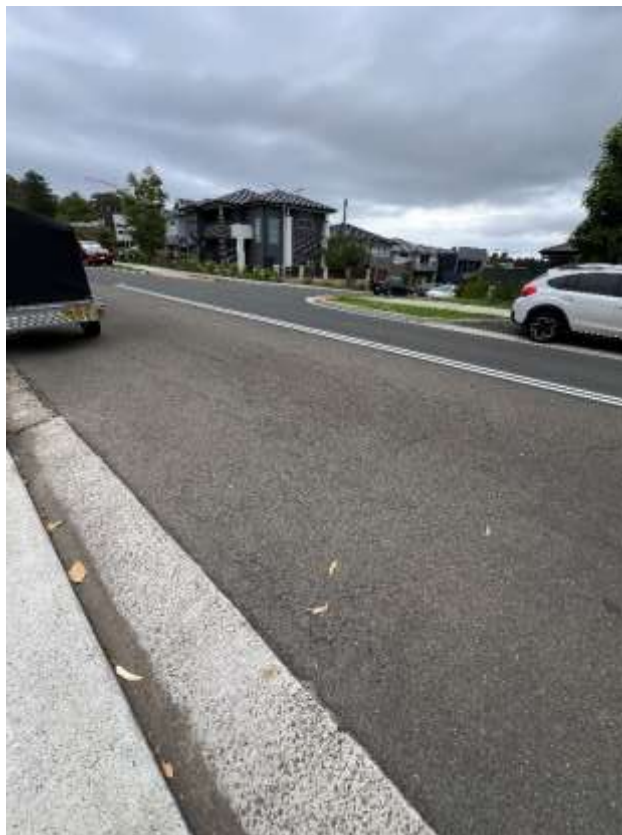
*Figure 128 – Crack is evident to the road outside 82 Warriewood Road Warriewood.*

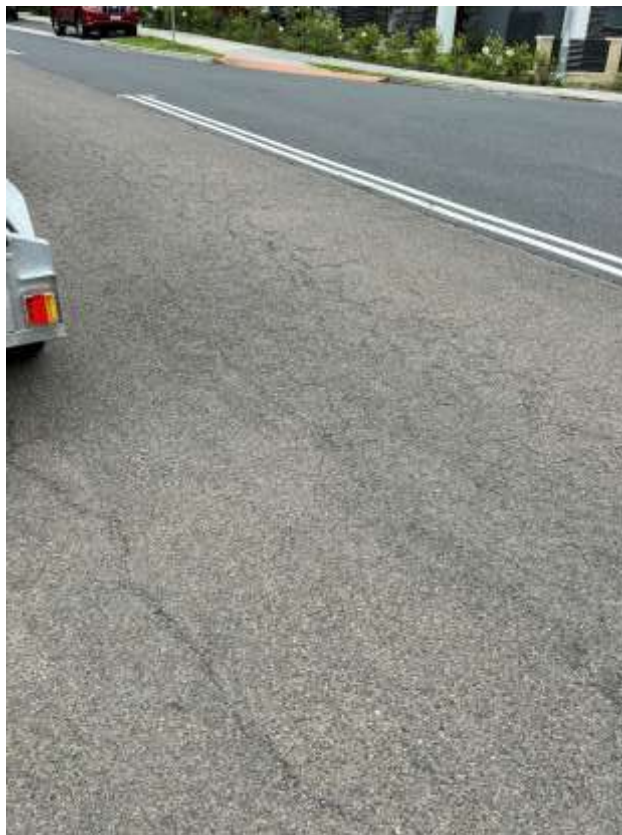
*Figure 130 – Crack is evident to the road outside 82 Warriewood Road Warriewood.*

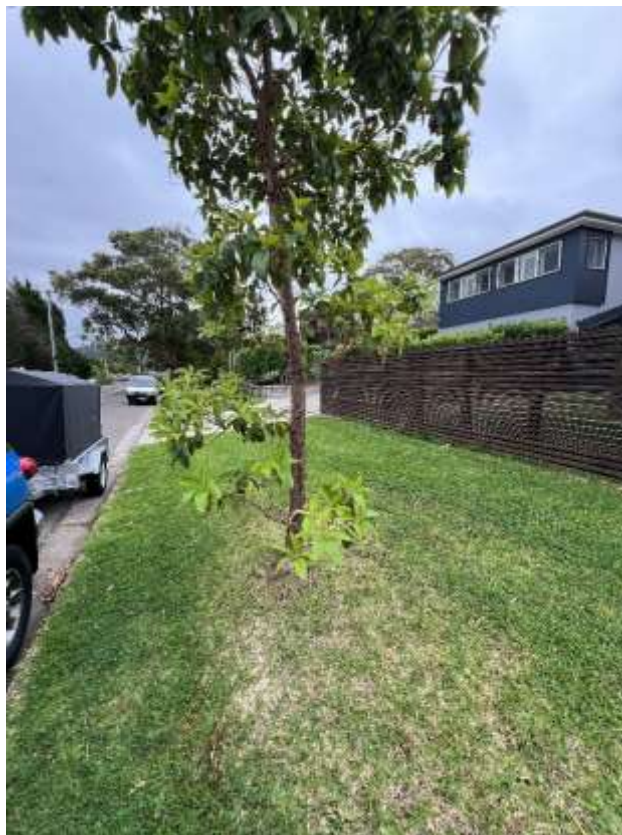
*Figure 132 – General condition of the tree.*

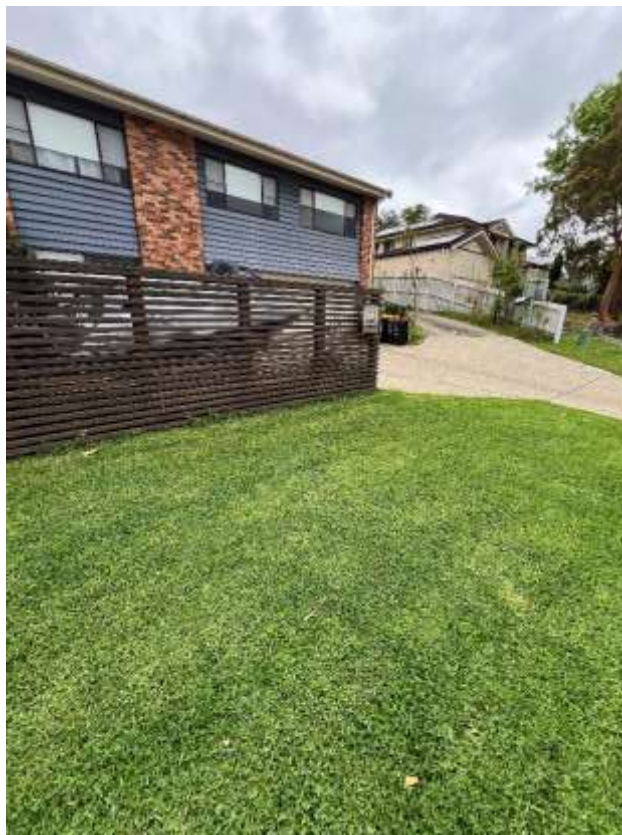
*Figure 134 – General condition of the nature strip.*

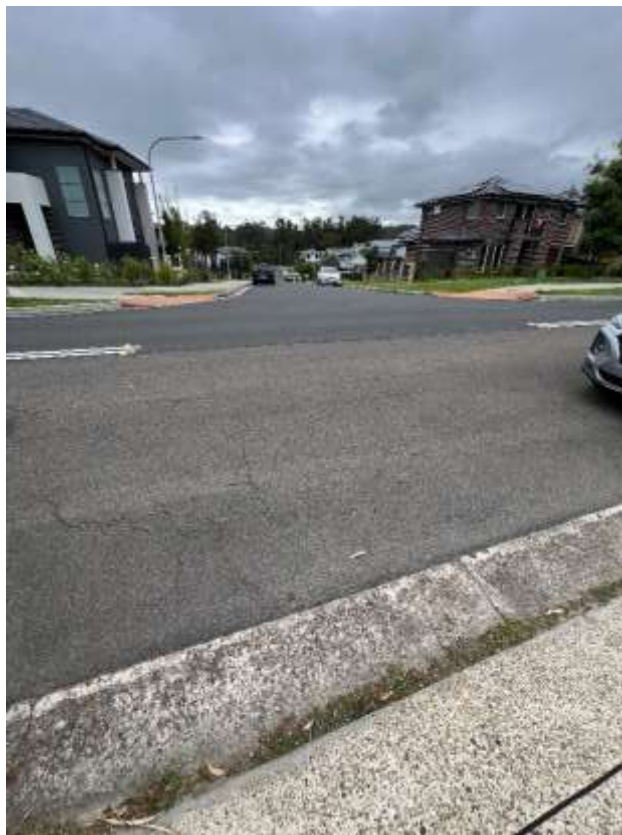
*Figure 136 – Crack is evident to the road outside 80 Warriewood Road Warriewood.*

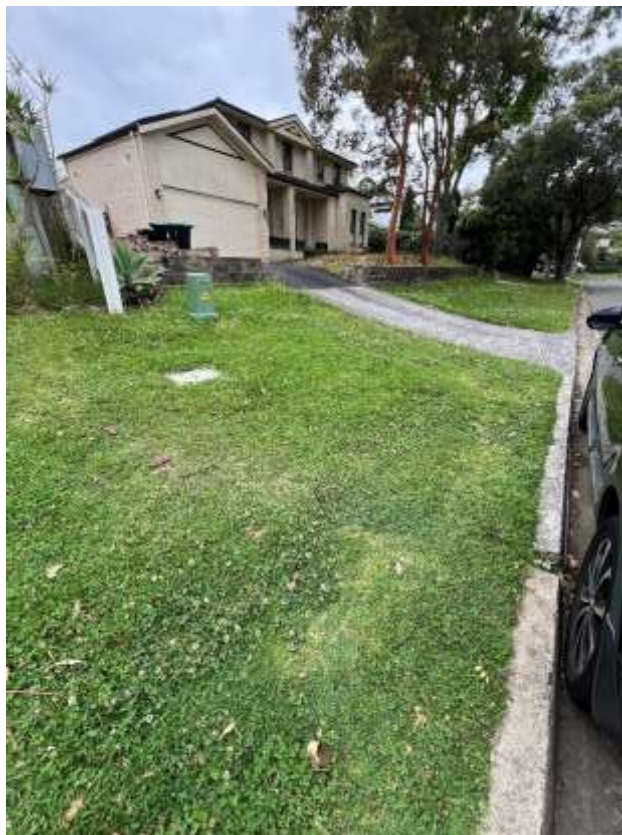
*Figure 138 – General condition of the nature strip.*
