J3246. 28th June, 2021. Page 1.

GEOTECHNICAL INVESTIGATION:

New Garage, Pool, and Tennis Court at 6 Guwara Road, Duffys Forest

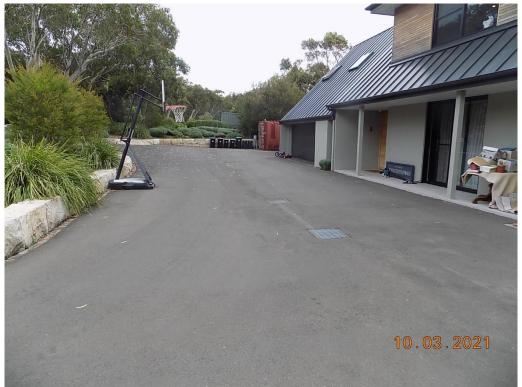
Photo 1

- **2.1** The site was inspected on the 10th March, 2021, and previously on the 14th September, 2015.
- 2.2 This large rural/residential property is on the low side of the road and has a NW aspect. The block is located on the gentle to moderately graded upper reaches of a hillslope. The slope falls across the site from the road frontage at gentle angles that gradually increase to moderate angles. The slope above the property eases to the crest of the slope. The slope below the property continues to increases in grade.
- **2.3** At the road frontage, a bitumen driveway runs to a parking area on the uphill side of the house and to a garage attached to the S side of the house (Photo 1). The

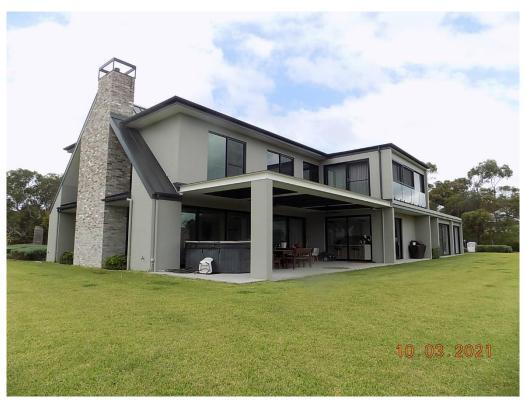
Photo 2

two-storey rendered masonry house is supported on masonry walls (Photo 2). No significant signs of movement were observed in the supporting walls. A large gently sloping lawn-covered fill extends off the N and W sides of the house (Photo 3). The fill is battered to stable angles and merges into the natural slope (Photo 4). A fire trail cuts through the property below the fill batter (Photo 5). The fill for the fire trail is also battered to stable angles and merges into the natural slope (Photo 6). Beyond the fire trail is undeveloped bush (Photo 7). Competent Medium Strength Sandstone was observed to be outcropping through the bush (Photo 8). The bush continues to and beyond the lower boundary.
