GEOTECHNICAL INVESTIGATION:

New Inclined Lift at 153 Seaforth Crescent, Seaforth

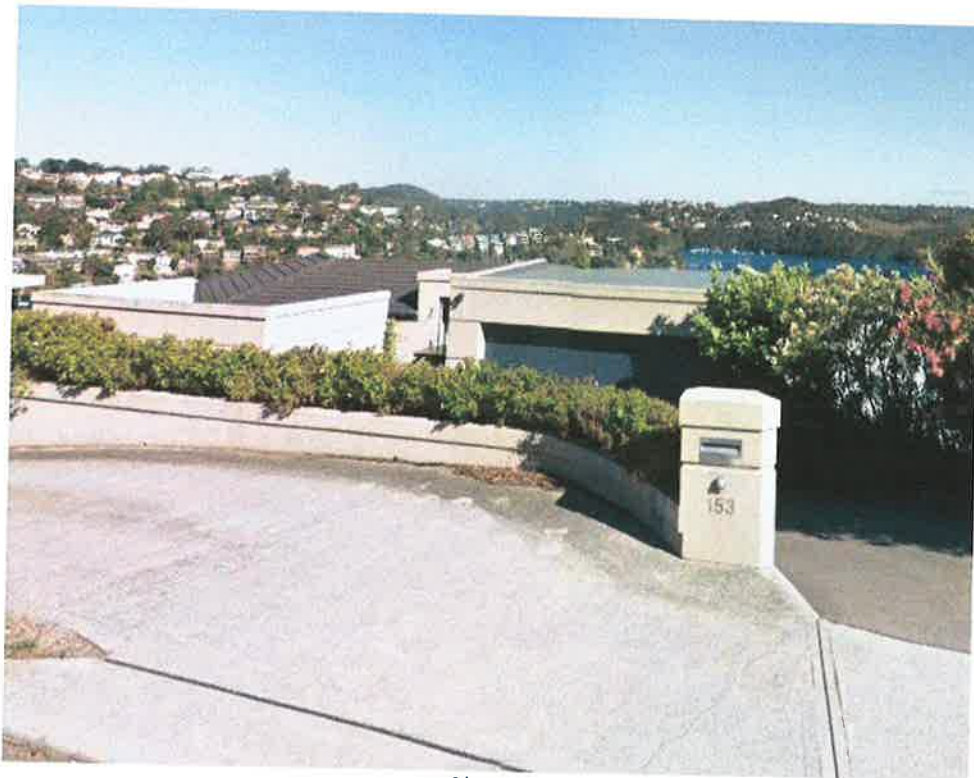
Photo 1

- 2.3 From the road frontage a concrete driveway extends to the garage and house (Photo 1). Outcropping rock was observed across the entire site. The two and three storey cement rendered brick house is supported on piers and walls. The piers stand vertical and are considered stable. The lower levels of the house have been cut 3.0m into sandstone that appears free of defects (Photo 2). On the downhill side of the house there is a suspended pool supported on concrete piers (Photo 3). A timber staircase runs down the slope on the SW side of the house (Photo 4). An inclined lift that runs downslope to the water front is proposed for this location. A ~5.0m rock face falls on the downhill side of the pool. This escarpment is undercut ~3.0m and has been partially supported by concrete piers (Photo 5). The slope below the rock face is

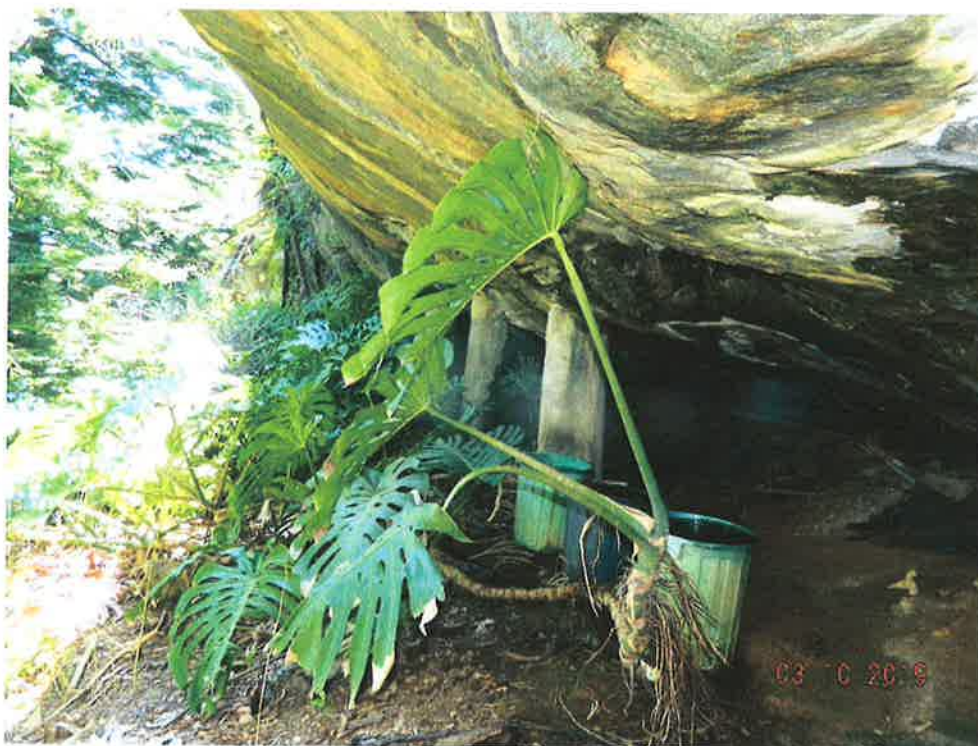
Photo 5

No geotechnical hazards were observed above, below, or beside the property. The steeply graded land surface that falls across the property is a potential hazard (**Hazard One**). The ~3.0m undercut rock face is a potential hazard (**Hazard Two**). The vibrations from the proposed excavations are a potential hazard (**Hazard Three**).

HAZARDS	Hazard One	Hazard Two
TYPE	The steep slope that falls across the property and continues above and below failing and impacting on the property.	The undercut rock face failing and impacting on the subject property (Photo 5)
LIKELIHOOD	'Unlikely' (10^{-4})	'Rare' (10^{-5})
CONSEQUENCES TO PROPERTY	'Medium' (20%)	'Major' (60%)
RISK TO PROPERTY	'Low' (2×10^{-5})	'Low' (2×10^{-5})
RISK TO LIFE	8.3×10^{-8} /annum	8.3×10^{-8} /annum
COMMENTS	'ACCEPTABLE' level of risk to life & property when the recommendation in Section 15 are followed.	'ACCEPTABLE' level of risk to life & property when the recommendation in Section 15 are followed.

Excavation methods are to be used that limit peak particle velocity to 5mm/sec at the undercut rock face. Vibration monitoring will be required to verify this is achieved.

If rock saws are used to cut the rock into segments approx. 0.25m wide that can be easily removed with light breaking vibration monitoring will not be required. Peak particle velocity will be less than 5mm/sec at the undercut rock face using this method provided the saw cuts are kept not wider than prescribed.

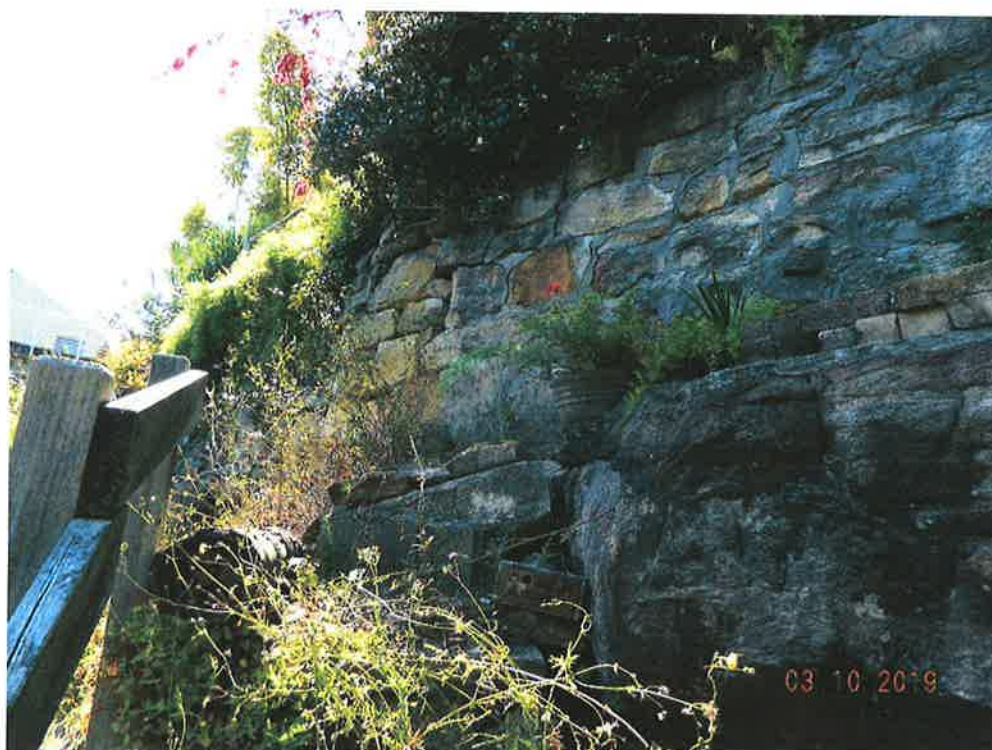
Photo 6

terraced in places with ~1.0m tall stack rock walls (Photo 6). Where terraces don't exist the steep natural slope is covered in native and exotic shrubs and trees. Below the rock face a rough stone path and sets of stairs traverse the steep slope diagonally until the waterfront is reached. At the waterfront a timber jetty and boat shed extends into Peach Tree Bay.

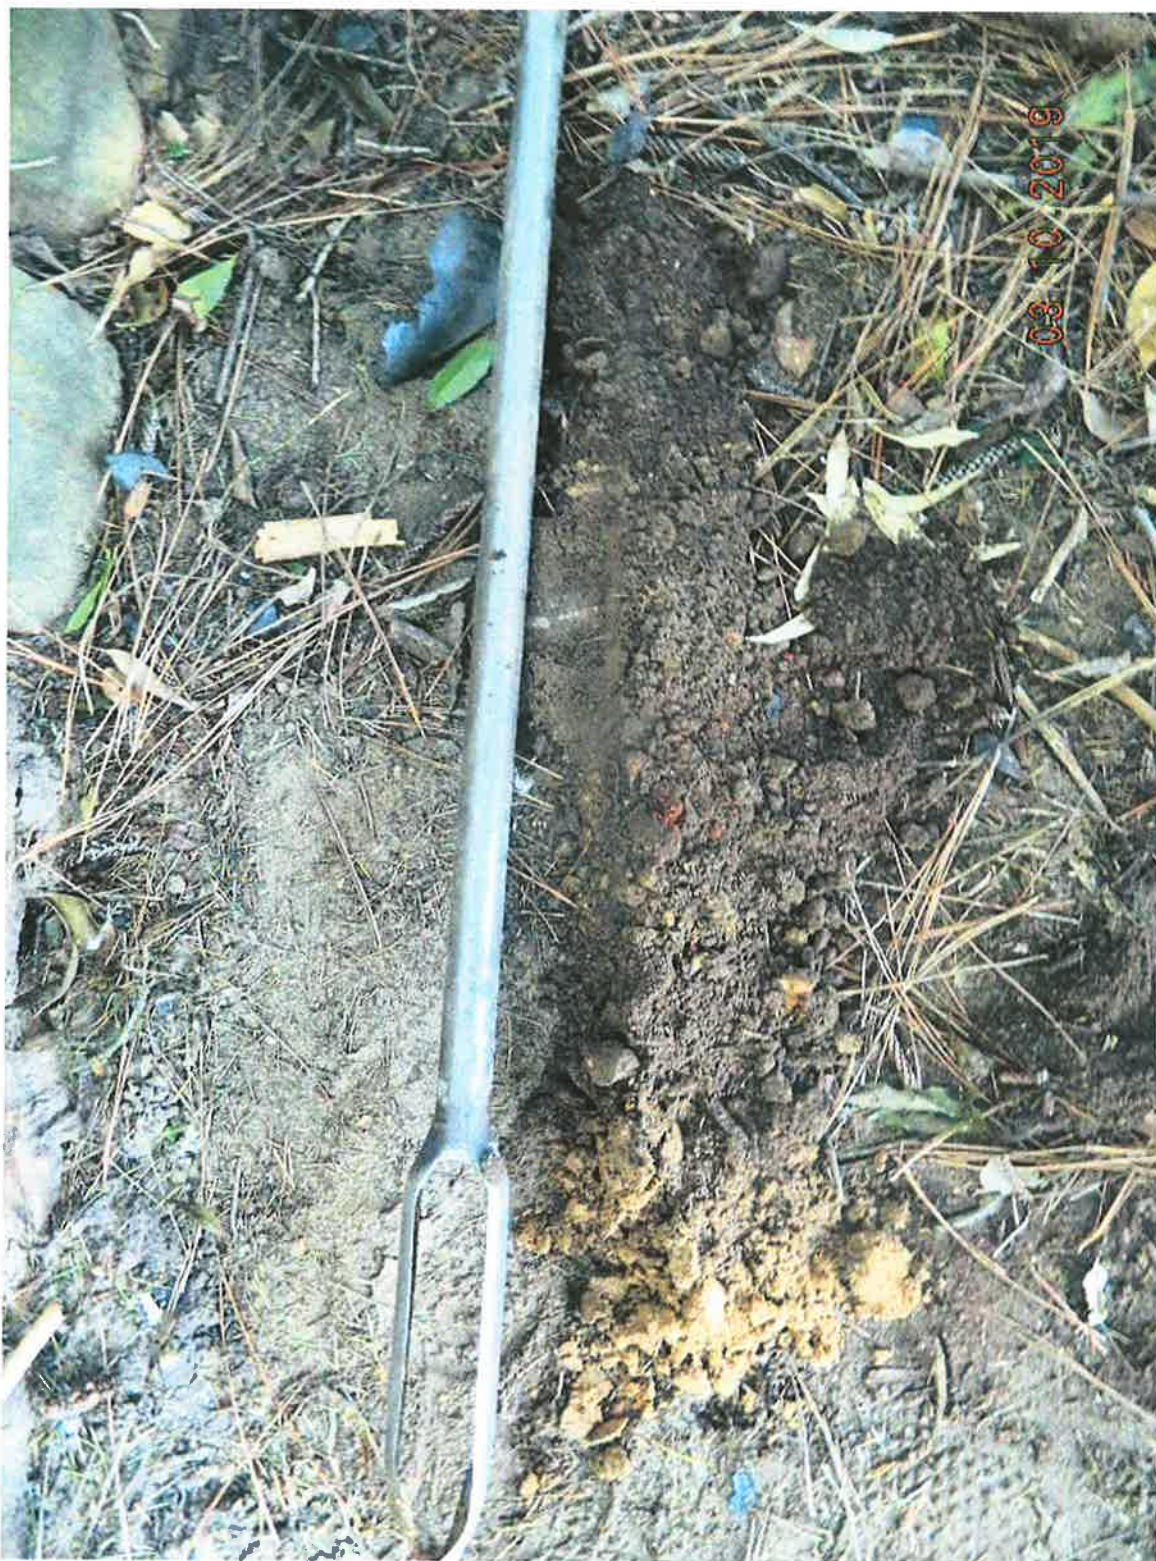
Photo 7 – AH1

AUGER HOLE 1 (~RL24.6) – AH1 (Photo 7)

Depth (m)	Material Encountered
0.0 to 0.4	SANDY SOIL , brown, medium grained with trace organic matter.
0.4 to 0.6	SAND , light brown, medium grained

Refusal @ 0.6m grinding on rock. No watertable encountered.

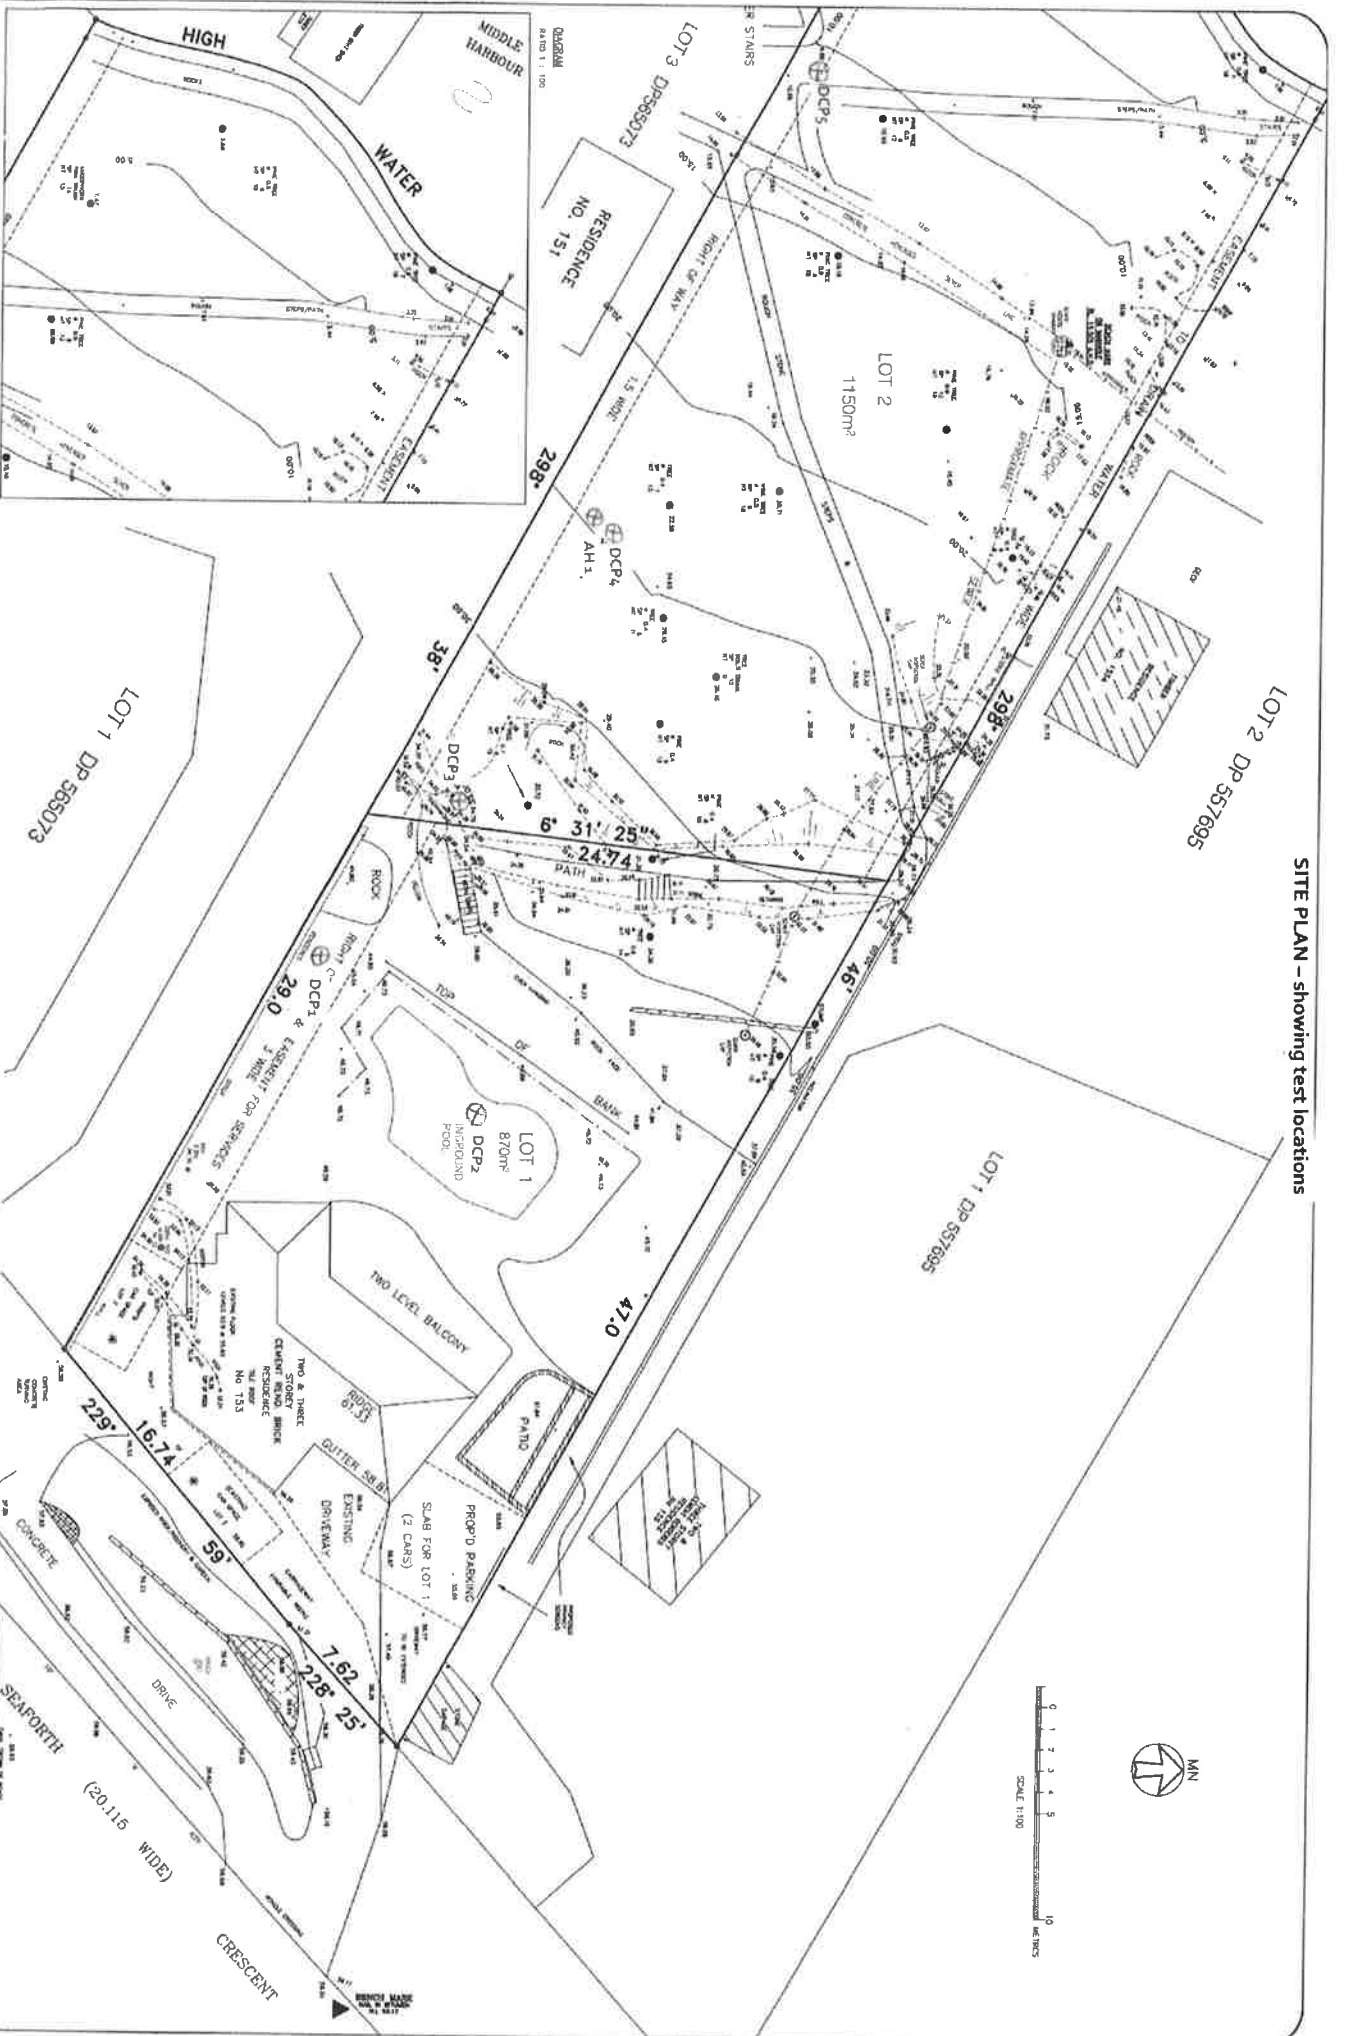
SITE PLAN - showing test locations

One auger hole was put down to identify the soil materials. Five Dynamic Cone Penetrometer (DCP) tests were put down to determine the relative density of the overlying soil and the depth to bedrock. The locations of the tests are shown on the site plan. It should be noted that a level of caution should be applied when interpreting DCP test results. The test will not pass through hard buried objects so in some instances it can be difficult to determine whether refusal has occurred on an obstruction in the profile or on the natural rock surface. This is not expected to be an issue for the testing on this site and the results are as follows:
