Date: 21 June 2022

Project No: 2022-114

**GEOTECHNICAL REPORT FOR PROPOSED ALTERATIONS AND ADDITIONS AT
65 DOLPHIN CRESCENT, AVALON BEACH, NSW.**

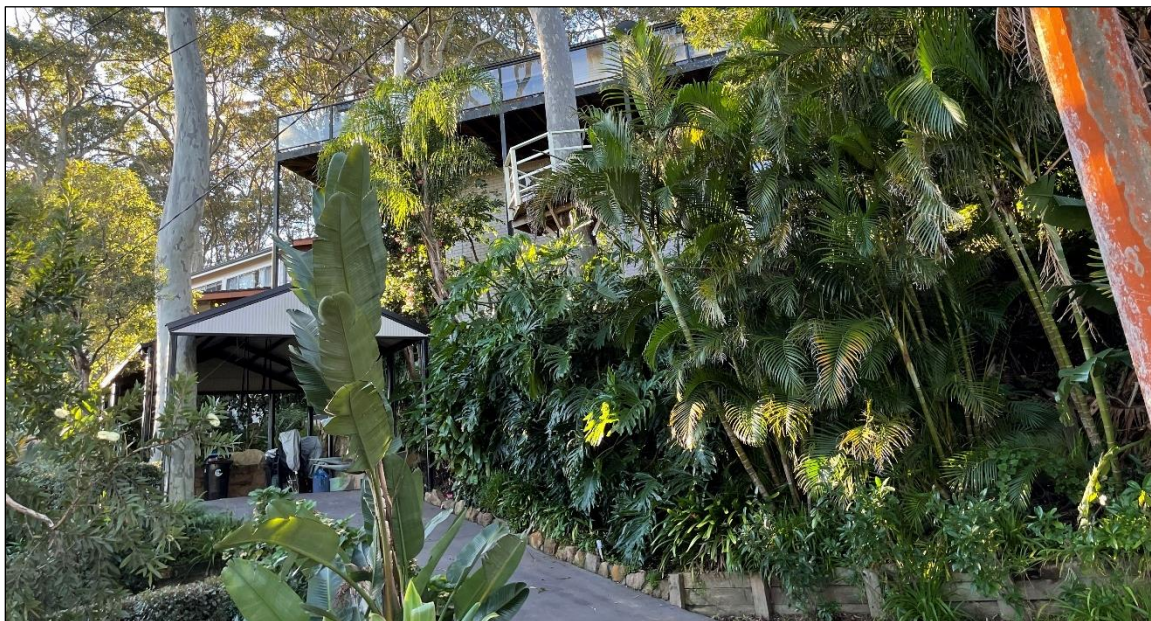
Photograph 2: Front of the property, looking broadly north

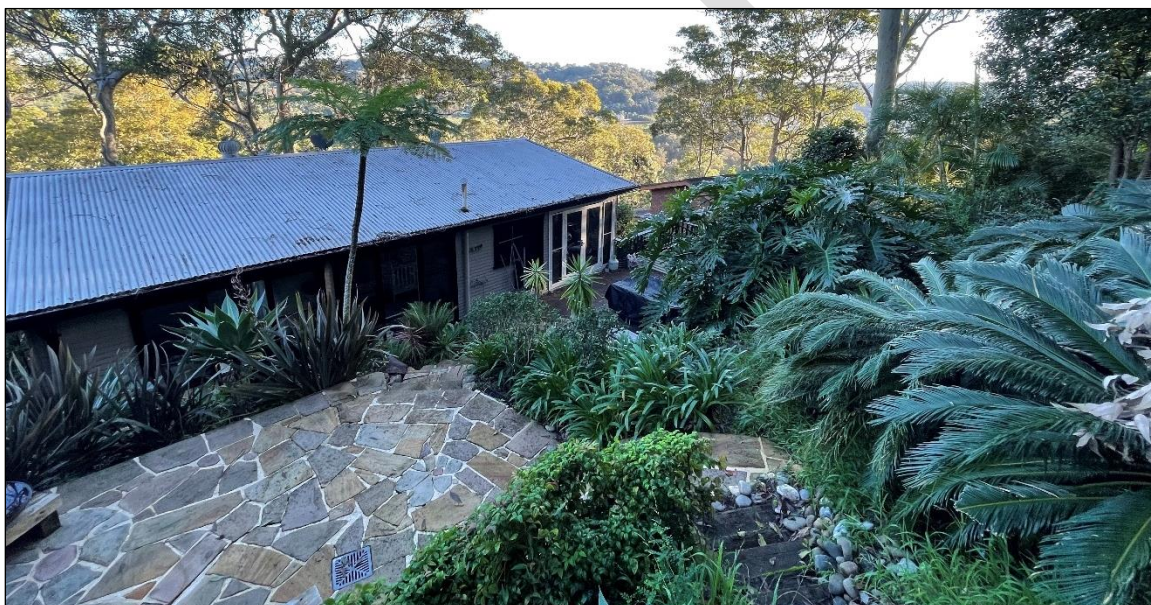
Photograph 3: Rear view of the property, looking broadly southwest

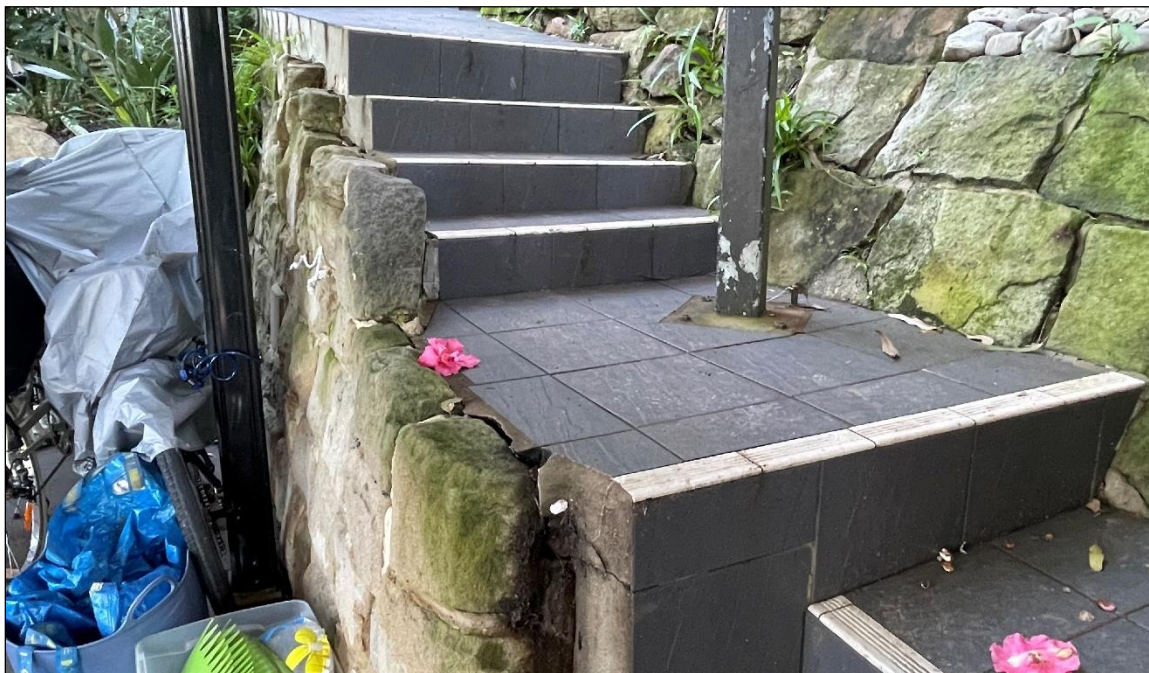
Sandstone block retaining walls up to approximately 1.0m in height supporting access steps and/or garden beds were observed within the front and the rear of the property. Adjacent to the carport a retaining wall which supports the front access stairs displayed signs of cracking. Photograph 4 shows the retaining wall adjacent to the carport.

Photograph 4: Sandstone block retaining wall located towards the front of the property

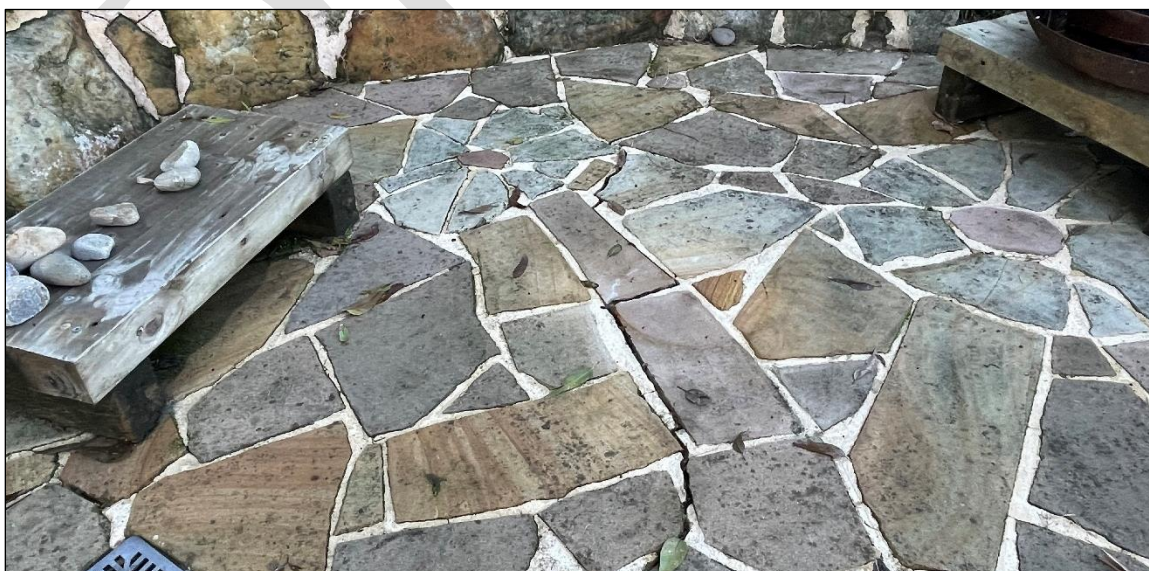
Minor cracking was also observed with a paved area within the rear of the property and is shown in Photograph 5.

Photograph 5: Cracks within the rear patio of the property.

The site dwelling appeared to be in a good condition without any major cracks or settlement evident to suggest deep seated instability issues exist. However, the existing retaining walls and the pavement indicated some settlement which is likely a result of downhill creep of colluvial soils and typical of 'normal' slope movement and unlikely indicative of a deep-seated stability issue.

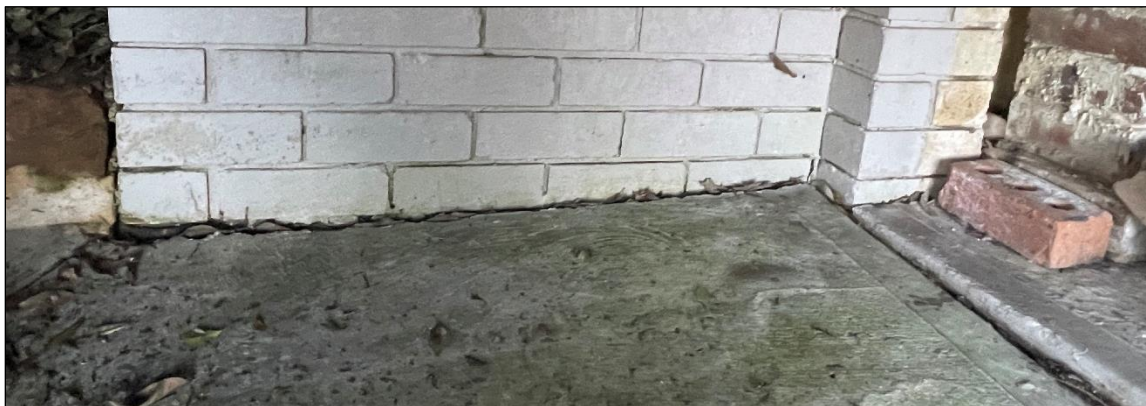
The concrete slab adjacent to the stairs adjacent to the front of the dwelling displayed signs of movement and a gap was observed in between the slab and the external wall of the dwelling which can be seen in Photograph 6.

Photograph 6: Gap between concrete slab and external wall of the dwelling

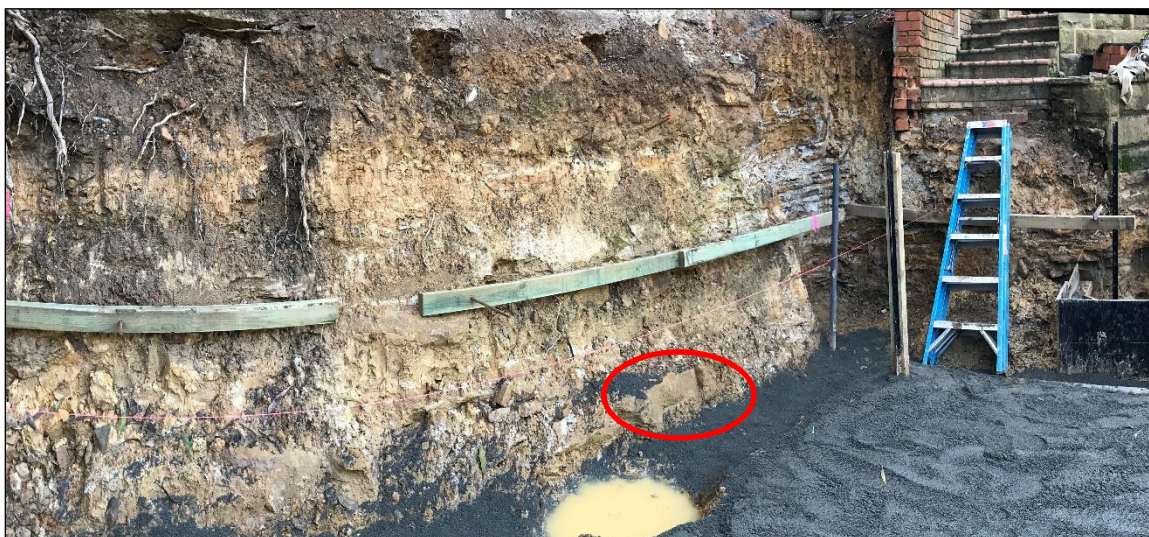
The neighbouring property to the east (No.67 Dolphin Crescent) contained a two-storey brick dwelling located within in the middle of the property with shared similar south dipping topography and was broadly at a similar elevation with the exception of the rear of the site which appeared up to approximately 0.5m higher in elevation compared to the site. The dwelling appeared to be in good condition with no visible cracks. During the investigation work the property was undergoing construction work and an excavation had been undertaken adjacent to the front of the property dwelling. The excavation comprised a vertical cut and appeared to be approximately 1.5m – 2.0m in depth and is shown in Photograph 7. The ground conditions exposed in the excavation within No.67 Dolphin Crescent comprised approximately 0.5m thickness of clayey topsoil/colluvial deposits underlain by approximately 1.5m depth of extremely low strength to very low strength bedrock. An interbed of apparently competent bedrock was observed with the excavation and is indicated on Photograph 7.

Photograph 7: View of the front of the excavation adjacent No.67 Dolphin Crescent with an interbed of competent bedrock (circled red).
