GEOTECHNICAL RISK MANAGEMENT POLICY FOR PITTWATER
FORM NO. 1 – To be submitted with Development Application

Report Title: Geotechnical Report 56 Crescent Road, Newport
Report Date: 17/12/18
Author: BEN WHITE
Author's Company/Organisation: WHITE GEOTECHNICAL GROUP PTY LTD

GEOTECHNICAL INVESTIGATION:

Alterations and Additions and New Pool at **56 Crescent Road, Newport**

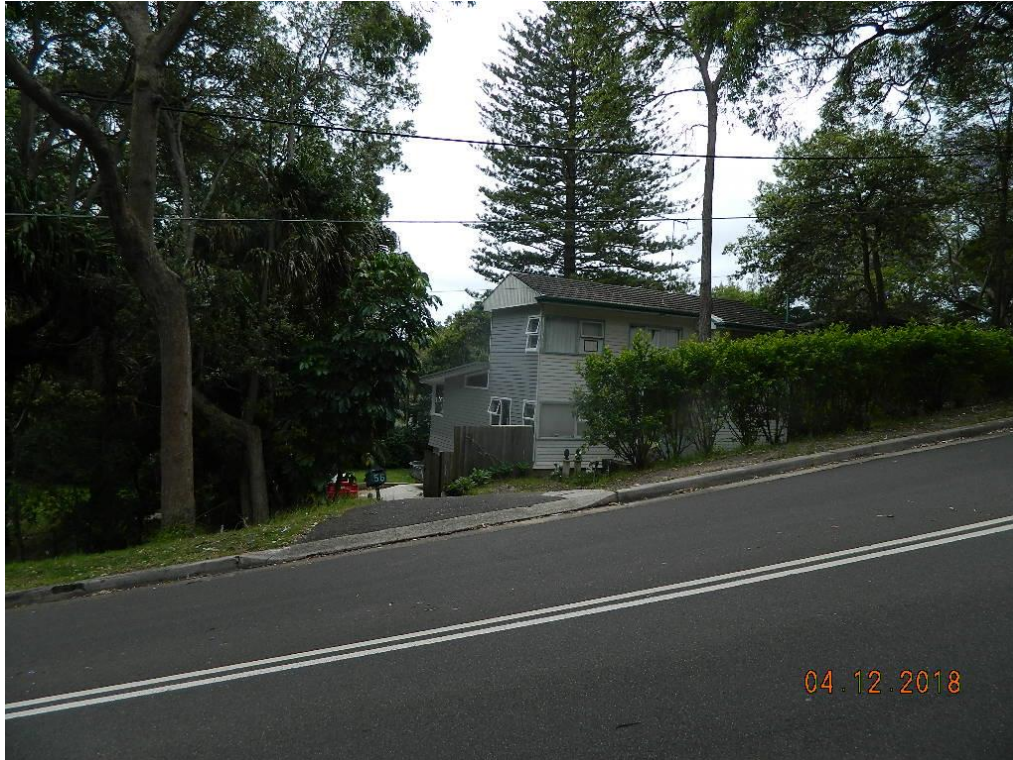
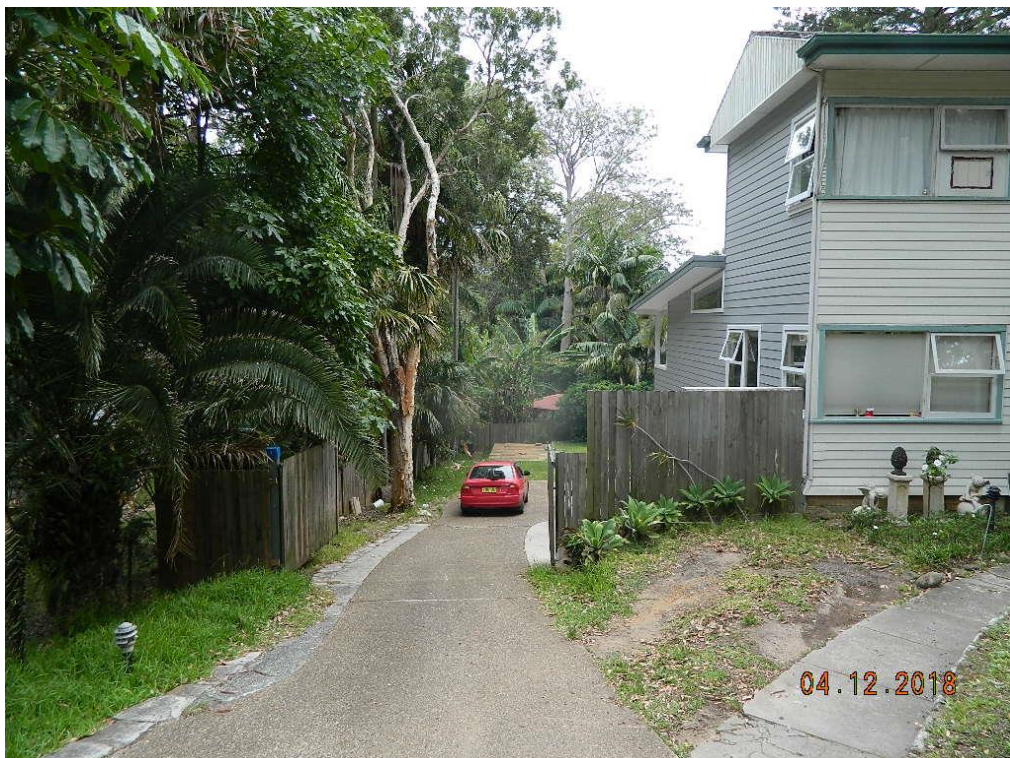
- 2.3** At the road frontage a concrete driveway runs down the S side of the property to a garage under the house (Photos 1 & 2). A gently sloping lawn falls from the road frontage (Photo 3). An excavation has been made in the slope to level the uphill side of the house. The cut is supported by a stable sandstone flagging retaining wall (Photo 4). A portion of the wall will be demolished as part of the proposed works. The

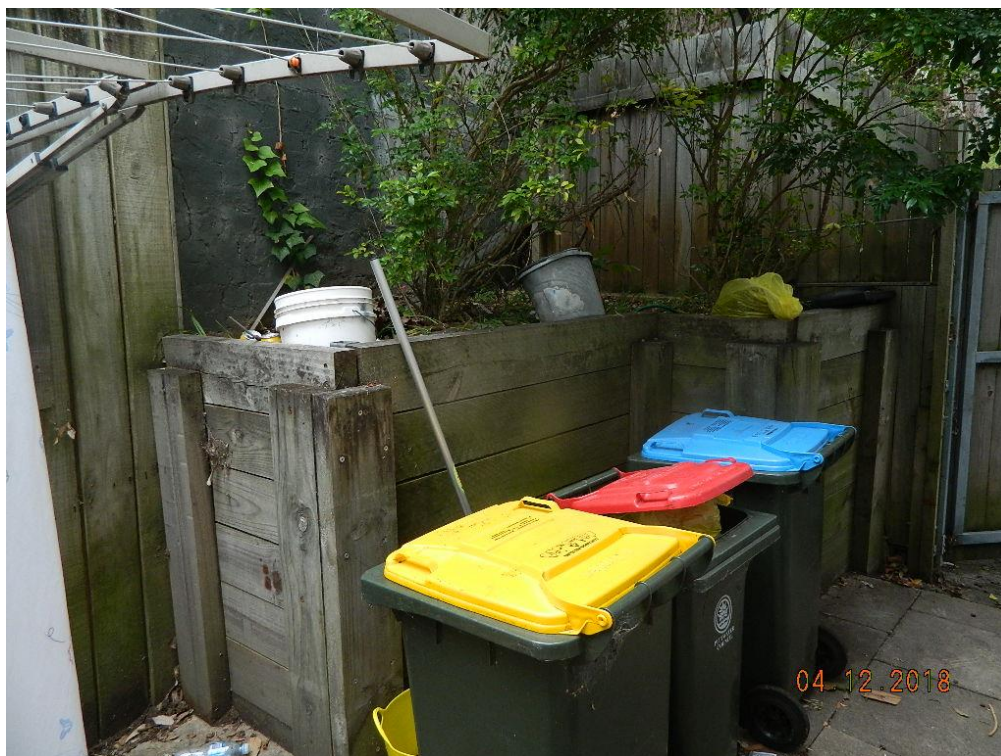
Photo 5

wall continues down a of the N side of the house as a stable treated pine retaining wall (Photo 5). The part two-storey timber framed and clad house is supported on brick walls and brick piers (Photo 6). A large vertical crack observed in the uphill supporting brick wall of the house (Photo 7). We are not sure why the cracking has occurred but it is not considered the result of settlement or an indication of slope instability. The brick piers stand vertical (Photo 8). A stable timber crib wall reaching a maximum height of ~1.5m runs along a portion of the N common boundary below the house. The wall continues on the N neighbouring property and supports a cut and fill for a level lawn area on the N neighbouring property (Photo 9). The slope that falls from the downhill side of the house to the lower boundary has been terraced. The terraces are supported by stable treated timber retaining walls that reach a maximum height of ~1.6m (Photos 10 & 11). No significant signs of movement related to slope instability were observed on the property. No geotechnical hazards that could impact on the subject property were observed on the neighbouring properties as seen from the subject property and the road.

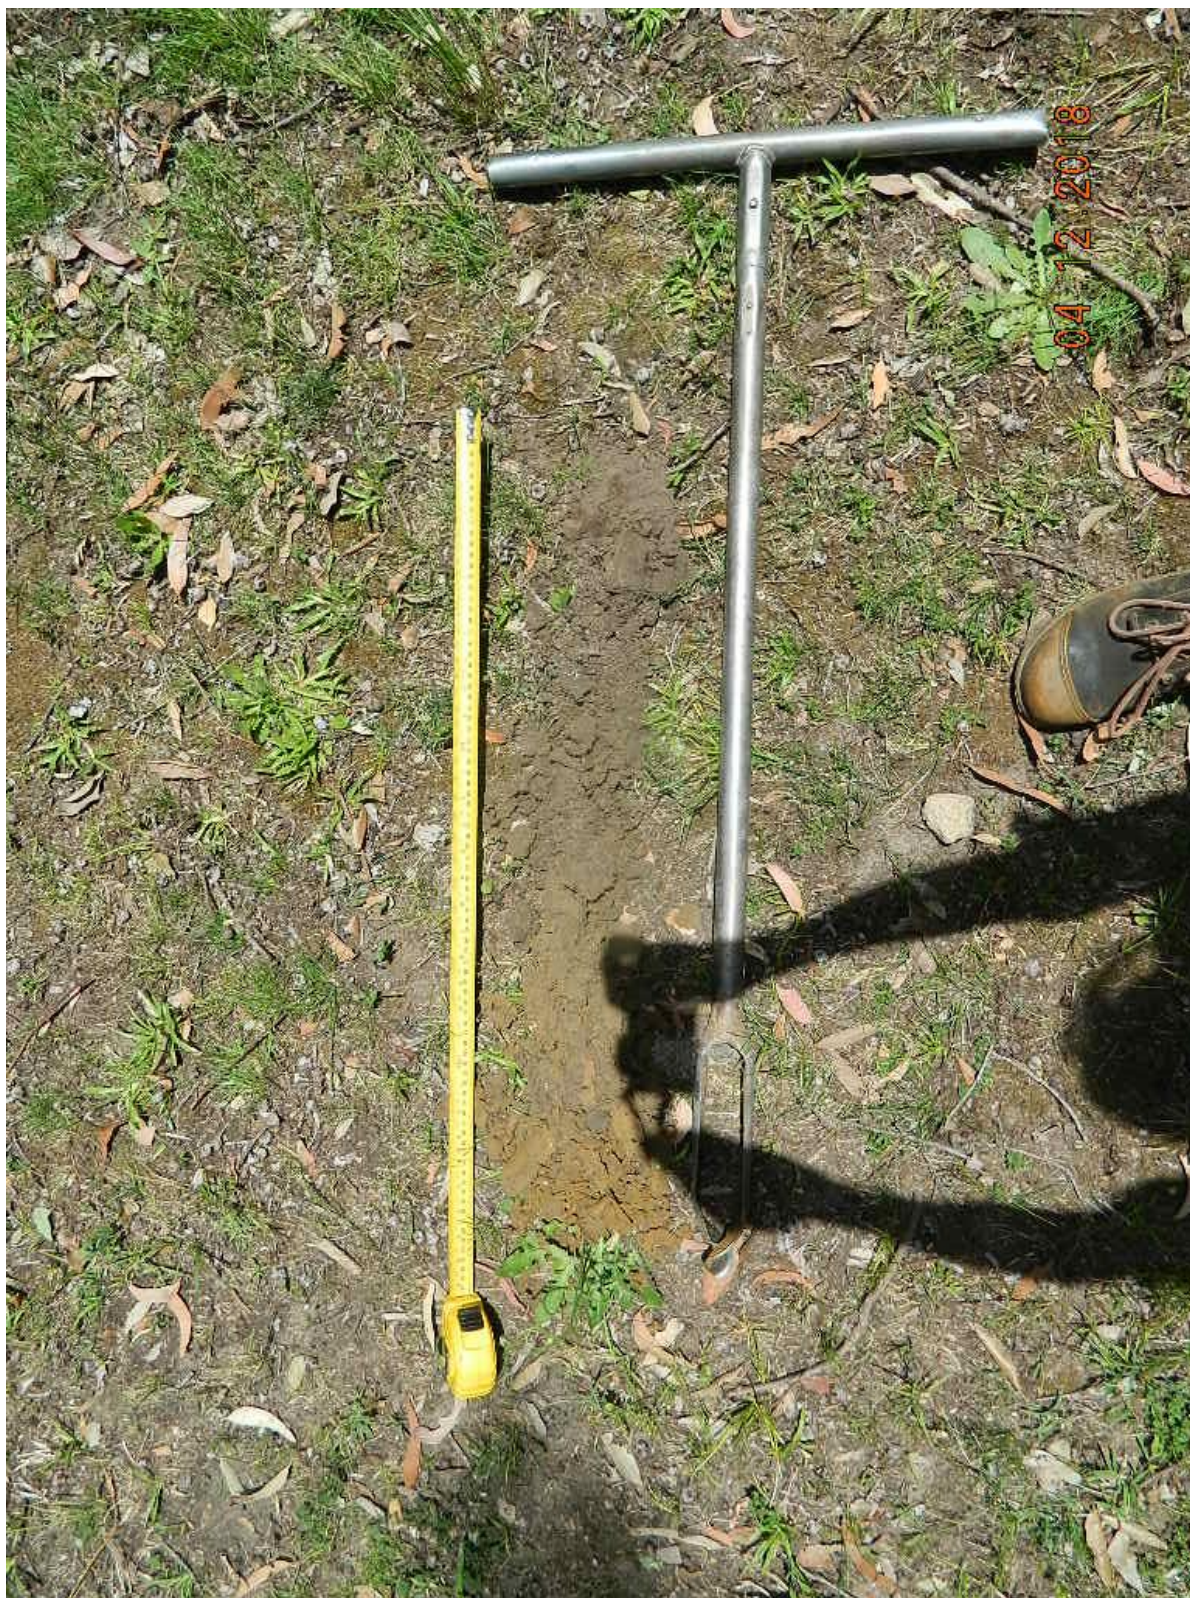
AUGER HOLE 1 (~RL14.4) – AH1 (Photo 12)

Depth (m)	Material Encountered
0.0 to 0.4	SANDY SOIL , light brown/brown, loose, fine to medium grained, organic matter, dry.
0.4 to 0.6	SANDY CLAY , orange/brown, firm, rock fragments, fine to medium grained, dry.
0.6 to 0.8	SANDY CLAY , orange/brown, stiff, fine to medium grained, dry.

End of hole @ 0.8m in sandy clay. No watertable encountered.

Photo 12 - End of the auger is at the bottom of the image

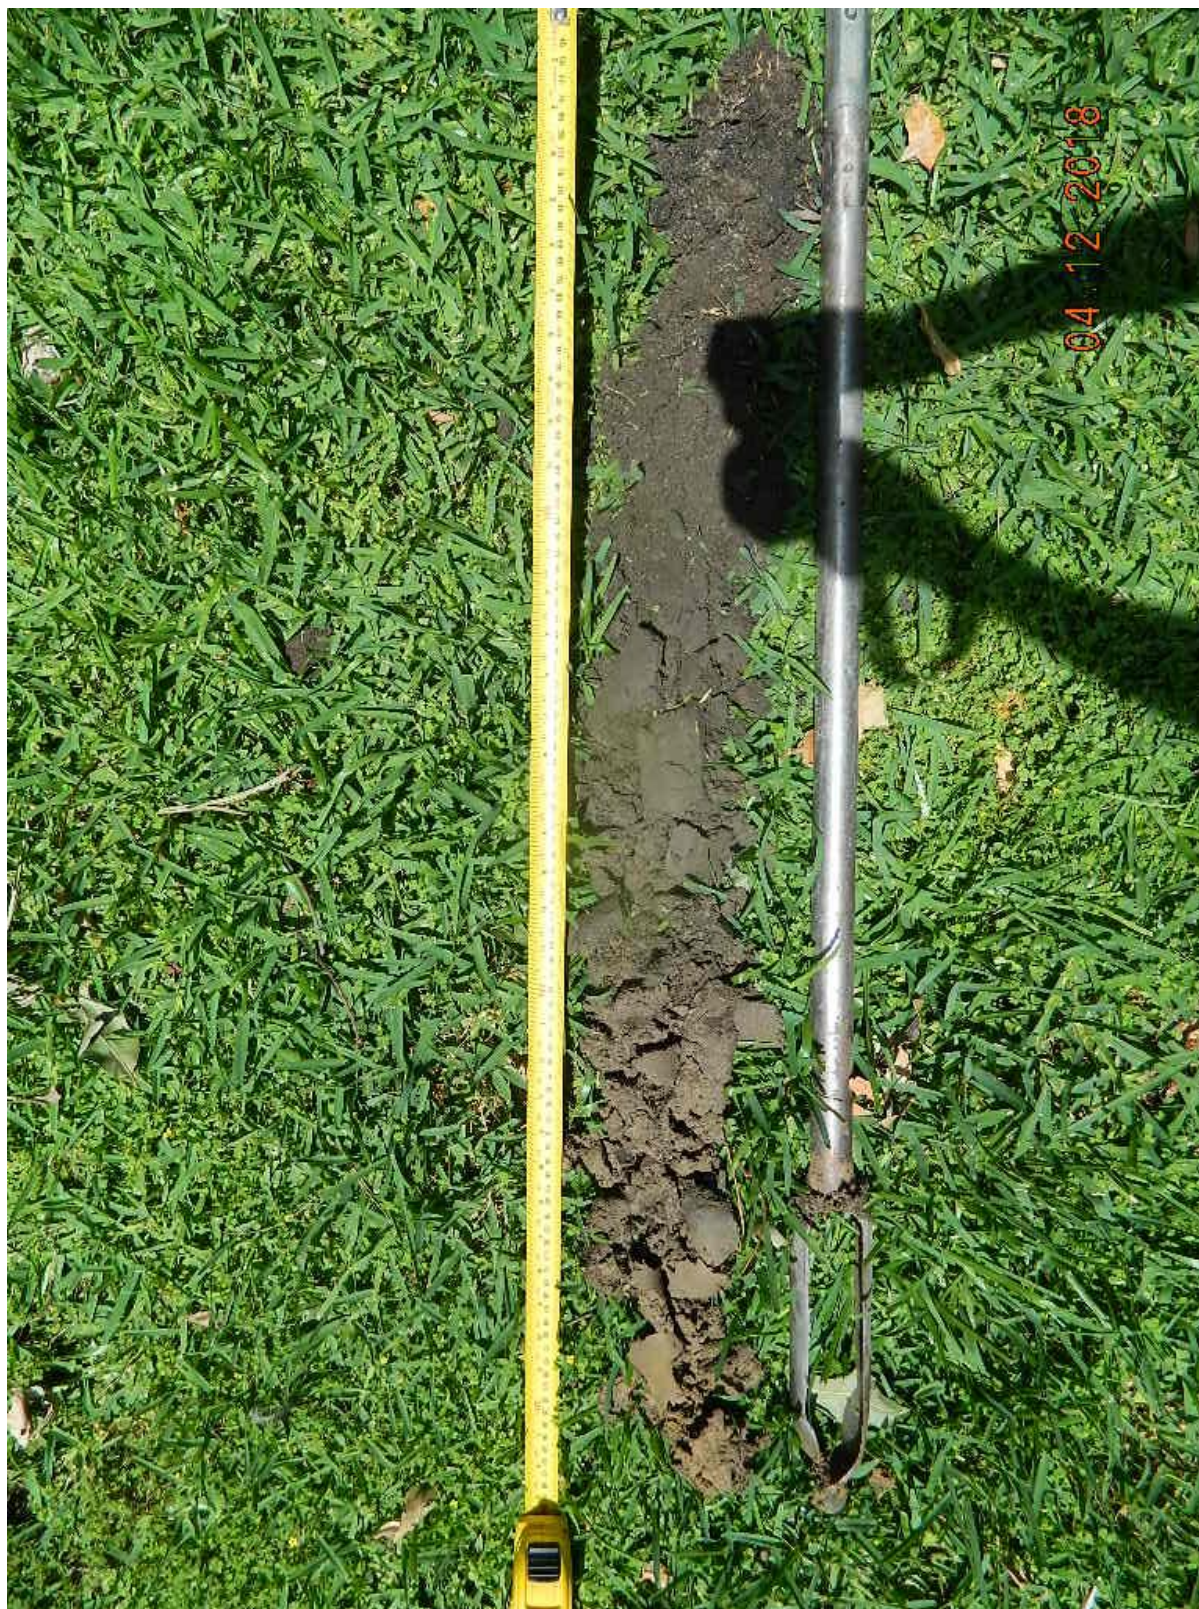
AUGER HOLE 2 (~RL10.1) – AH1 (Photo 13)

Depth (m)	Material Encountered
0.0 to 0.4	SANDY SOIL , dark brown, loose, fine to medium grained, organic matter, dry.
0.4 to 0.6	SILTY SAND , brown, loose, fine grained, dry.
0.6 to 0.8	SILTY SAND , light brown, firm, fine grained, dry.
0.8 to 0.9	SANDY CLAY , light brown/orange, firm, fine to medium grained, damp.

End of hole @ 0.9m in sandy clay. No watertable encountered.

Photo 13 - End of the auger is at the bottom of the image

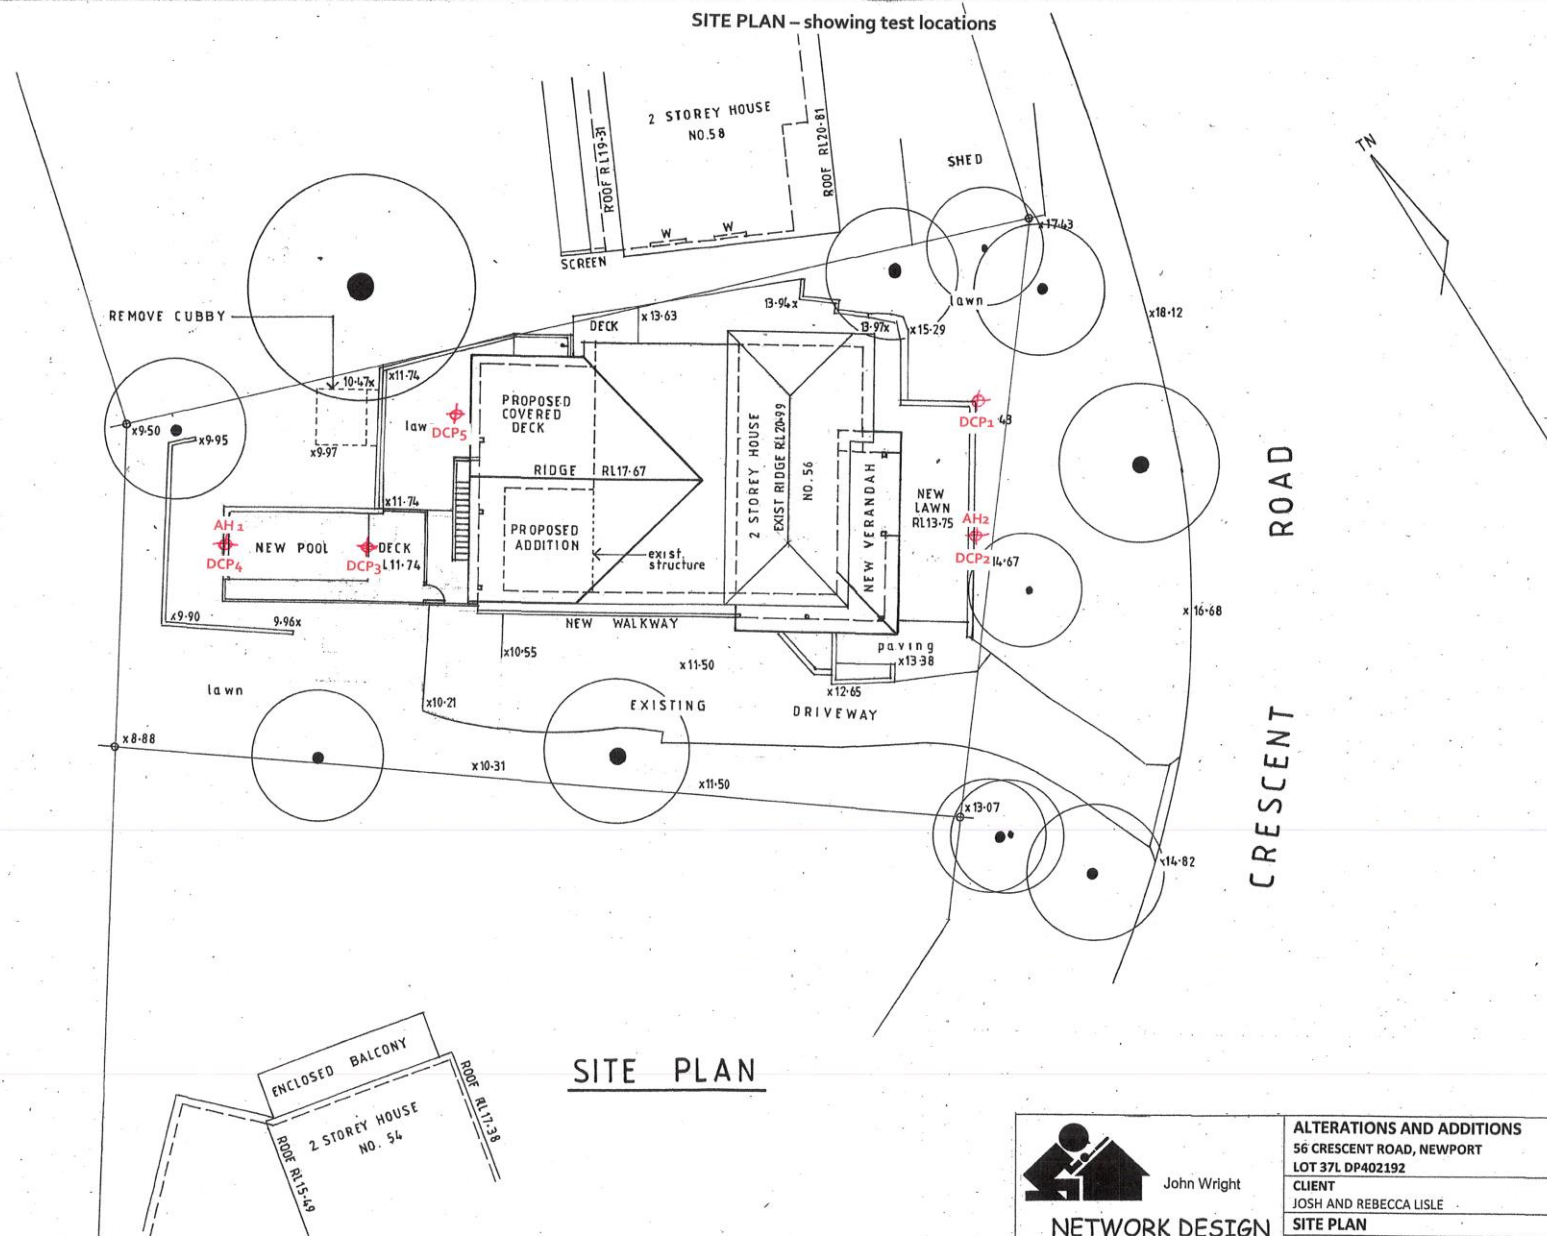
SITE PLAN

Strength Shale that becomes progressively stronger with depth. See Site Plan attached for a diagrammatical representation of the expected ground materials.
