**Re: Premises – 19 Joseph Street, AVALON NSW 2107  
BCA Compliance Inspection & Commentary**

We completed an inspection of the site at 19 Joseph Street, Avalon on Saturday, 25 May 2019.

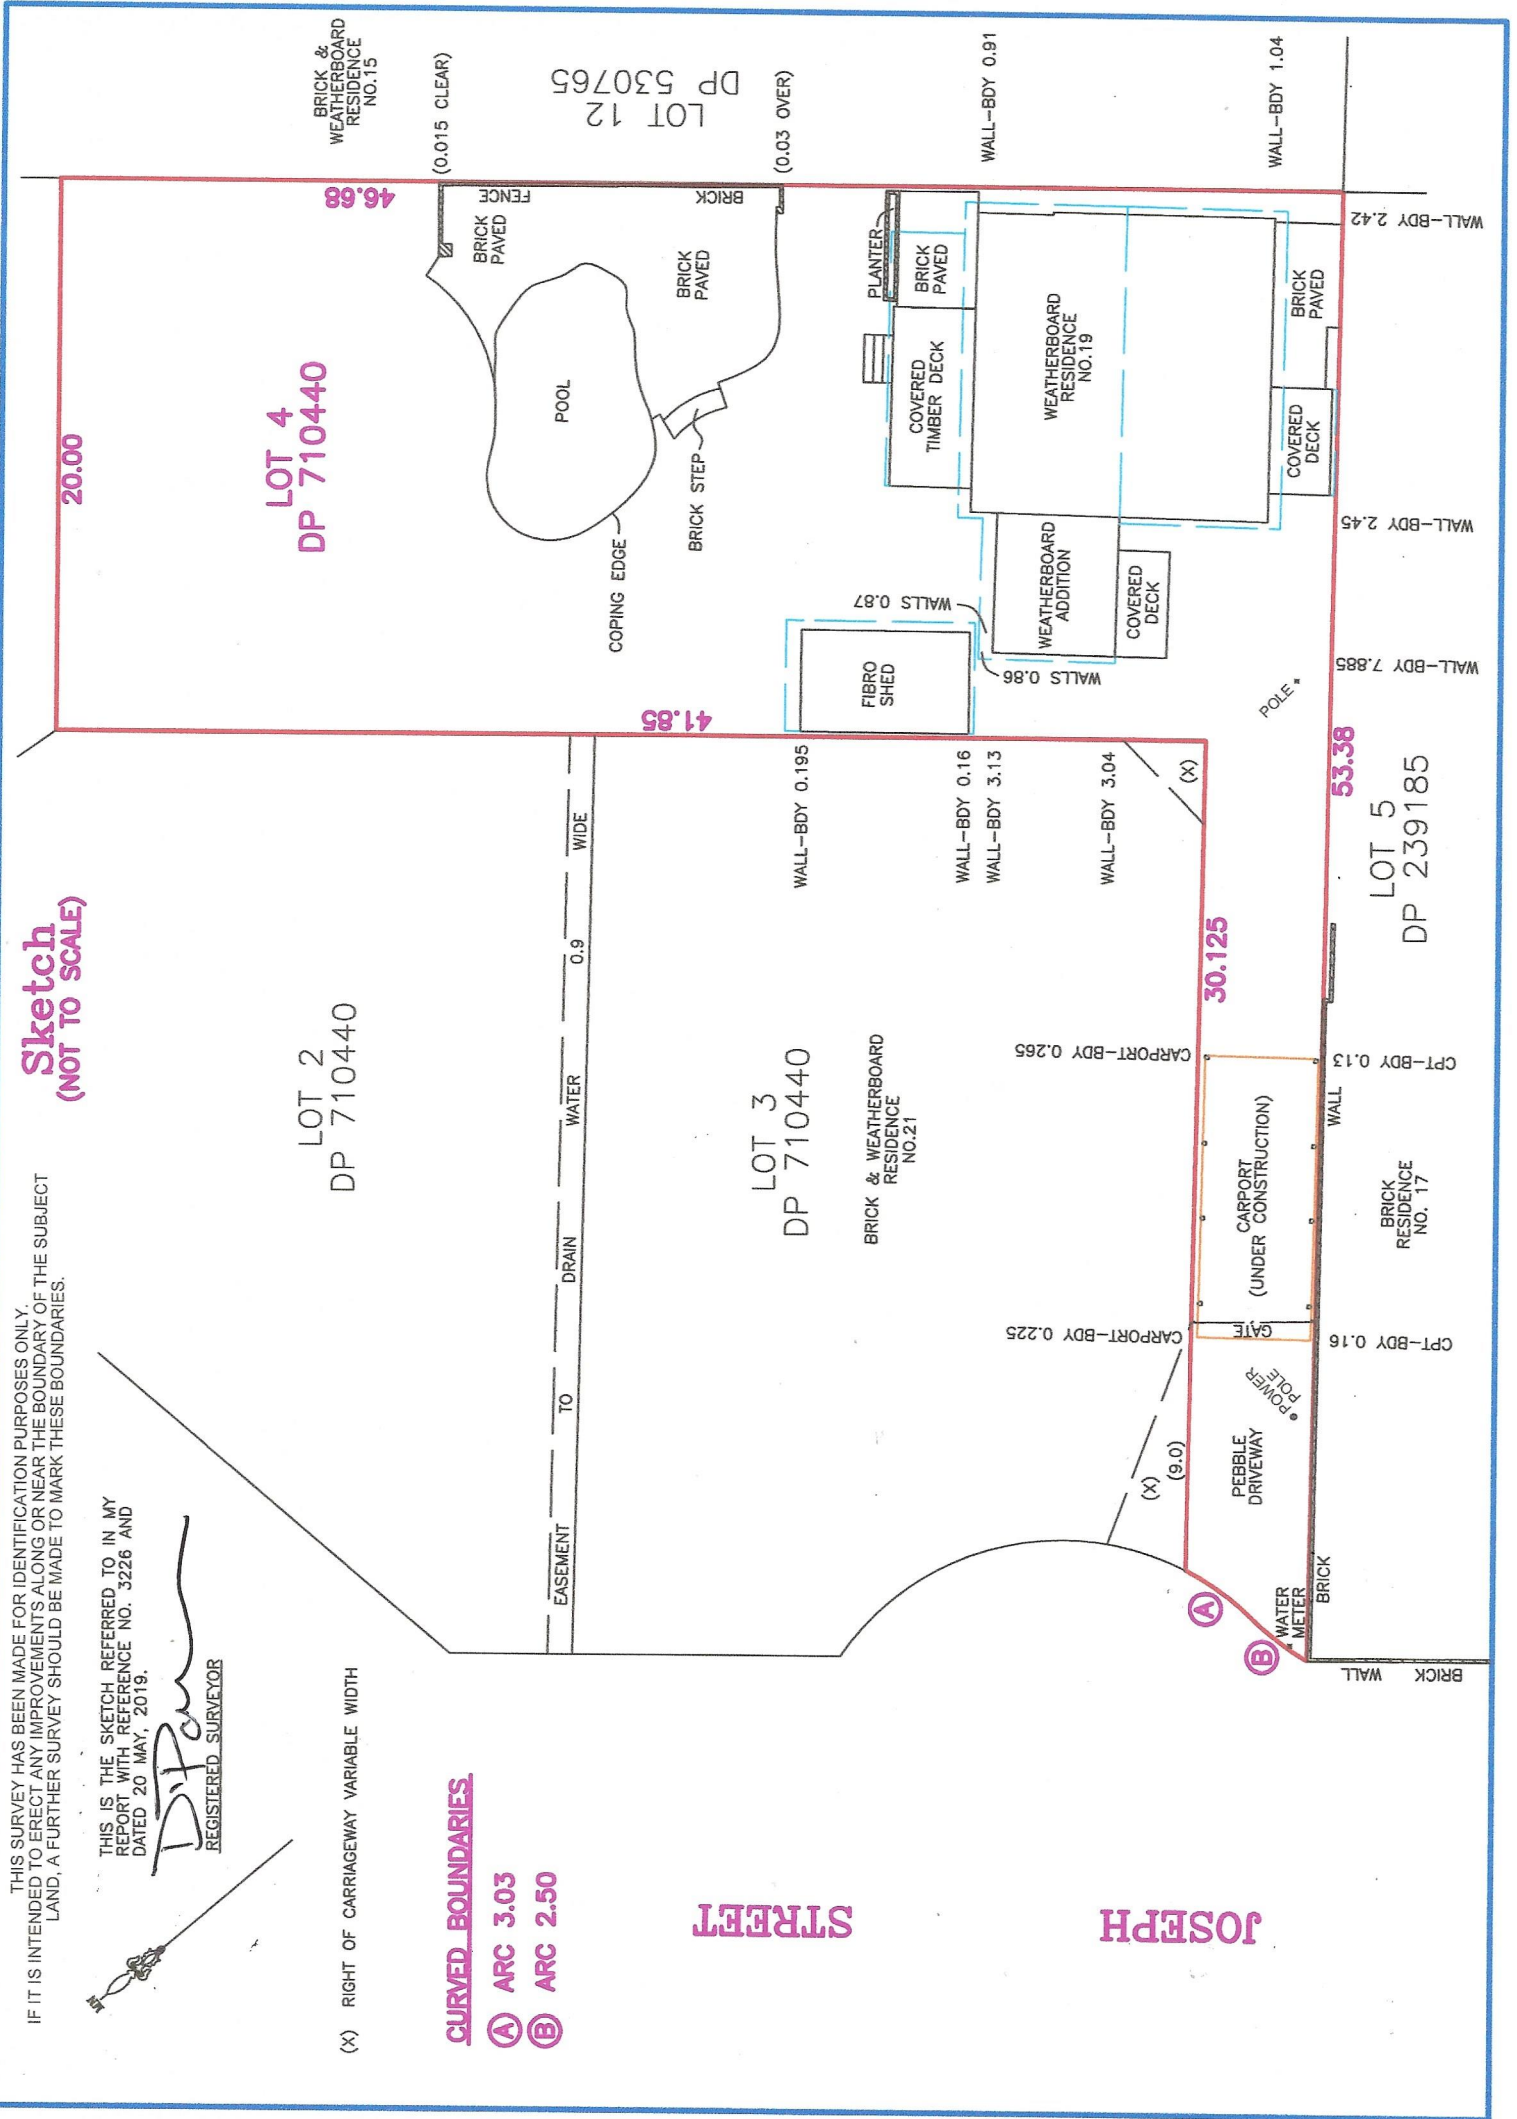
**Sketch**  
 (NOT TO SCALE)

The dwelling is separated from the rear side shed by a distance of 870mm – see attached a copy of the survey report prepared by David Parsons.

The carport is setback from the existing dwelling (on the same allotment) by more than 1.8m – see attached, a copy of the survey report. No additional fire safety upgrade works are required for BCA compliance purposes.

To comply with the terms of the BCA, it is recommended that the rear facing wall of the shed (to the dwelling and the additions) be upgraded to achieve a fire resistance level (FRL) of not less 60/60/60 where the separation between the dwelling and the shed is less than 900mm.

To achieve the necessary FRL, a possible solution would be to over clad the external cladding of the shed with a product such as Hebel Power Panel.
