Report Title: Geotechnical Report 78 Powderworks Road, Narrabeen
Report Date: 01/03/21

GEOTECHNICAL INVESTIGATION:

New Dwelling and Pool at 78 Powderworks Road, North Narrabeen

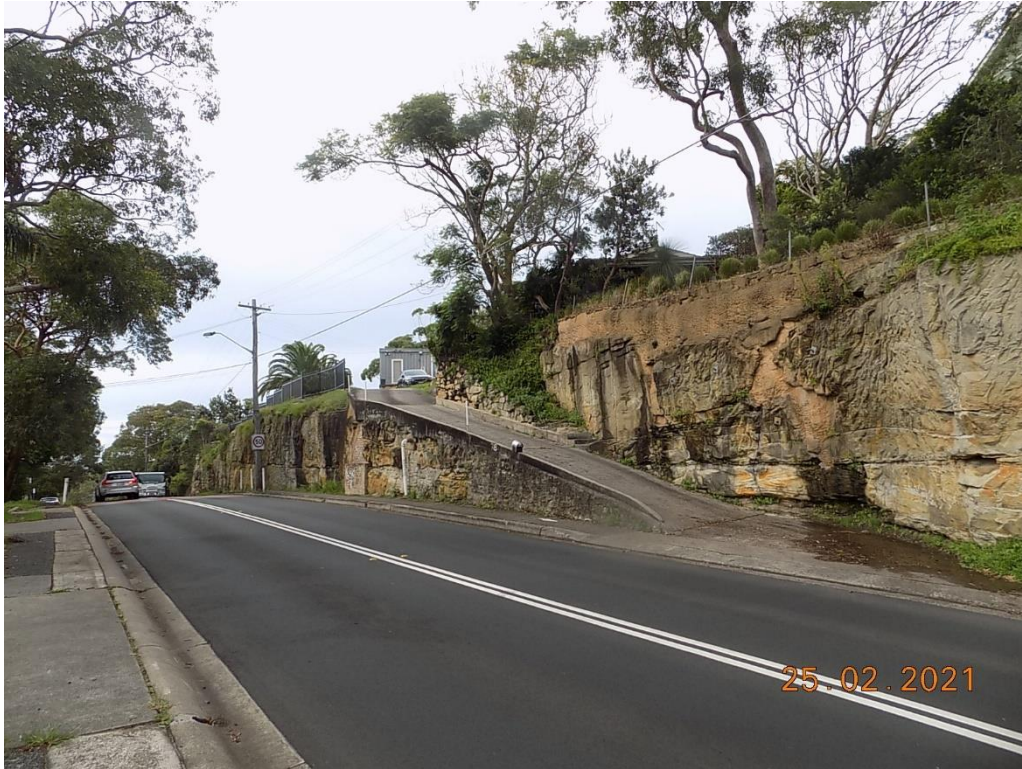
Photo 1

- 2.3** At the road frontage, the concrete driveway runs up past the house to a parking area on the uphill side of the property (Photos 1 & 2). The driveway and road are both cut into the slope. Both excavations are taken entirely through sandstone bedrock. The excavations reach a maximum height of ~3.5m (Photo 3). The majority of the cut face is through Medium Strength Sandstone that displays no significant geological defects. However, there are 3 areas of interest where several rock bolts and sprayed concrete have shored jointed and softer sections of rock (Photos 4 & 5). The existing house (photo 6) is partially supported directly on to outcropping Medium Strength Sandstone (Photo 7). The house will be demolished as part of the proposed works and the remainder of the site will be cleared.

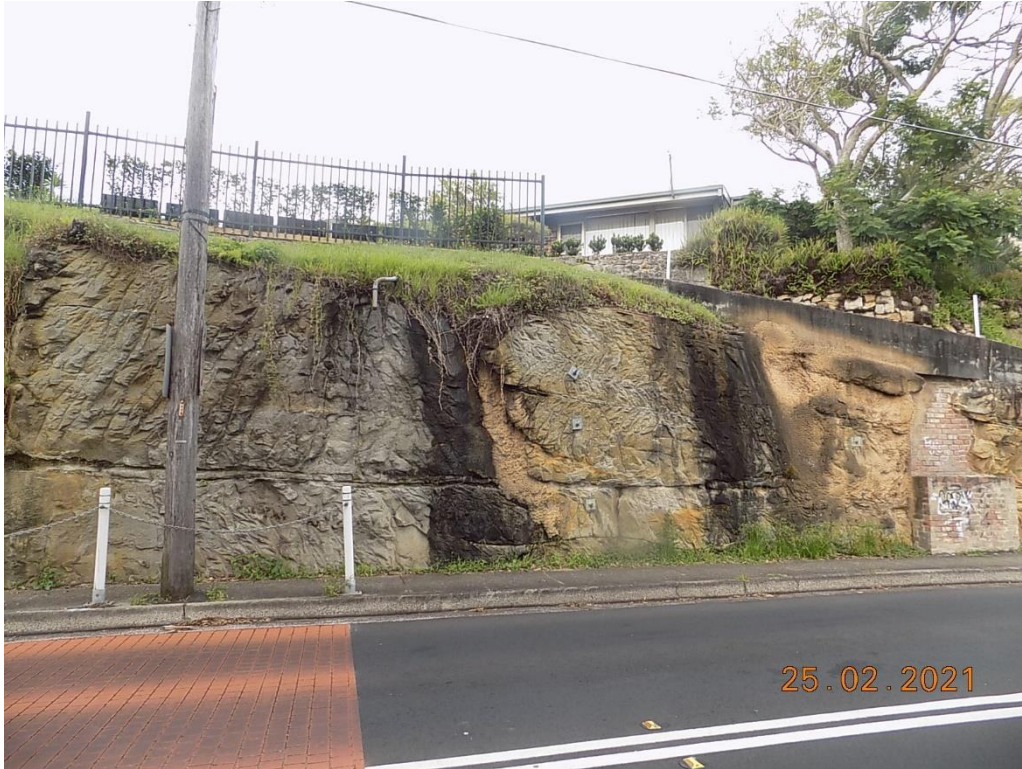
Photo 3

No current geotechnical hazards were observed beside the property. The gentle to steeply graded land surface that falls across the property and continues below is a potential hazard (**Hazard One**). The cut face that rises ~3.5m above the road is a potential hazard (**Hazard two**).

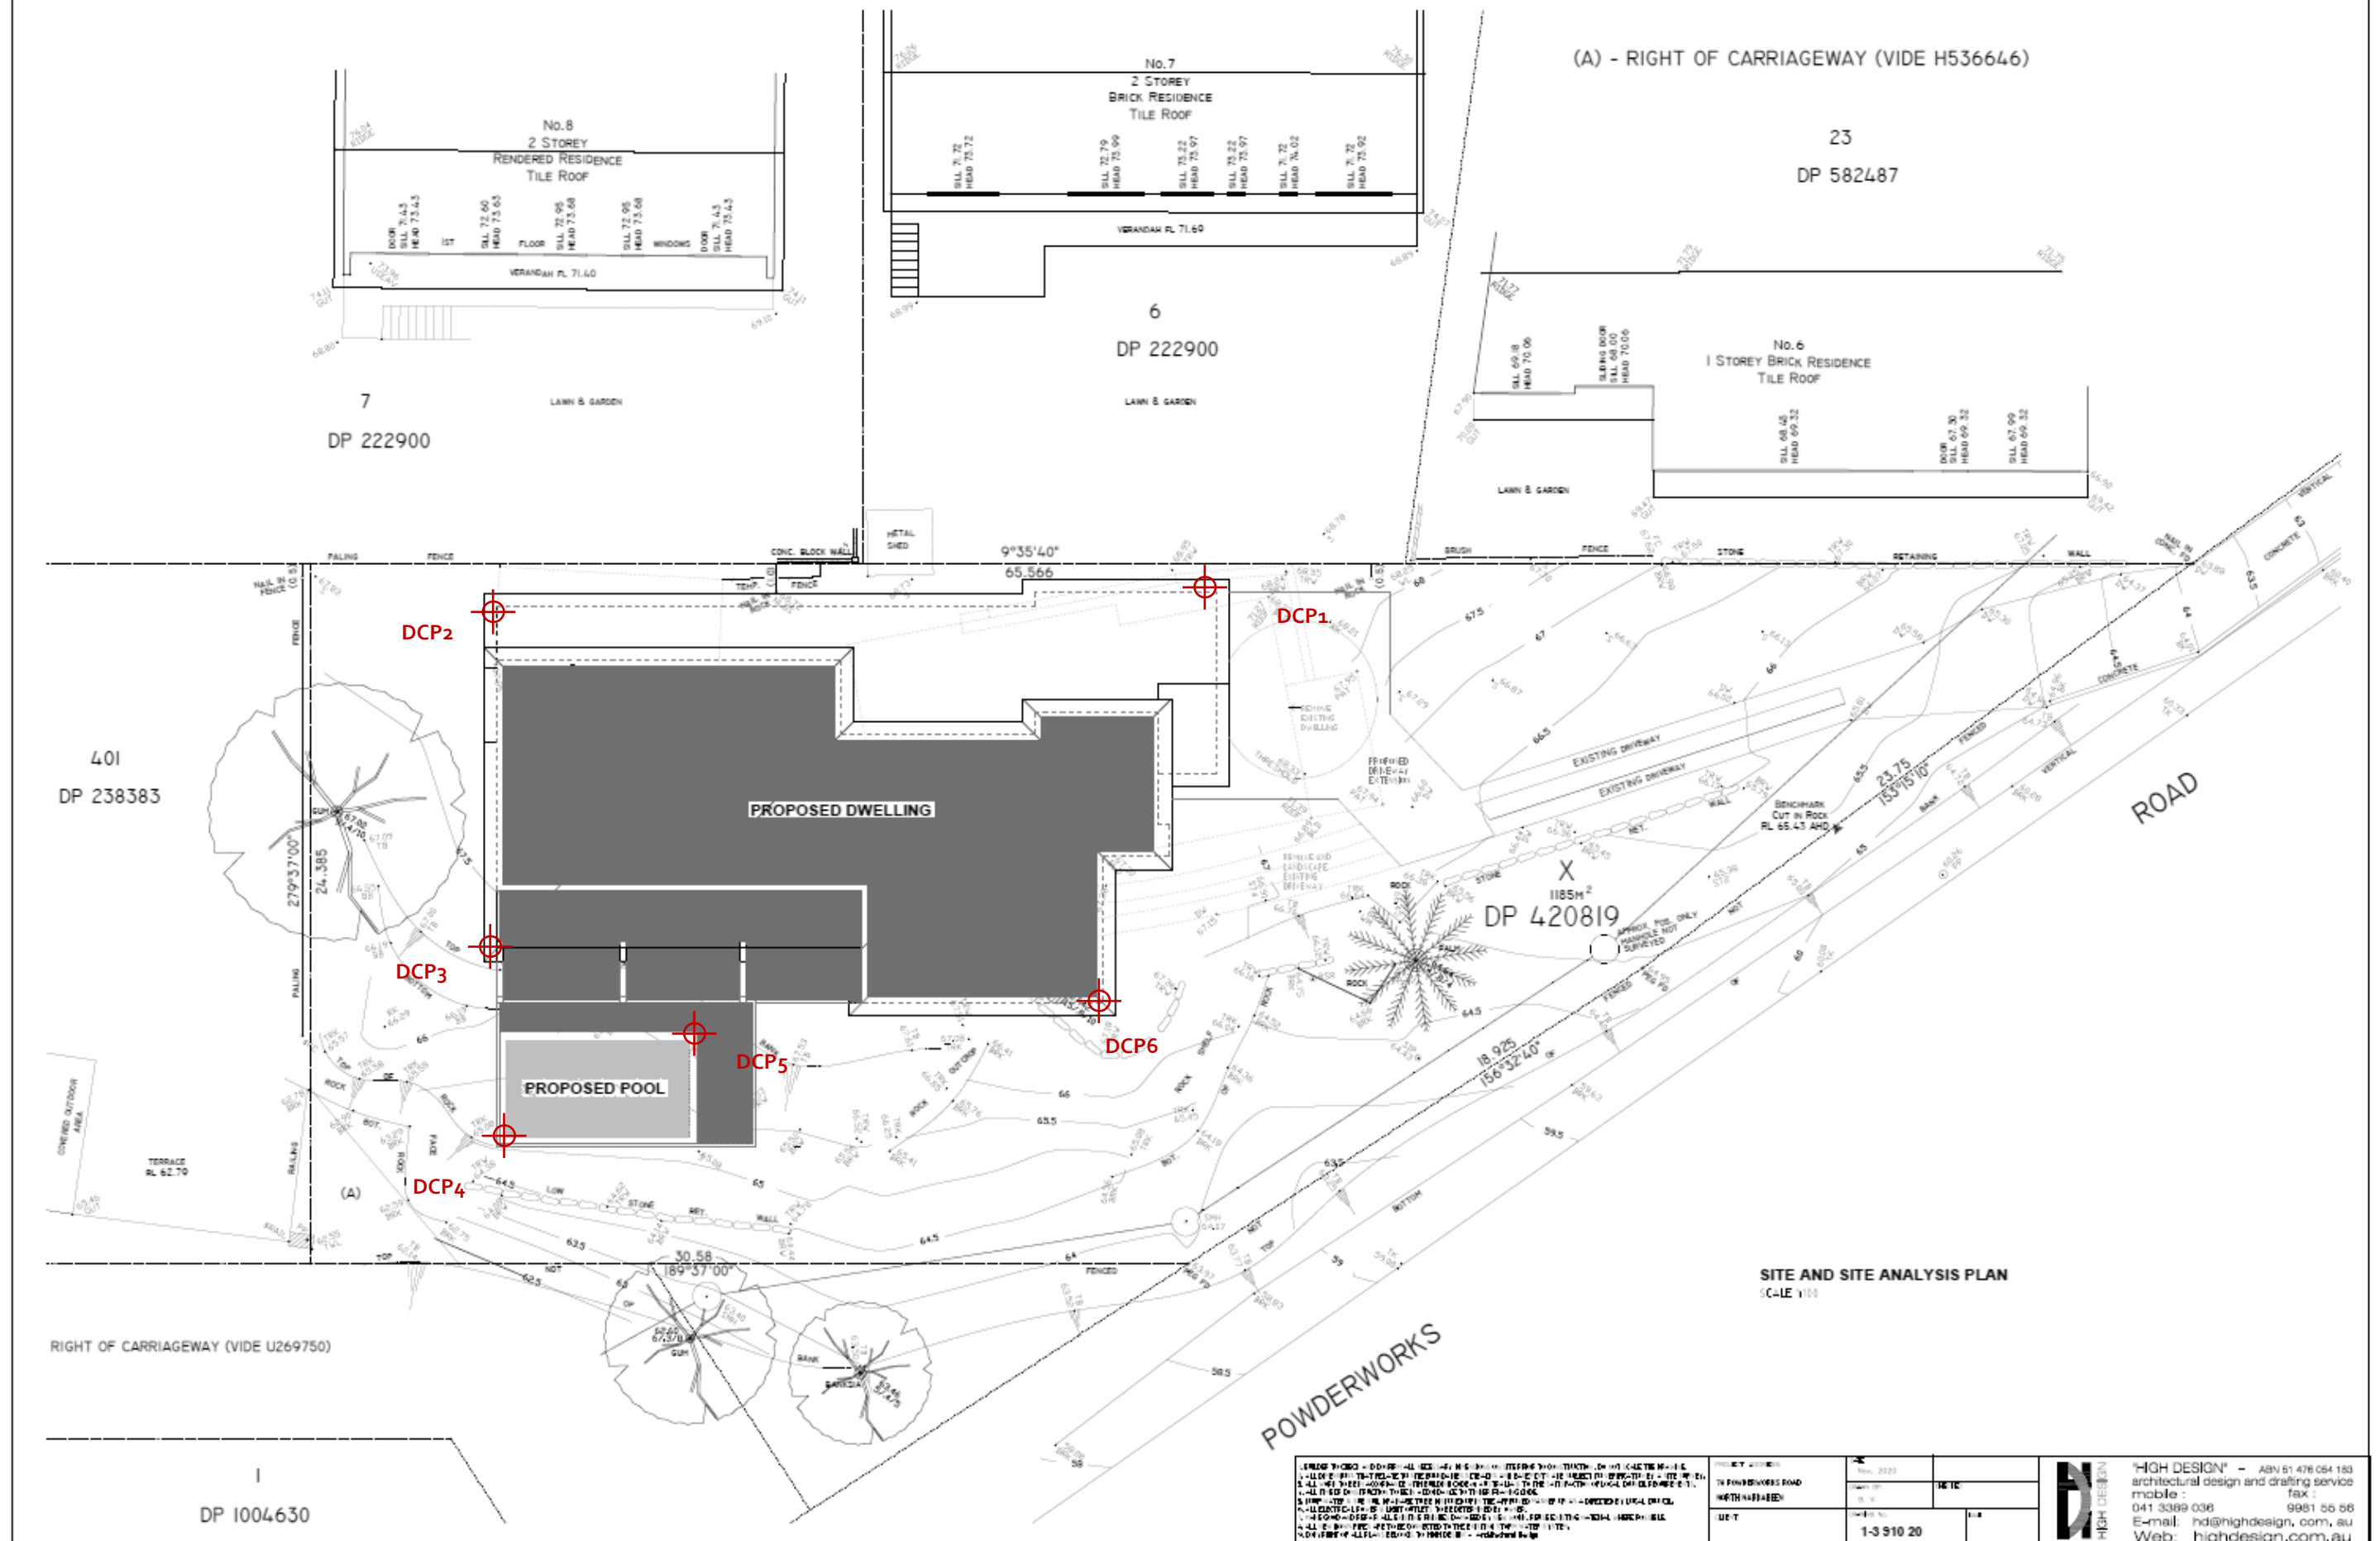
SITE PLAN – showing test locations

Six DCP (Dynamic Cone Penetrometer) tests were put down to determine the relative density of the overlying soil and the depth to bedrock. The locations of the tests are shown on the site plan attached. It should be noted that a level of caution should be applied when interpreting DCP test results. The test will not pass through hard buried objects so in some instances it can be difficult to determine whether refusal has occurred on an obstruction in the profile or on the natural rock surface. This is not expected to be an issue for the testing on this site. However, excavation and foundation budgets should always allow for the possibility that the interpreted ground conditions in this report vary from those encountered during excavations. See the appended "Important information about your report" for a more comprehensive explanation. The results are as follows:

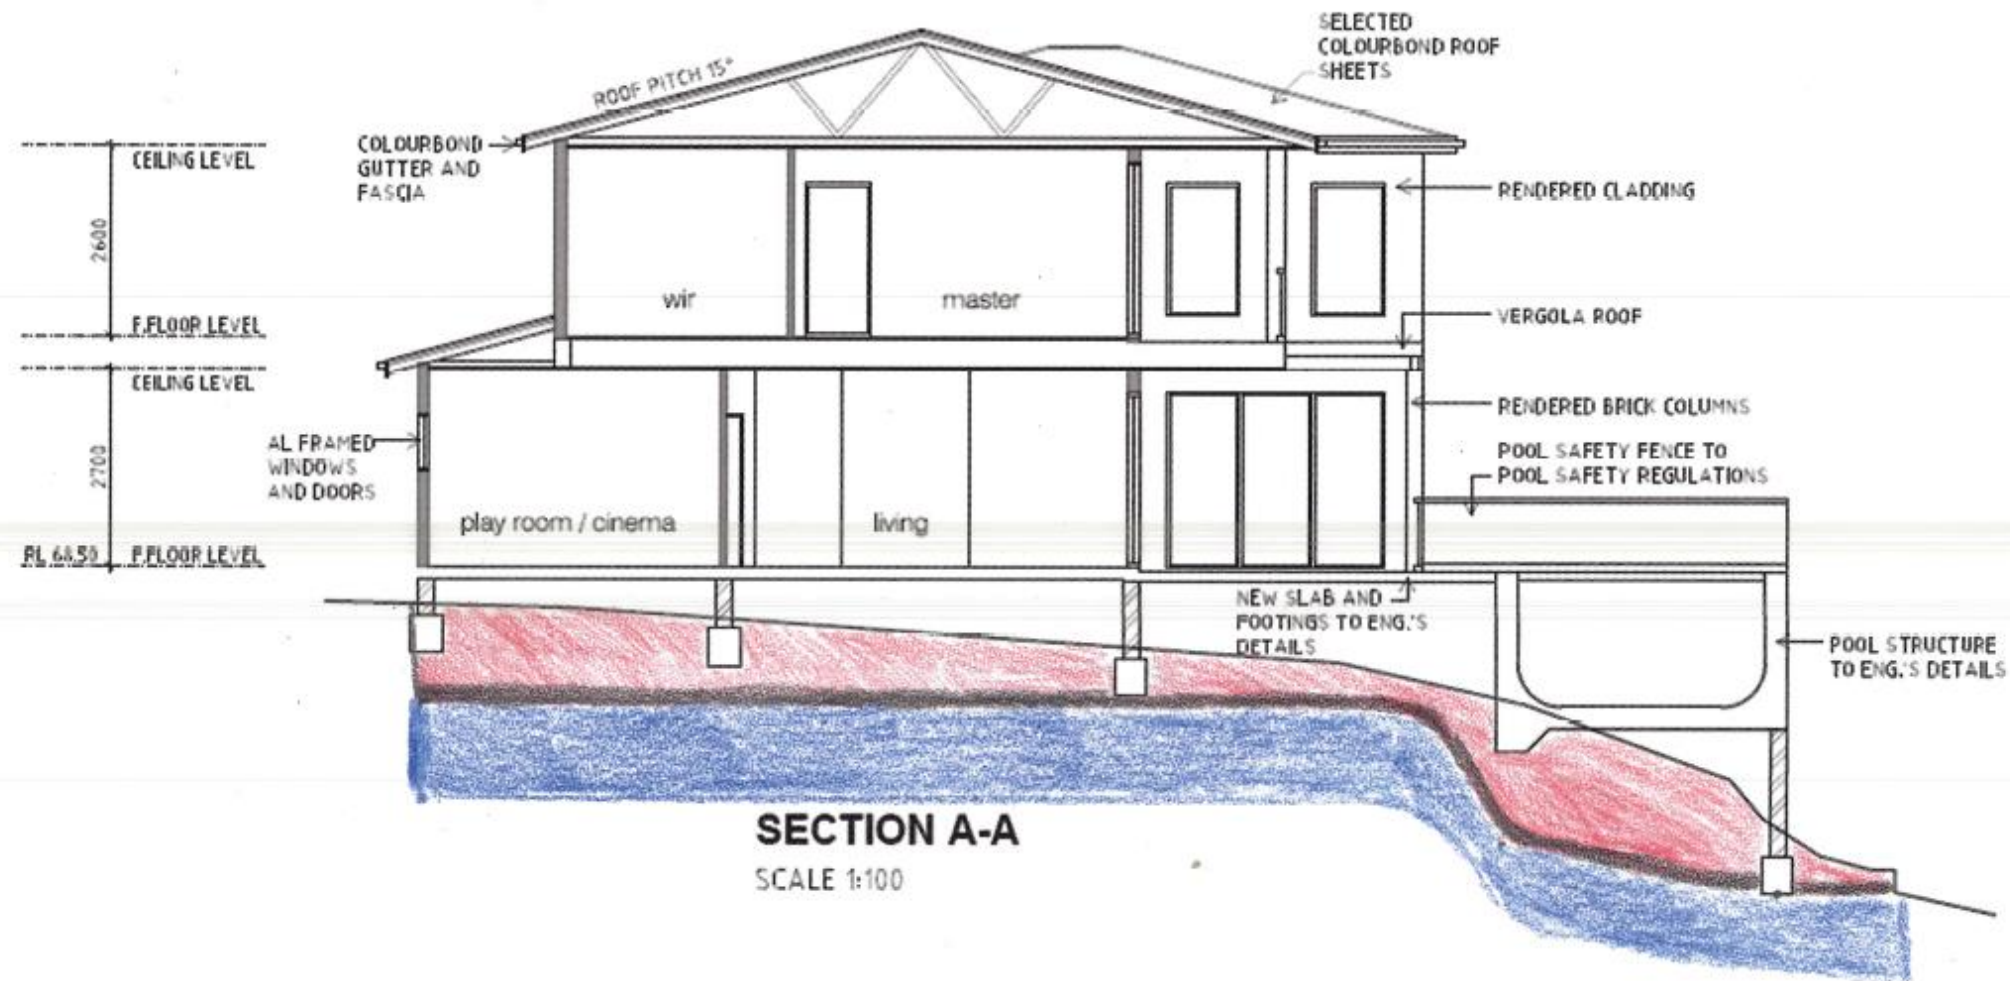
TYPE SECTION – Diagrammatical Interpretation of expected Ground Materials

Filling has been placed below the house for landscaping. In the test locations, the depth to rock ranged between 0.15 to 2.0m below the current surface, being slightly deeper due to the presence of fill and due to the stepped nature of the underlying bedrock. The outcropping sandstone on the property is estimated to be Medium Strength or better and similar strength rock is expected to underlie the entire site. See Type Section attached for a diagrammatical representation of the expected ground materials.
