## ***Construction Impact & Management Statement: Lodged DA2021/1802 November 2021***

**Site:** Lot 10 in DP 233448  
11 Bertana Crescent  
WARRIEWOOD, NSW

**Client:** Mrs. Angela Curgenven  
c/ Mark Hurcum Design Practice Pty Ltd  
271 Alfred Street North  
NORTH SYDNEY, NSW 2060

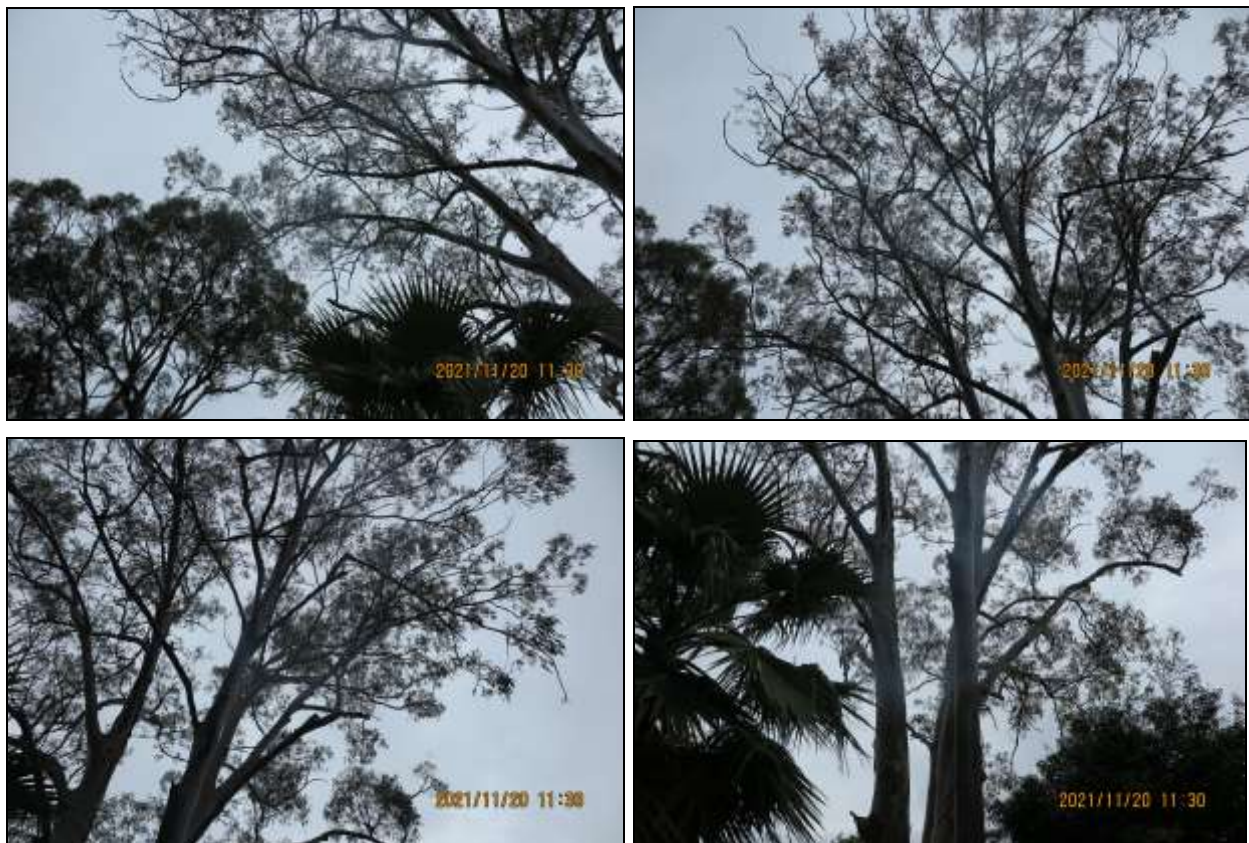
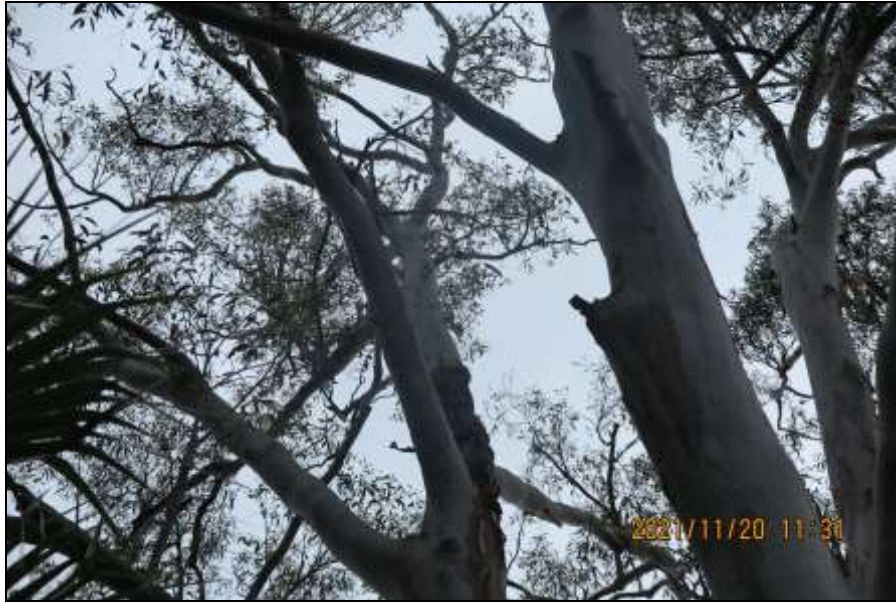
Figure 9: Previous page photographs illustrates dead/dying branches/branch tips plus branch failure sites. Above arrow points towards dysfunctional tissue consistent as an indicator of internal fungal pathogen activity.

The following photographs confirm dead/dying branches throughout the tree canopy as well as multiple previous 'branch failure sites'. Of greatest concern relative to tree health, vigour & risk is that the tree displays many dead/dying branch tips which is usually linked to 'root dysfunction'.

The above photograph (red arrow) confirms additional concern relative to the tree & its Useful Life Expectancy as this area is consistent as an indicator of internal fungal pathogen activity.

- **Relative to the information as presented the GMW Consultancy supports the replacement of the discussed tree in a location where it can develop with no conflict to exiting built fom. proposed works as presented in documentation reviewed.**
- **The DA submission be re-assessed for determination by council officers taking into account the contents of this document.**

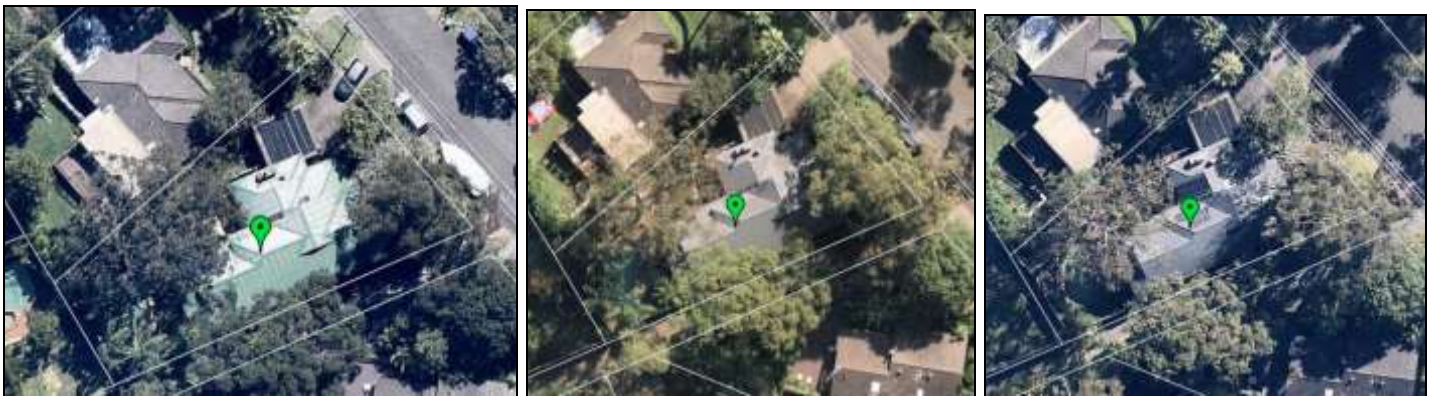
Figure 10: Left to right, arial photographs dated Sunday 2 Oct 2016, Monday 13 Apr 2020 & Wednesday 11 August 2021 clearly confirm canopy density decline in the last five (5) years.
