Arboricultural Impact Assessment

NEWPORT SLSC.
7TH OF AUGUST
2024

Leigh Brennan
Tree Management Strategies

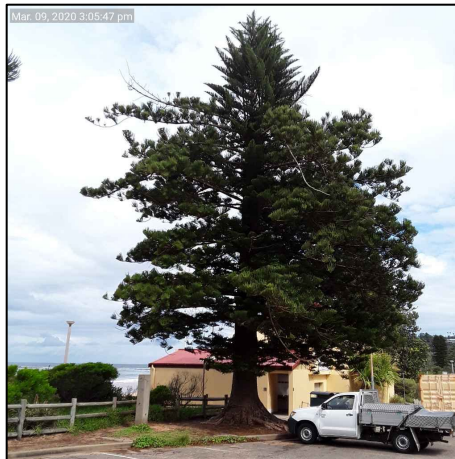
Tree No	1		
Genus-Species	<i>Araucaria heterophylla</i>		
Common name	Norfolk Island Pine		
Age	Mature		
Retention value	High		
Landscape Significance	High		
Useful Life Expectancy	Medium		
Condition	Fair/Poor		
Health	Fair/Poor		
General Measurements			
DAB metres (radius) Above buttress	2.06	Height (Metres)	16
DBH metres (radius) Breast Ht	1.01		
Canopy Spread (Metres)			
North	6.00	South	6.00
East	6.00	West	6.00
SRZ Measurements			
SRZ area (Square Metres)	Refer to the Tree Impact Plan	SRZ radius (Metres)	4.48
SRZ Incursion (Square Metres)	Refer to the Tree Impact Plan	SRZ Incursion %	Refer to the Tree Impact Plan
TPZ Measurements			
TPZ area (Square Metres)	Refer to the Tree Impact Plan	TPZ radius (Metres)	12.12
TPZ Incursion (Square Metres)	Refer to the Tree Impact Plan	TPZ Incursion %	Refer to the Tree Impact Plan
Observations / Comments			
<p>Basal Wound observed, basal swelling indicates reaction wood with potential decay. Minor amount of deadwood observed.</p>

Tree 1 is given a high retention value due to its age, health, condition and position in the landscape. Tree 1 has an acceptable incursion of 8.79% to its TPZ by the proposed new building envelope.

Tree 1 has an additional incursion of 6.94% by the proposed sea-wall construction. The construction footprint is within close proximity to the SRZ of Tree 1, refer to the Tree Impact Plan (Appendix 1).

The total combined incursion to Tree 1 is 15.73%, refer to the Tree Impact Plan (Appendix 1).

Given the close proximity of seawall construction to the SRZ of Tree 1, it is advisable to map the roots to assess the size and number of roots that could be affected. This will help ensure the long-term structural integrity of Tree 1.

To minimise root damage to Tree 1, a no dig type hardstand paving construction method is recommended within the TPZ, refer to the Tree Management Plan (Section 5) of this report.

A tree protection fence is recommended for Tree 1 as shown on the Tree Impact Plan (Appendix 1) and detailed in the Tree Management Plan (Section 5) of this report.

Given the proximity of seawall construction to the SRZ of Tree 1, it is advisable to map the roots to assess the size and number of roots that could be affected. This will help ensure the long-term structural integrity of Tree 1.

Vacuum excavation is recommended along the line of seawall excavation. The soil is vacuumed to a minimum depth of 600mm exposing roots potentially impacted by the proposed development.

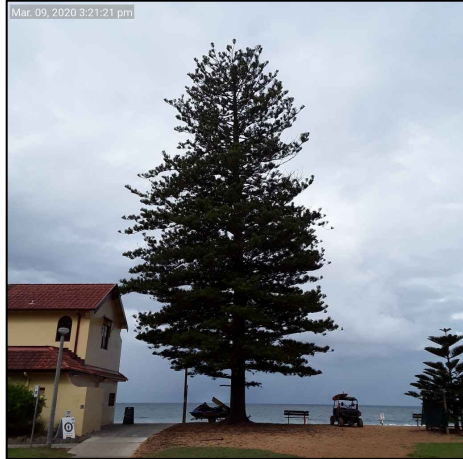
Tree No	2		
Genus-Species	<i>Araucaria heterophylla</i>		
Common name	Norfolk Island Pine		
Age	Mature		
Retention value	High		
Landscape Significance	High		
Useful Life Expectancy	High		
Condition	Fair		
Health	Fair		
General Measurements			
DAB metres (radius)	1.28	Height	25.00
DBH metres (radius)	1.06		
Canopy Spread (Metres)			
North	7.00	South	7.00
East	7.00	West	7.00
SRZ Measurements			
SRZ area (Square Metres)	Refer to the Tree Impact Plan Impact Plan	SRZ radius (Metres)	3.67
SRZ Incursion (Square Metres)	Refer to the Tree Impact Plan	SRZ Incursion %	Refer to the Tree Impact Plan
TPZ Measurements			
TPZ area (Square Metres)	Refer to the Tree Impact Plan	TPZ radius (Metres)	12.72
TPZ Incursion (Square Metres)	Refer to the Tree Impact Plan	TPZ Incursion %	Refer to the Tree Impact Plan
Observations / Comments			
Tree in good health and condition

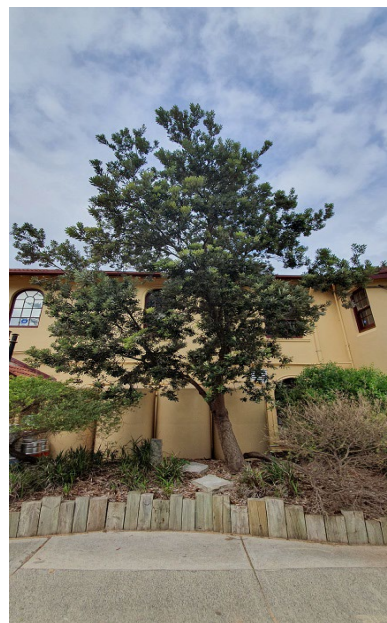
Tree No	3		
Genus-Species	<i>Banksia integrifolia</i>		
Common name	Coast Banksia		
Age	Semi-Mature		
Retention value	Medium		
Landscape Significance	Medium		
Useful Life Expectancy	Medium		
Condition	Fair		
Health	Fair		
General Measurements			
DAB metres (radius) Above buttress	0.30	Height (Metres)	8.00
DBH metres (radius) Breast Ht	0.24		
Canopy Spread (Metres)			
North	3.00	South	3.00
East	3.00	West	3.00
SRZ Measurements			
SRZ area (Square Metres)		SRZ radius (Metres)	2.00
SRZ Incursion (Square Metres)		SRZ Incursion %	
TPZ Measurements			
TPZ area (Square Metres)	26.06	TPZ radius (Metres)	2.88
TPZ Incursion (Square Metres)	0.43	TPZ Incursion %	1.65
Observations / Comments

Tree 3 is given a medium retention value as per IACA Significance of a Tree, Assessment Rating System (STARS) © (IACA 2010) ©. Tree 3 has a minor incursion of 1.65% by the landscape wall and paving/hardstand, refer to the Tree Impact Plan (Appendix 1).

The incursion to Tree 3 is considered minor with no adverse effects expected. Tree 3 will have will remain viable into the future.

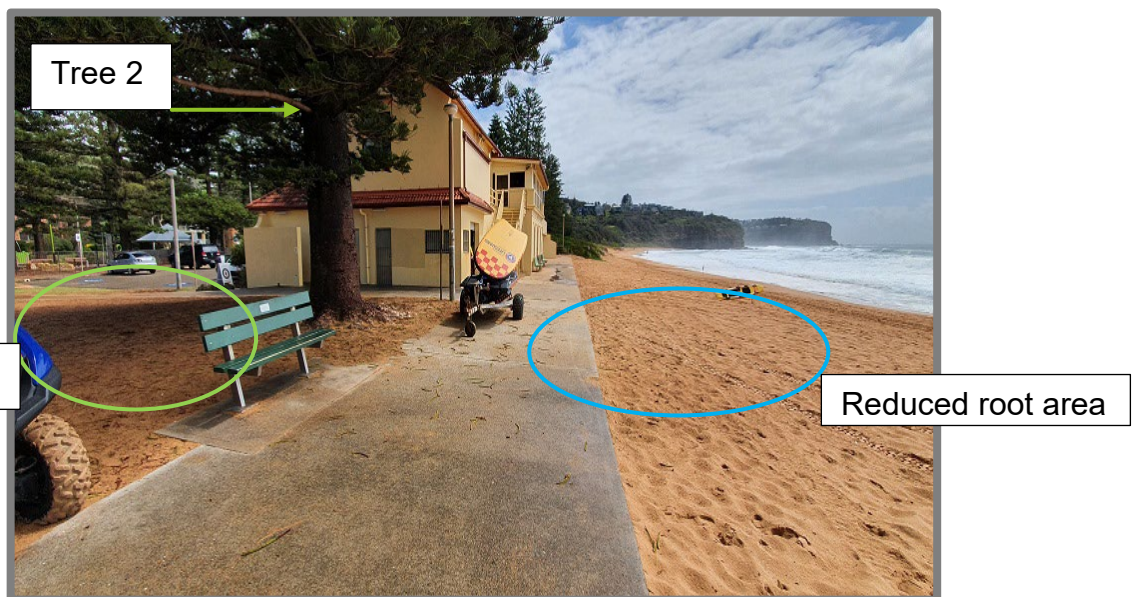
Figure 2: Tree 2

Tree 2 is given a high retention value due to its age, health, condition and position in the landscape. Tree 2 has a major incursion of 17.81% to its TPZ by the proposed sea-wall design, refer to the Tree Impact Plan (Appendix 1). The theoretical TPZ of Tree 2 currently extends onto the beach area shown in (Figure 2). Although roots are theoretically in this area, my professional opinion is the number of roots will be reduced due to the lack of water and nutrients in this area and therefore the incursion would be reduced. The main root mass is thought to be in the area to the west of the trunk, refer to (Figure 2). The current root zone incursion calculation is based on sheet piling, to ensure no excavation occurs beyond the extent shown in the Tree Impact Plan. Alternate minimally invasive construction methods may be considered with the approval of the arborist.

Tree 2 also has a potential impact to its TPZ by the new paving/hardstand alignment. To minimise this incursion and ensure Tree 2's ongoing health, the below tree sensitive construction methods and tree protection measures are recommended.

The impact to Tree 2 is acceptable considering sensitive construction methods, adequate tree protection measures and project arborist supervision throughout construction.

To minimise root damage to Tree 2, a no dig type paving/hardstand construction method is recommended within the TPZ, refer to the Tree Management Plan (Section 5) of this report.

To minimise the potential root loss incurred from the seawall construction, a temporary irrigation system and soil conditioner application is recommended, refer to the Tree Management Plan (Section 5) of this report.

A Project Arborist should be onsite for the excavation of the proposed seawall to ensure roots are pruned with a final cut to undamaged wood.

A tree protection fence is recommended for Tree 2 as shown on the Tree Impact Plan (Appendix 1) and detailed in the Tree Management Plan (Section 5) of this report.

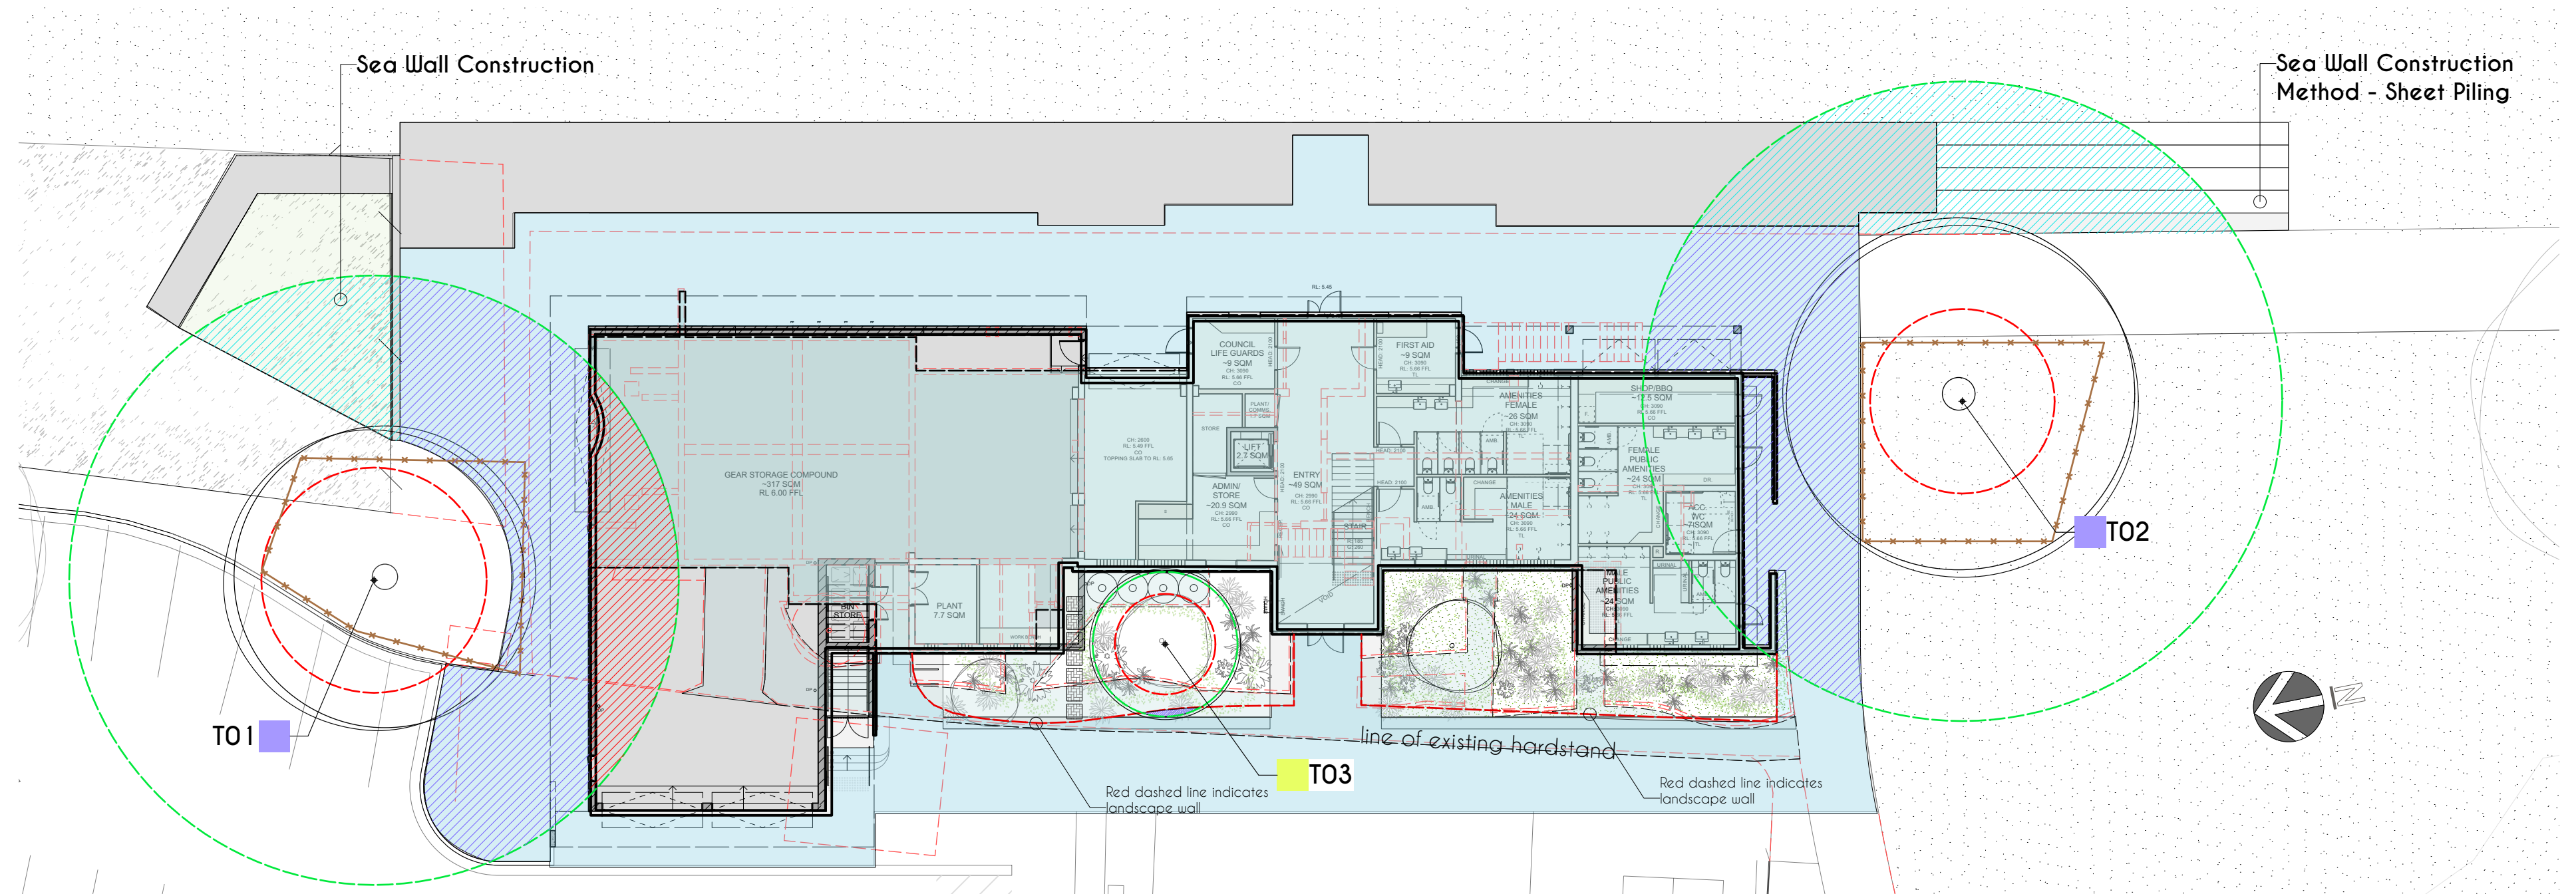
T03

SRZ = No Incursion
 TPZ = 26.06sqm
Paving and Landscape Wall
 Incursion = 0.43sqm
 Incursion = 1.65%
