Development Application for <u>Reform Projects Pty Ltd</u>	Name of Applicant
Address of site <u>1102-1106 Barrenjoey Road, Palm Beach, NSW</u>

**REPORT TO
REFORM PROJECTS PTY LTD**

**ON
SEEPAGE ANALYSIS AND GEOTECHNICAL
ASSESSMENT
(In Accordance with Pittwater Council Risk
Management Policy)**

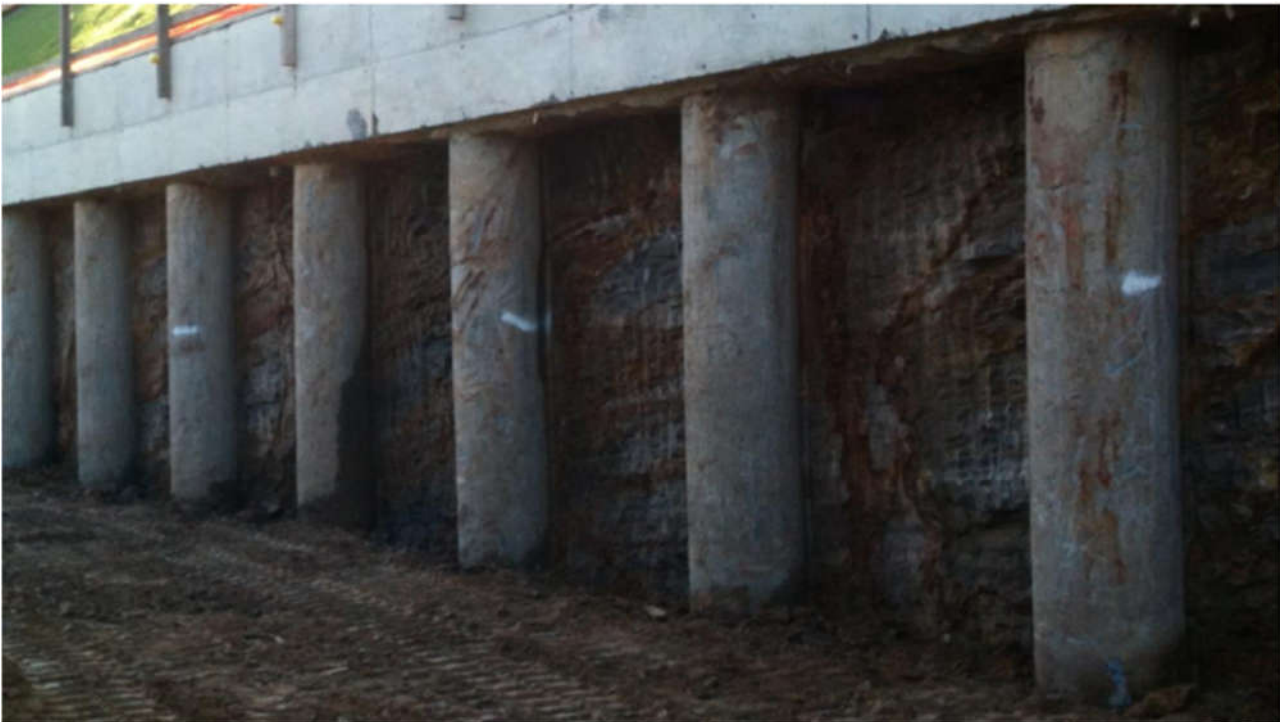
Plate 1: Photograph of Soldier Pile Wall Prior to being Shotcreted (Figure 3 from Witt Report)

The soldier pile wall comprised 0.6m diameter piles spaced at about 2.5m, with mesh and shotcrete infill panels between piles. Over the lower about 0.8m to 0.9m mesh and shotcrete has not been placed and here the materials exposed were assessed to comprise moderately weathered siltstone of low to medium strength. Water seepage was observed in this face, both over the siltstone cut face and through the shotcrete panels. Some cracks varying from 'hairline' to 2mm in width were observed in the shotcrete panels but overall the soldier pile wall appeared to be in good condition. There was a concrete section about 1.1m high above the piles, which appeared to be the capping beam. Above the capping beam was about a 1m high mesh fence. The architectural section drawing by Mills Architecture & Interiors (Ref: Drawing No. DA.01) details the base of the soldier piles at RL-0.25m. We have extracted a photograph from the Witt geotechnical investigation report, as shown below in Plate 1, of the soldier pile wall prior to being shotcreted. It appears the portion below the capping beam comprises weathered rock.

Near the southern boundary, water seepage was observed below the boulder. Along the soldier pile wall, water seepage was observed both through the shotcrete and mesh panels and over the lower siltstone bedrock exposed in the cut face below the shotcrete and mesh.

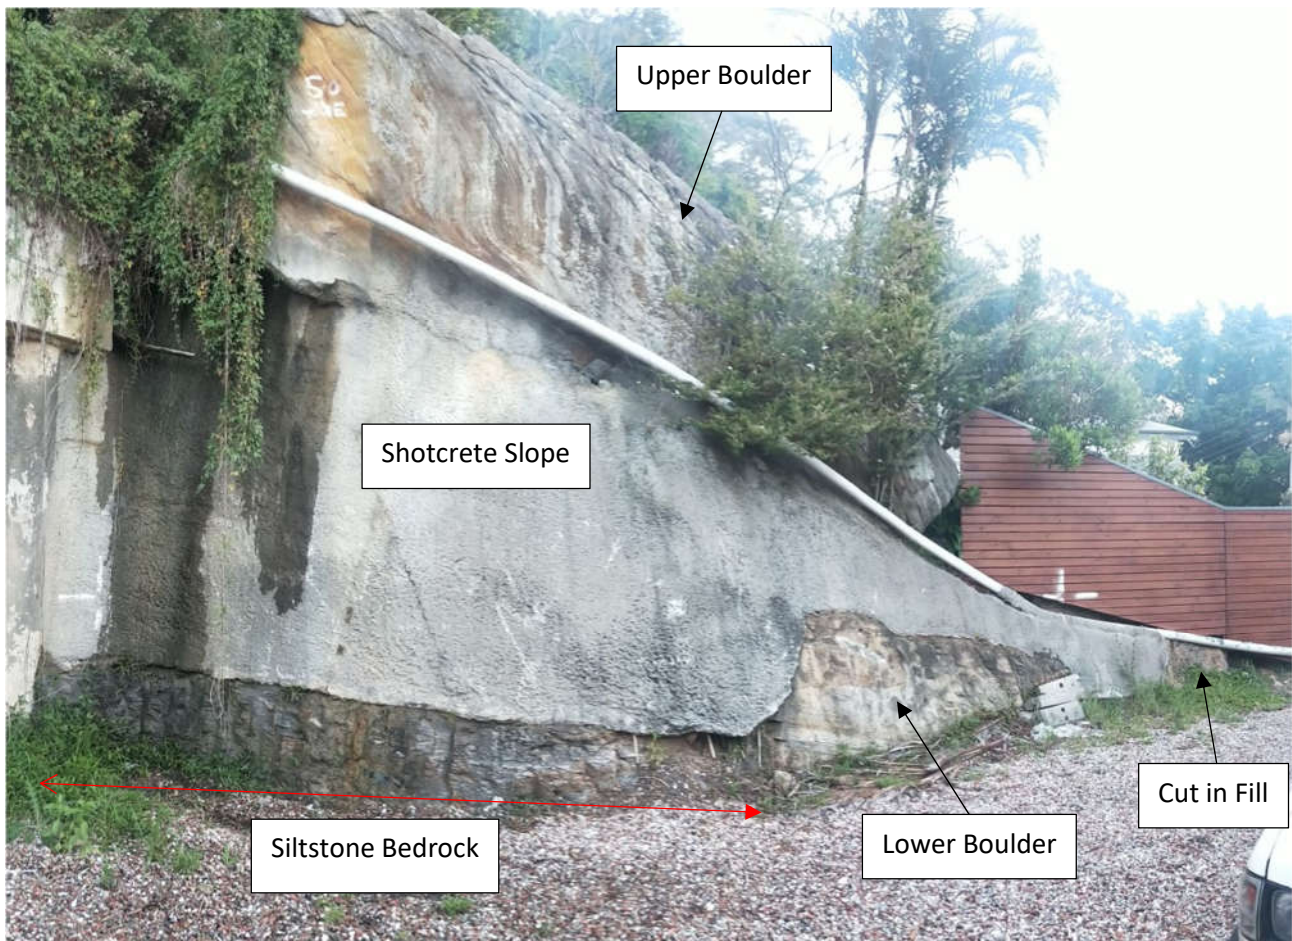
Plate 2: Photograph 1 of Large Boulders and Shotcreted Cut Face At/Near Southern Boundary (Facing South)

The below site description should be read in conjunction with Plate 2, which includes a photograph of the southern boundary area. Extending into the site near the southern boundary is a large sandstone boulder. This boulder is located in the upper portion of the profile and where excavation has extended below it the cut face has been protected with shotcrete. The boulder is approximately 2m to 3m high and extends for a length of about 7.5m. The shotcreted cut has a maximum height of approximately 3.5m and extends for a length of about 10.5m. The boulder overhangs the eastern end of the cut by about 1m to 1.5m over a length of 1.5m. Water seepage was observed below the boulder along the eastern 2m length of the shotcrete facing. A second sandstone boulder is exposed below the western end of the upper boulder. This boulder extends for a length of about 2.5m over the lower 0.7m to 1.3m of the cut. Between the eastern soldier pile wall and this lower boulder, siltstone bedrock was exposed below the shotcrete for a length of about 6m to 7m over the lower 0.8m of the cut. The siltstone bedrock was assessed to be moderately weathered and of low to medium strength. A 0.8m high vertical cut in fill was observed over a length 1m at the westernmost end of the southern cut.

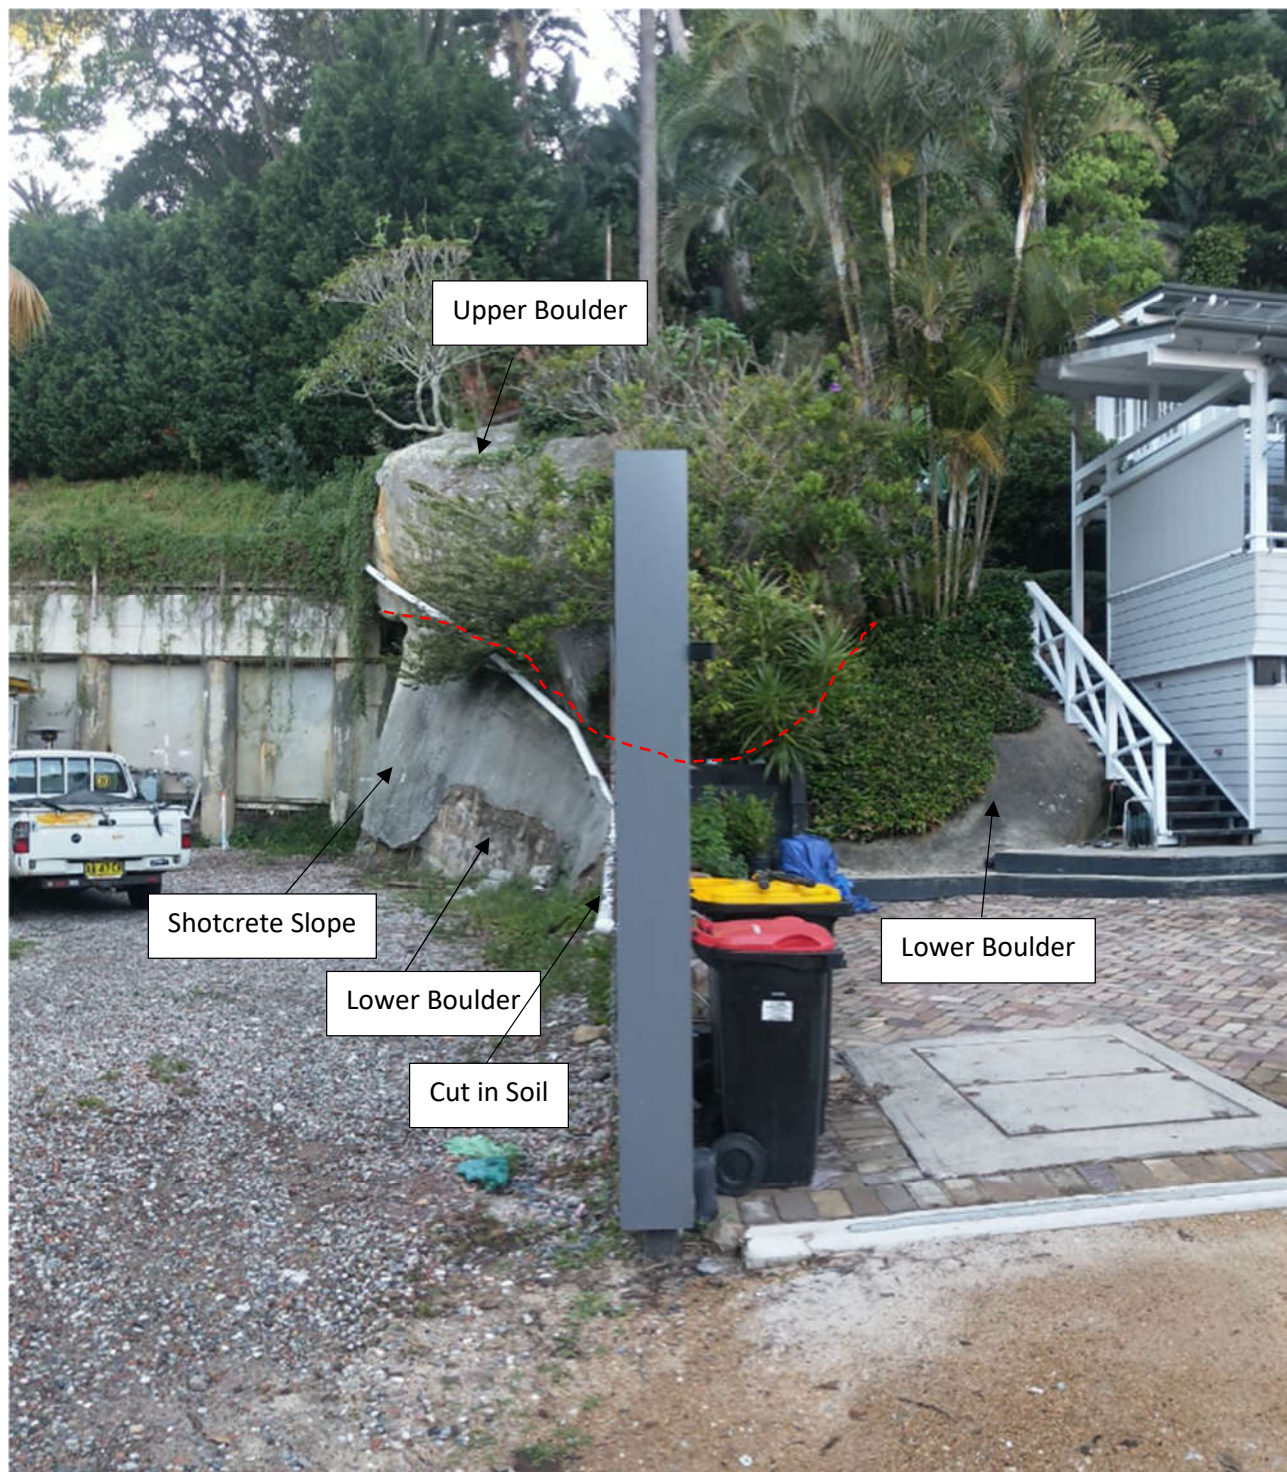
Plate 3: Photograph 2 of Large Boulders and Shotcreted Cut Face At/Near Southern Boundary (Facing East)

The site is bound by residential development to the south, 1100 Barrenjoey Road, beyond the boundary. It appears that the upper boulder visible in the southern cut face extends an additional 2.5m to the south and overlies another large boulder that extended further to the south. This can be seen below in Plate 3. Beyond these boulders is a two-storey timber clad house. To the east of the site is a flat grass area (driveway) and then a single-storey shed. To the north is a one and two storey rendered building ('Barrenjoey House', which is heritage listed) while Barrenjoey Road bounds the site to the west. All adjoining structures appeared in good condition when viewed from the site.

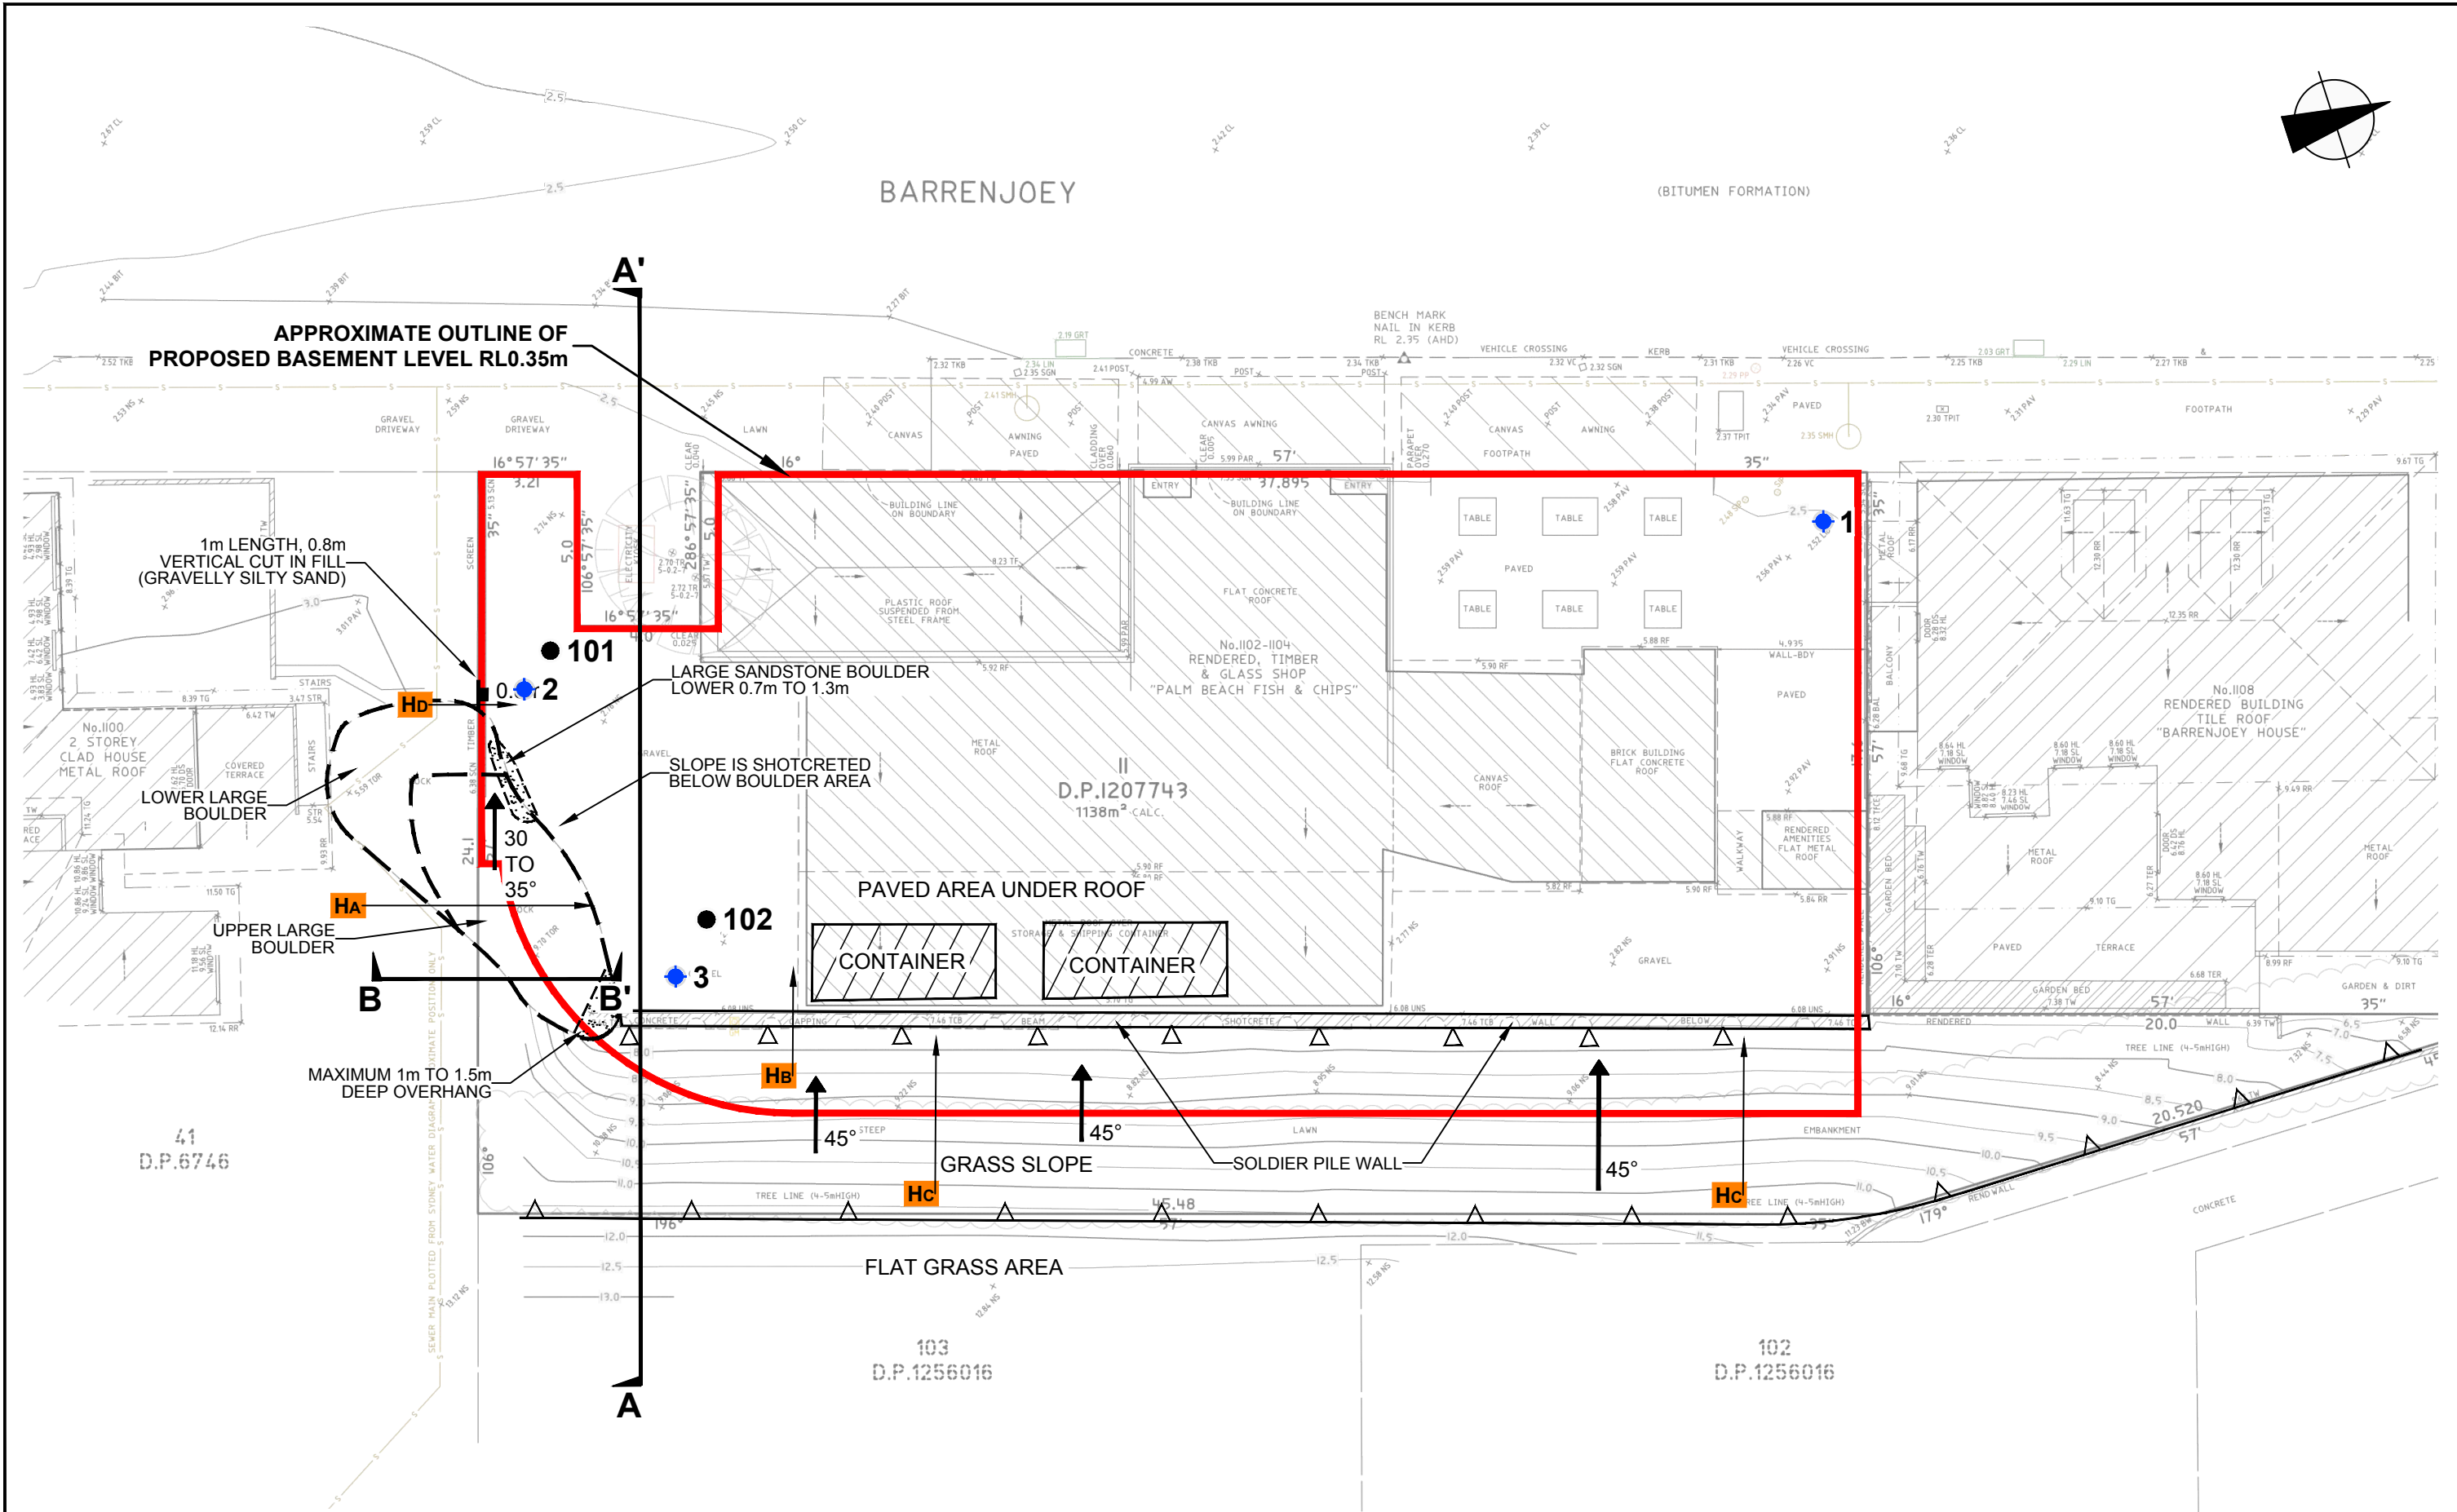
- A Stability of existing large boulder near/at the southern boundary (requires shotcrete slope below to fail, assumed as engineered);
- B Stability of the soldier pile wall to the east of the buildings (assumed as engineered);
- C Stability of the reinforced hillside upslope (east) of the soldier pile wall (assumed as engineered);
- D Stability of the localised 0.8m high vertical cut in fill along a 1m length at the southern boundary; and,
- E Stability of new engineered retaining walls

These potential hazards are indicated in schematic form on the attached Figure 3.
