GEOTECHNICAL INVESTIGATION:

Additions and Alterations at **56 Peronne Avenue, Clontarf**

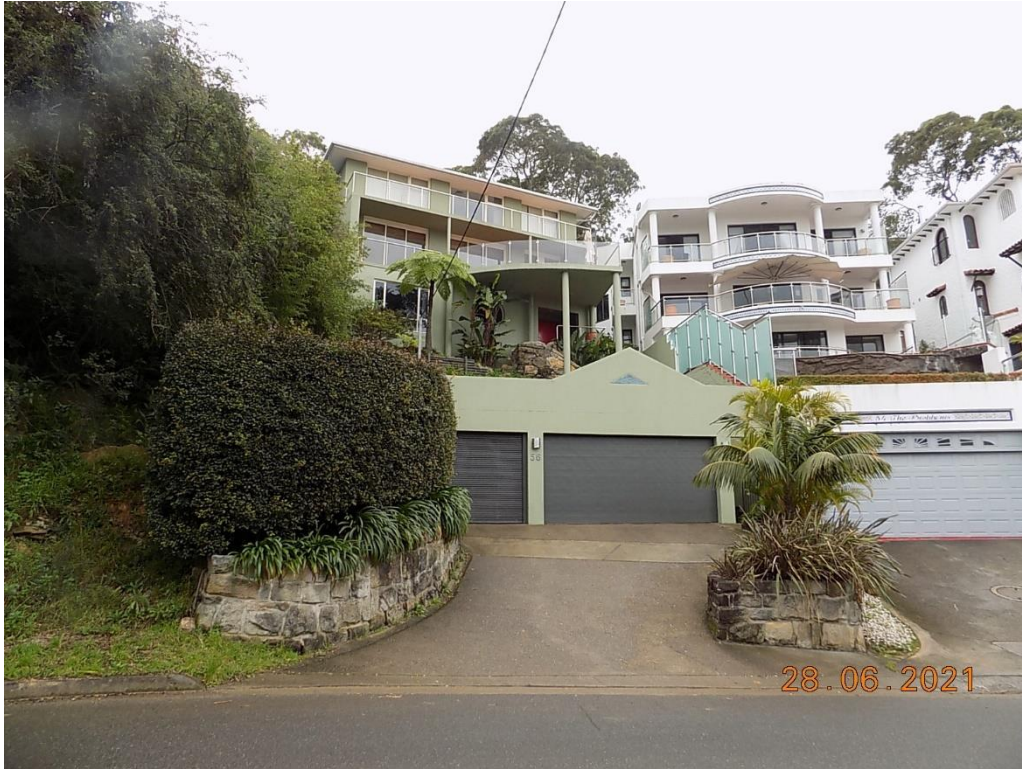
Photo 1

- 2.3** At the road frontage, a concrete driveway runs to a garage on the downhill side of the property. A stable, sandstone block retaining wall supports the cut for the driveway (Photo 1). The garage has been cut into the slope. The cut for the rendered brick garage has been taken entirely through Medium Strength Sandstone and appears stable (Photo 2). The garage is of brick construction and shows no signs of movement. A stable masonry retaining wall reaching up to ~3.0m high runs up the E common boundary and supports the E neighbouring pool area (Photo 3). A stable timber retaining wall supports the fill for a garden bed between the garage and the house

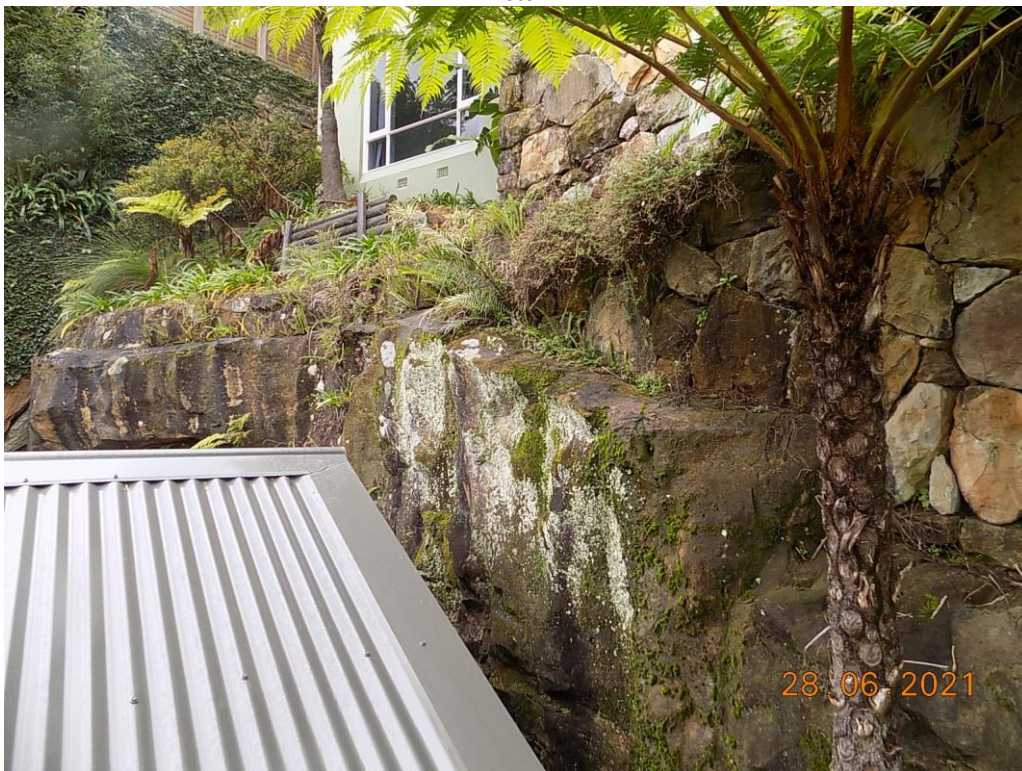
Photo 2

No geotechnical hazards were observed beside the property. The steeply graded slope that rises across the property and continues above and below is a potential hazard (**Hazard One**). The large sandstone face that steps ~2.0m up the slope is a potential hazard

(photo 2) (**Hazard Two**). The vibrations from the proposed excavations are a potential hazard (**Hazard Three**). The proposed excavation is a potential hazard until retaining walls are in place (**Hazard Four**). The tilted and partially collapsed retaining wall on the uphill side of the property is a potential hazard (Photo 11) (**Hazard Five**).

HAZARDS	Hazard One	Hazard Two	Hazard Three
TYPE	The steep slope that rises across the property and continues above and below failing and impacting on the proposed works.	The sandstone face that rises ~2.0m up the slope failing and impacting on the proposed works (Photo 2).	The vibrations produced during the proposed excavation impacting on the surrounding structures.
LIKELIHOOD	'Unlikely' (10^{-4})	'Unlikely' (10^{-4})	'Possible' (10^{-3})
CONSEQUENCES TO PROPERTY	'Medium' (15%)	'Medium' (25%)	'Medium' (15%)
RISK TO PROPERTY	'Low' (2×10^{-5})	'Low' (2×10^{-5})	'Moderate' (2×10^{-4})
RISK TO LIFE	9.1×10^{-7} /annum	2.9×10^{-7} /annum	5.3×10^{-7} /annum
COMMENTS	This level of risk is 'ACCEPTABLE', subject to the advice in Section 16 being followed.	This level of risk is 'ACCEPTABLE'.	'UNACCEPTABLE' level of risk to life and property. To move risk to 'ACCEPTABLE' levels, the recommendations in Section 12 are to be followed.

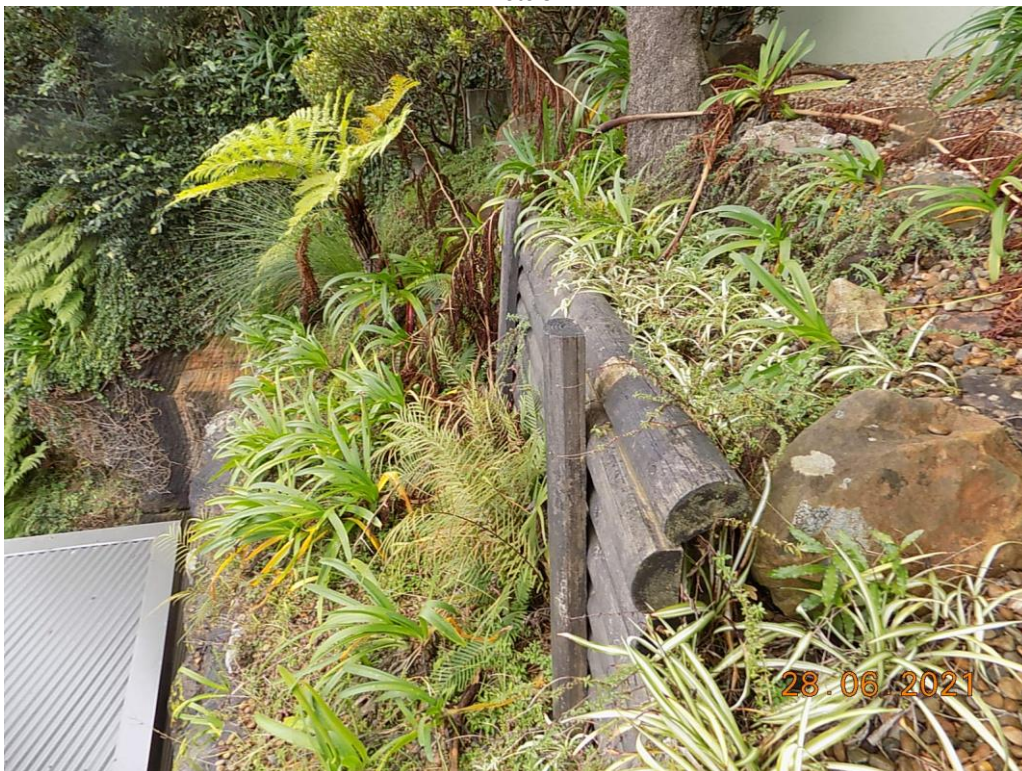
Photo 4

(Photo 4). A ~2.5m high, stable sandstone block retaining wall runs along the W common boundary and supports the neighbouring property (Photo 5). The part three-storey brick house on the downhill side of the property is supported on external brick walls and external steel columns. The brick walls show no significant signs of movement and the steel columns appear to stand vertical. Access to the foundation space of the dwelling on the downhill side of the property was unavailable at the time of inspection. Competent Medium Strength Sandstone outcrops immediately above the dwelling on the downhill side of the property (Photo 7). The outcrop was observed to be slightly undercut but is considered stable. A series of low timber retaining walls up to ~0.5m high form garden beds that terrace the slope between the upper and lower dwellings (Photo 8). A timber log retaining wall supports the fill for a decked path leading to the uphill dwelling. This retaining wall and deck are to be demolished as part of the proposed works. The part two-storey, steel and timber framed and clad house on the uphill side of the property is supported on brick walls and steel posts (Photo 9). Some of the supporting walls and posts were observed to be supported directly onto outcropping Medium Strength Sandstone. The brick walls show no significant signs of movement and the steel posts appear to stand vertical. Exposed sandstone benches continue to step up the slope to the upper common boundary (Photo 10). A rough stack rock wall on the upper common boundary supports the fill for the E neighbouring property (photo 11). The wall appears to be in the process of collapsing. See **Section 16** for advice regarding this wall.

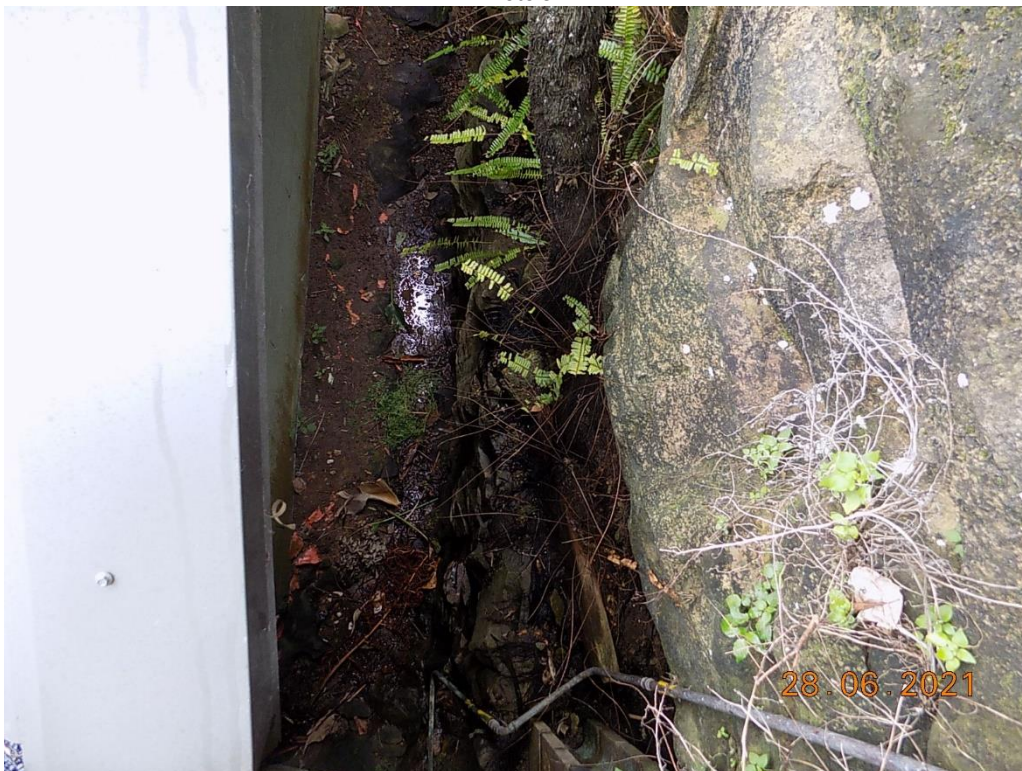
Photo 6

Normal ground water seepage is expected to move over the buried surface of the rock and through the cracks. This type of seepage was observed at the rock exposure immediately behind the garage (Photo 6). Due to the slope and elevation of the block, the water table is expected to be many metres below the base of the proposed excavation.

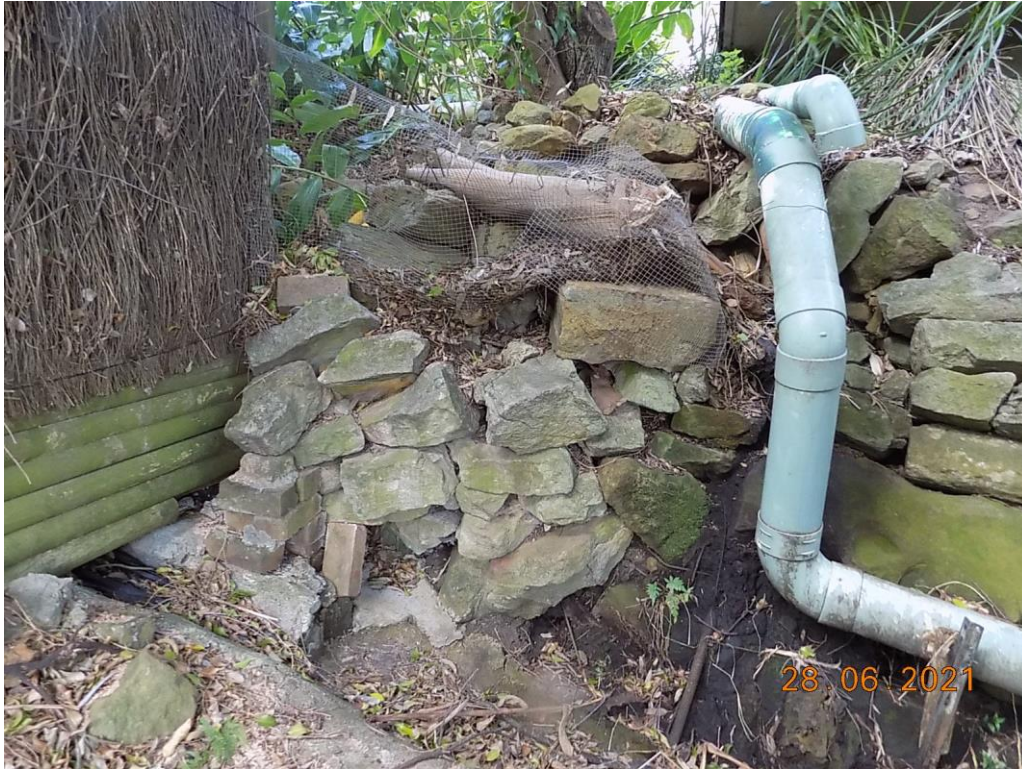
Photo 11

HAZARDS	Hazard Four	Hazard Five
TYPE	The excavation (up to a maximum depth of 1.2m) collapsing onto the work site before retaining walls are in place.	Further movement of the stack rock retaining wall above the house that causes damage or failure (Photo 11).
LIKELIHOOD	'Possible' (10^{-3})	'Likely' (10^{-2})
CONSEQUENCES TO PROPERTY	'Medium' (15%)	'Insignificant' (0.5%)
RISK TO PROPERTY	'Moderate' (2×10^{-4})	'Low' (5×10^{-5})
RISK TO LIFE	8.3×10^{-6} /annum	4×10^{-7} /annum
COMMENTS	'UNACCEPTABLE' level of risk to life and property. To move risk to 'ACCEPTABLE' levels, the recommendations in Section 13 are to be followed.	This level of risk to life and property is 'ACCEPTABLE'. Section 16 provides recommendations regarding this wall.

The roughly stacked rock retaining wall on the uphill common boundary is in the process of collapsing (photo 11). Should it collapse, it will block the drain and damage the pipes. We recommend it be restacked or rebuilt to current engineering standards during the proposed works. Alternatively, the retaining wall can be inspected by the owners on an annual basis or after heavy prolonged rainfall, whichever occurs first, keeping a photographic record of the inspections. We can carry out these inspections upon request. Should any new movement be observed, the retaining wall is to be remediated or rebuilt to current engineering standards.

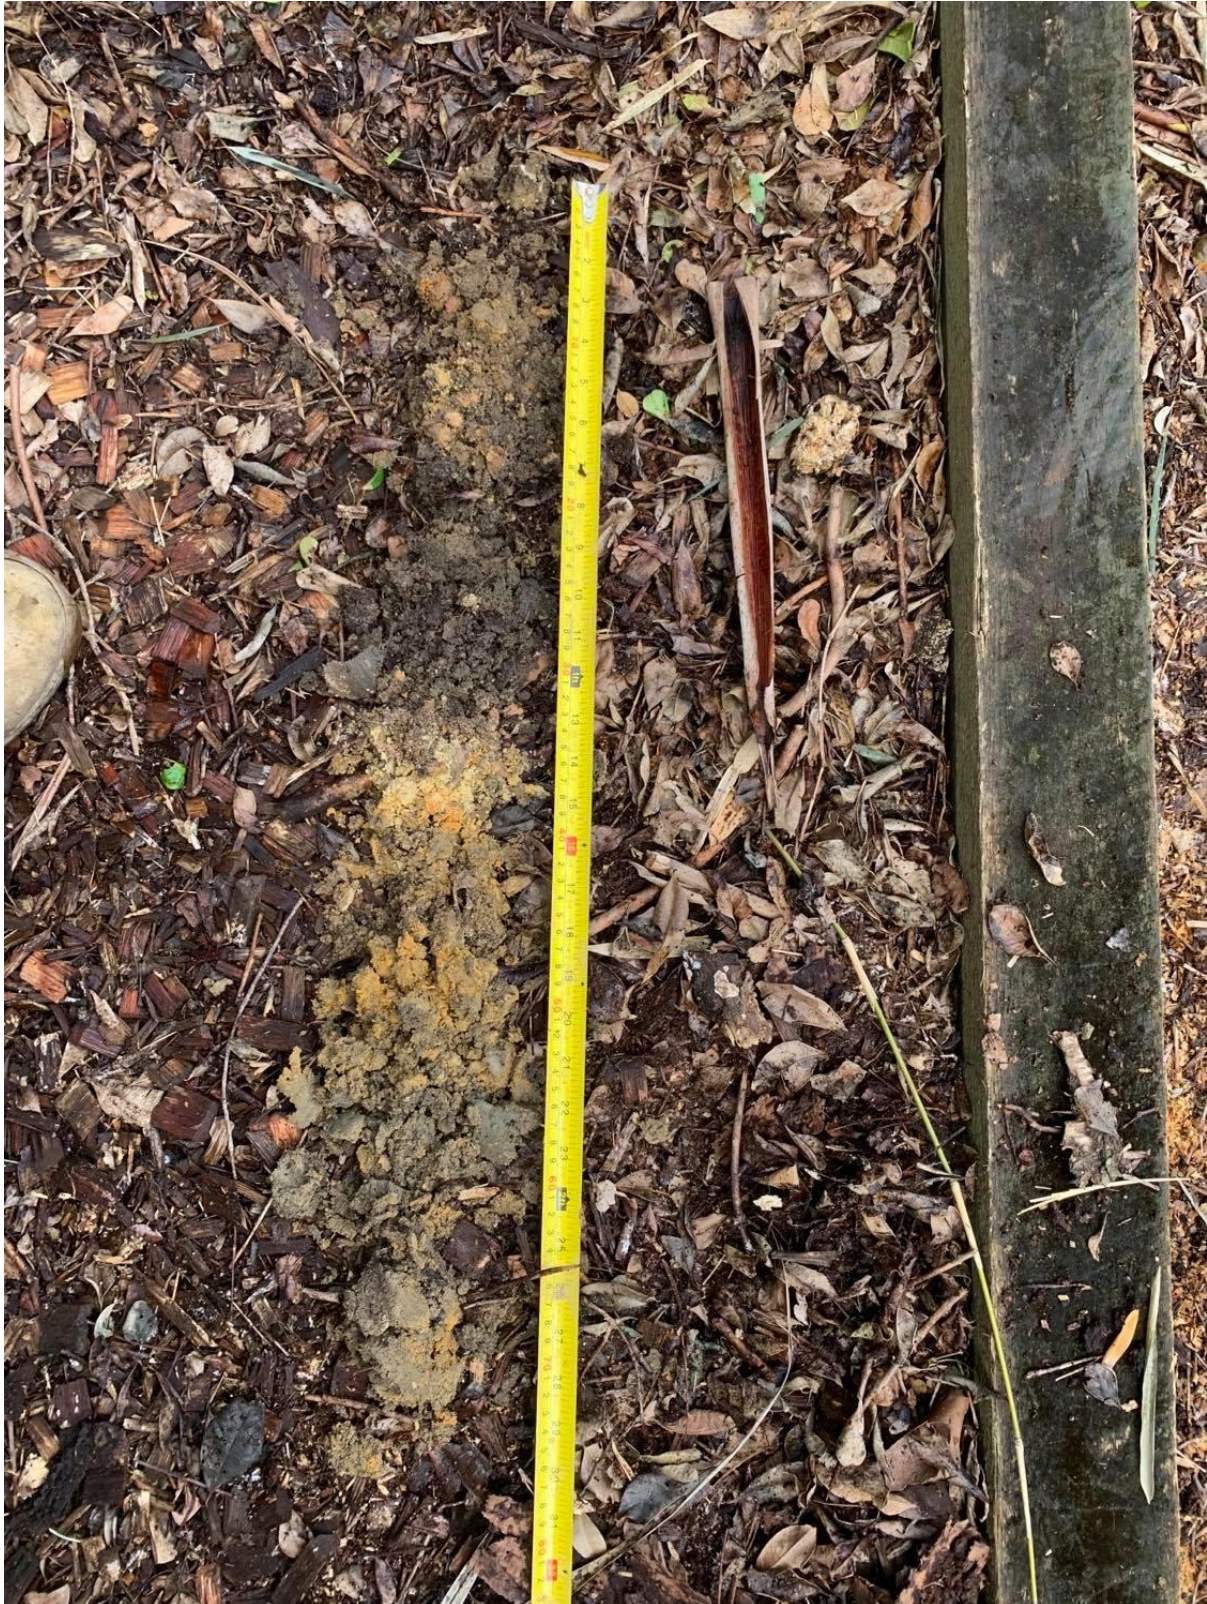
Photo 12 (top to bottom)

AUGER HOLE 1 (~RL52.5) – AH1 (Photo 12)

Depth (m)	Material Encountered
0.0 to 0.3	FILL , sandy soil, dark brown, loose, damp, orange and yellow sand intermixed, fine to coarse grained, fine trace of organic matter.
0.3 to 0.5	FILL , yellow, white, and orange sand, loose, damp, fine to coarse grained, traces of rock fragments.
0.5 to 0.7	FILL , orange and brown clayey sand, loose to medium dense, dry, medium grained.

Refusal @ 0.7m on rock. No watertable encountered.
