51 PLATEAU ROAD, AVALON
ADDENDUM TO ACCOMPANY GEOTECHNICAL REPORT

MT 31454
20^h April, 2018
Page 1

RISK ANALYSIS & MANAGEMENT FOR PROPOSED CARPORT RELOCATION AT 51 PLATEAU ROAD AVALON

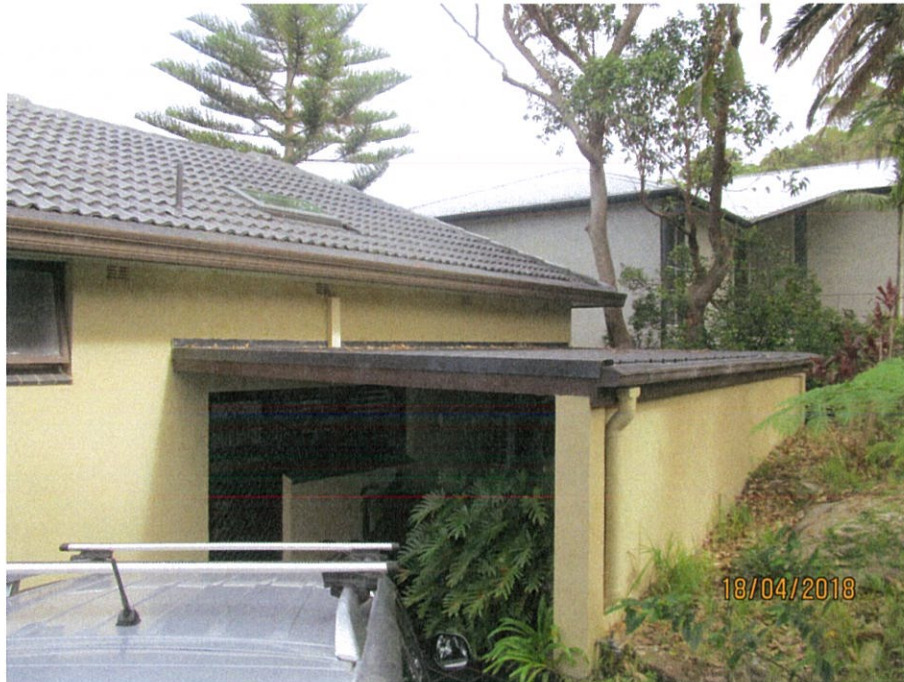
Photo 1

3.3 Vehicular entry is via a steep concrete driveway that arcs around from the road frontage to a carport that runs along the northern side of the residence (Photo 1). Pedestrian access is also via the driveway. Rock steps (Photo 2), along the eastern side of the residence lead down to a lower deck area (Photo 3). From the deck area steps formed by wooden sides (Photo 4) lead from the south western corner of the residence through a heavily vegetated area to a level grassed area running along the southern boundary (Photos 5 & 6). Under the deck area there is an area of stacked rock and soils (Photo 7). This area was stable at the time of the inspection, but attention will need to be paid to ensure its long term stability in the future. There is a wooden retaining wall on the southern boundary of the adjacent property to the west. This wall is showing signs of failure and will need attention in the near term. The stability of this wall is not considered a risk to the stability of the subject property. Rock steps extend up past the wooden steps on the western side of the residence (Photo 4), and lead to a large sandstone outcrop (Photo 9). Sandstone outcropping is abundant in the garden area between the residence and the road frontage (Photos 10 & 11). Between the northern boundary and the road kerb is a low wooden wall in good condition (Photo 12). At the time of our inspection the house and grounds were found to be in good condition with no signs of significant movement related to slope instability.

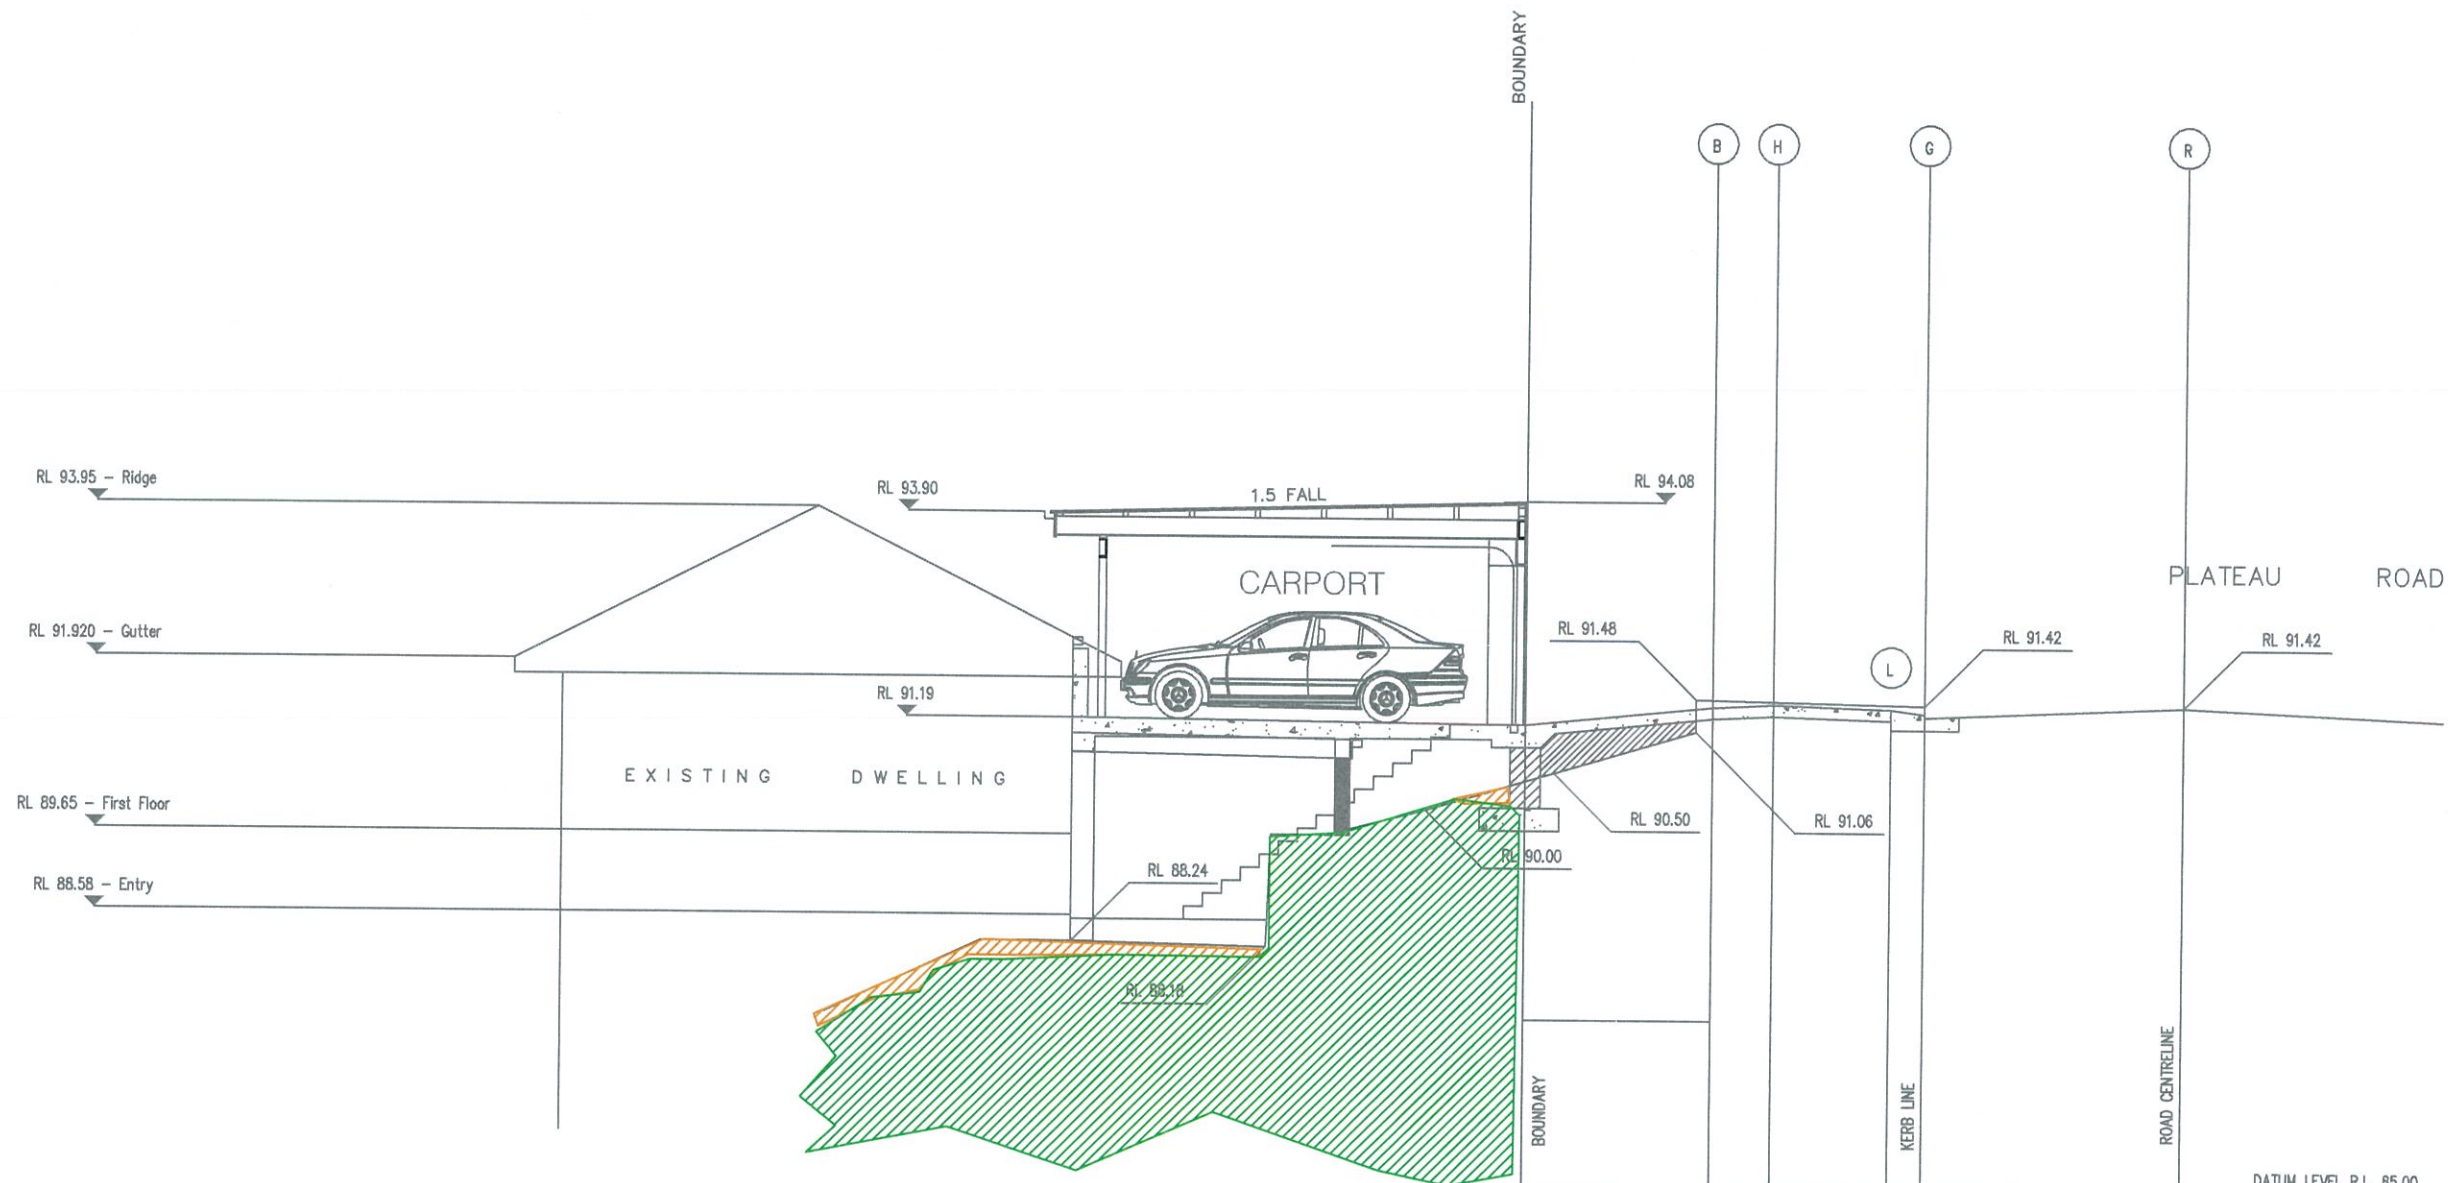
NOTE
INTERPRETED SUB SURFACE SECTION ONLY.
ACTUAL GROUND CONDITIONS MAY VARY.
