23 Hay Street, Collaroy Plateau

Geotechnical Comments for Section 4.55

GEOTECHNICAL INVESTIGATION:

New House (Alts & Adds) & Pool at 23 Hay Street, Collaroy Plateau

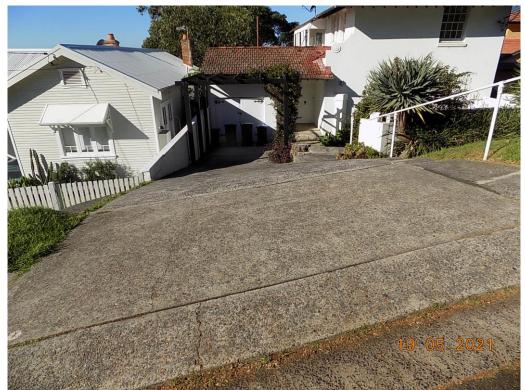
Photo 1

2.3 At the road frontage, a concrete driveway runs to a carport and garage attached to the N side of the house (Photo 1). Both the carport and garage will be demolished as part of the proposed works. An excavation has been made in the slope

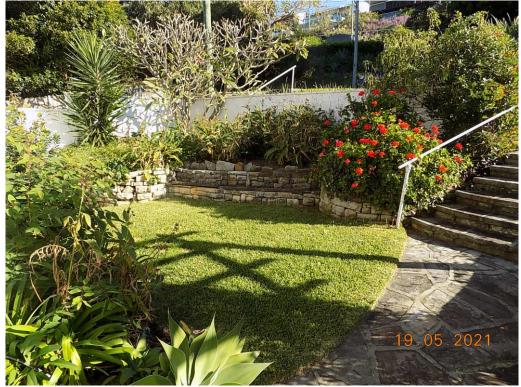
Photo 2

between the road frontage and the house for a gently sloping lawn and garden area (Photo 2). The cut is supported by a concrete block retaining wall that displays stepped cracking and will also be demolished as part of the proposed works (Photo 3). The part three-storey rendered brick house is supported on brick walls and brick piers (Photo 4). The majority of these walls and piers will be demolished as part of the proposed works. The S supporting wall that is to remain displays significant cracking in multiple locations (Photos 5 & 6). We recommend this wall be rebuilt as part of the proposed works. A stone-paved fill extends off the NE corner of the house (Photo 7). The fill and its supporting sandstone block retaining wall (Photo 8) will both be removed as part of the proposed works. A gently sloping lawn falls from the downhill side of the house to the lower common boundary (Photo 9). Portions of the lawn have been filled and are battered to stable angles.

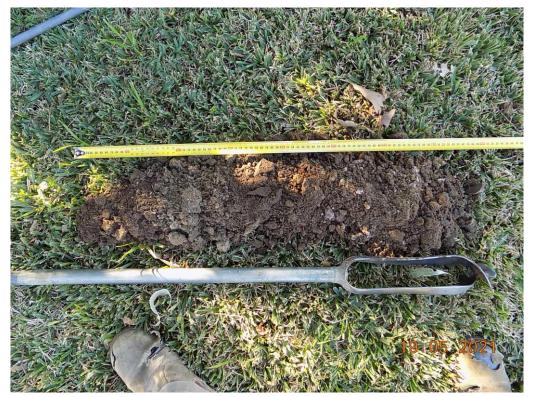
AUGER HOLE 1 (~RL27.4) – AH1 (Photo 10)

Depth	(m)	Material Encountered
0.0 to	0.8	FILL , disturbed clayey soil, dark brown, medium dense to dense, dry, fine to coarse grained with fine trace organic matter and rock fragments.

End of test @ 0.8m in fill. No water table encountered.

Photo 10 – AH1: Downhole is from left to right
