Geotechnical Assessment

Project: Alterations & Additions
2-4 Kent Street, Collaroy NSW

Prepared for:
Mark & Belinda Farrell

Ref: AG 25035
3 February 2025

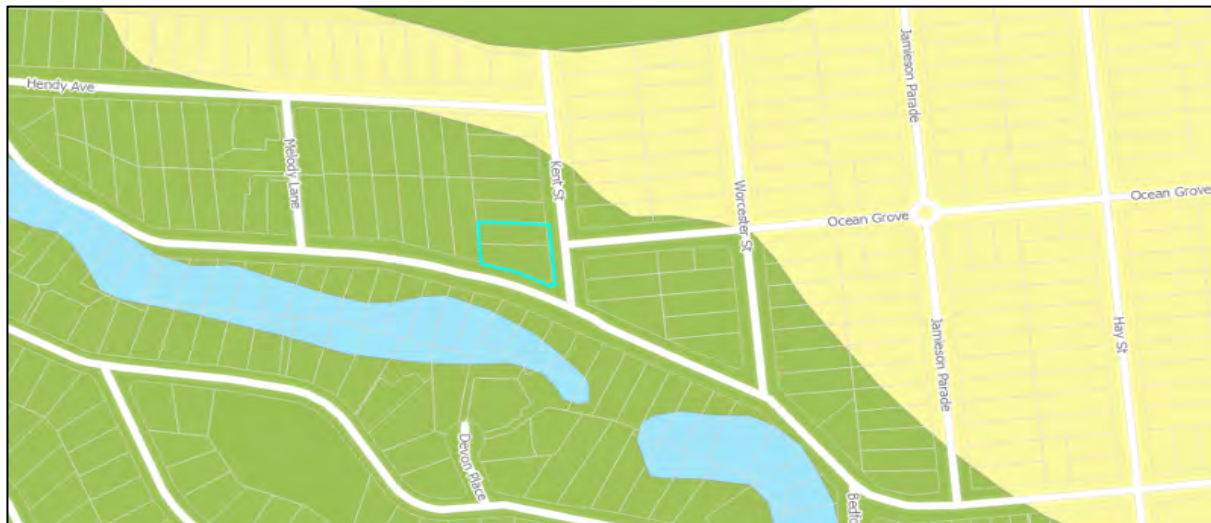
Image 2. Warringah Landslip Risk Map:
2-4 Kent Street, Collaroy NSW (© NBC Maps)

- No evidence of significant soil creep, tension cracks or landslip instability were identified across the site or on adjacent properties as viewed from the subject site at the time of our inspection.
- The property is classified as **Area D** with reference to Northern Beaches Council WLEP – Warringah Landslip Risk Map (**Image 2**).

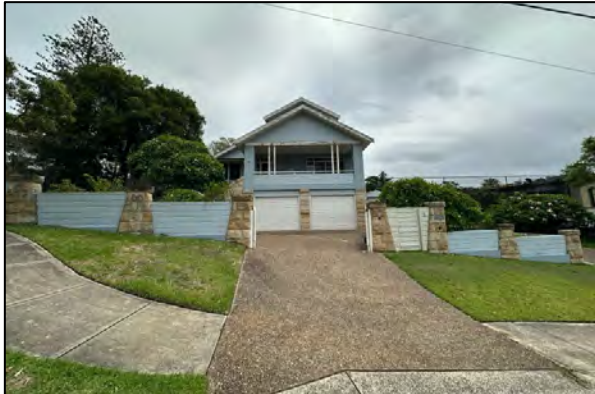
Photo 1: Site frontage, looking west.

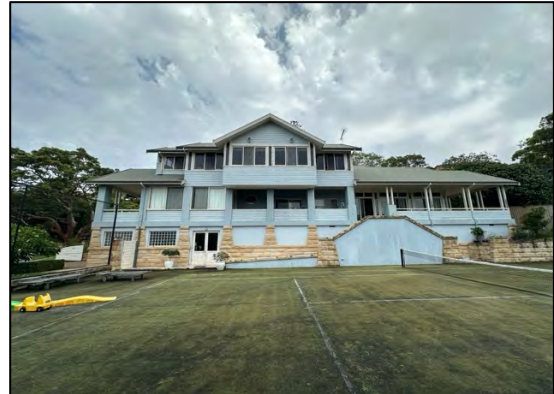
Photo 2: Photo taken from southern boundary, looking north.

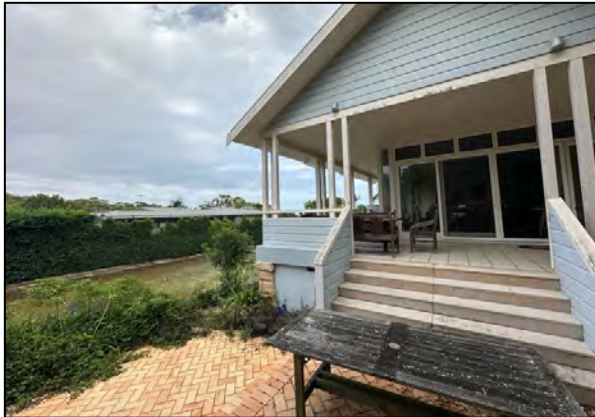
Photo 3: Photo taken from rear of site, looking east.

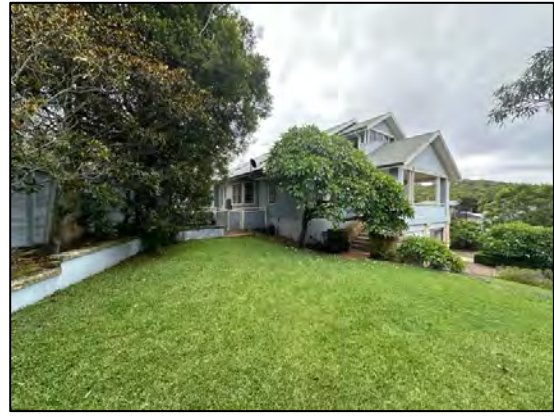
Photo 4: Photo taken from southeastern corner of site, looking west.

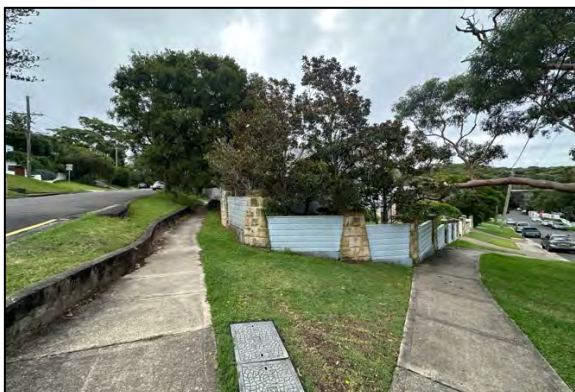
Photo 5: Photo taken from outside of southeastern corner of site, looking west.
