# ARBORICULTURAL IMPACT REPORT

13A OCEAN ROAD  
PALM BEACH NSW

4 JULY 2016

PREPARED FOR MICHELE AND TREVOR MATTHEWS

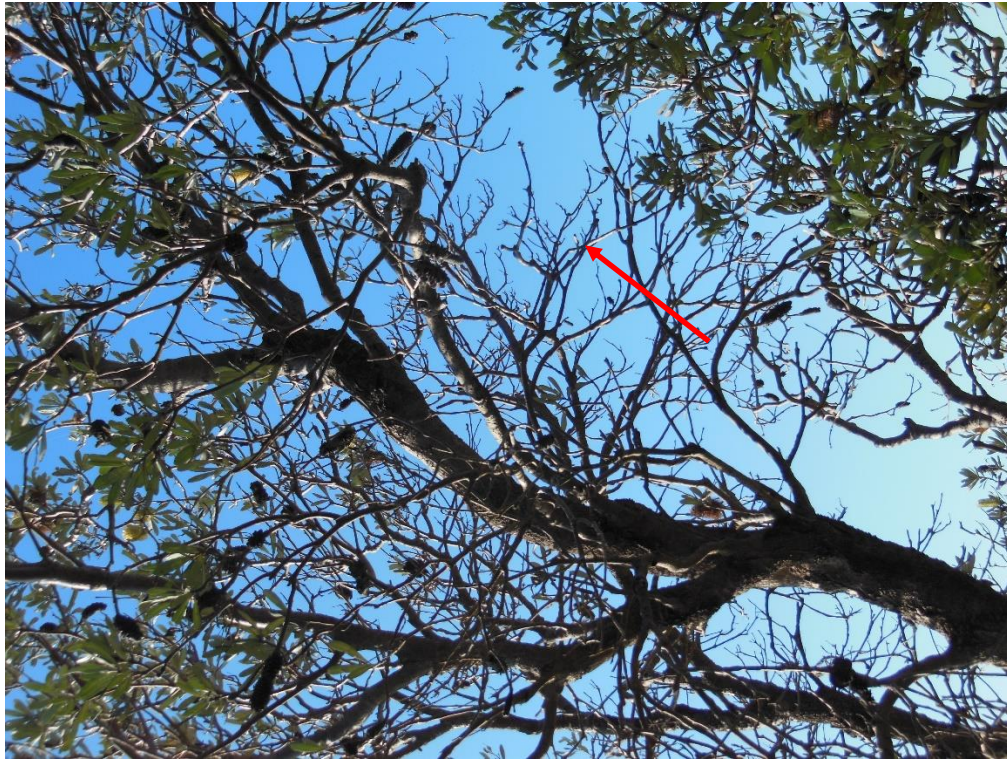
| <b>Tree Number</b> | <b>Species and Common Name</b> | <b>Summary</b> |
|---|---|---|
| 1 | <i>Banksia integrifolia</i><br>(Coast Banksia) | A mature, single trunked specimen approximately 7 metres in height with a canopy spread of 4 metres and a diameter at breast height (DBH) of ca. 280mm. In moderate health and of low to moderate landscape significance. Basal trunk not seen (access limited). At the time of inspection the tree was of moderate health and fair vigour and exhibited reduced foliage density and high levels of dieback. |

Photograph 1: Tree #1 - Illustrating the reduced foliage density and high levels of dieback.

| Tree Number | Species and Common Name | Summary |
|---|---|---|
| 1 | <i>Banksia integrifolia</i> (Coast Banksia) | The tree is within the footprint of the proposed dwelling and will require removal. |

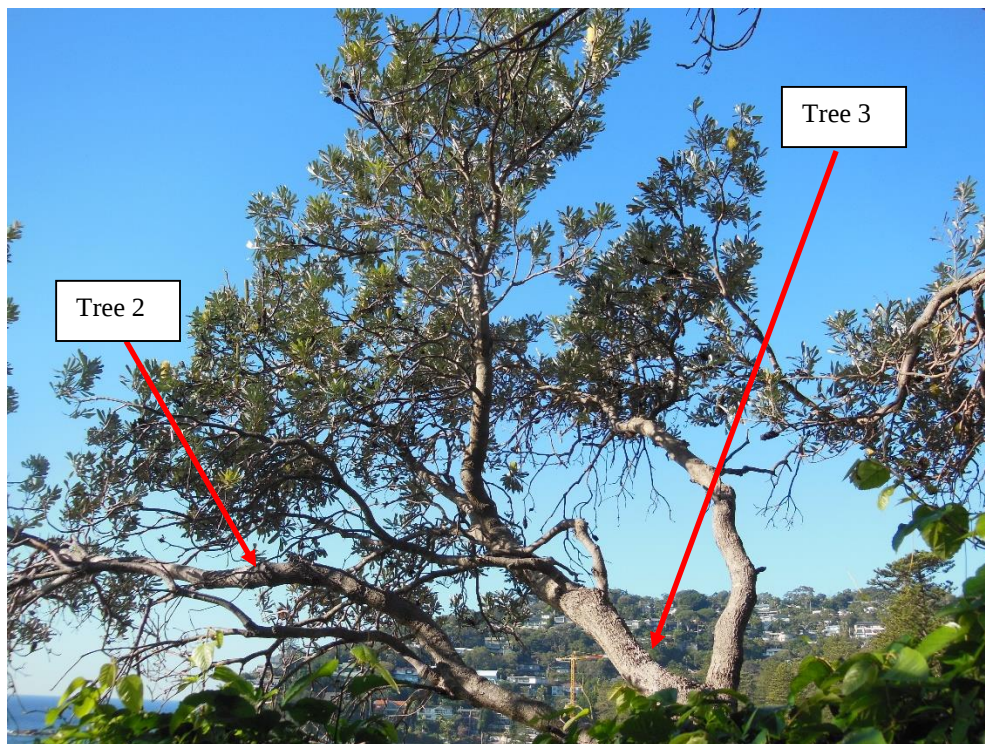
| <b>Tree Number</b> | <b>Species and Common Name</b> | <b>Summary</b> |
|---|---|---|
| 2 | <i>Banksia integrifolia</i><br>(Coast Banksia) | A mature, single trunked specimen approximately 7 metres in height with a canopy spread of 4 metres and a DBH of ca. 200mm. In good health and of low to moderate landscape significance. The tree displays a slight trunk lean and canopy bias to the south. At the time of inspection the tree was of fair vigour and exhibited moderate levels of dieback. |
| 3 | <i>Banksia integrifolia</i><br>(Coast Banksia) | A mature, single trunked specimen approximately 8 metres in height with a canopy spread of 7 metres and a DBH of ca. 350mm. In good health and of moderate landscape significance. At the time of inspection the tree was of fair vigour and exhibited moderate levels of dieback. |

Photograph 2: Illustrating the tree numbers 2 and 3.

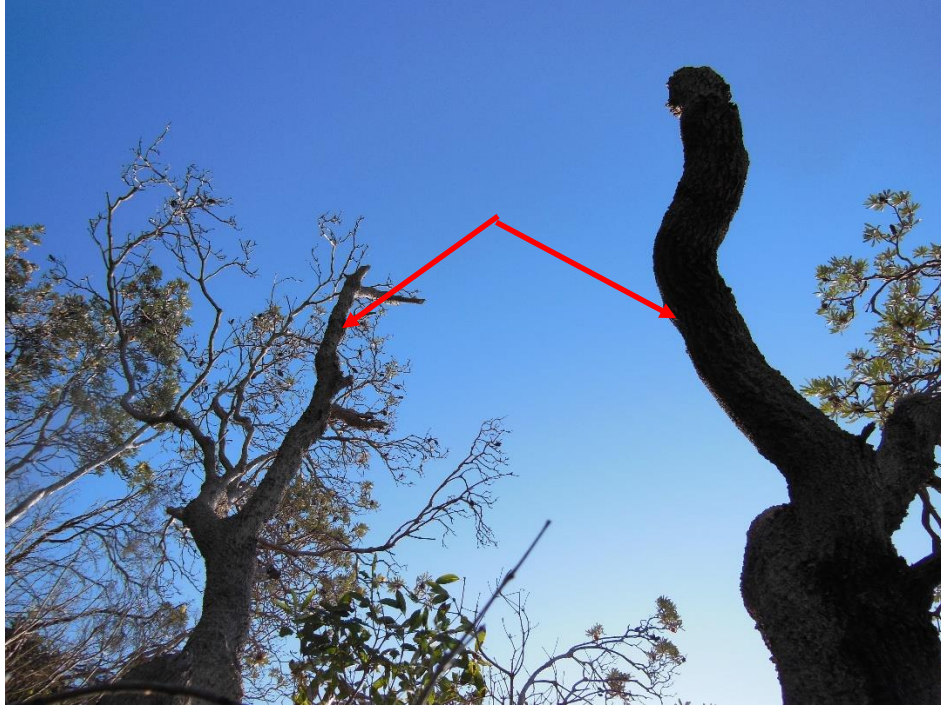
| <b>Tree Number</b> | <b>Species and Common Name</b> | <b>Summary</b> |
|---|---|---|
| 4 | <i>Banksia integrifolia</i><br>(Coast Banksia) | A mature, single trunked specimen approximately 9 metres in height with a canopy spread of 8 metres and a DBH of 410mm. In poor health and of low landscape significance. The tree displays fair branch attachment with codominant leaders from 1.4 metres - not considered at risk of failure in the short to medium term. At the time of inspection the tree was of poor health and poor vigour and exhibited significantly reduced foliage density and significant levels of dieback. There are lesions on the lower trunk indicative of fungal canker. |

Photograph 3: Tree # 4 - Illustrating the significantly reduced foliage density and significant levels of dieback.

| Tree Number | Species and Common Name | Summary |
|---|---|---|
| 4 | <i>Banksia integrifolia</i> (Coast Banksia) | The tree is within the footprint of the proposed dwelling and will require removal. |

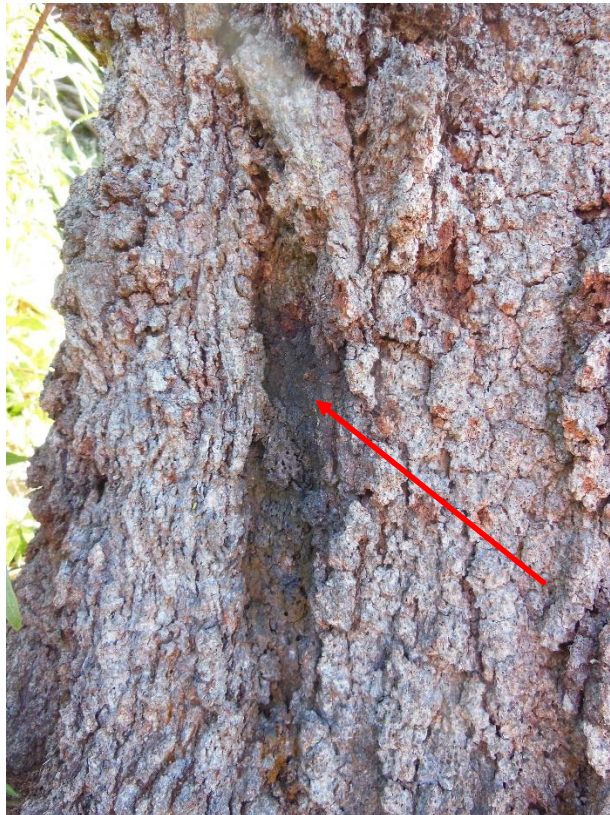
Photograph 4: Tree # 4 - Illustrating the lesions on the lower trunk indicative of fungal canker.

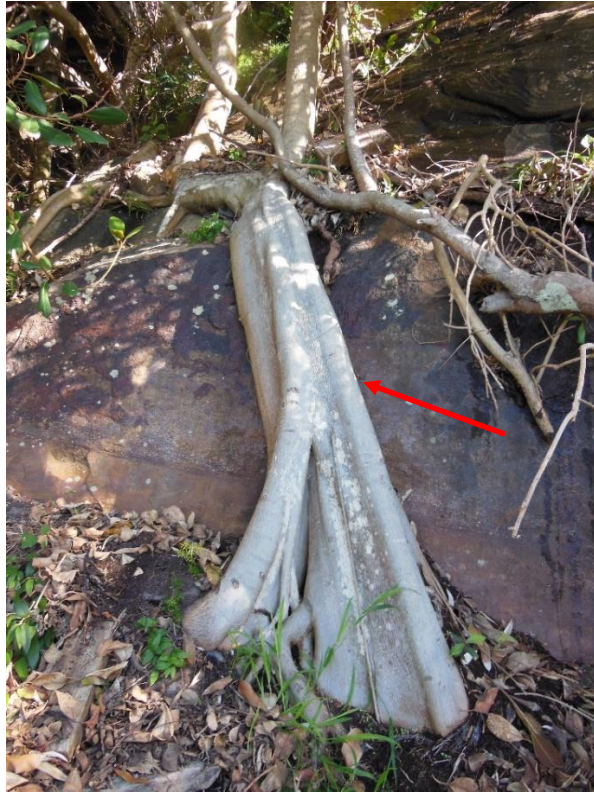
| <b>Tree Number</b> | <b>Species and Common Name</b> | <b>Summary</b> |
|---|---|---|
| 6 | <i>Ficus rubiginosa</i><br>(Port Jackson Fig) | A semi mature, single trunked specimen approximately 7 metres in height with a canopy spread of 9 metres and a DBH of 340mm. In good health and of moderate landscape significance. The tree has a slight lean along the rock face on which it is growing. Exposed woody roots from tree within site to east of trunk. |

Photograph 5: Tree # 6 - Illustrating the slight lean along the rock face on which it is growing.

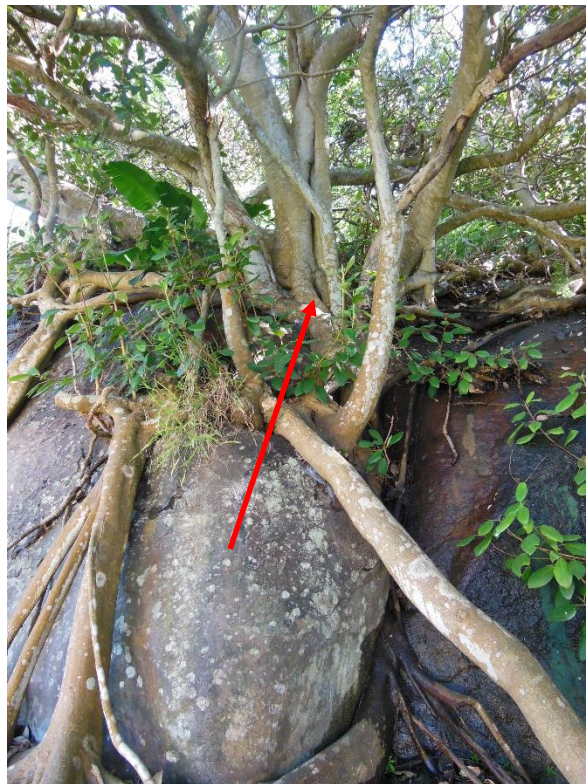
| 10 | <i>Ficus rubiginosa</i><br>(Port Jackson Fig) | A mature, multi trunked specimen approximately 9 metres in height with a canopy spread of 16 metres and DBH of up to ca. 450mm (ca. 700mm above the root flare). In good health and of high landscape significance.<br>The tree displays fair branch attachment with multiple leaders with some evidence of poor attachment at the junctions - the junctions are weak points in the tree's structure with increased risk of failure but are not considered at risk of failure in the short term. Exposed woody roots from the tree within the site. |

| Tree Number | Species and Common Name | Summary |
|---|---|---|
| 10 | <i>Ficus rubiginosa</i> (Port Jackson Fig) | The proposed dwelling is located 2.9 metres from the tree at the closest point and is calculated to encroach within 34.26m <sup>2</sup> or 15.46% of the tree’s identified TPZ – this is a moderate level of impact and within an acceptable threshold. The root zone impacts will be reduced to a degree by the exposed sandstone outcrops in the area impacted. While some canopy pruning is likely the extent of pruning will be reduced due to the level change between the tree and dwelling. |

Photograph 6: Tree # 10 - Illustrating the location and context.

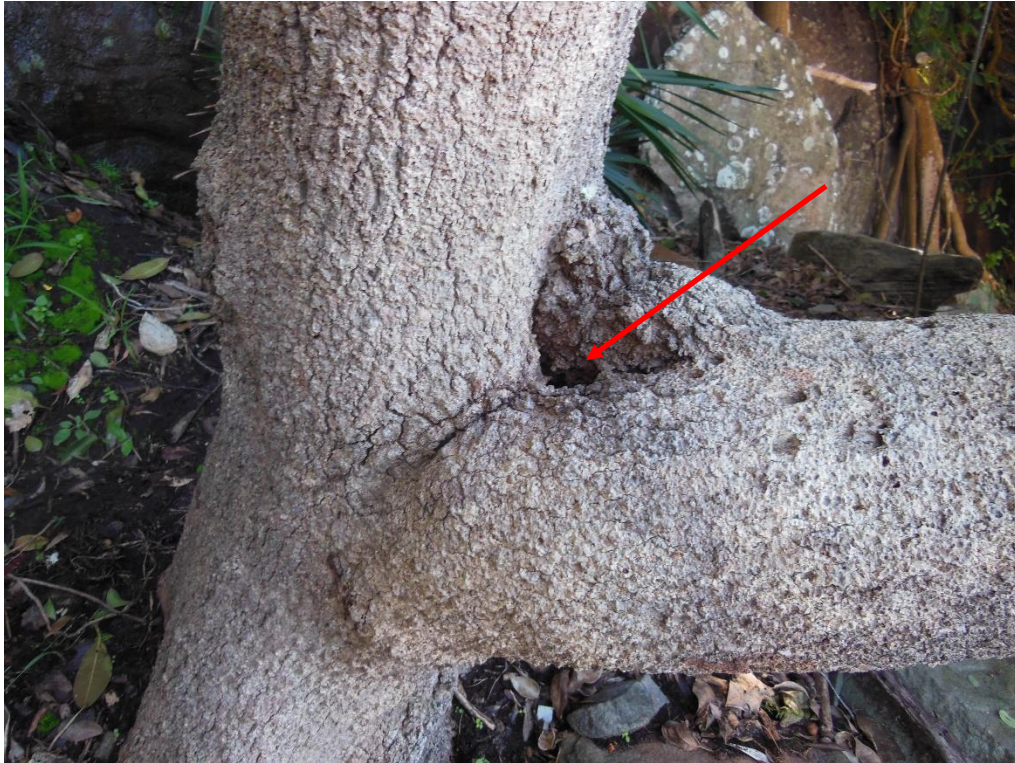
| 11 | <i>Banksia integrifolia</i><br>(Coast Banksia) | A mature, multi trunked specimen approximately 8 metres in height with a canopy spread of 7 metres and DBH of up to 260mm (300mm above the root flare). In moderate health and of moderate landscape significance.<br>The tree displays fair to poor branch attachment with codominant leaders form 1 metre with evidence of decay in the trunk at the junction of leaders. At the time of inspection the tree was of moderate health and fair vigour and exhibited moderate to high levels of dieback. |

| 11 | <i>Banksia integrifolia</i><br>(Coast Banksia) | The proposed dwelling is located 2.9 metres from the tree at the closest point and is calculated to encroach within 0.87m <sup>2</sup> or 2.14% of the tree's identified TPZ – this is a low level of impact and within an acceptable threshold. |

Photograph 7: Tree # 11 - Illustrating the codominant leaders from 1 metre with evidence of decay in the trunk at the junction of leaders.

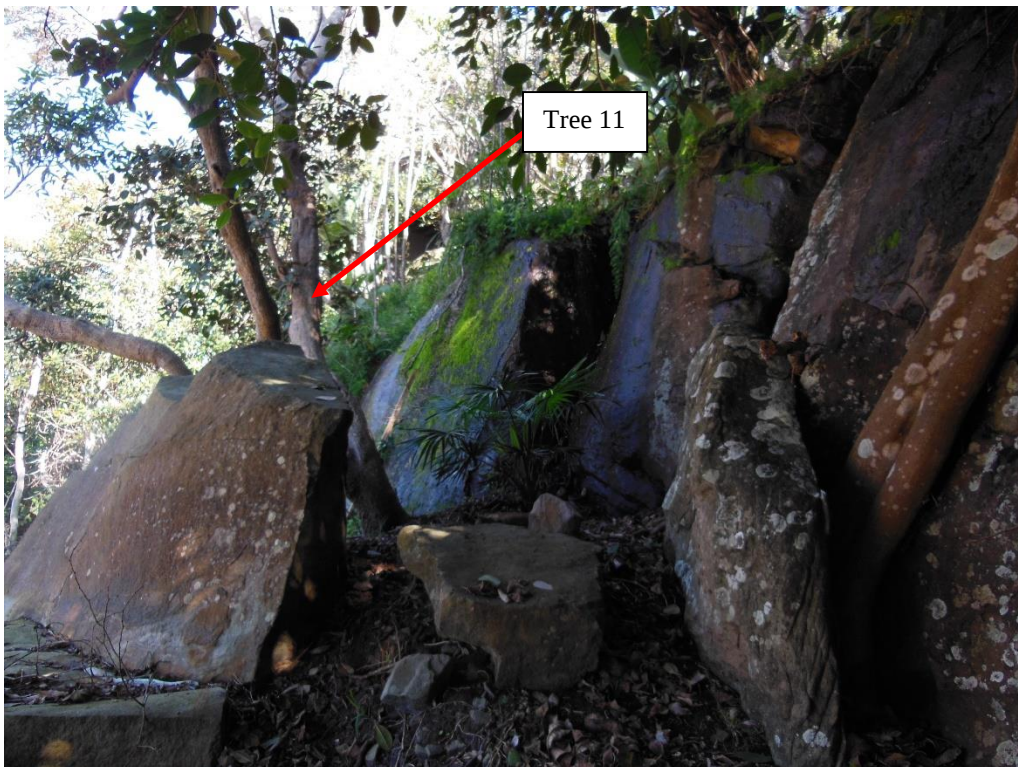
Photograph 8: Illustrating an exposed rock face and level change within the site in the vicinity of trees 10 and 11.

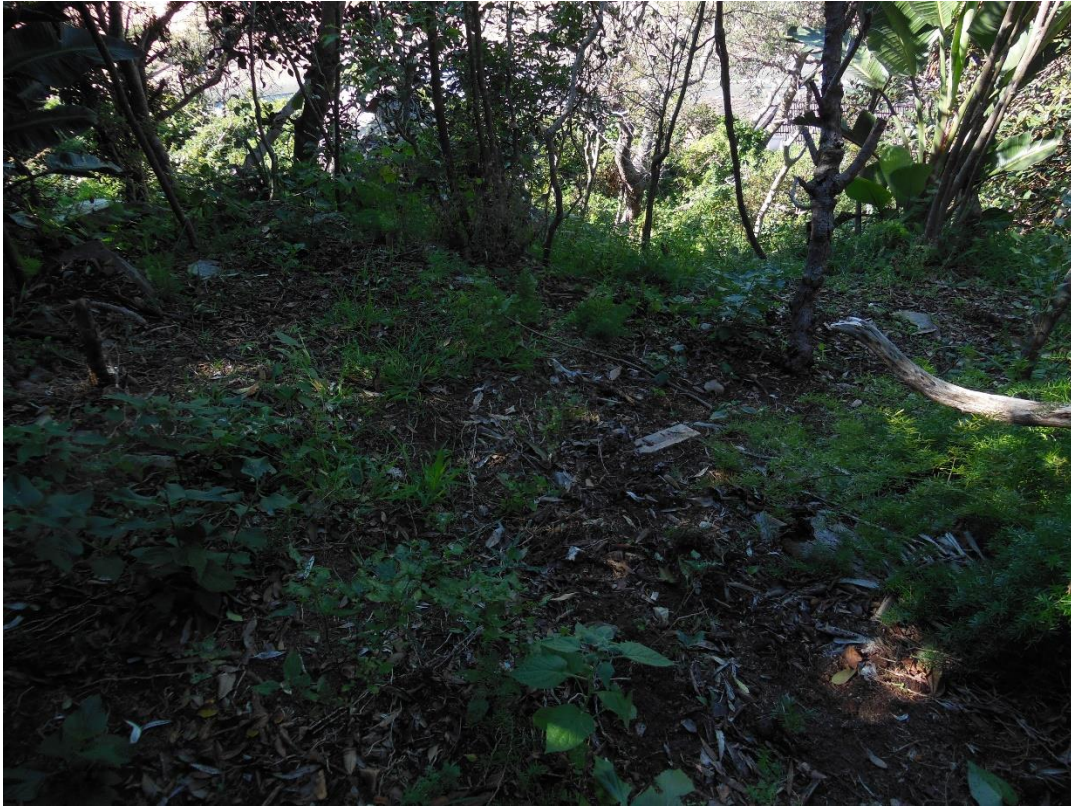
Photograph 9: Illustrating the vegetated nature of the site.

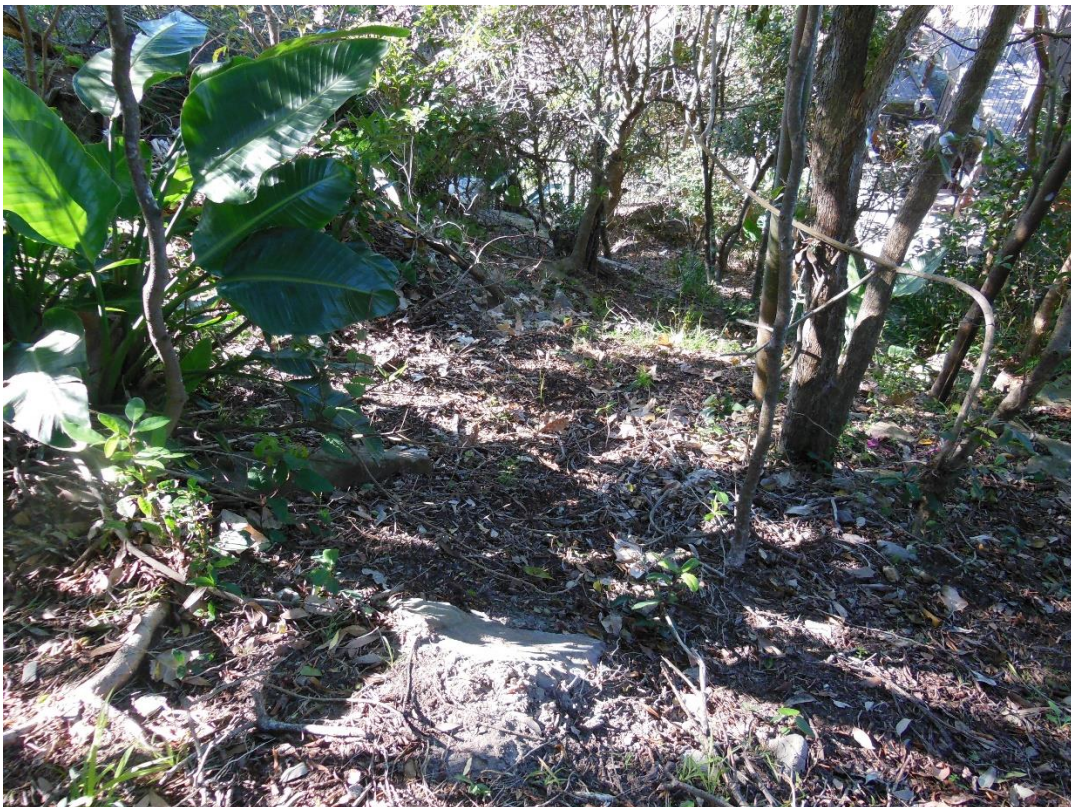
Photograph 10: Illustrating the vegetated nature of the site.
