135 Seaforth Crescent, Seaforth

Comments on updates to Plans

GEOTECHNICAL INVESTIGATION:

New Pool and Decks at 135 Seaforth Crescent, Seaforth

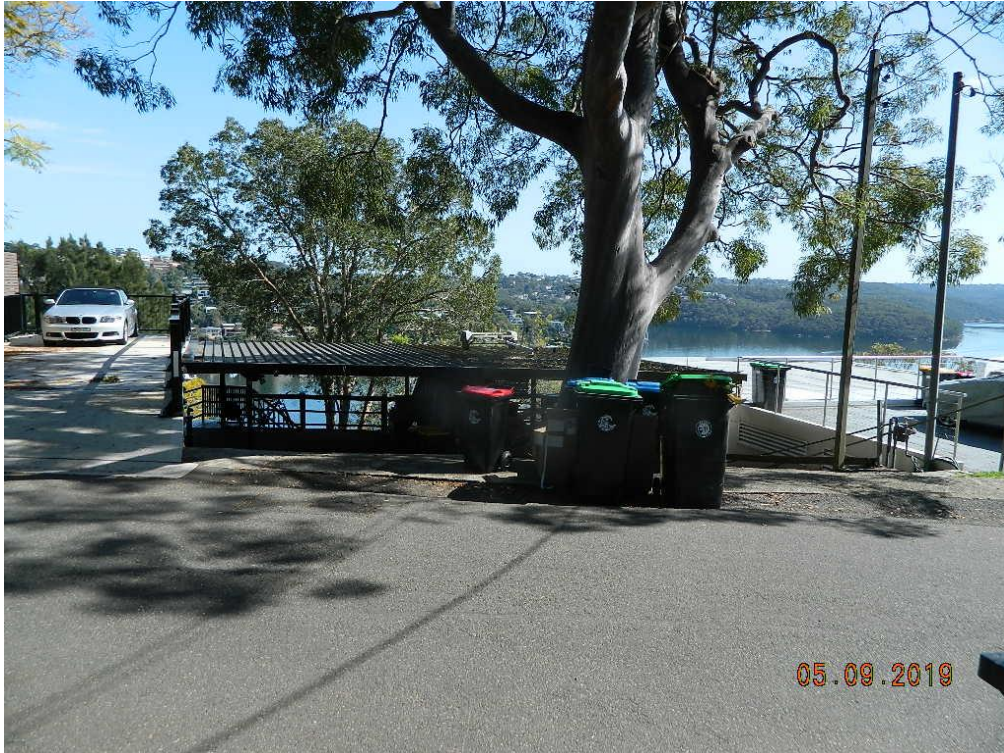
Photo 1

- 2.3** At the road frontage, a concrete driveway runs to a suspended carport on the uphill side of the property (Photo 1). A timber and steel stair case runs downslope from the carport to the house (Photo 2). Outcropping sandstone was observed across the entire site. The three storey timber framed and clad house continues downslope. The house is partially suspended and is supported by steel beams and concrete footings on sandstone (Photo 3). All visible footings showed no signs of movement and are considered stable. An inclined lift runs along the S boundary and rough sandstone block set of stairs along the E side of the property (Photo 4). A $\sim 3.0\text{m}$ high sloped and jointed sandstone rock face extends downslope of the house (Photo 5). The rock face is considered stable. The footprint of the suspended pool will fall over

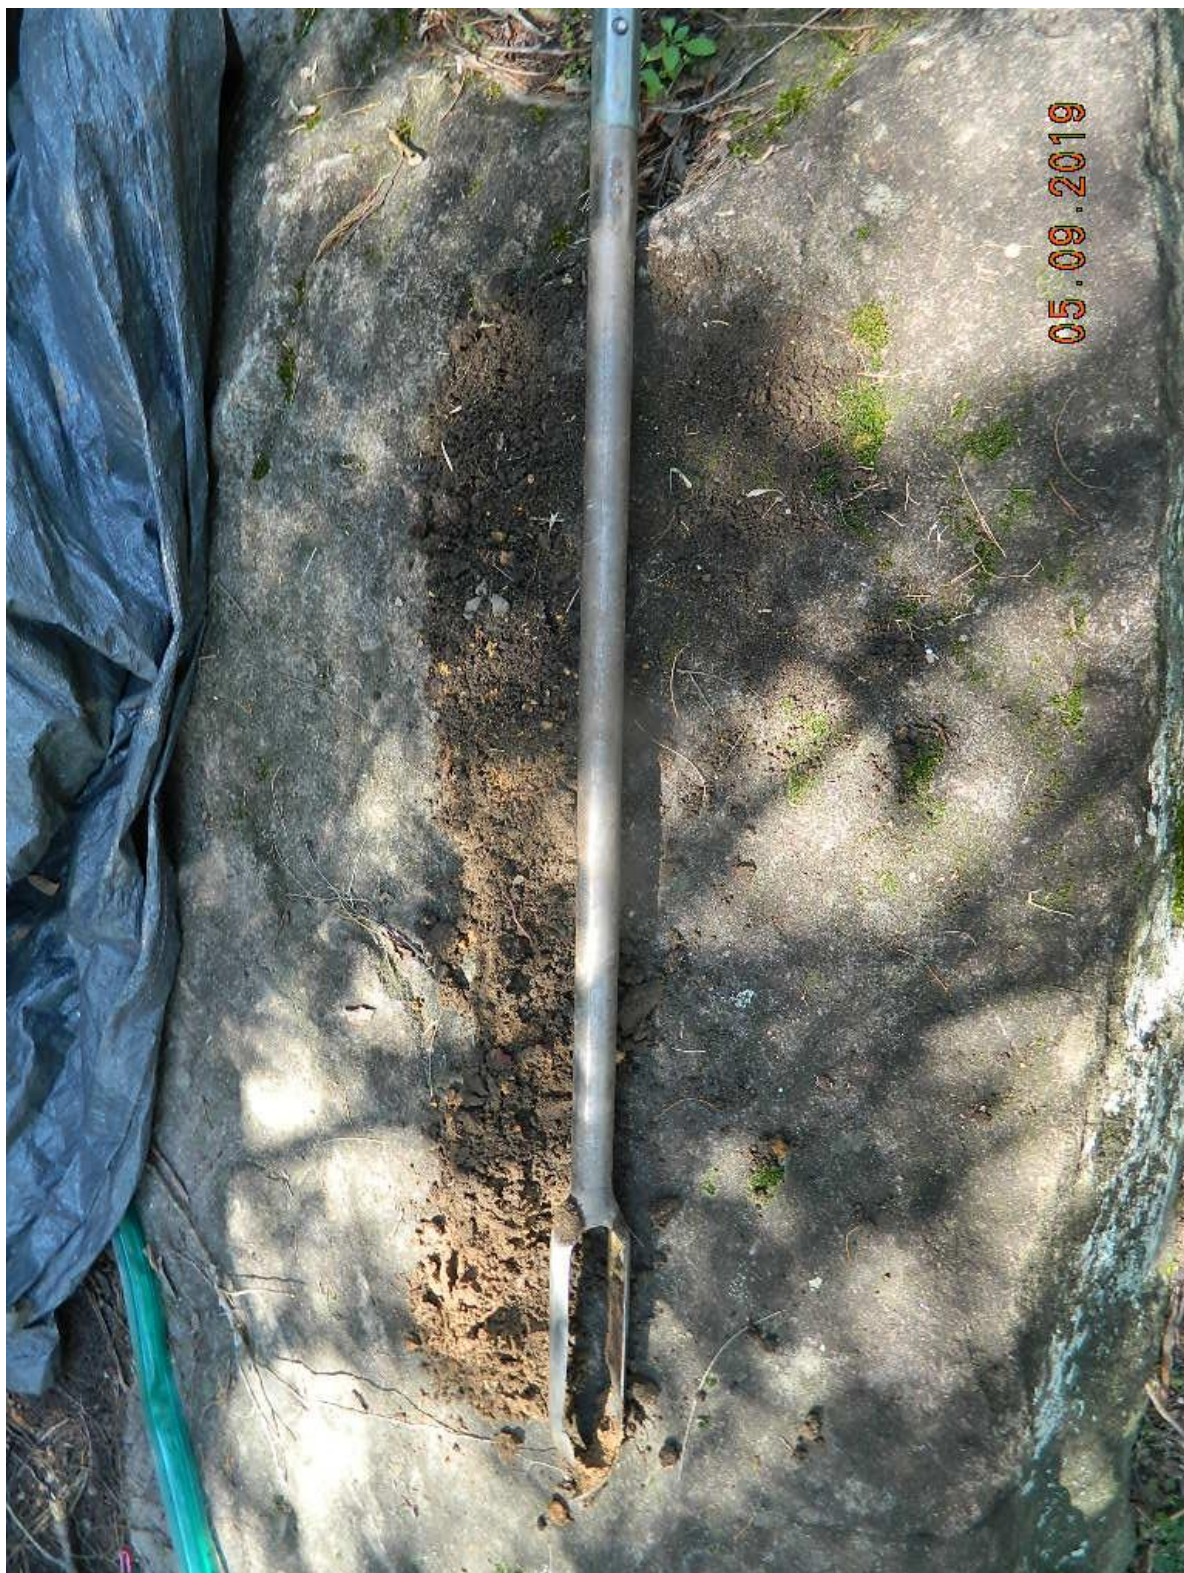
Photo 7 – AH1: Downhole is from top to bottom

AUGER HOLE 1 (~RL33.8) – AH1 (Photo 7)

Depth (m)	Material Encountered
0.0 to 1.0	Sandy Soil , brown, medium grained with sandstone fragments

Refusal @ 1.0m grinding on rock. No watertable encountered.

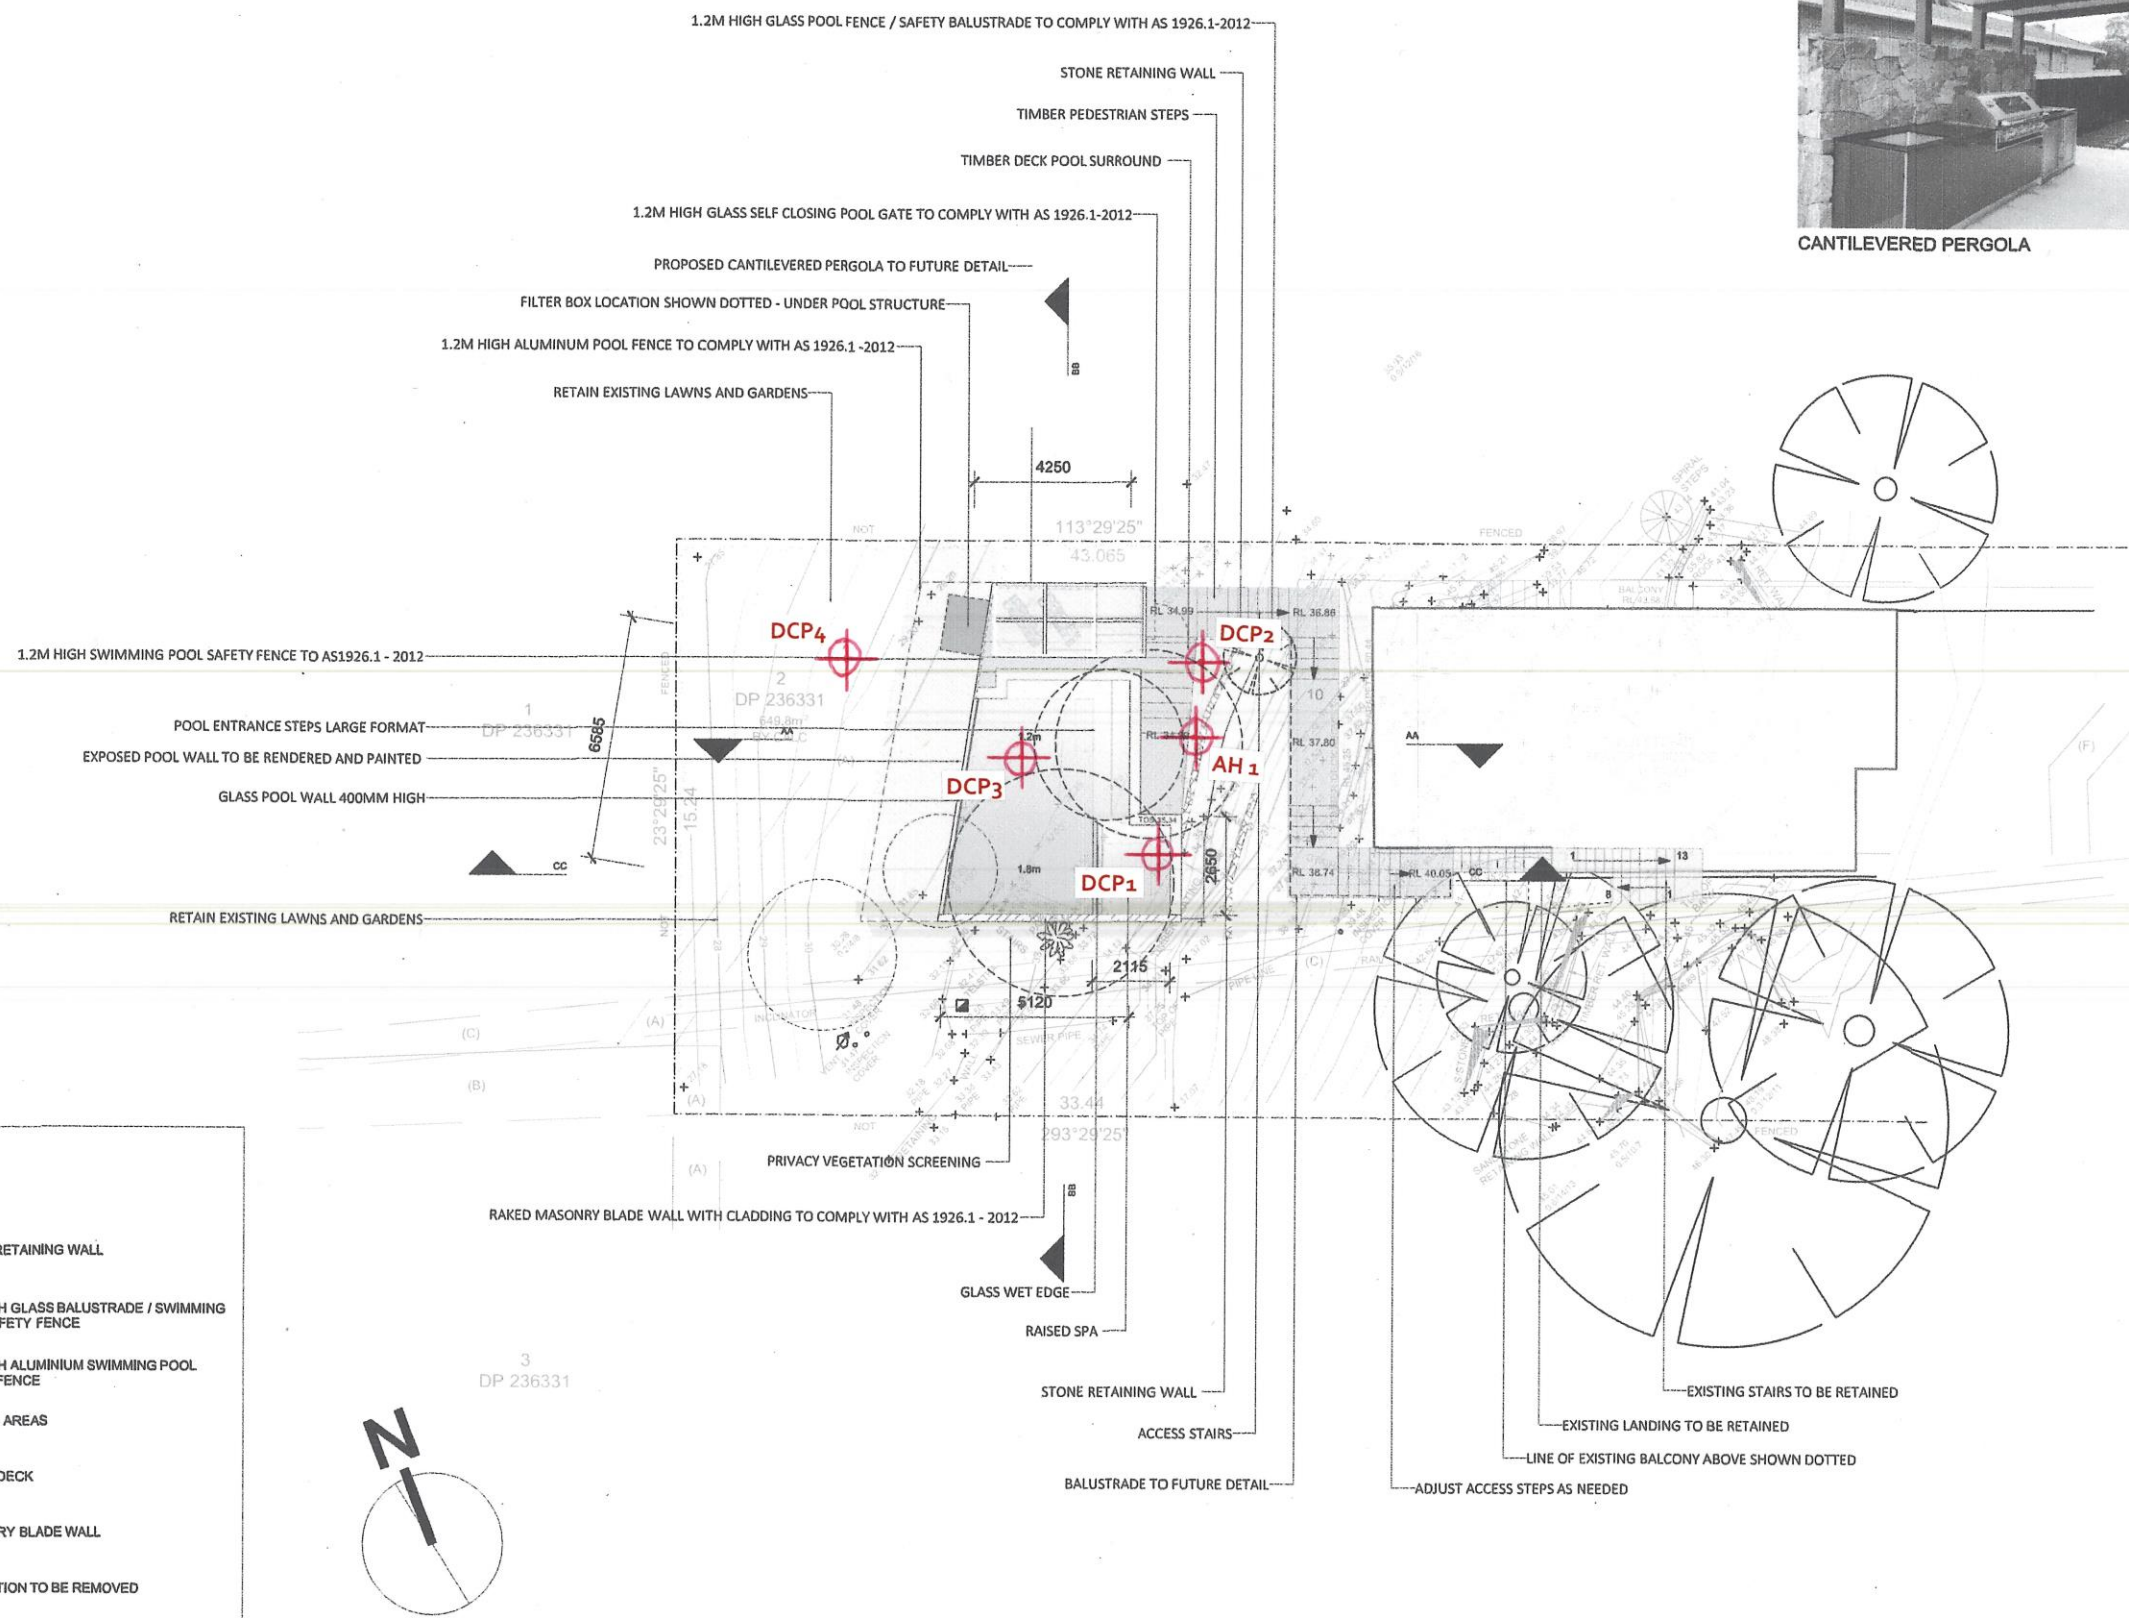
SITE PLAN – showing test locations

One auger hole was put down to identify the soil materials. Four Dynamic Cone Penetrometer (DCP) tests were put down to determine the relative density of the overlying soil and the depth to bedrock. The locations of the tests are shown on the site plan. It should be noted that a level of caution should be applied when interpreting DCP test results. The test will not pass through hard buried objects so in some instances it can be difficult to determine whether refusal has occurred on an obstruction in the profile or on the natural rock surface. This is not expected to be an issue for the testing on this site and the results are as follows:

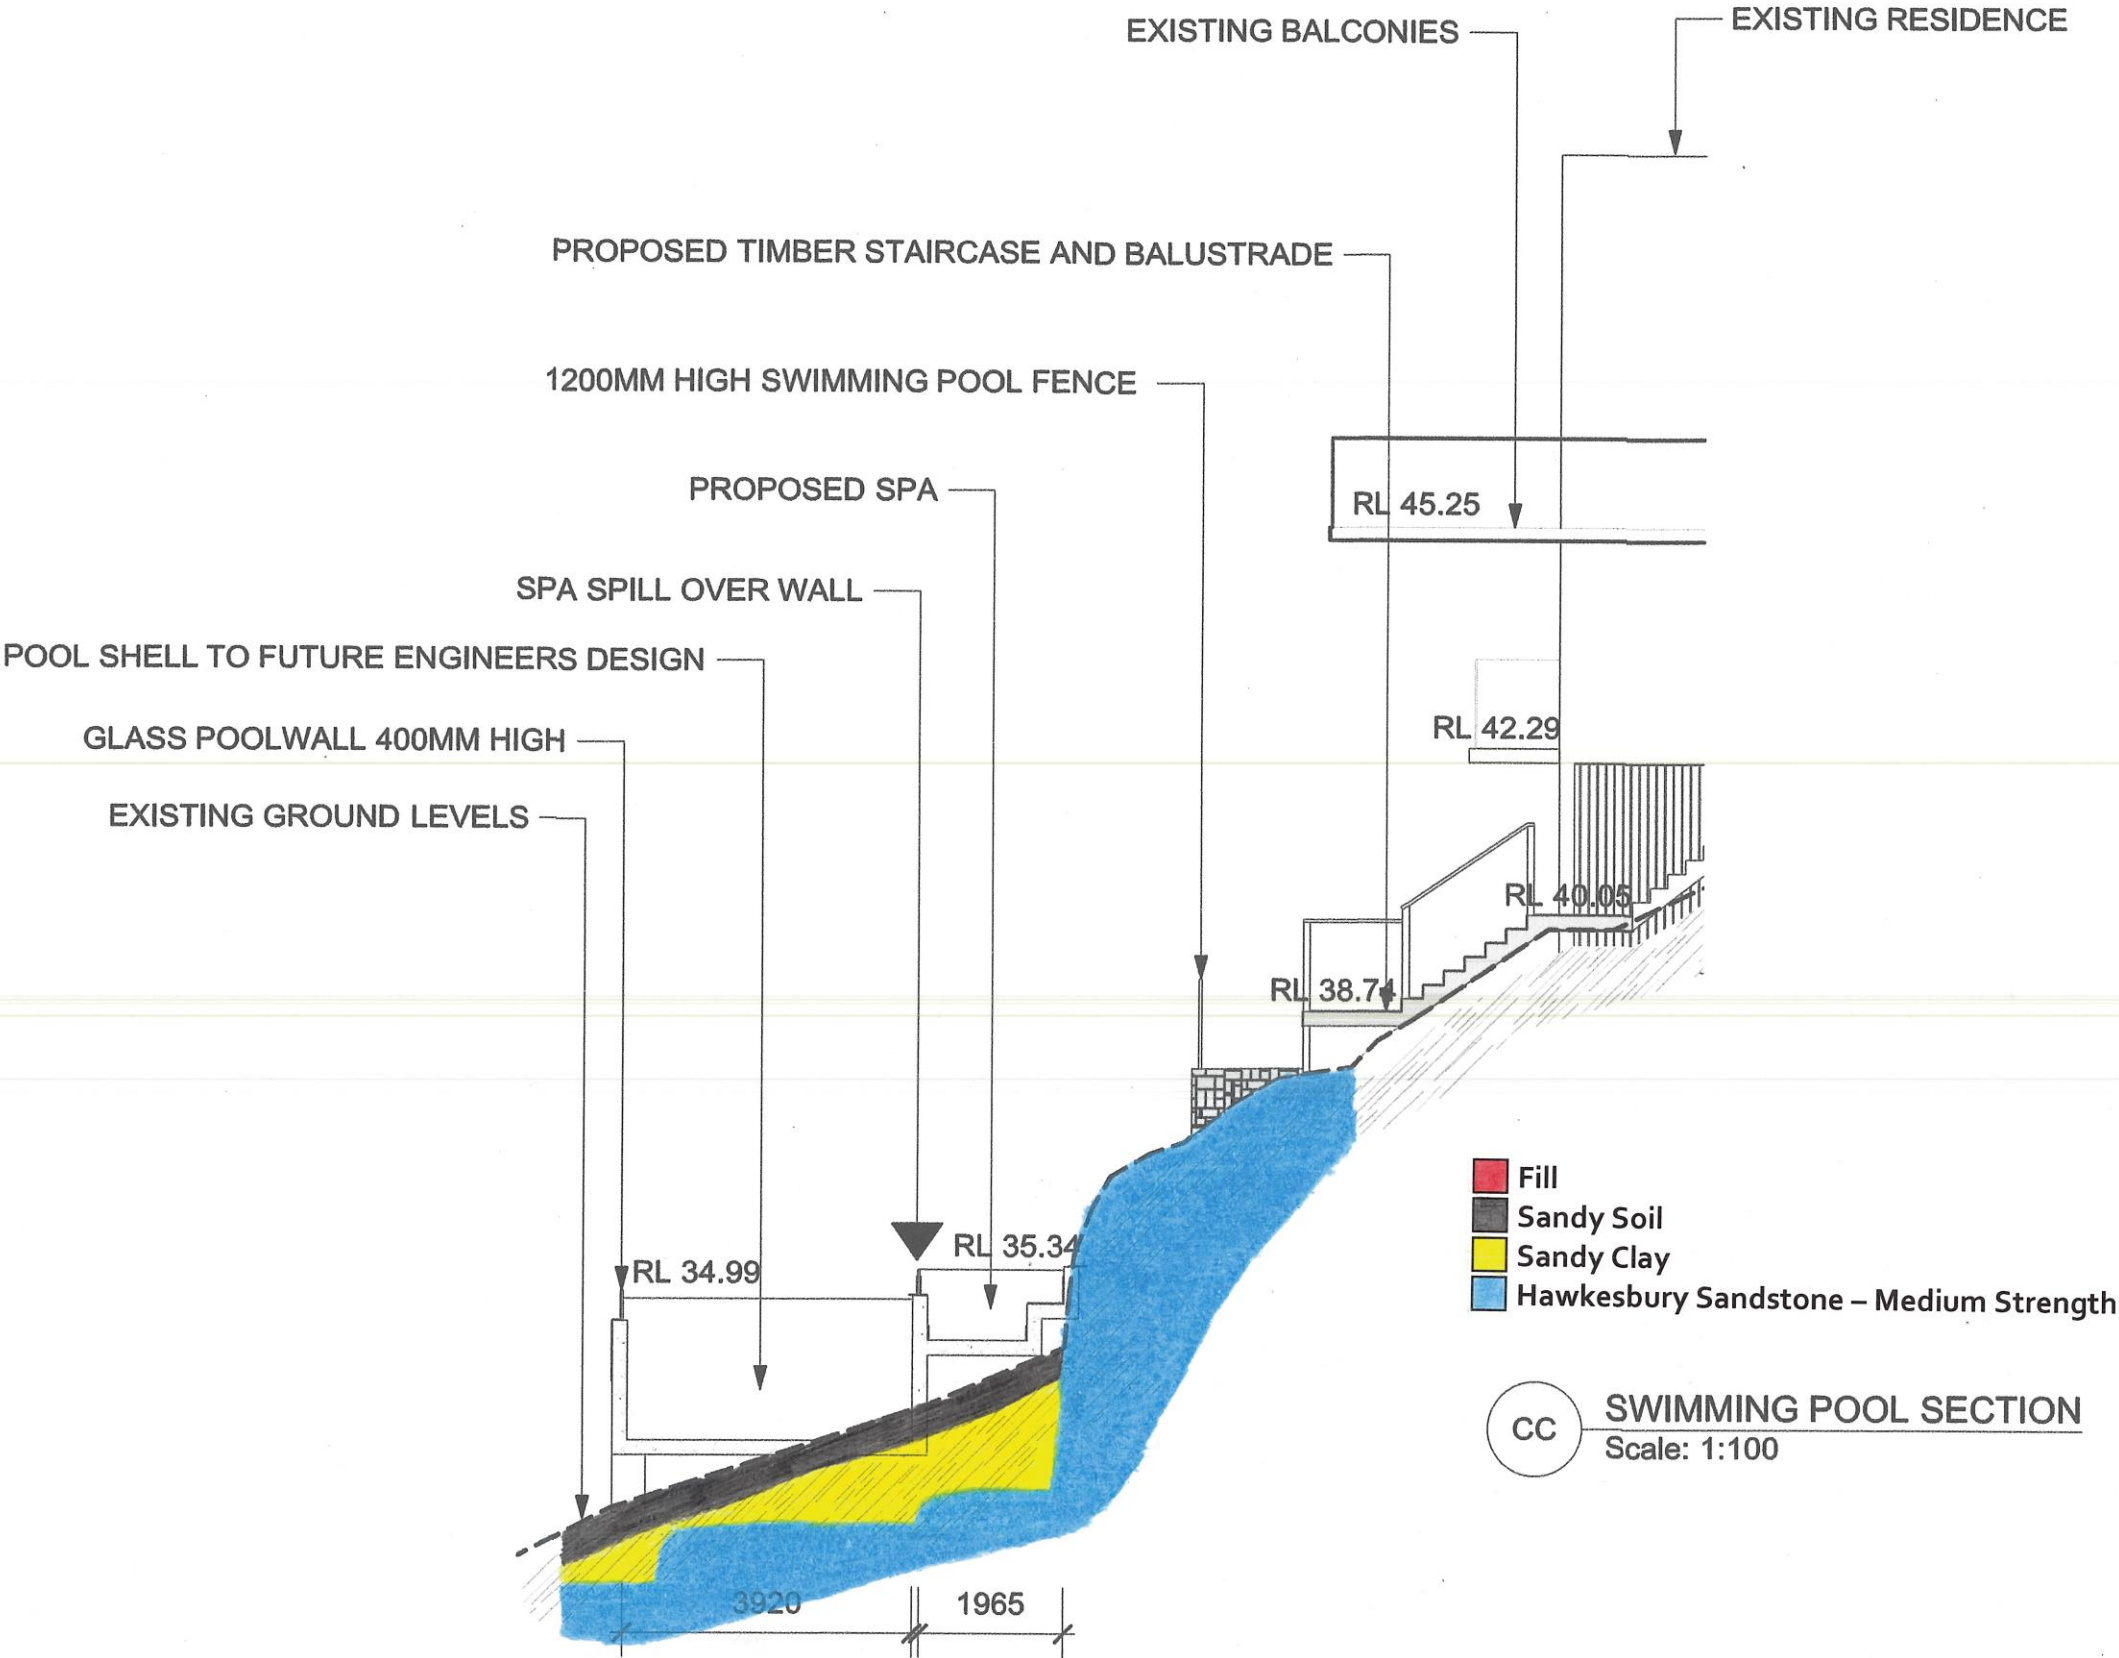
TYPE SECTION – Diagrammatical Interpretation of Expected Ground Materials

nature of the top layer of bedrock. The outcropping sandstone on the property is estimated to be Medium Strength or better and similar strength rock is expected to underlie the entire site. See Type Section attached for a diagrammatical representation of the expected ground materials.
