## **Geotechnical Assessment**

**Project:** Alterations & Additions  
25 Carrington Parade, Freshwater NSW

**REF: AG 21402**  
2 December 2021

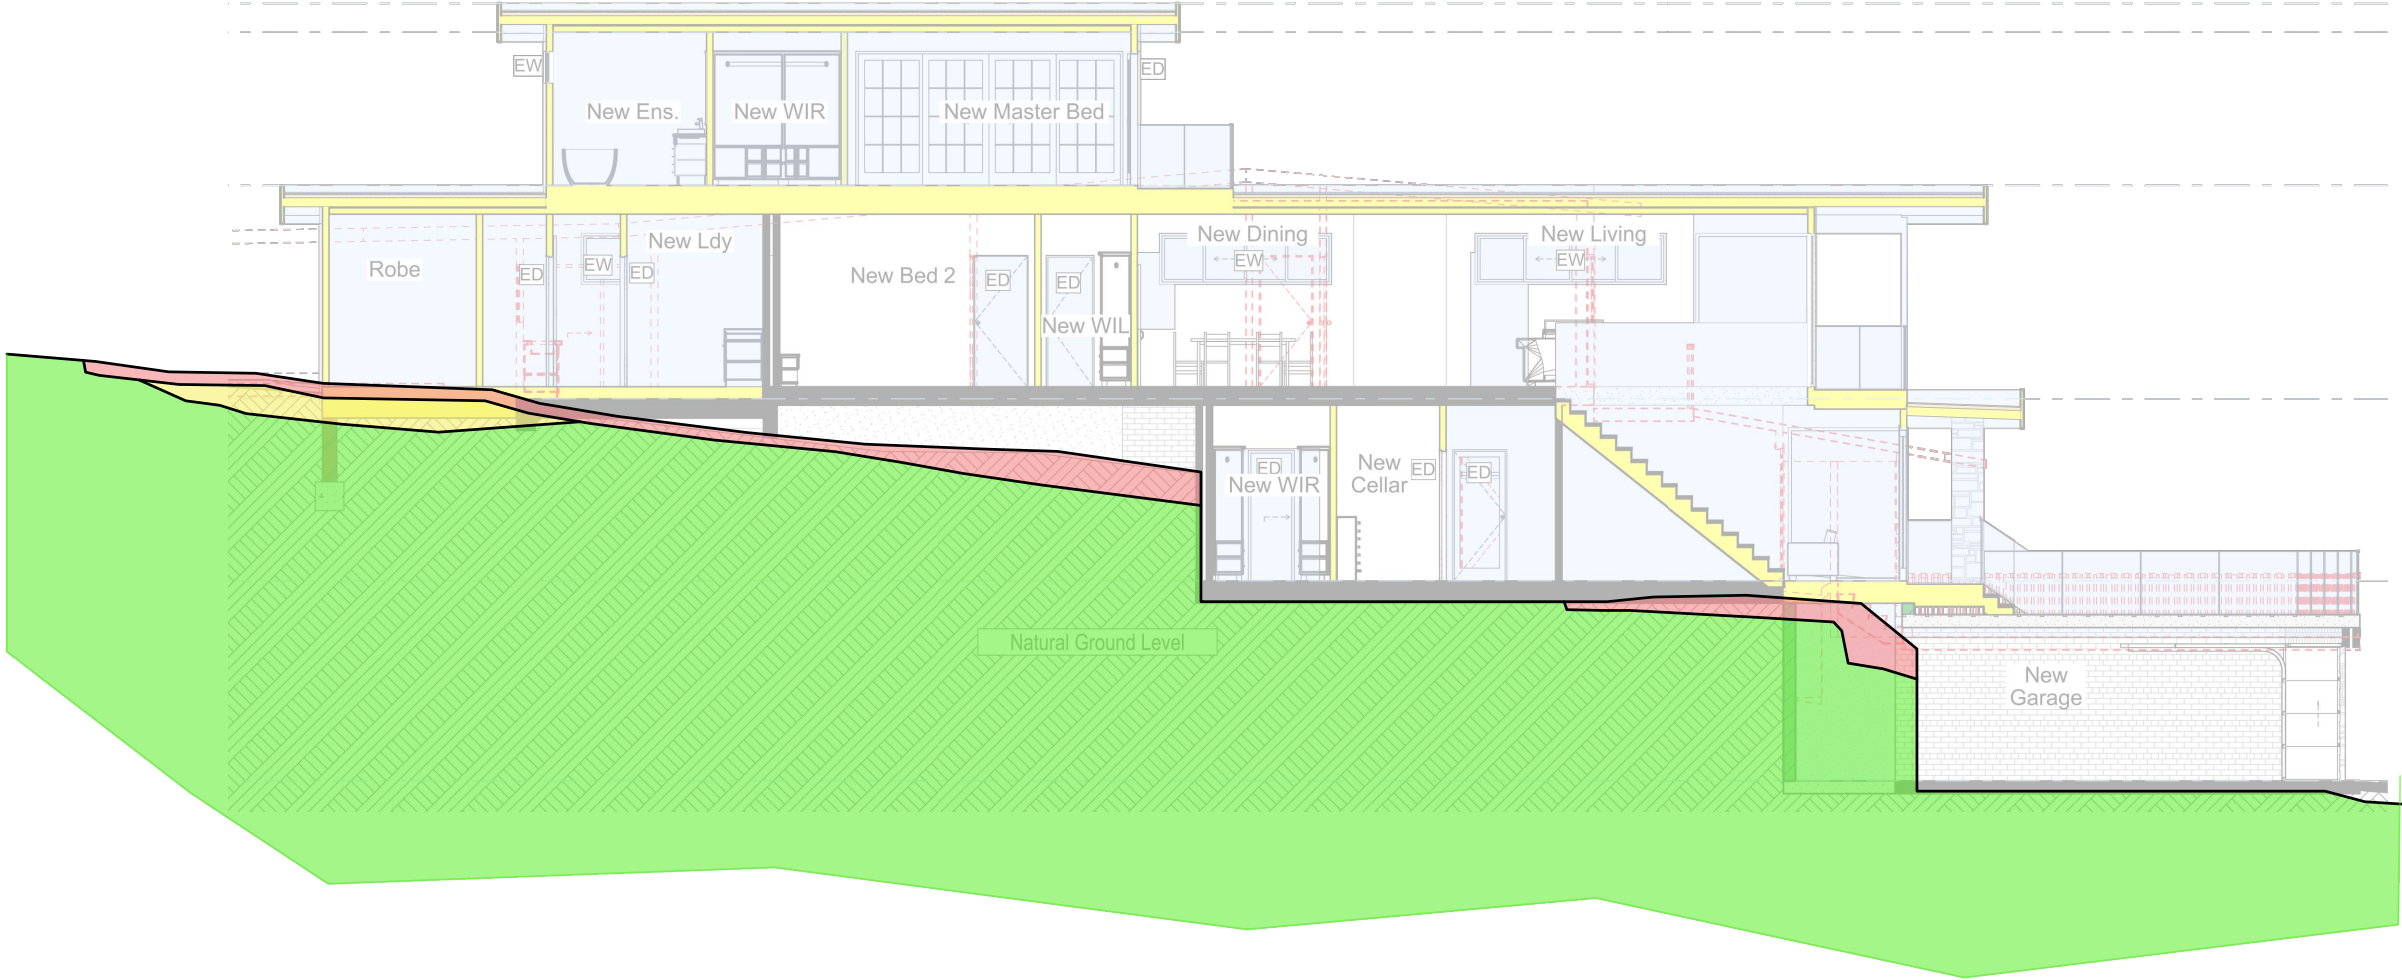
**INFERRED GEOLOGICAL SECTION**  
SCALE NTS

The soil profile consists of shallow uncontrolled sandy fill and sandy topsoil (O & A Horizons), sandy clay (B Horizon) and weathered bedrock (C Horizon). Based on our observations and the results of testing on site, we would expect weathered sandstone bedrock to be found within 0.15 to 1.0 metres below current surface levels across the area of the proposed works.

| Recommendation | Description |
|---|---|
| <b>Footings</b> | <p>All pad, strip or piered footings should be founded on and socketed a minimum of 200mm into the in situ underlying weathered bedrock. For fully cleaned footings in sandstone, the allowable bearing pressure is <b>800kPa</b>. Higher allowable bearing capacities may be achievable subject to inspection and certification by Ascent.</p> <p>Pier footings should be of sufficient diameter to enable effective base cleaning to be carried out during construction. Small diameter piers that cannot be cleaned should be designed for shaft friction, resulting in a longer rock socket.</p> <p>No footings are to be placed on undercut or cantilevered rock. Vertical excavations through sandstone should maintain a minimum setback of 500mm from any existing footings.</p> <p>To mitigate the risk of differential settlement, it is essential that all footings are founded on competent bedrock of similar consistency. This may require excavation through sandstone floaters or the relocation of planned footings.</p> <p><b>It is essential that the foundation materials of all footing excavations be inspected and approved before steel reinforcement and concrete is placed. This inspection should be scheduled while excavation plant and operators are still on site, and before steel reinforcement has been fixed or the concrete booked.</b></p> |
