Geotechnical Assessment

Project: Alterations & Additions
7 Crown Road, Queenscliff NSW

REF: AG 21256

24 August 2021

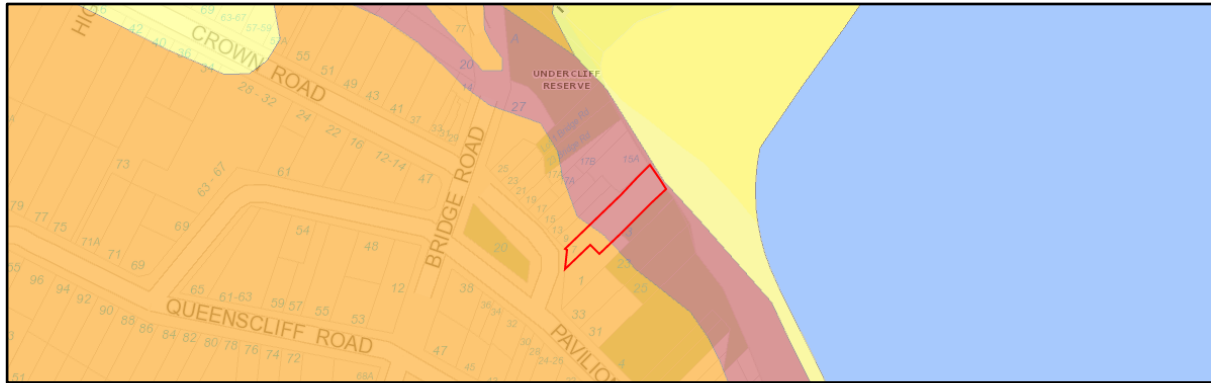
Image 2. WLEP Landslip Risk Map
– 7 Crown Road, Queenscliff NSW

- No evidence of significant soil creep, tension cracks or landslip instability were identified across the site or on adjacent properties as viewed from the subject site at the time of our inspection.
- The property is classified as **Areas B & C** with reference to Northern Beaches Council WLEP – Warringah Landslip Risk Map (**Image 2**).

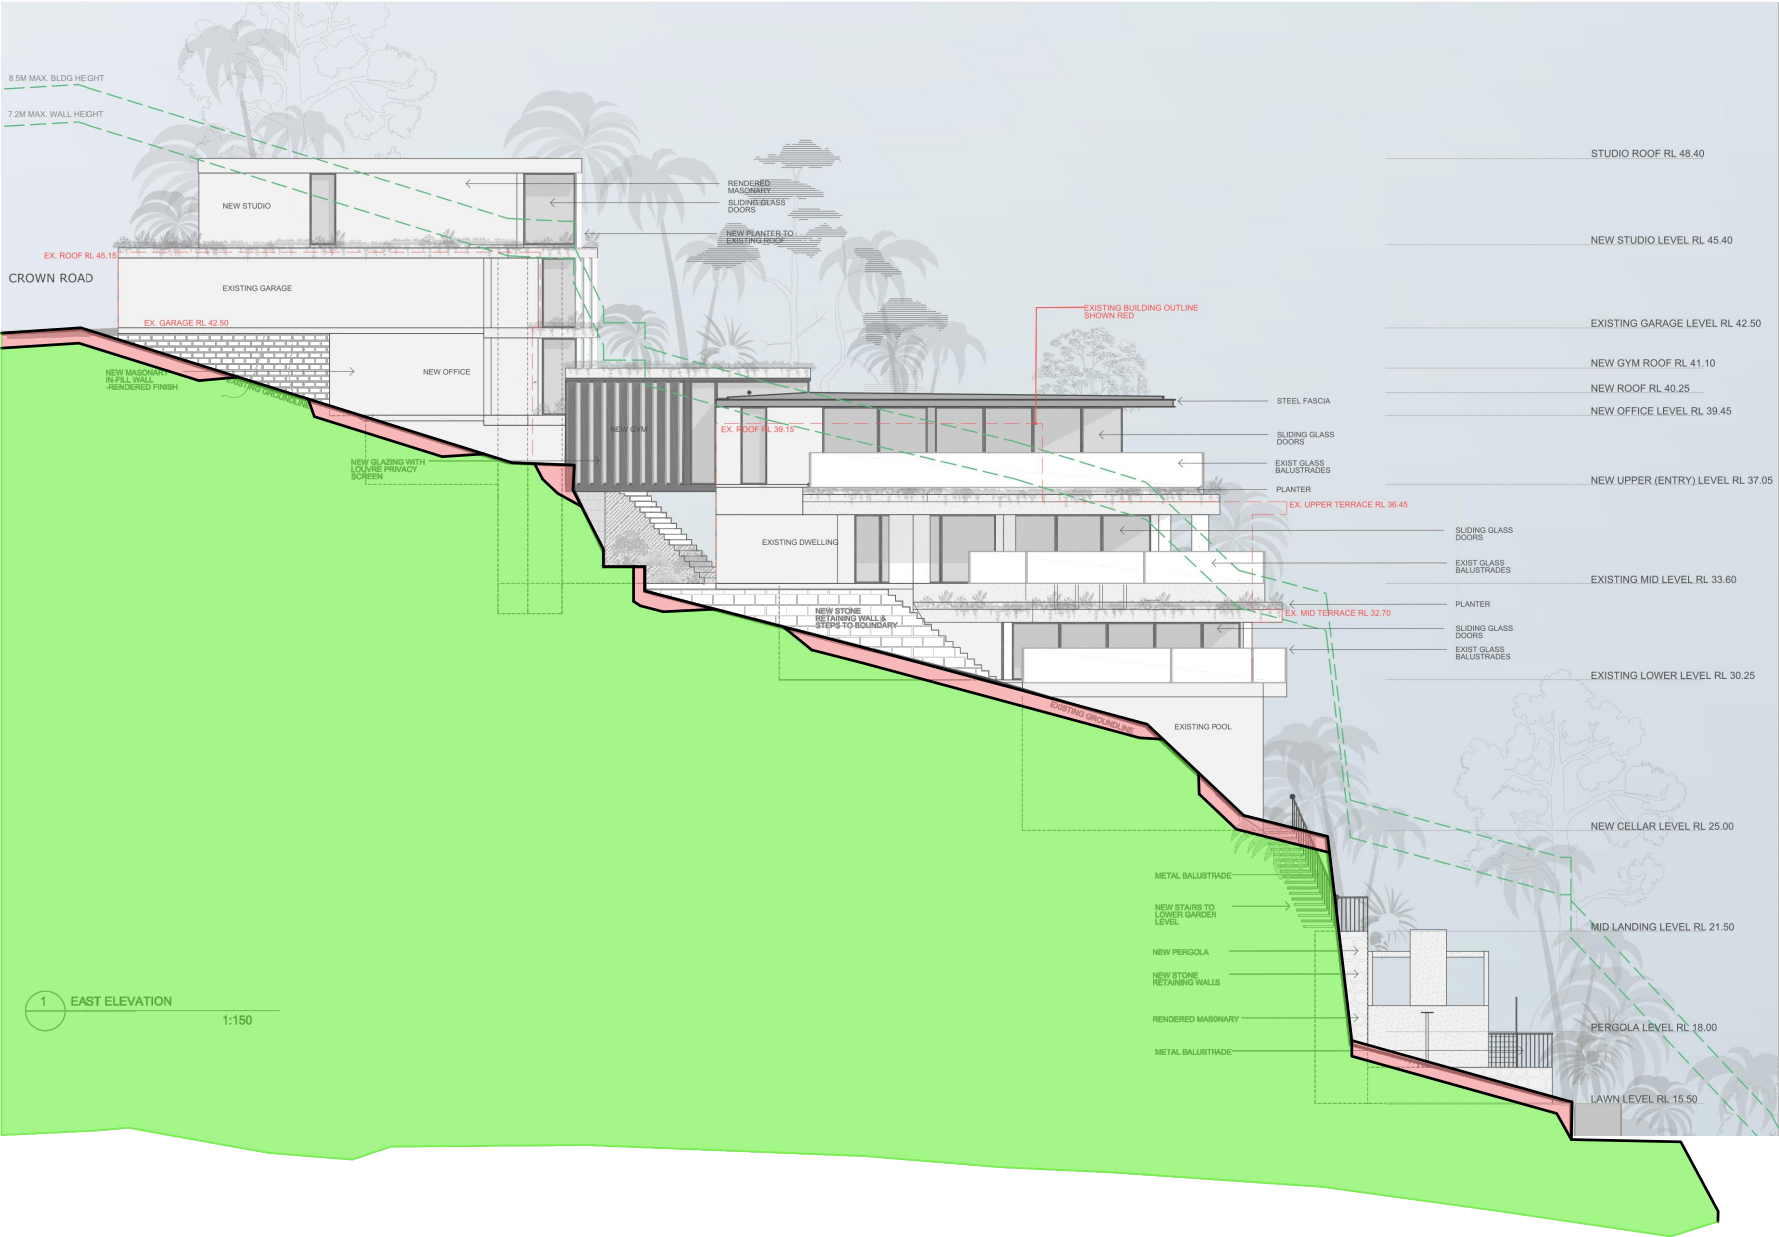
INFERRED GEOLOGICAL SECTION
SCALE NTS

INTERPRETED SUBSURFACE SECTION ONLY.
ACTUAL GROUND CONDITIONS MAY VARY.
