## AS2870-2011 SITE CLASSIFICATION

No.183 Barrenjoey Road, Newport NSW

Our REF: AWT61715

AS2870 Site Classification

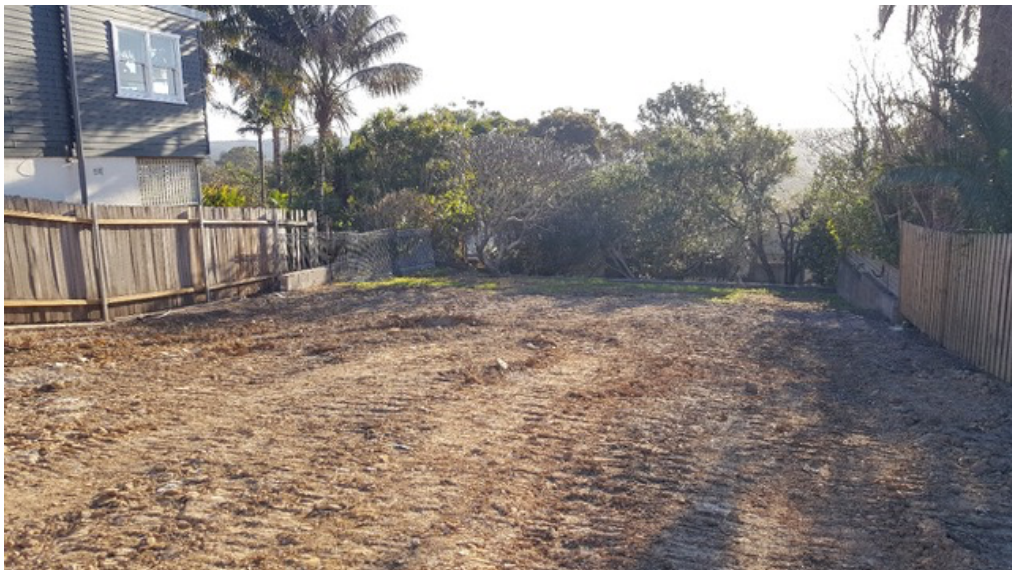
### SITE PHOTO:

Site Features:	Vacant site with grasses and trees
Site Drainage:	Poor (At time of testing)
Ground Slope	Gentle
Proposed Earthworks:	Assume 50/50% Cut/Fill
Ips Value:	TS2 (700-1000 mm) = 2.6%
$y_s$ :	31-40mm
$H_s$ :	1800mm
Water Table/Seepage:	Not present
Fill:	Yes (uncontrolled)
Rock:	Yes (1000mm at TS1 and 1600mm at TS2)
Slope Instability Assessment:	Not commissioned
