Report Title: Geotechnical Report 1 Livistona Lane, Palm Beach

Report Date: 23/4/25

## **GEOTECHNICAL INVESTIGATION:**

### **New Decking at 1 Livistona Lane, Palm Beach**

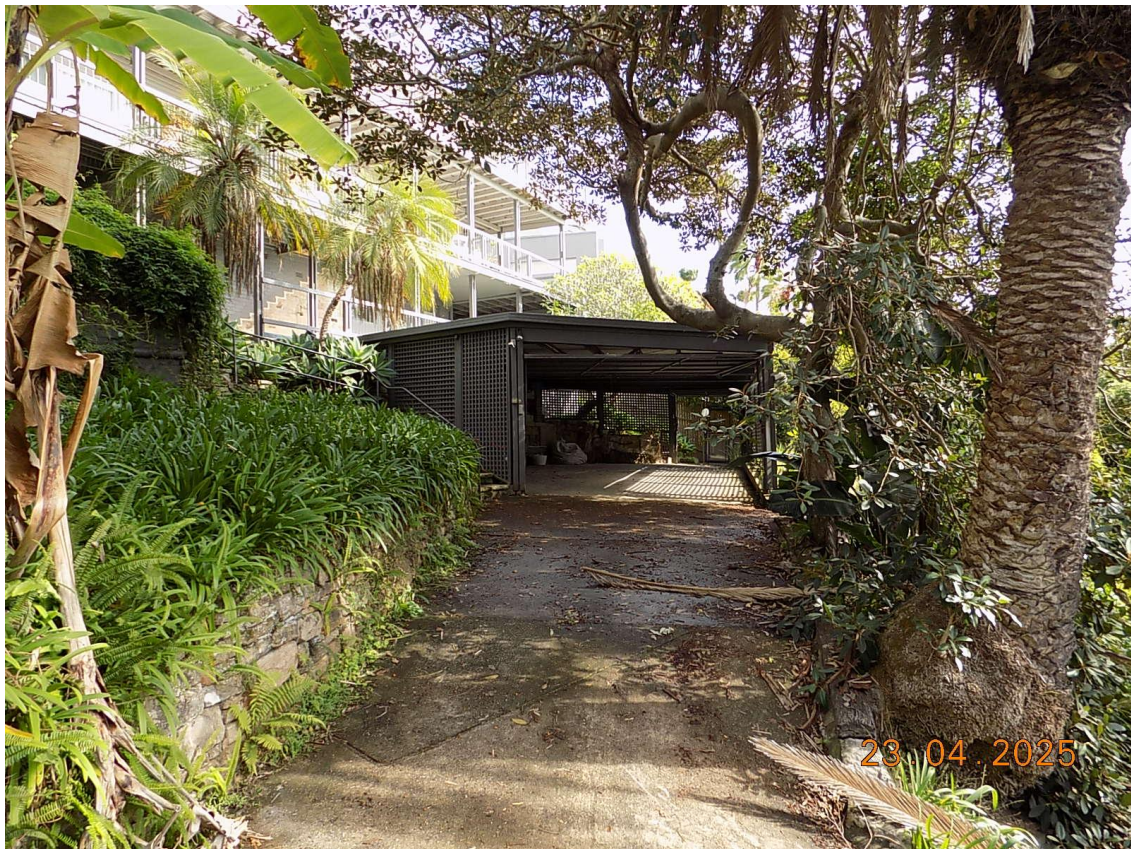
Photo 1

- 2.3** At the road frontage, a concrete driveway runs up and across the slope to a carport between the road frontage and the house (Photo 1). Cuts and fills for the driveway and landscaping in this location are terraced in stable retaining walls of dry stack stone composition reaching  $\sim 1.0\text{m}$  high. A cut for the carport on the uphill side is supported by stable retaining walls of mortared and dry stack sandstone, and concrete crib construction reaching  $\sim 1.8\text{m}$  high (Photo 2). Cracking through the mortar was observed in some locations (Photo 2). To maintain ongoing stability, these walls require occasional maintenance which may involve re-mortaring/restacking. Fill

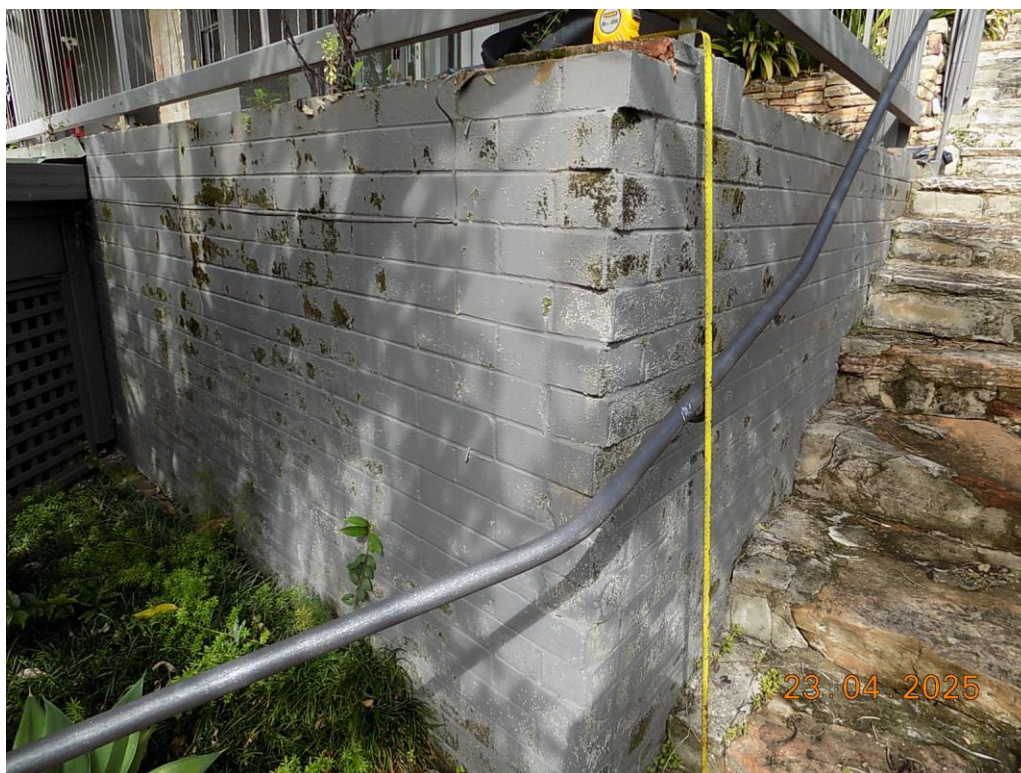
Photo 3

for formwork for the concrete terrace between the carport and the house is supported by a stable brick retaining wall reaching ~1.6m high (Photo 3). The part three-story timber clad house is supported on brick walls. No significant signs of movement were observed in the visible supporting walls. A cut for the ground floor of the house has been taken through Low to Medium Strength Sandstone which outcrops and steps up the slope (Photo 4). Similar strength rock was also observed in a cut face on the S neighbouring property (Photo 5). The outcropping rock was observed to be free from significant geological defects that could affect its stability. The steeply graded slope between the uphill side of the house and the uphill common boundary is a terraced garden (Photo 6). The terraces are supported by retaining walls of sandstone block, sandstone flagging and mortared sandstone construction reaching up to ~1.8m high (Photo 7). Some of these walls have been constructed with a tilt back into the slope. Cracking through the mortar was observed in places. However, these walls are also considered stable subject to ongoing maintenance.

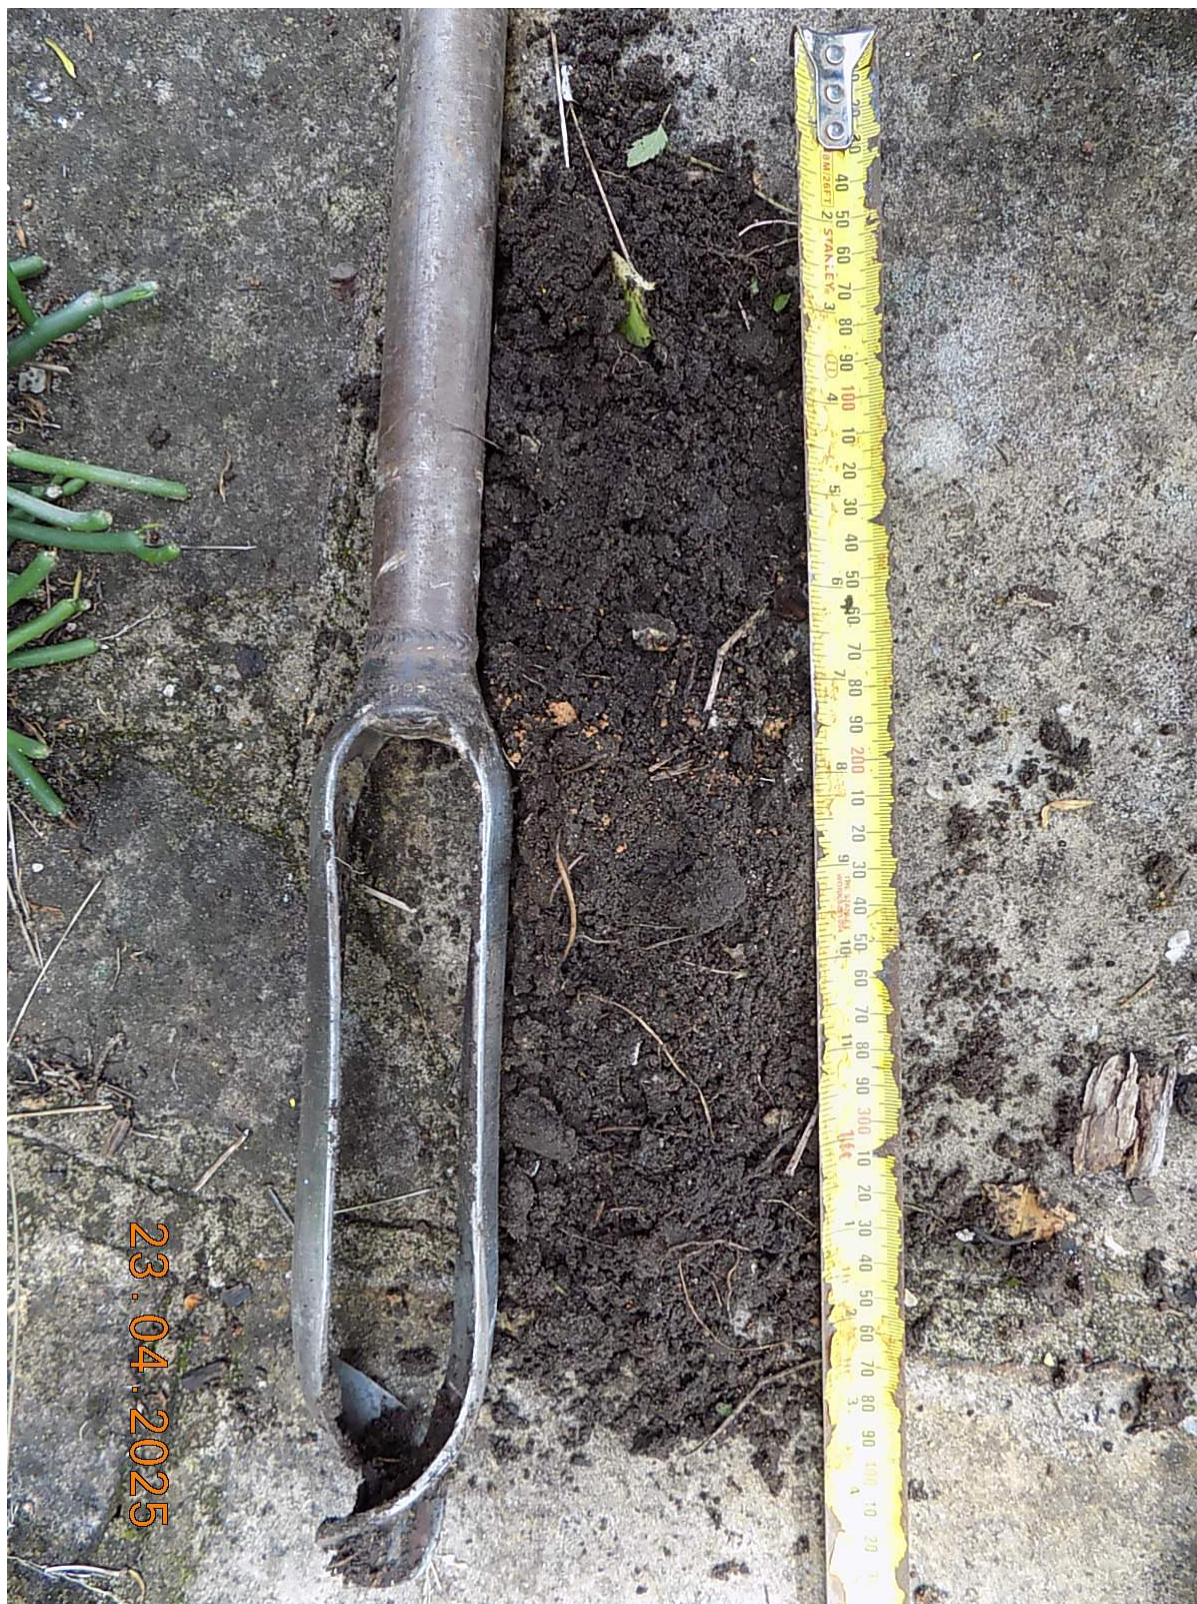
Photo 8 – downhole is top to bottom

## AUGER HOLE 1 (~RL38.1) – AH1 (Photo 8)

Depth (m)	Material Encountered
0.0 to 0.4	<b>TOPSOIL</b> , clayey soil, brown, Very Soft to Soft, damp, fine to coarse grained, sandstone fragments included.

Refusal @ 0.4m on rock. Auger grinding. No water table encountered.

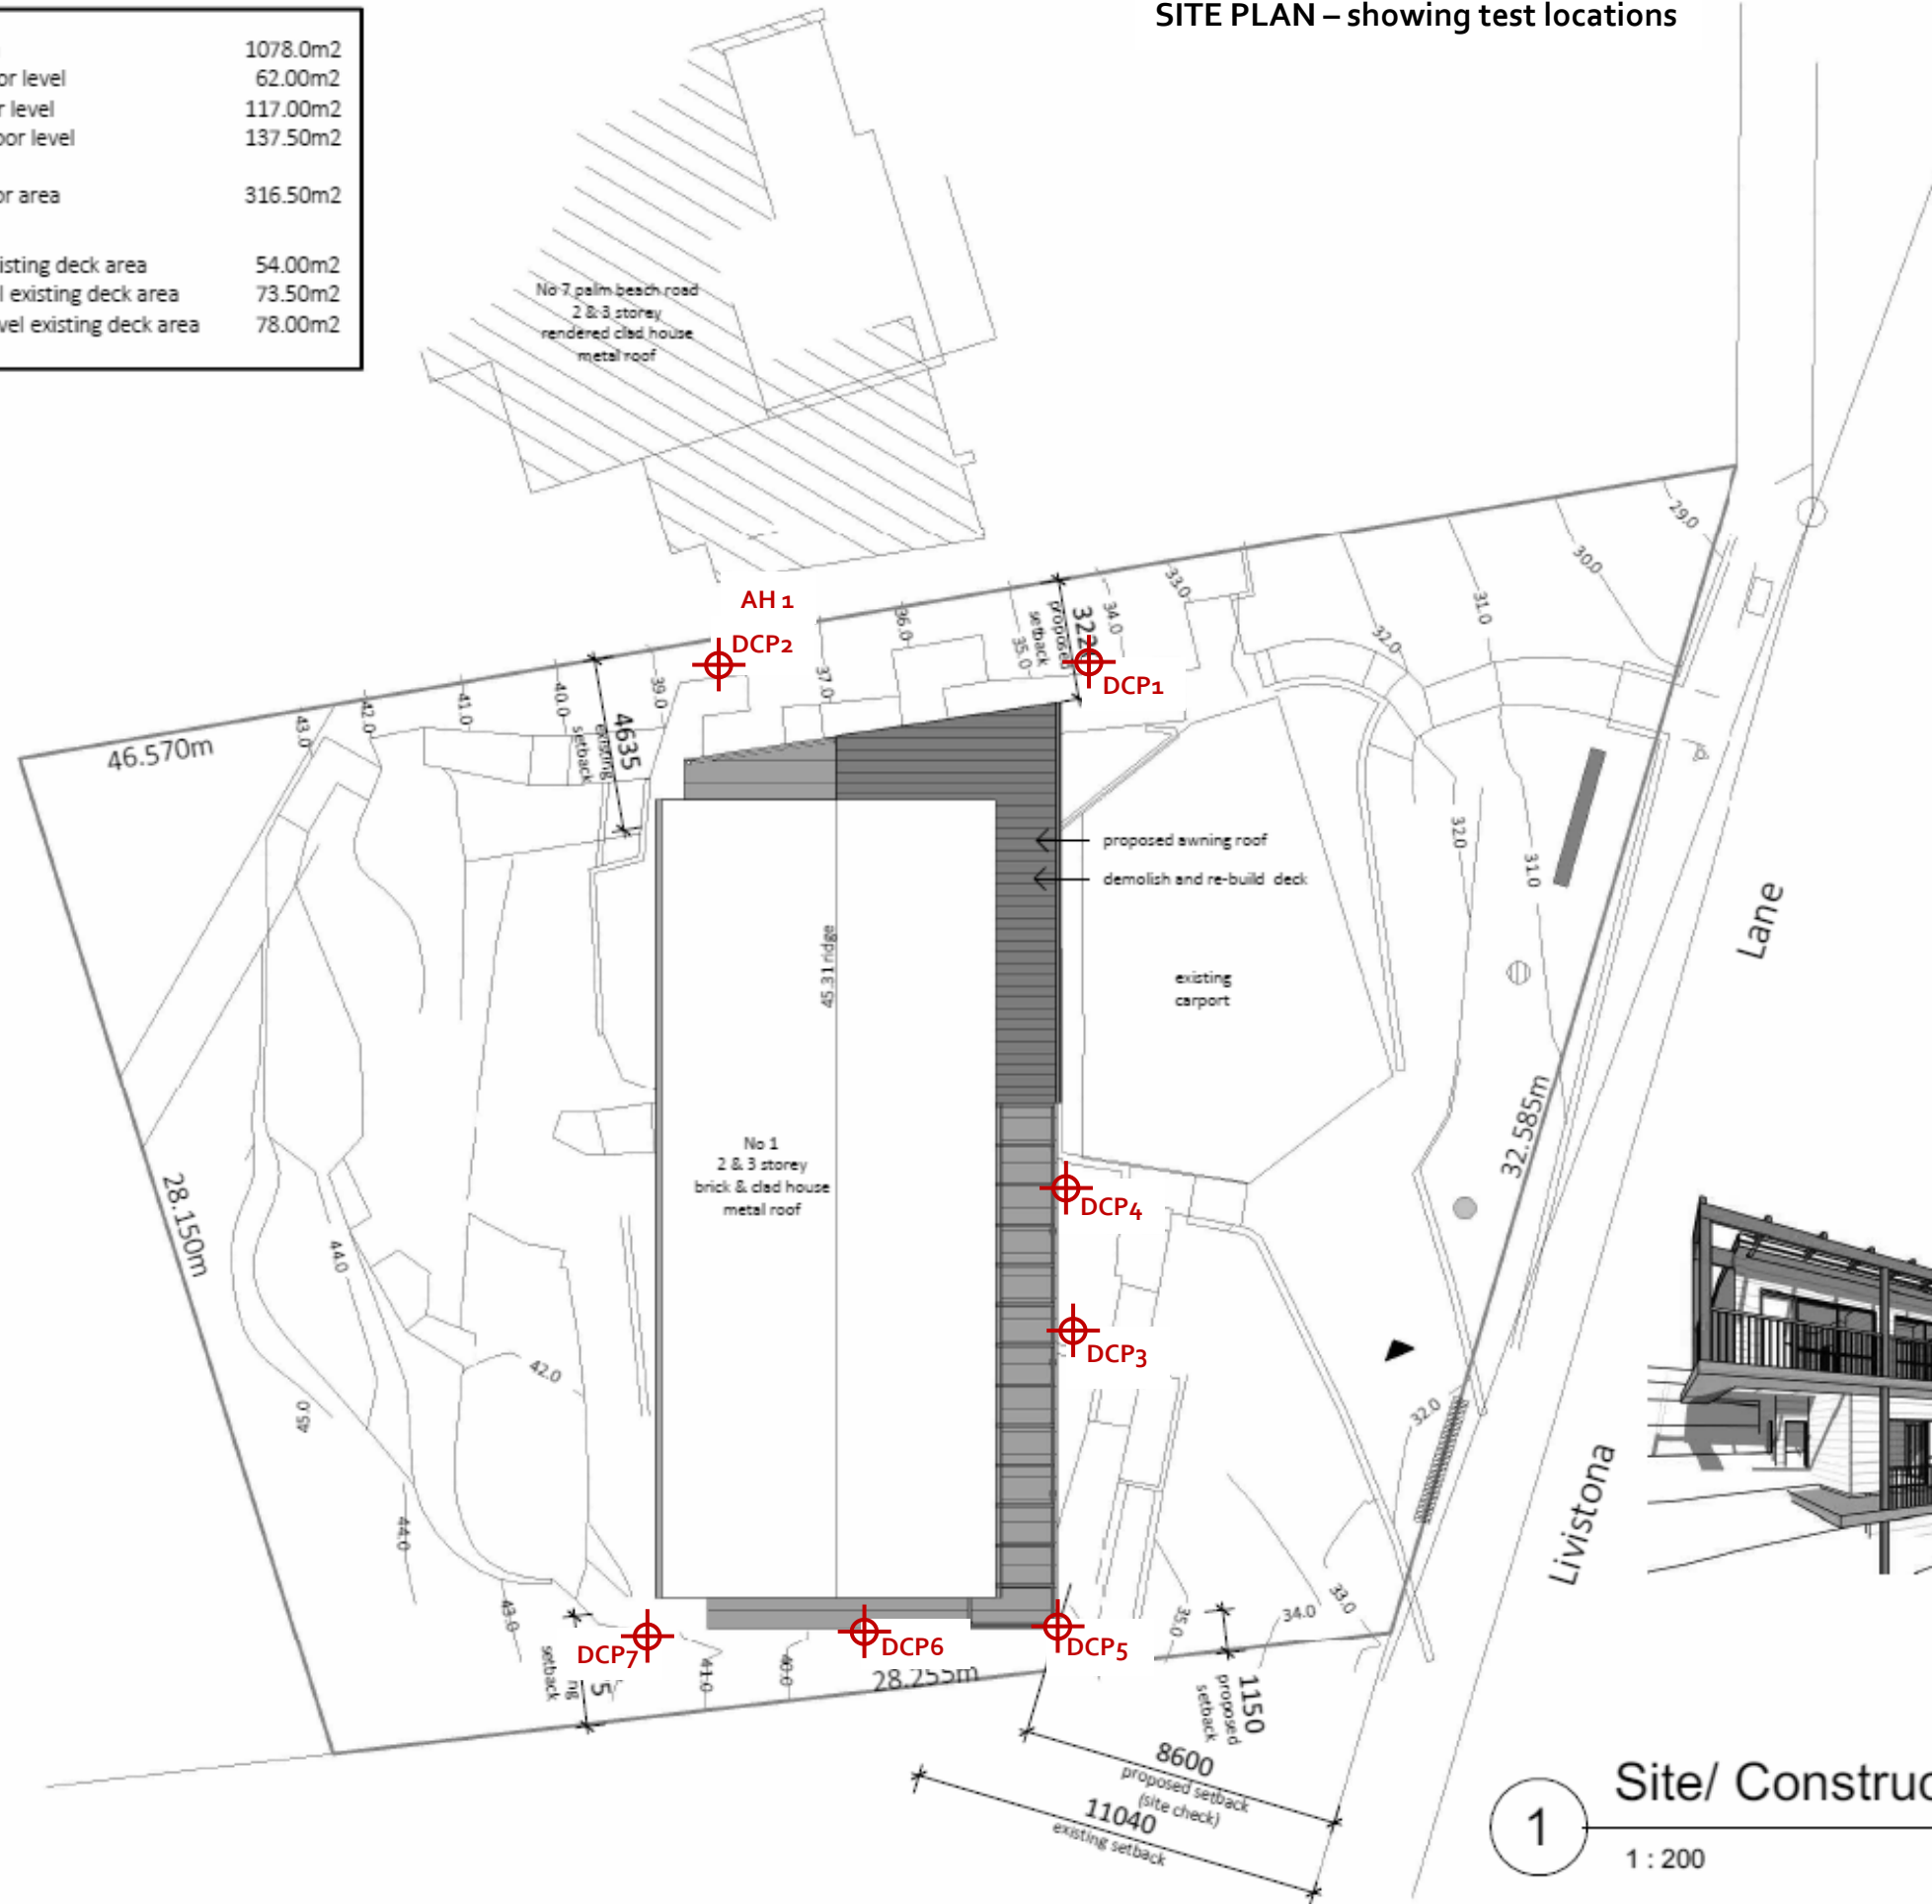
## SITE PLAN – showing test locations

One hand Auger Hole (AH) was put down to identify the soil materials. Seven Dynamic Cone Penetrometer (DCP) tests were put down to determine the relative density of the overlying soil and the depth to bedrock. The locations of the tests are shown on the site plan attached. It should be noted that a level of caution should be applied when interpreting DCP test results. The test will not pass through hard buried objects so in some instances it can be difficult to determine whether refusal has occurred on an obstruction in the profile or on the natural rock surface. This is not expected to have been an issue for this site. But due to the possibility that the actual ground conditions vary from our interpretation there should be allowances in

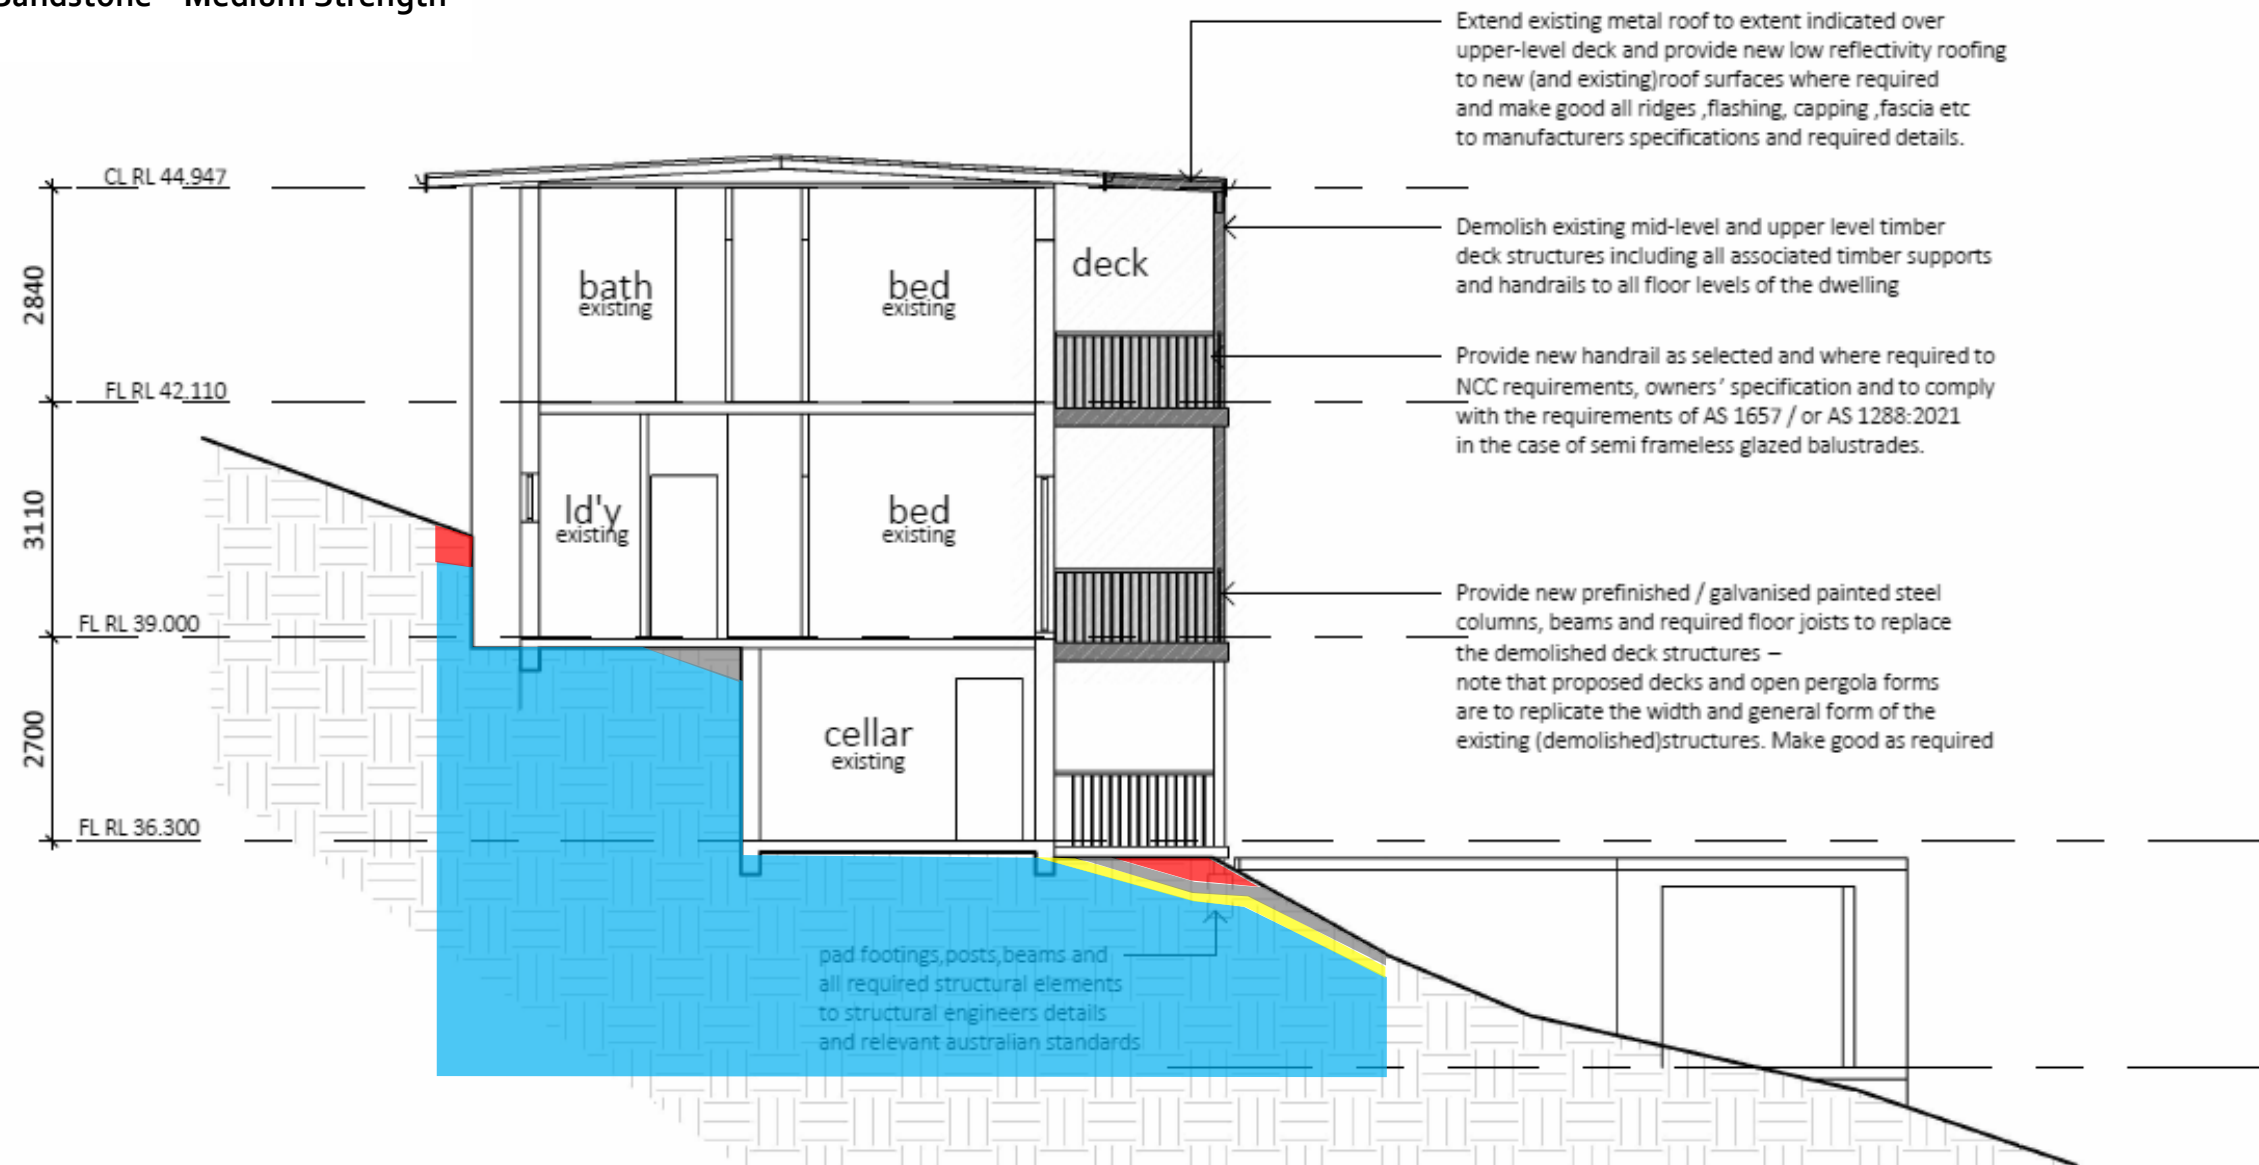
Expected Ground Materials

The surface features of the block are controlled by the outcropping and underlying sandstone bedrock that steps up the property forming sub-horizontal benches between the steps. Where the grade is steeper, the steps are larger and the benches narrower. Where the slope eases, the opposite is true. Where the rock is not exposed, it is overlain by shallow soils over clays that fill the bench step formation. Filling has been placed above and below the house for landscaping to a height of ~1.8m. In the test locations, where the rock is not exposed, it was encountered at depths of between 0.2m to 1.1m below the current surface, being slightly deeper due to the presence of fill and the stepped nature of the underlying bedrock. The outcropping sandstone on the property is estimated to be Medium Strength, with some areas of Low Strength Rock. This material was exposed in a cut face on the S neighbouring property at the time of inspection (Photo 5). Medium Strength Sandstone is expected to underlie the proposed works, as all the DCP tests bounced at refusal. See Type Section attached for a diagrammatical representation of the expected ground materials.

- Fill
- Topsoil
- Clay
- Hawkesbury Sandstone – Medium Strength
